Civil & Structural Engineering Design Services Pty. Ltd.

D-11-267736

Re: Preliminary Geotechnical Assessment – Proposed Alterations & Additions at 13 Hyndes Places, Davidson, NSW

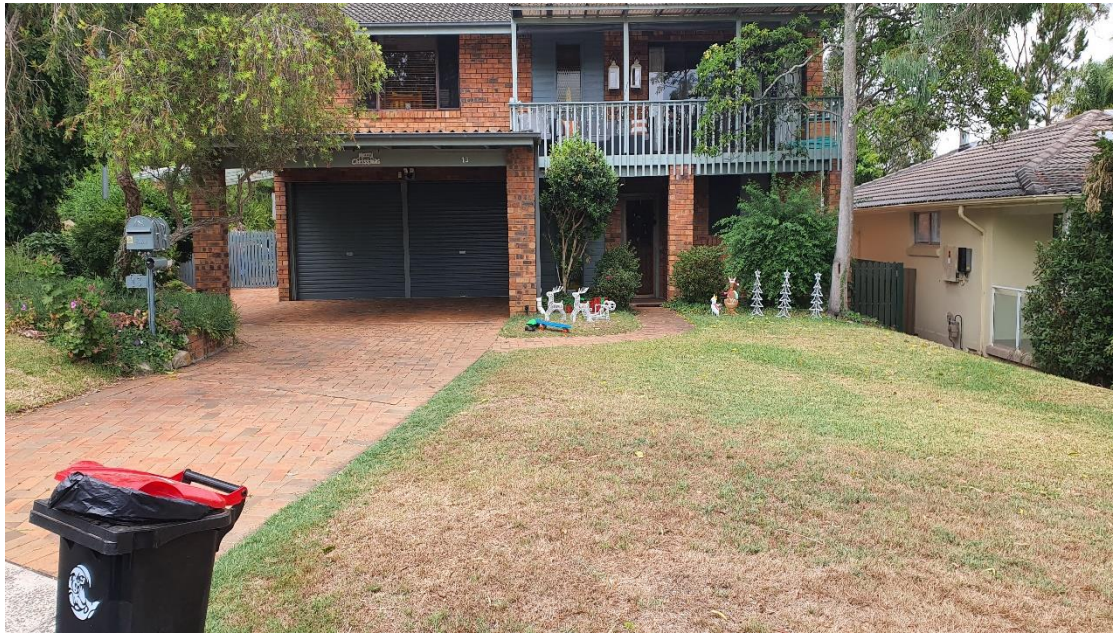
- Front of the property

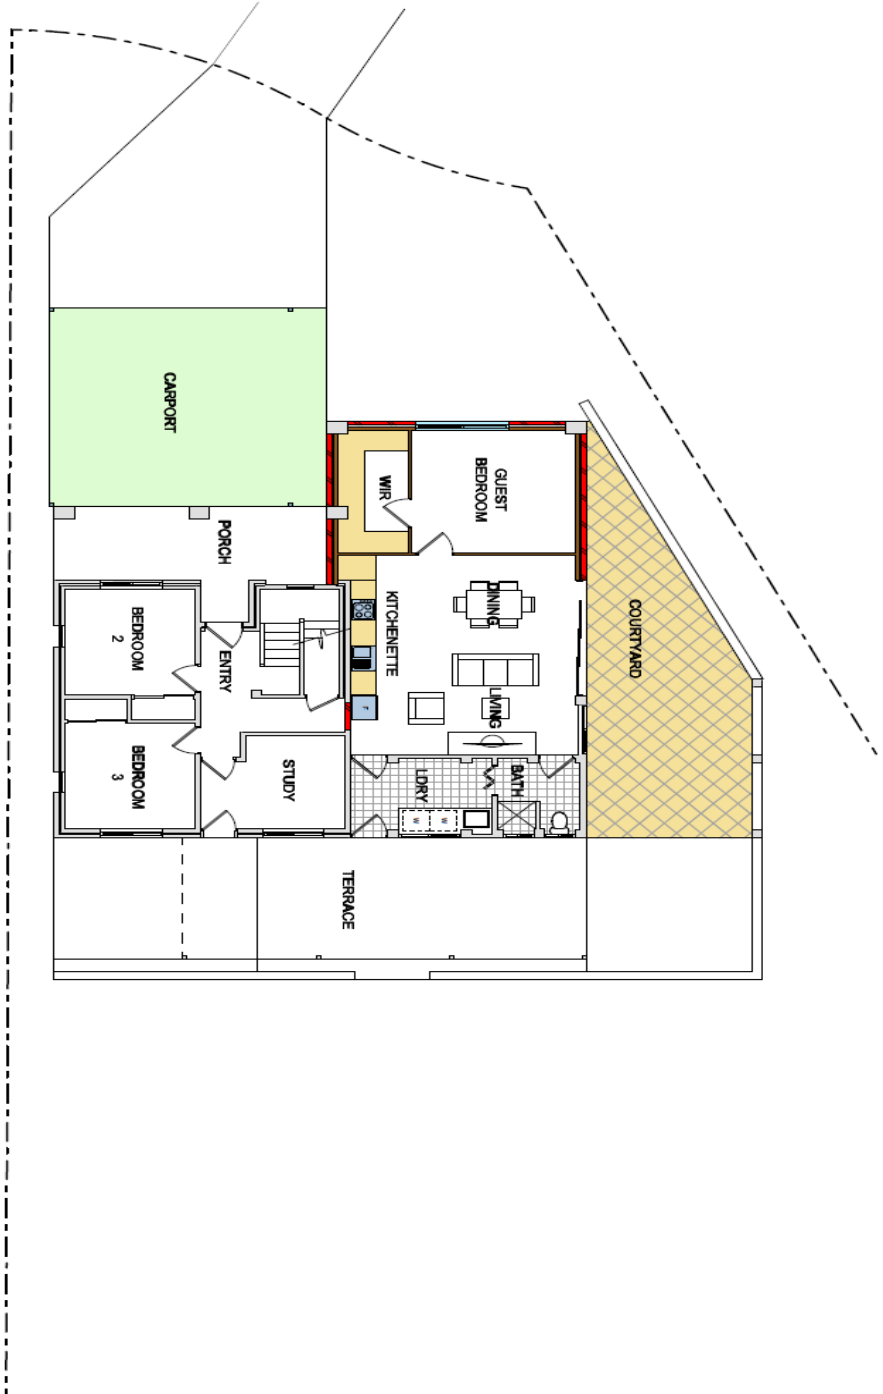
The proposed development consists of Alterations & Additions, new bedroom addition on first floor (northern side) & new Carport to be constructed at the front (North-West side) of the property as show on the architectural details prepared by JAH DESIGN SERVICES refer Appendix 'B'.

PROPOSED GROUND FLOOR PLAN- 15/11
 FOR: TALBOT FAMILY- 13 HYNDES PLACE DAVIDSON
