**Preliminary Site Investigation  
inclusive of  
Supplementary Sampling  
& Waste Classification**

**Abbott Road Fields  
Curl Curl NSW 2096**

**Prepared for  
Urbis Pty Ltd  
(On Behalf of Optus Pty Ltd)**

### **Ref No: CUAB-19-PSI**

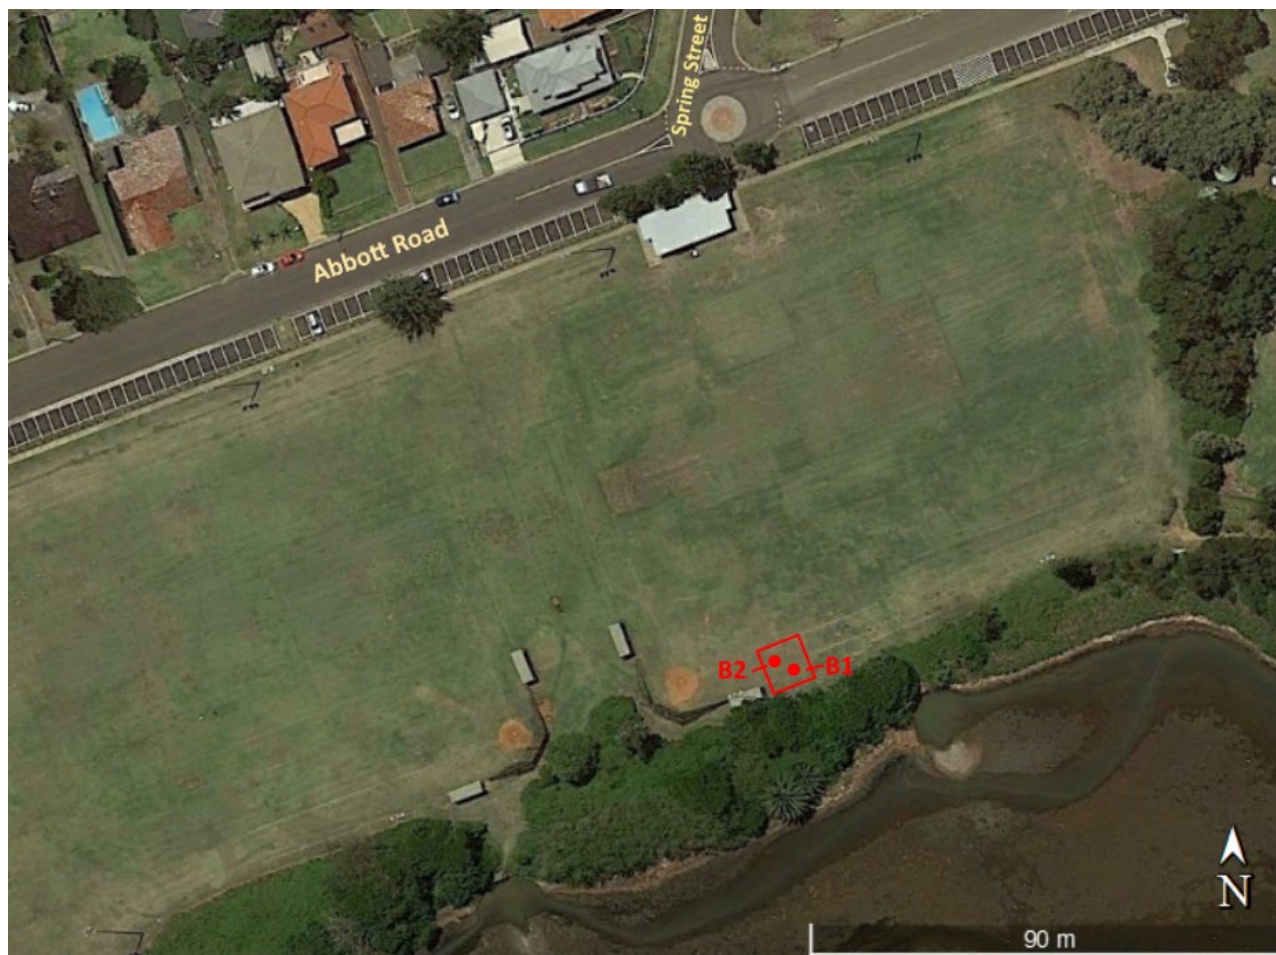
## Site Map

**Note: Red line is the approximate boundary of Site, red dots show approximate sampling locations**

With the intention of achieving the best possible understanding of the site conditions, Canopy decided to obtain two near surface samples at two different locations (B1 1.0 m and B2 0.5 m) and to also obtain one additional sample from a deeper area below the surface (3.5 m in B1). Locations of the borings are shown in the Site Map contained within Appendix B.

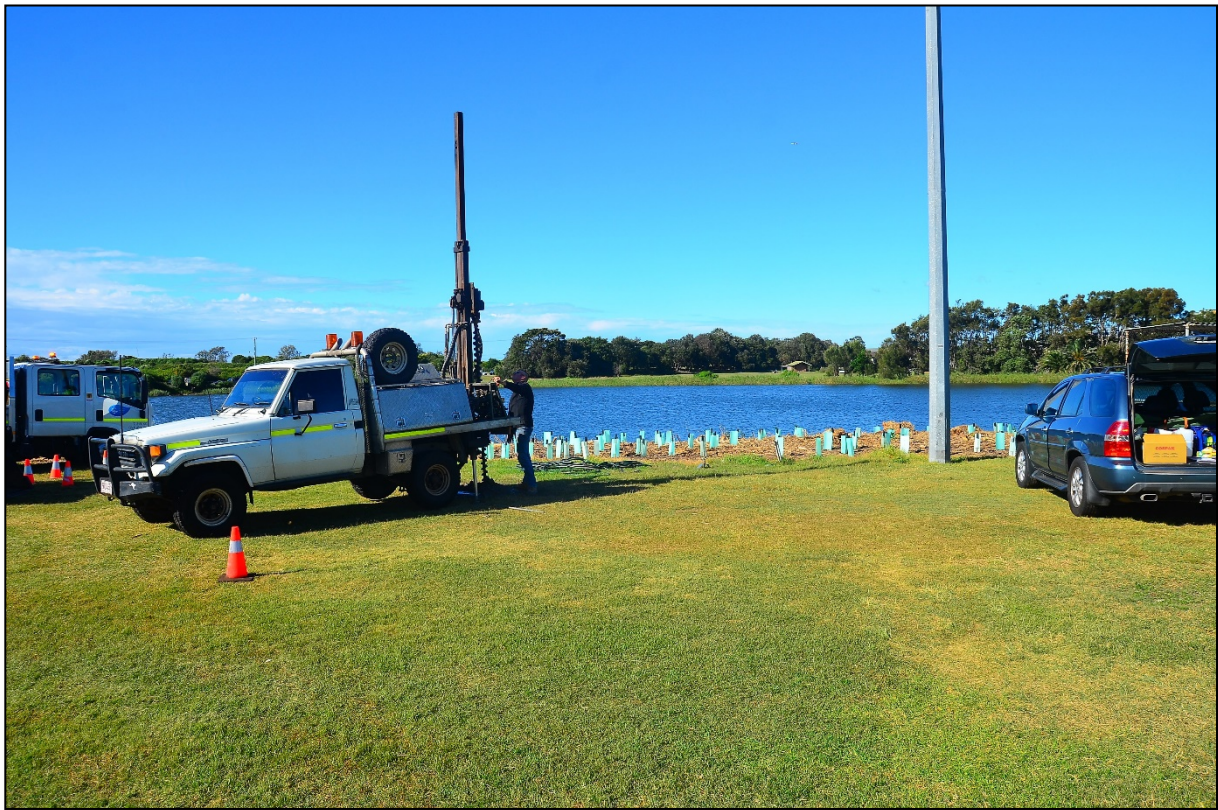
**Photo 1:**  
Setup process for Boring B1

The subsurface conditions found during drilling were broadly speaking a thin layer of top soil (grass covered) followed by a fill layer of fine to medium grained sand with silt and clay containing some rock fragments. Foreign material (rubber, cloth) was encountered to a depth of approximately 3 m bgl.

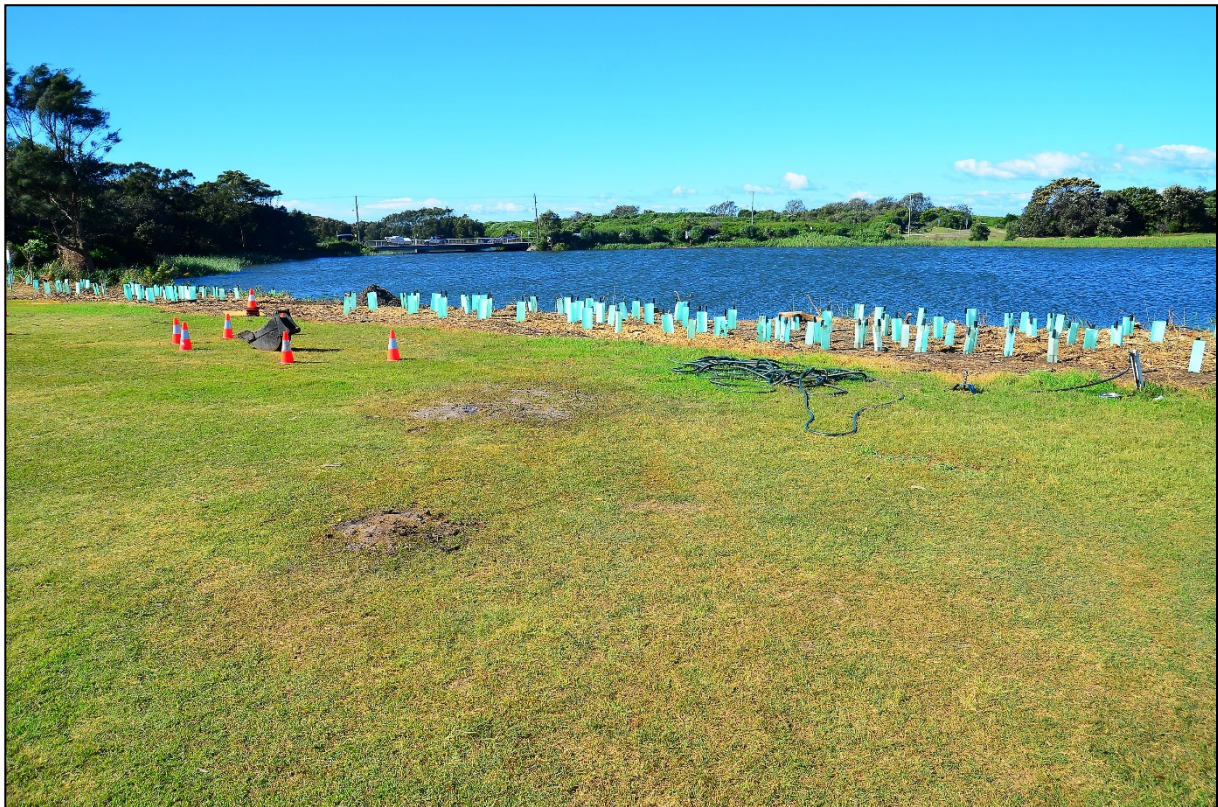
**Photo 2:**  
Locations of Borings B1 and B2 upon completion of drilling operations

Boring B1 reached a total depth of 9.0 m bgl, Boring B2 was terminated at 3.0 m bgl. Bore logs providing more detailed information about the subsurface conditions are provided in Appendix I.

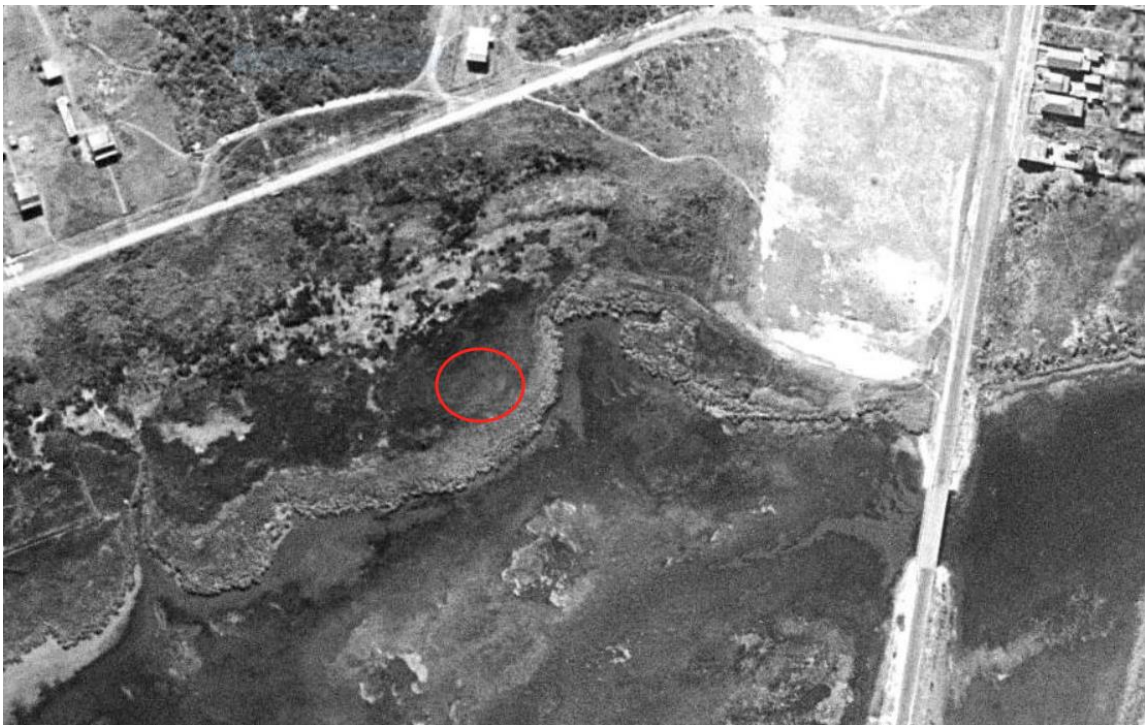
Six Maps aerial Curl Curl 1943

Year	Site Description and Surrounding Area
1943	It can be observed from the image that the site appears to be a tidal wetland or estuarine environment with coastal vegetation including grasses, sedges and herbs. Abbott Road can be seen to the north of the site and Griffin Road to the east. Low density residential housing lies to the north.
2005	This image shows the site has been levelled and developed into a sports field. Some vegetation can be seen on the south of the site bordering Curl Curl Lagoon. To the north is a carpark bordering Abbott Road with medium density residential housing to the north of Abbott Road.
2009	The Site appears to be more or less in the same state as the previous picture with slight growth of vegetation.
2014	The Site appears to be relatively the same. Additional sporting courts have been constructed approximately 250m to the west of the site.
2018	The Site appears to be more or less in the same state as the previous picture with slight growth of vegetation.
