# Acid Sulphate Management Plar

Warringah Recreation Centre – Cnr Pittwater & Kentwell Road, North Manly

71113A-IDF

October 2024

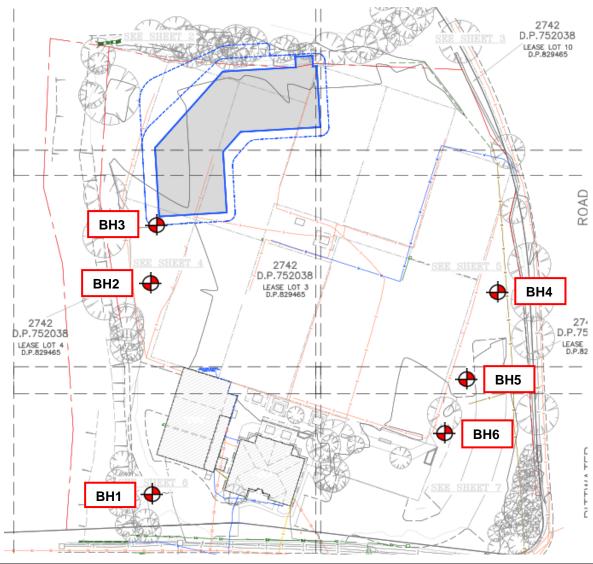
# 11.1 Appendix A – Borehole Location Plan

Fieldwork was undertaken on 3<sup>rd</sup> July 2024 and included drilling six boreholes (BH1-BH6) using a 4wd mounted drill rig using solid flight spiral augers to a maximum depth of 3.0m at the locations shown on Figure 1, attached in Appendix A.

Title	Borehole Location Plan	Council	Northern Beaches Council	Drawn By	Ben
Project	Acid Sulphate Soil Assessment	Job Number	71113-IDF	Checked By	Dane
Site Address	Warringah Recreation Centre – North Manly	Figure Number	Figure 1	Date	Jul-24

Soil sampling was undertaken in general accordance with the Acid Sulphate Soil Guidelines (Refer to Figure 1 for the borehole locations). Test results were compared to the relevant New South Wales Environment Protection Authority (NSW EPA) criteria.
