Geotechnical Investigation

1112-1116 Barrenjoey Road, Palm Beach NSW

Report No: E25203.G03_Rev2

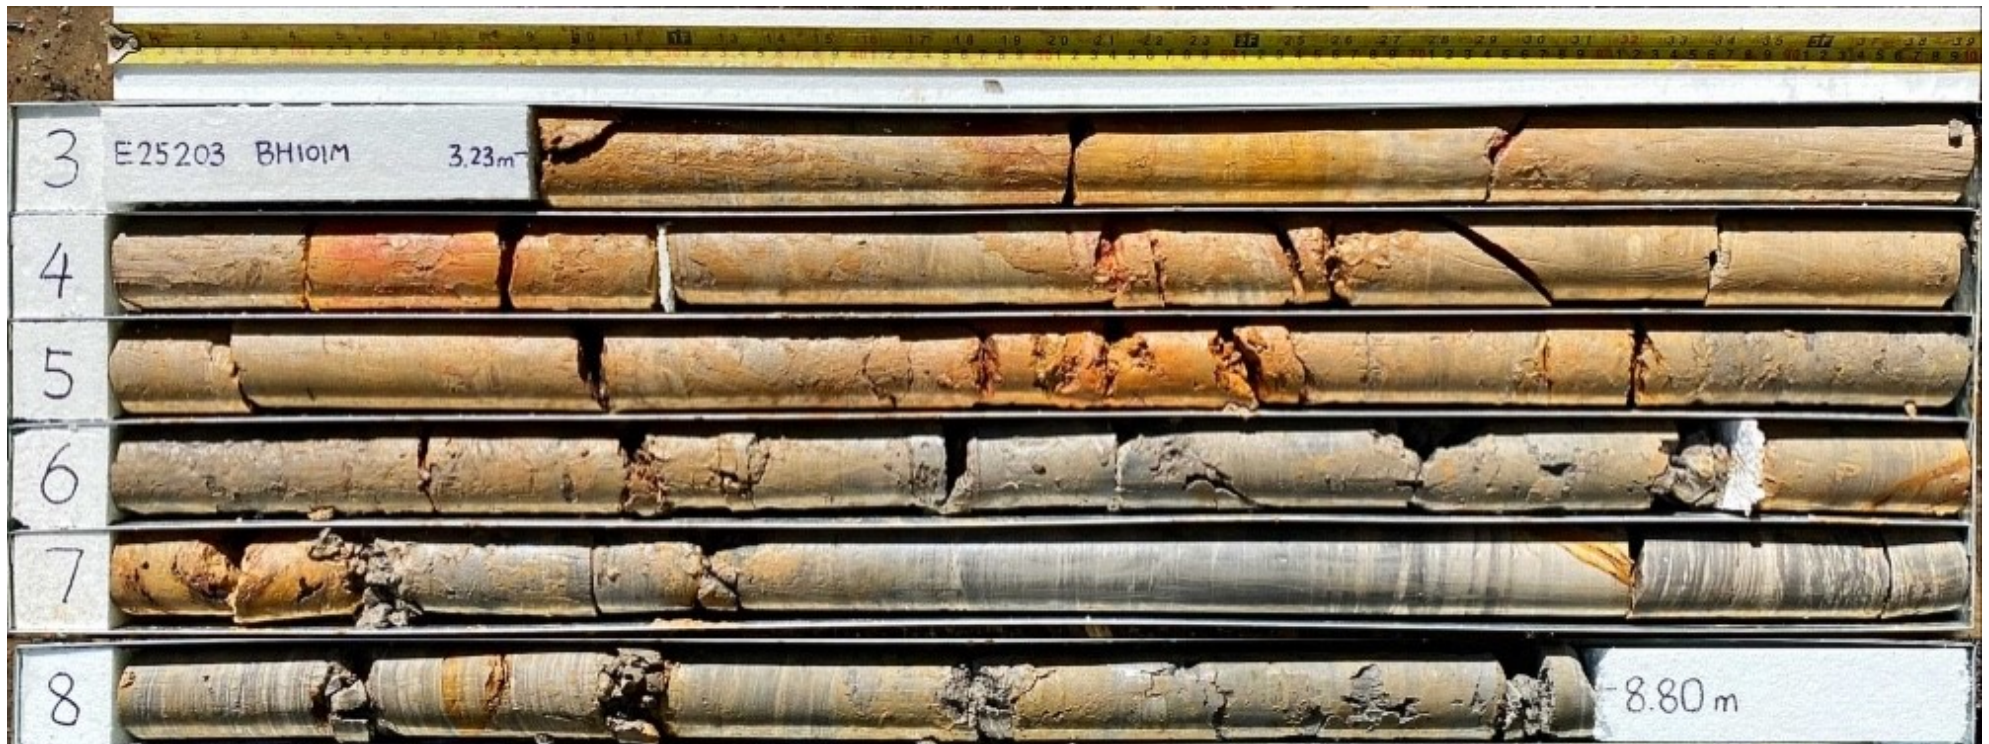
CORE PHOTOGRAPH OF BOREHOLE: BH101M

Project	Proposed Development	Depth Range	3.23m to 8.80m BEGL	
Location	1112-1116 Barrenjoey Road, Palm Beach NSW	Contractor	BG Drilling	
Position	See Figure 2	Drill Rig	CE180	
Job No.	E25203.G03	Logged	KX	Date 11 / 06 / 2021
Client	Palmdev Pty Ltd	Inclination	-90°	Date 14 / 07 / 2021
		Box	1-2 of 2	
		Checked	SR

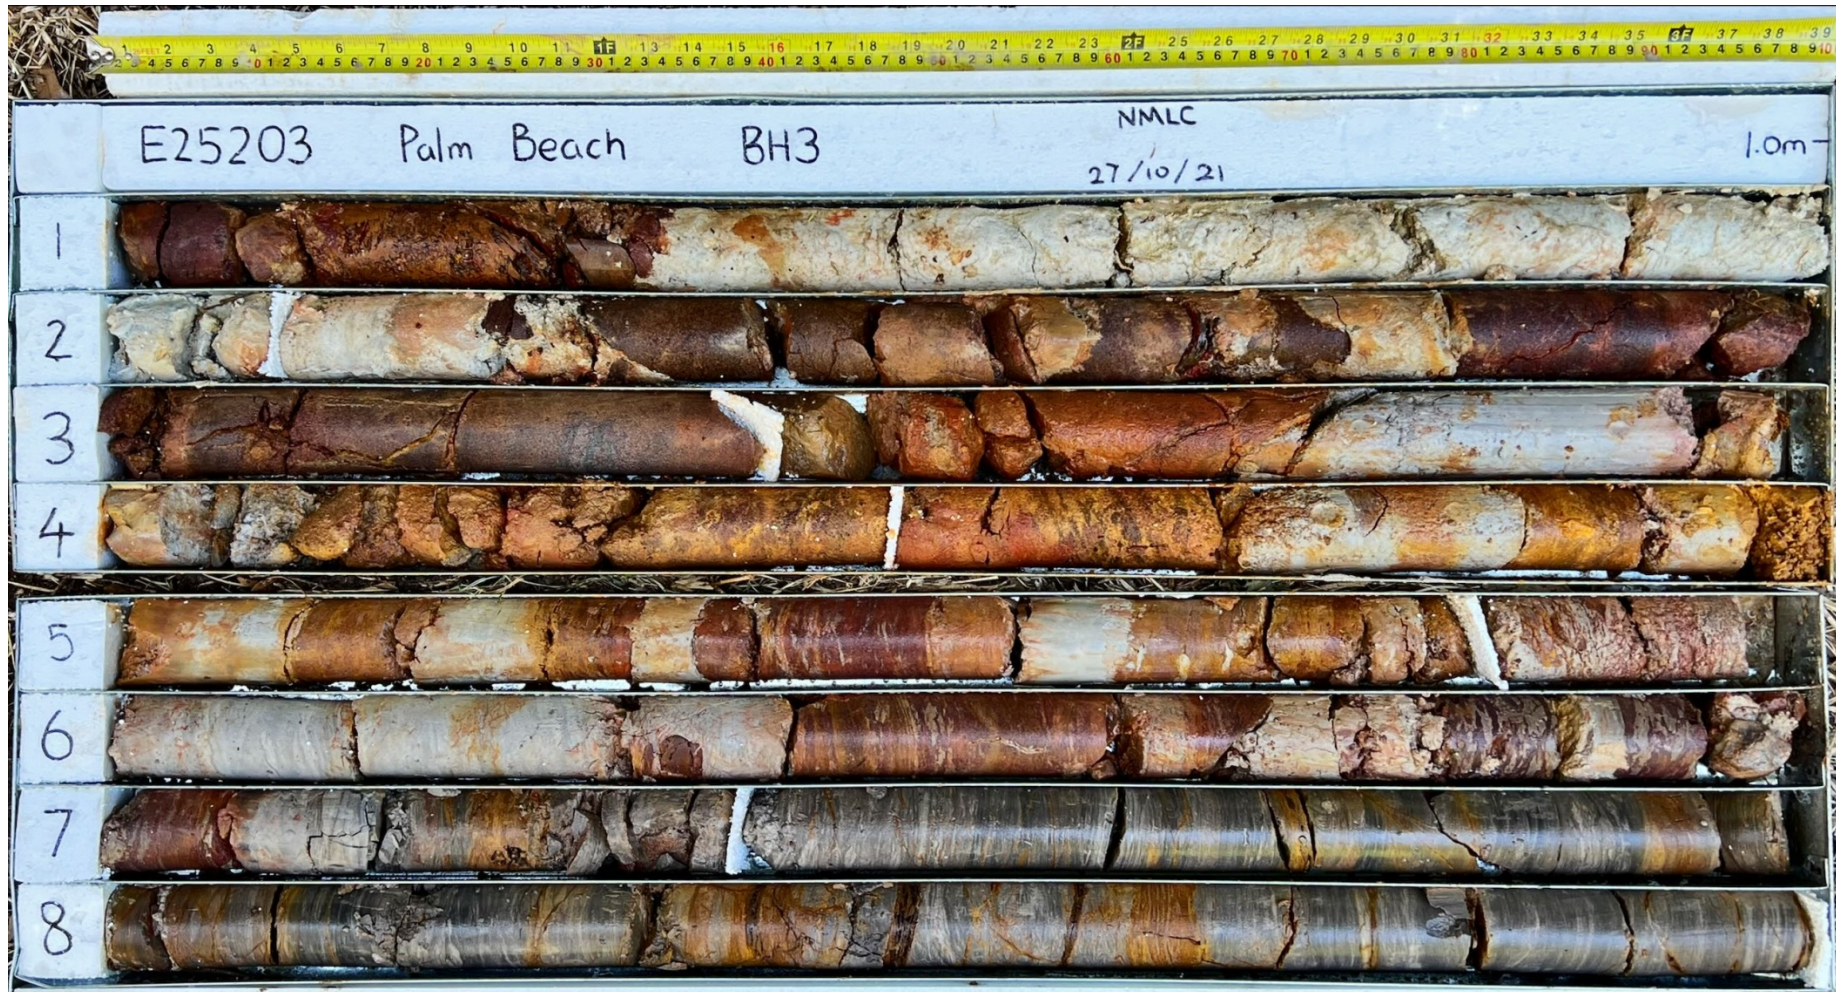
CORE PHOTOGRAPH OF BOREHOLE: BH103

Project	Proposed Development	Depth Range	1.00m to 9.00m BEGL	
Location	1112-1116 Barrenjoey Road, Palm Beach NSW	Contractor	TightSite	
Position	Refer to Figure 2	Drill Rig	Hand Portable	
Job No.	E25203.G03	Logged	KX	Date 27 / 10 / 2021
Client	Palmdev Pty Ltd	Box	1-2 of 3	Checked Date

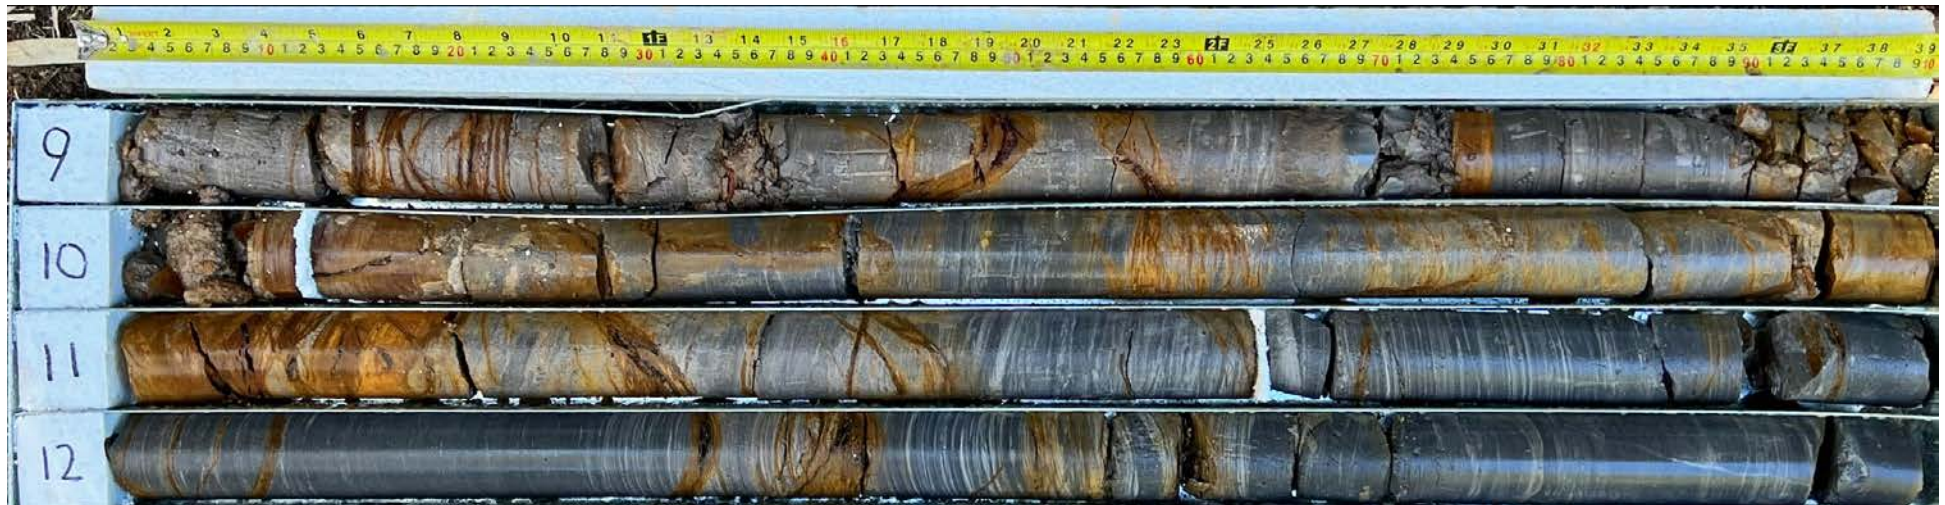
CORE PHOTOGRAPH OF BOREHOLE: BH103

Project	Proposed Development	Depth Range	9.00m to 13.00m BEGL		
Location	1112-1116 Barrenjoey Road, Palm Beach NSW	Contractor	TightSite		
Position	Refer to Figure 2	Drill Rig	Hand Portable		
Job No.	E25203.G03	Logged	KX	Date	27 / 10 / 2021
Client	Palmdev Pty Ltd	Box	3 of 3	Checked
				Date

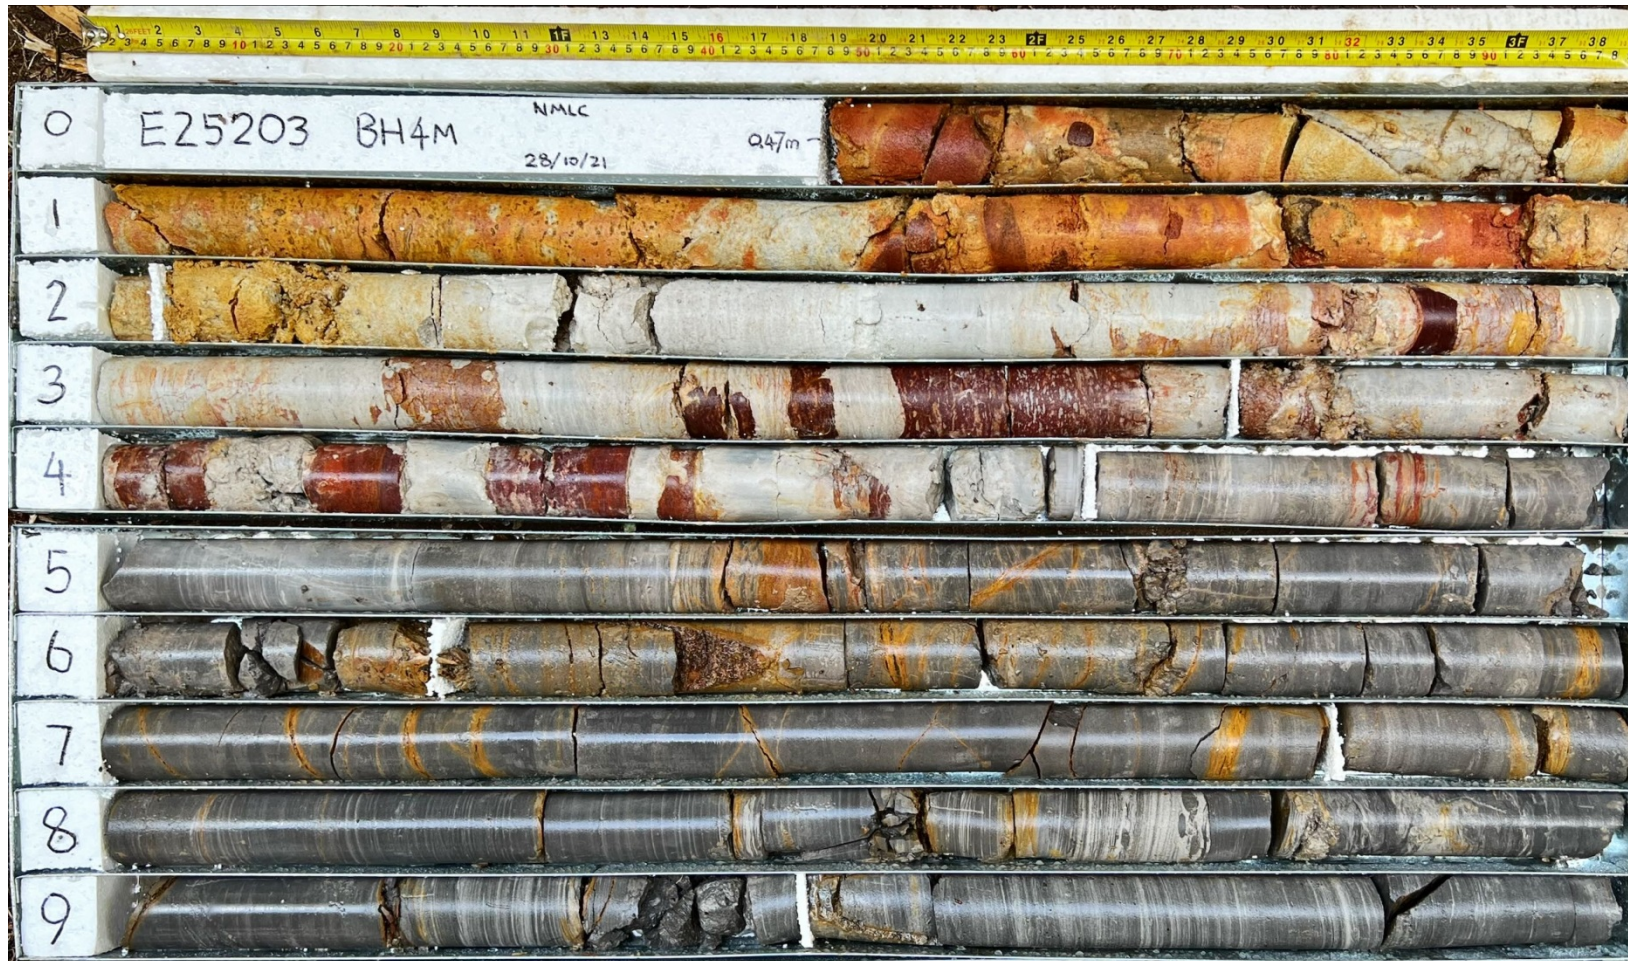
CORE PHOTOGRAPH OF BOREHOLE: BH104M

Project	Proposed Development	Depth Range	0.47m to 10.00m BEGL	
Location	1112-1116 Barrenjoey Road, Palm Beach NSW	Contractor	TightSite	
Position	Refer to Figure 2	Drill Rig	Hand Portable	
Job No.	E25203.G03	Logged	KX	Date 27 / 10 / 2021
Client	Palmdev Pty Ltd	Box	1-2 of 3	Checked Date

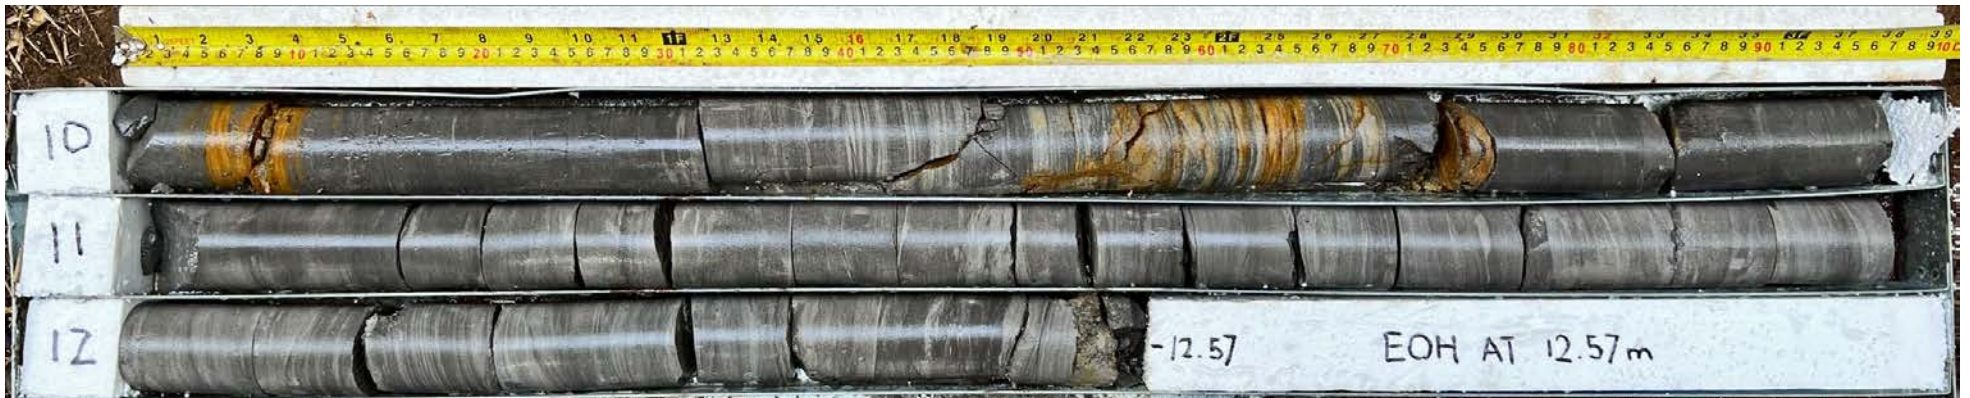
CORE PHOTOGRAPH OF BOREHOLE: BH104M

Project	Proposed Development	Depth Range	10.0m to 12.57m BEGL	
Location	1112-1116 Barrenjoey Road, Palm Beach NSW	Contractor	TightSite	
Position	Refer to Figure 2	Drill Rig	Hand Portable	
Job No.	E25203.G03	Logged	KX	Date 27 / 10 / 2021
Client	Palmdev Pty Ltd	Box	3 of 3	Checked Date
