Review of Environmental Factors

for
Boardwalk and Bridge Replacement
at
Long Reef Headland

Prepared for Northern Beaches Council

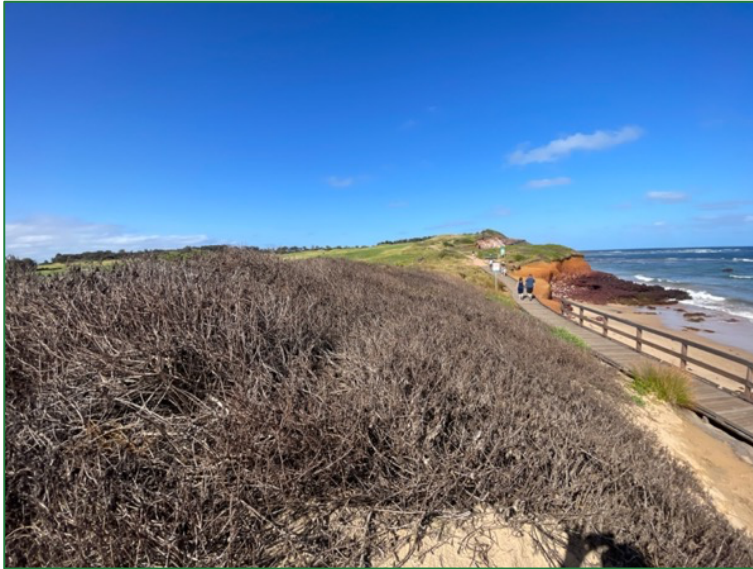
Photo 1. The sand dune proposed to be cut, looking north

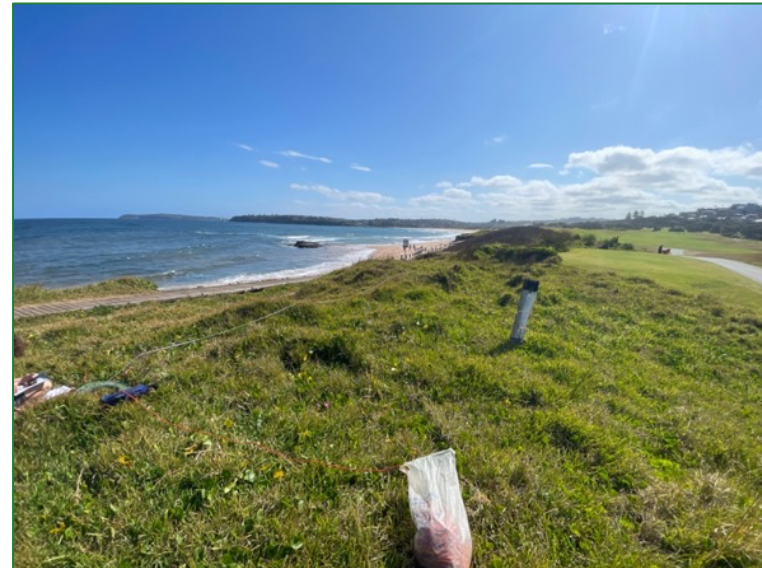
Photo 4. The sand dune proposed to be cut, looking south

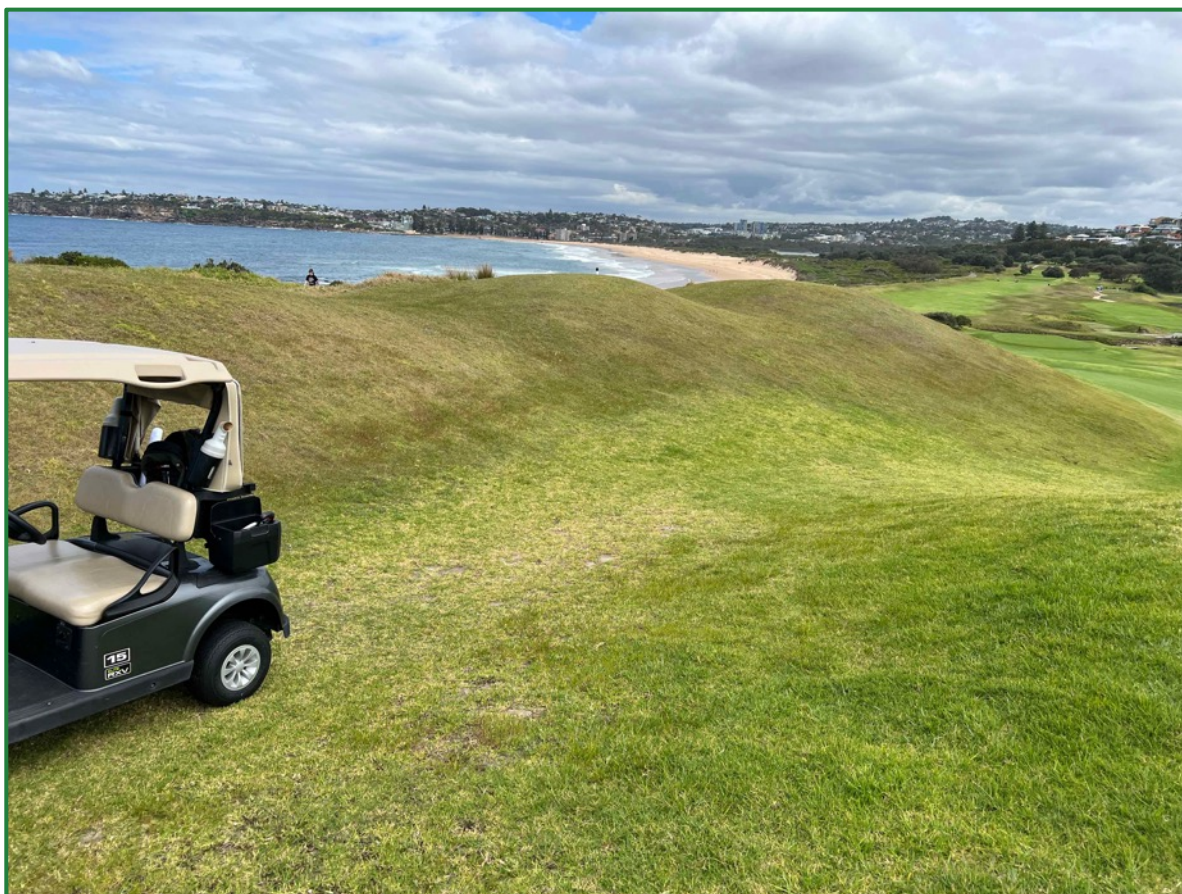
Existing sand mound on Golf Course

The sand will be obtained partially from the excavation in the southern area, and the rest will be taken from existing mounds on the golf course. The location of these mounds is shown on Map 6c and is shown in the photograph below. The sand from these mounds will undergo appropriate testing for contaminants and Acid Sulphate Soils.

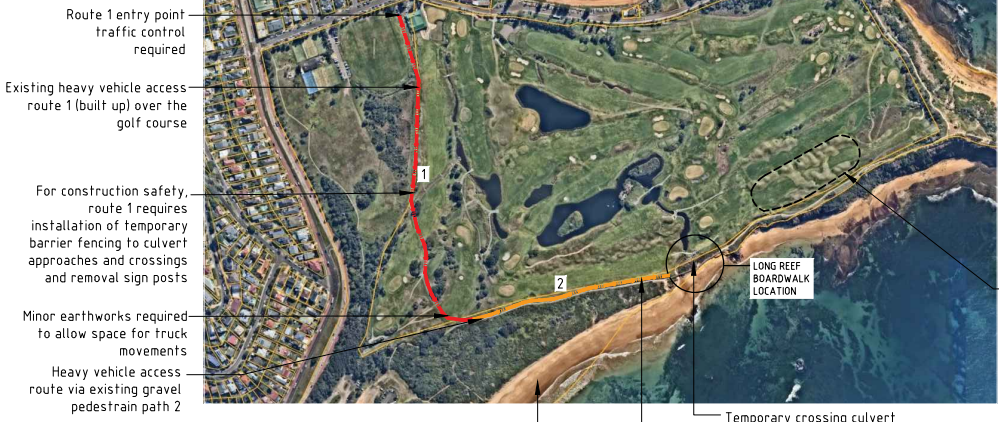
1 LONG REEF VEHICLE ACCESS PLAN
NTS

- KEY
- Hard vehicle access route via existing gravel & grass track
 - Hard vehicle access route via existing gravel & pedestrian path

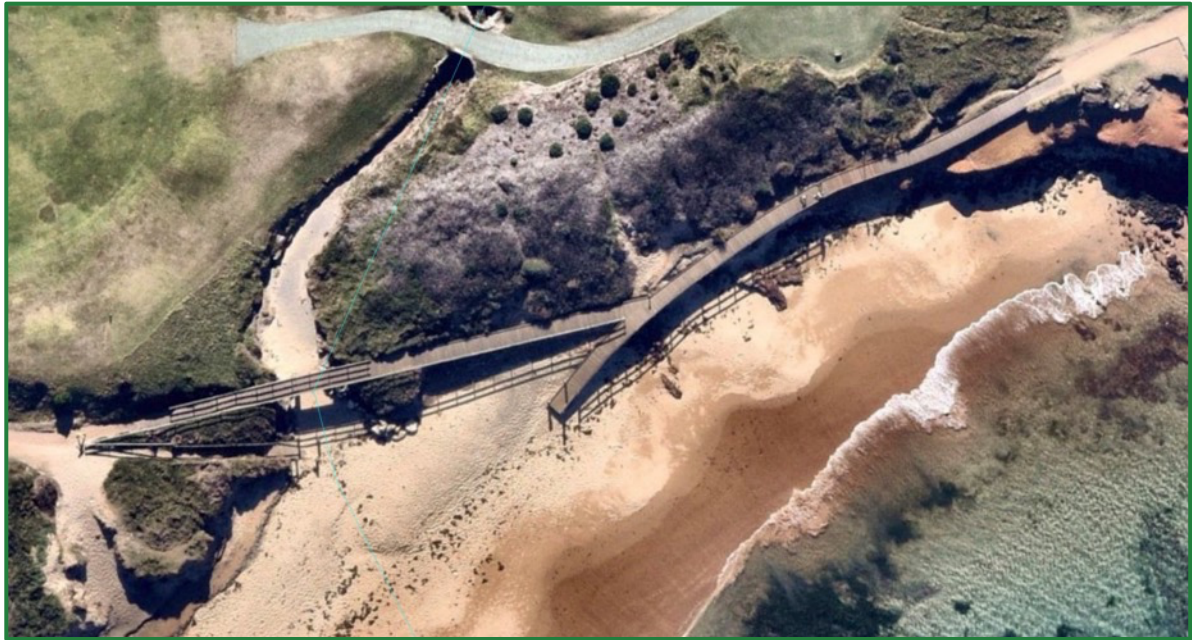
Current sand at the beach

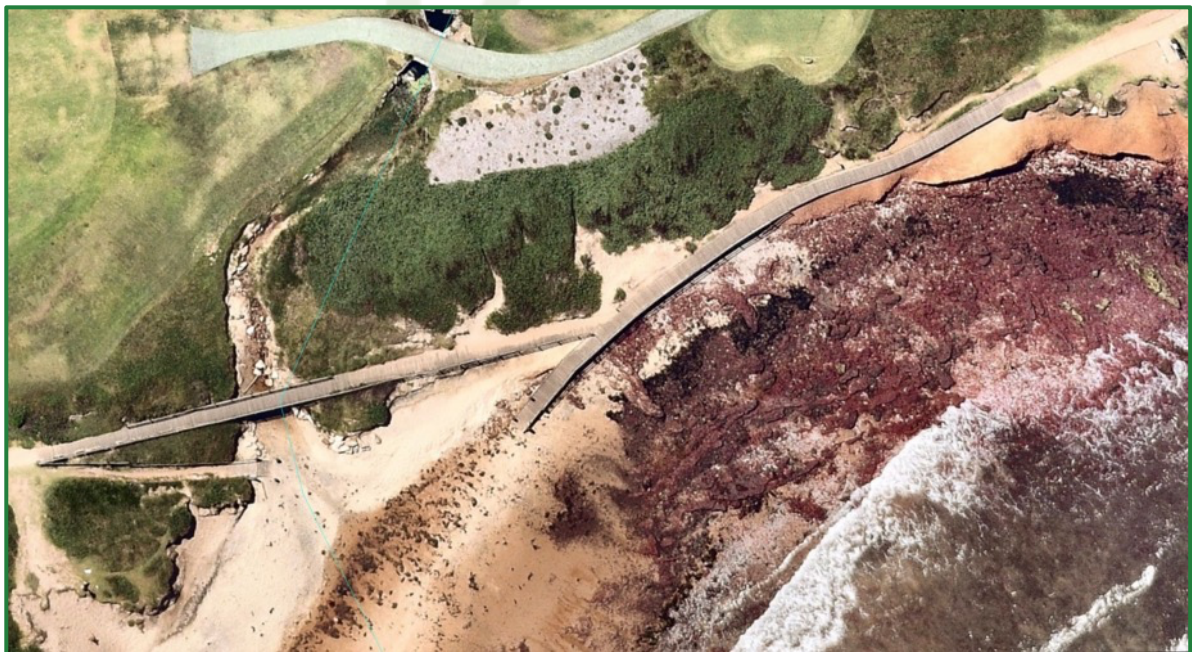
After storm July 2022

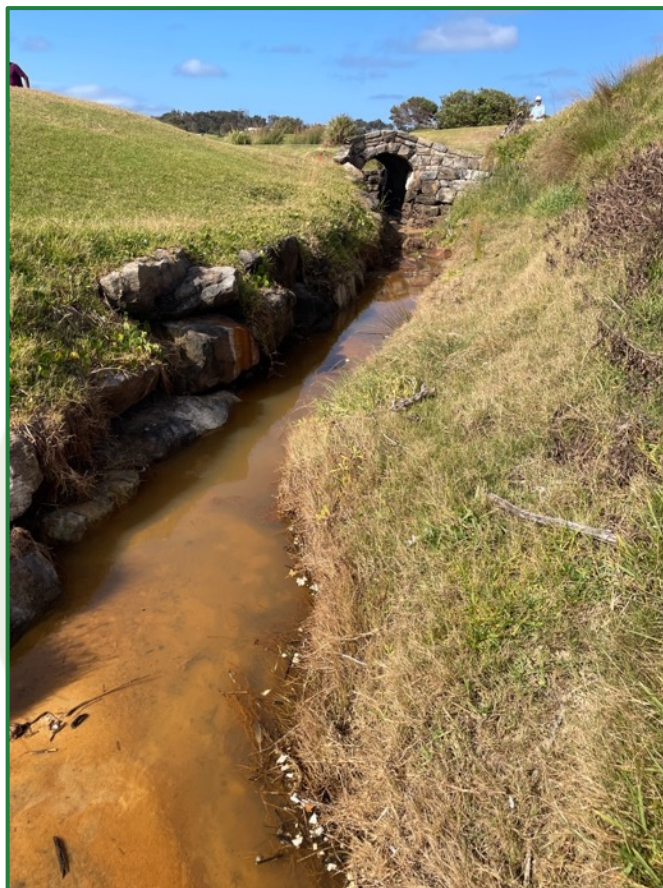
The drainage line that goes through the site. Photo is taken on the northern side of the site looking north.

An intermittent drainage line (pictured below) dissects the site. This drains water from the freshwater soaks (springs) and the catchment east of Pittwater Road including the golf course and playing fields. Waves and salt water occasionally wash up as far as the bridge shown.

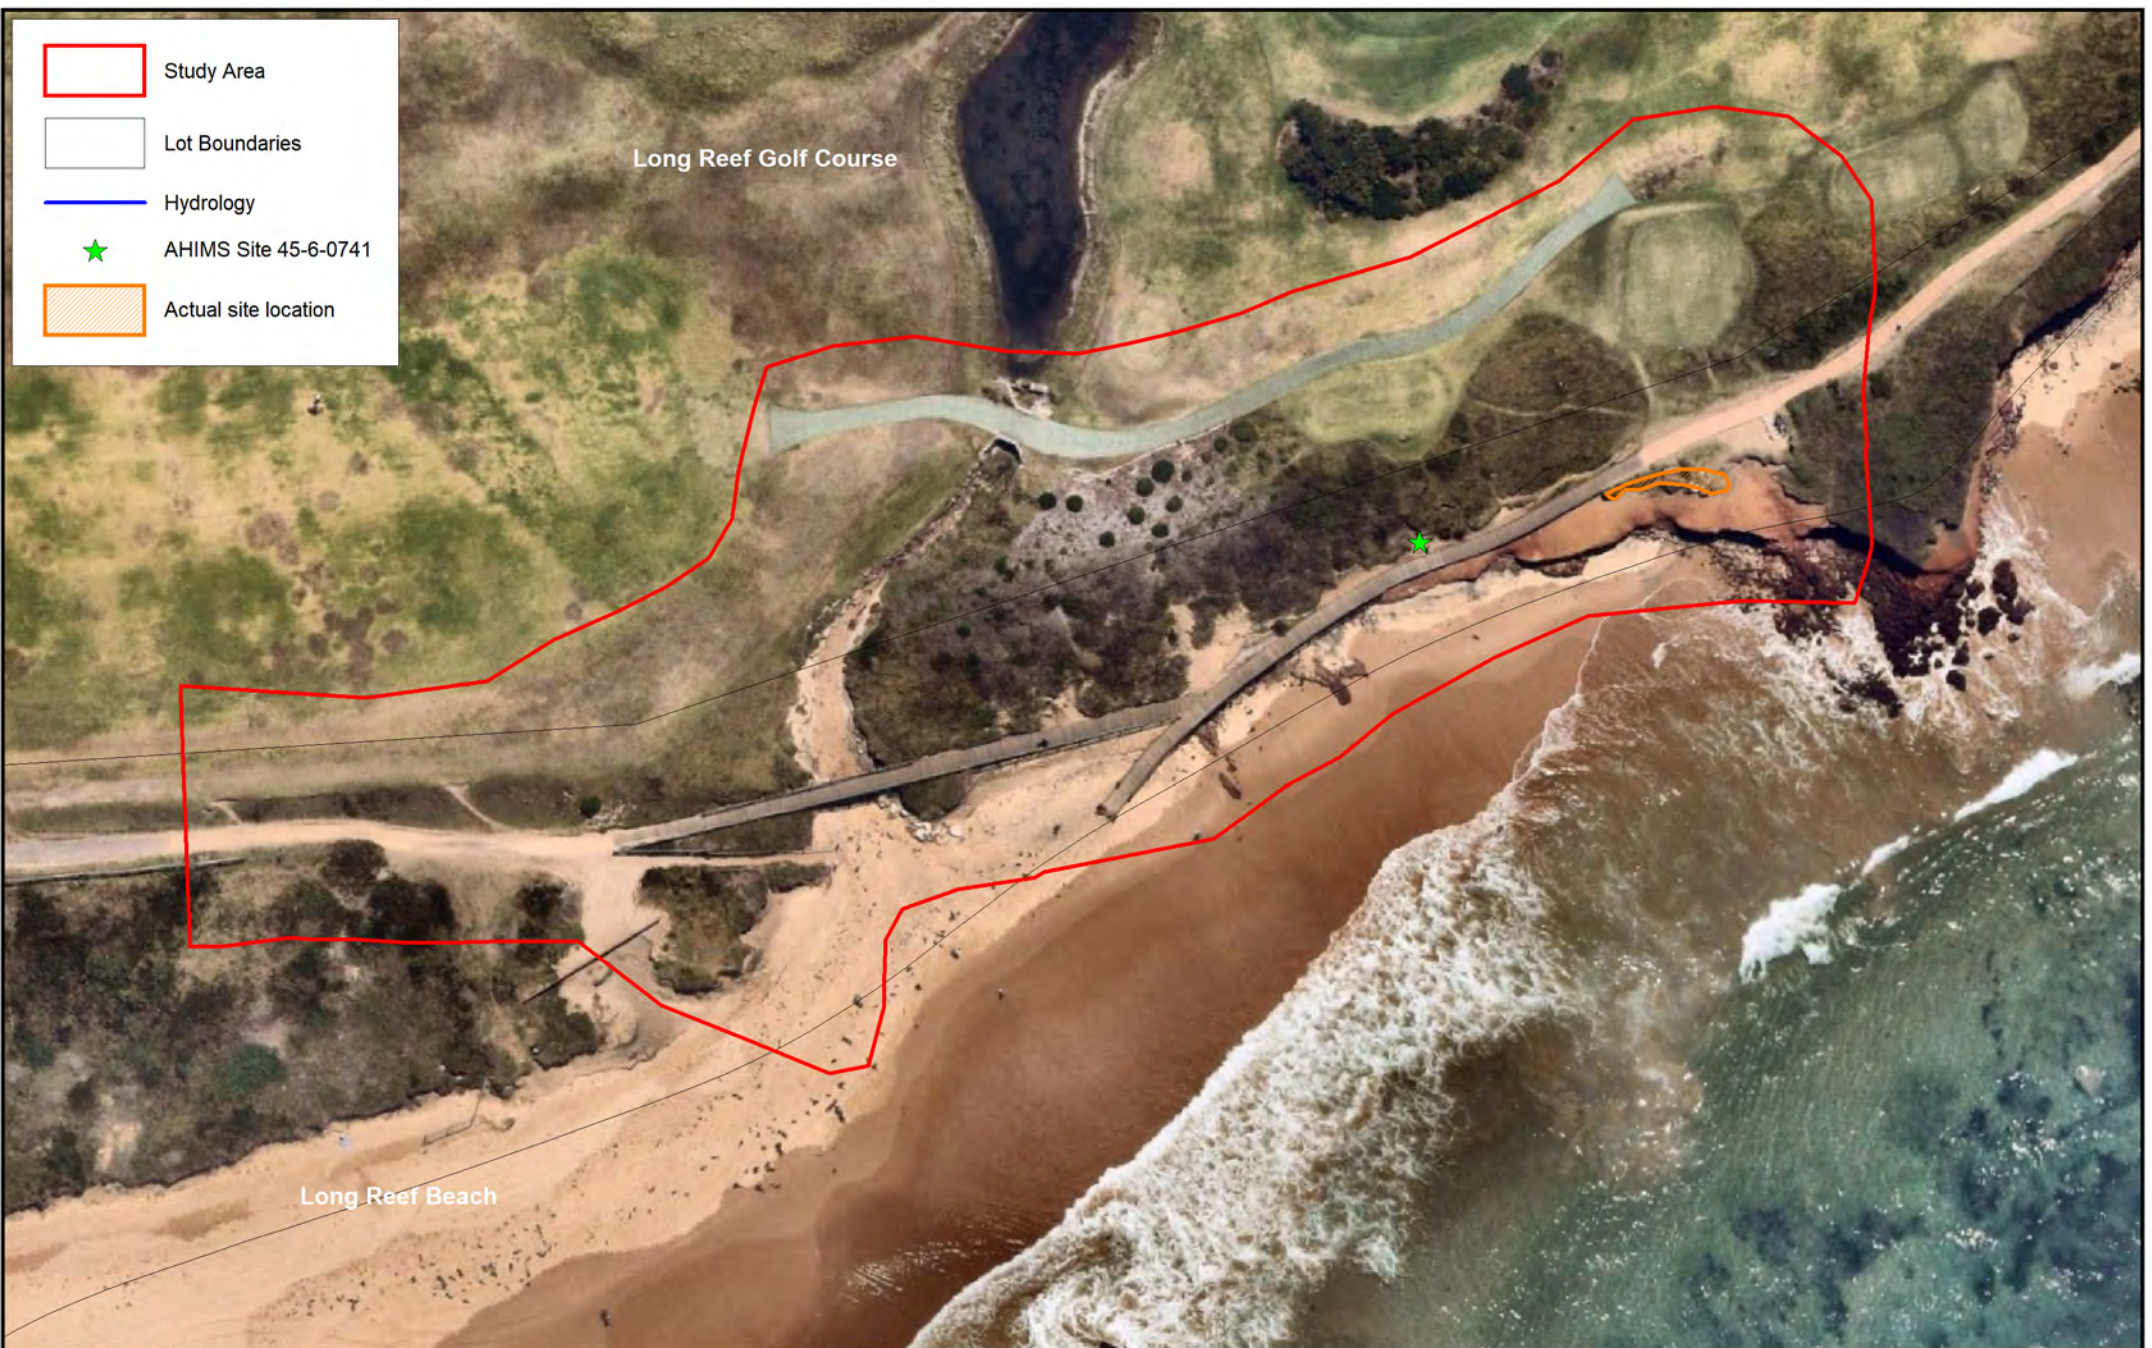
Figure 6: Location of registered AHIMS Site # 45-6-0741 in relation to study area.

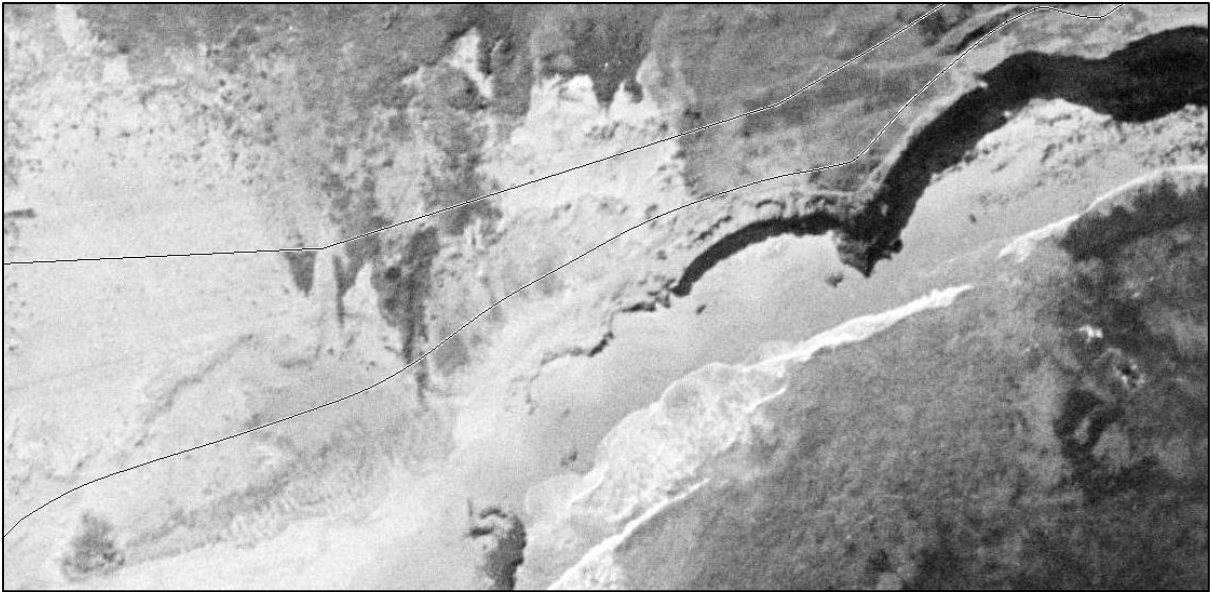
Plate 8: 1943 aerial imagery with current cadastral boundaries overlaid (Source: SIXMaps)

Comparison of the 1943 historical imagery (Plate 8) and imagery from 2022 (Plate 9) with cadastral boundaries overlaid allows an assessment of the impact of natural erosion of the coast over time. Even allowing for discrepancies in the alignment of the imagery, the alteration to the coastline over these years is significant.

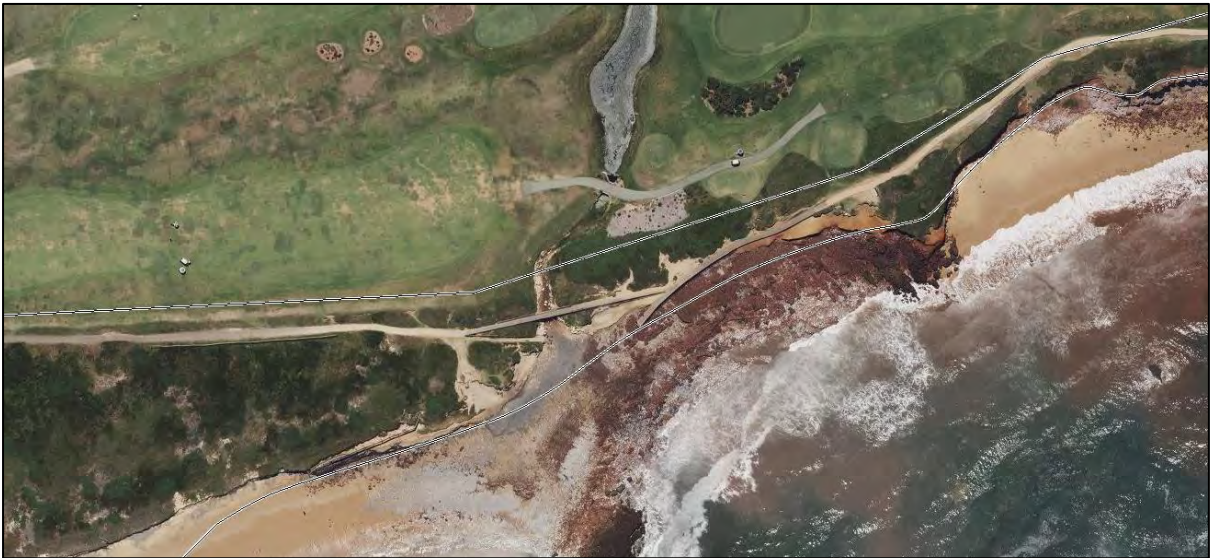
Plate 9: 2022 aerial imagery with current cadastral boundaries overlaid (Source: SIXMaps)

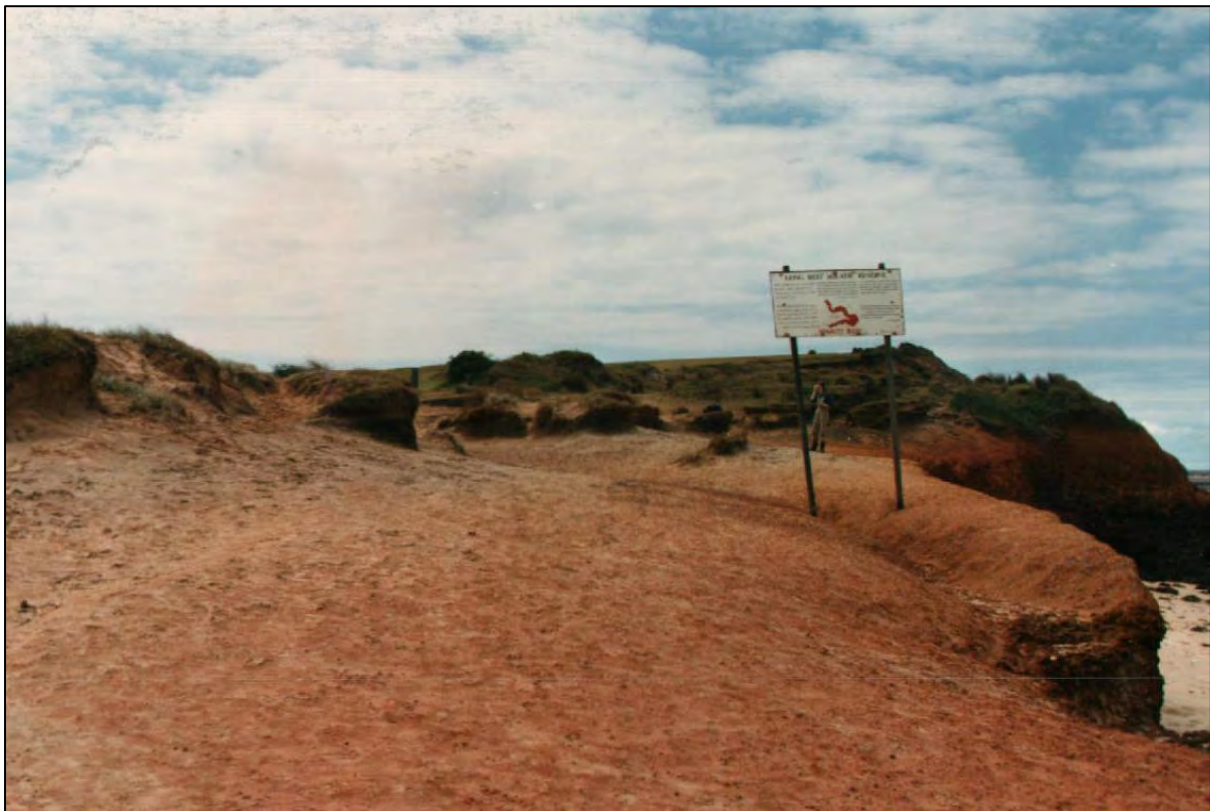
Plate 10: QP3 as recorded in 1987, located in eroded section to left of image (Brayshaw McDonald 1987)

*Shell was observed along only 22 m of the eroded bank, which is over 50 m long in total. A maximum of 20 individual shells were seen, most of these being large triton (over 80%), Cockle, oyster (*Saccostrea commercialis*) and sand snail (probably *Polinices aulacoglossa*) shells were also observed. Fragmented shell and an indurated mudstone artefact were observed below the bank, along the gullied and sheet washed erosion area. Another stone artefact was located 25 metres east of the erosion bank on a gravel lag. This was also of indurated mudstone, and consisted of an unmodified flake < 3 cm long.*

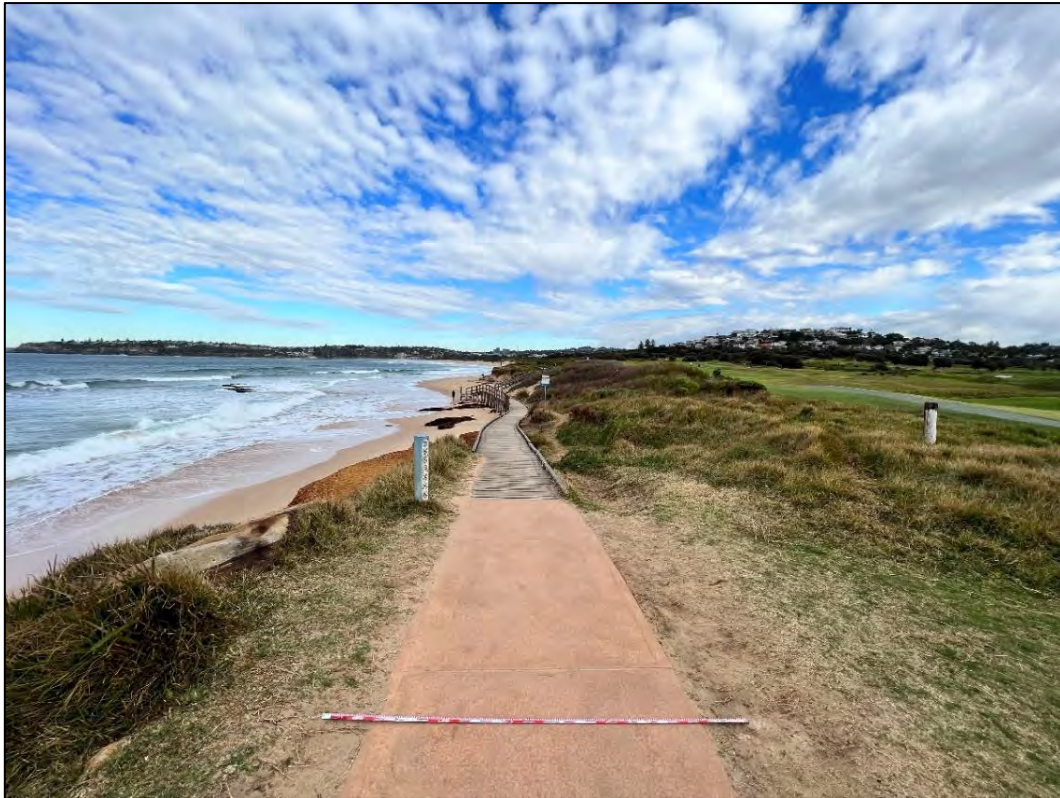
Plate 11: View south east along the existing section of Long Reef board work that is to be replaced and a new board walk constructed approximately 10 m to the north (to the right in the image).

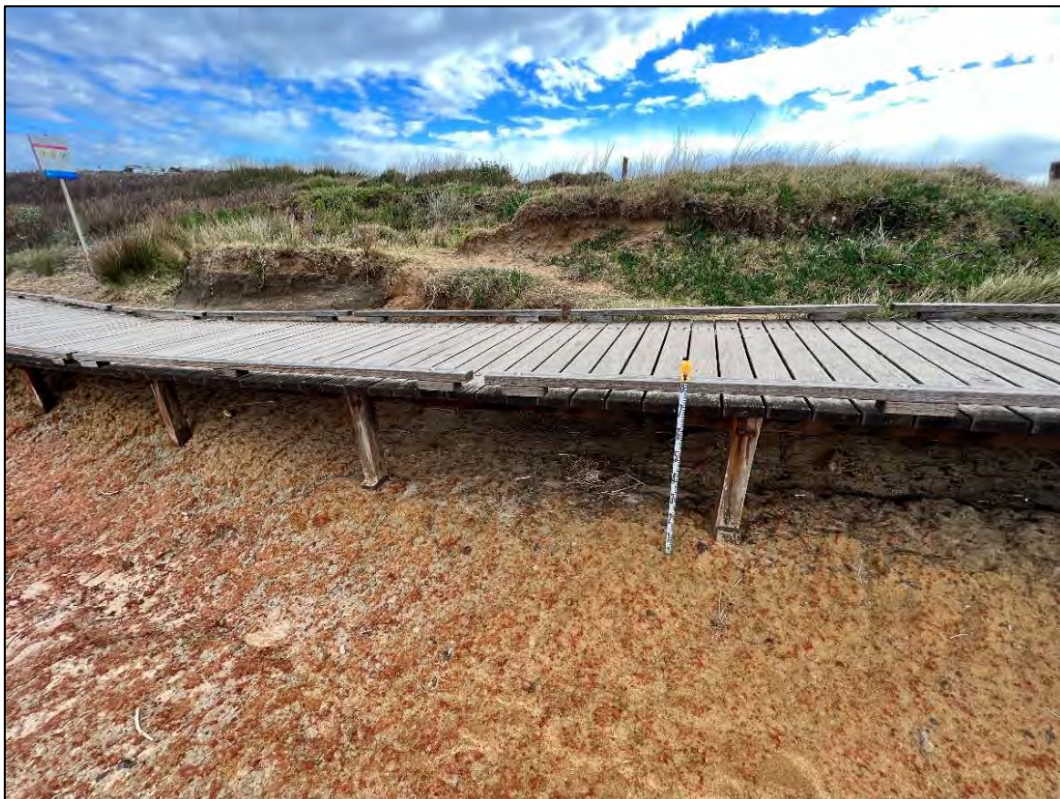
Plate 12: View north of western section of Long Reef boardwalk showing the exposed underlying geology on the south side of the boardwalk, and disturbed sand dunes profile on the north side.

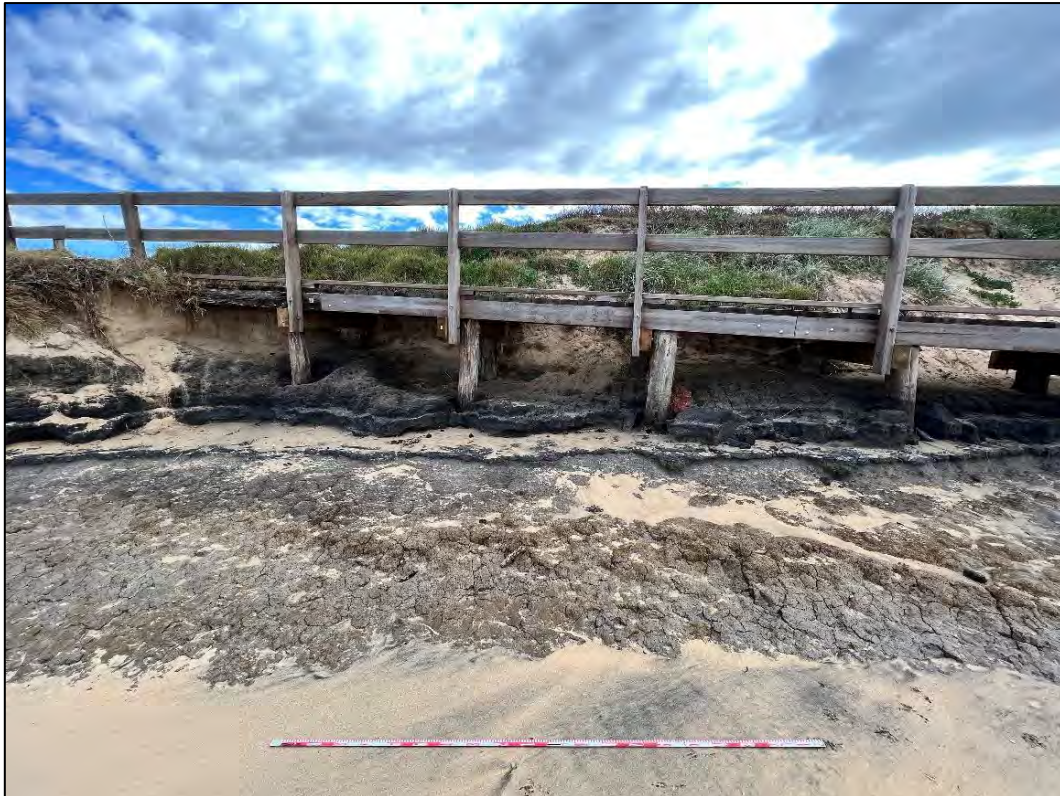
Plate 13: View north of eastern section of Long Reef boardwalk showing the exposed underlying geology on the south side of the boardwalk, and disturbed sand dunes profile on the north side.

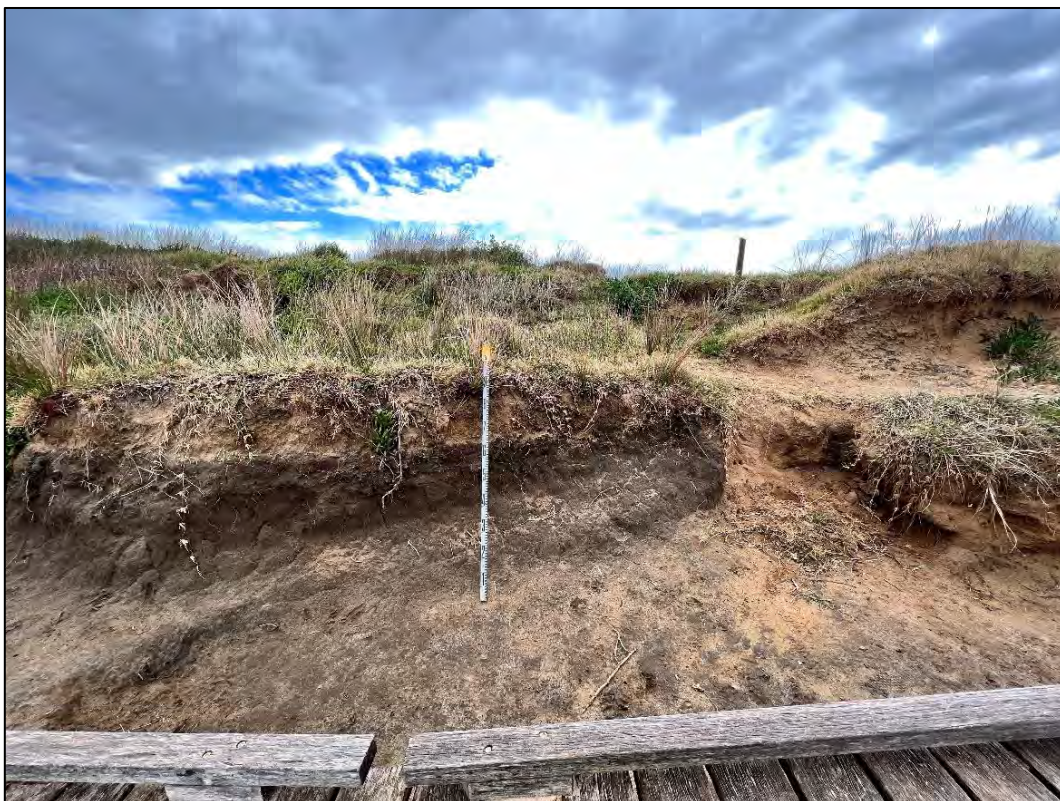
Plate 14: View north of exposed area where AHIMS #45-6-0741 was recorded.

The section on the northern side of the wooden track where the registered Aboriginal site AHIMS #45-6-0741 (AP3) has been mapped was closely inspected. This area has been subjected to extensive erosion and the construction of the boardwalk since it was recorded in the 1980s, and it is highly unlikely that the area retains an intact soil profile from that time. The current exposed areas were observed to comprise approximately 30 cm of a mixed-sand profile below the vegetation cover (Plate 14). This overlaid a sticky clayey peat-like profile that is part of the underlying geology. There was no evidence that a shell midden was still within the site. No shell, stone artefacts, charcoal and/or faunal remains were observed, and the site was considered to have been destroyed by natural actions in the more than 30 years since it was originally recorded.

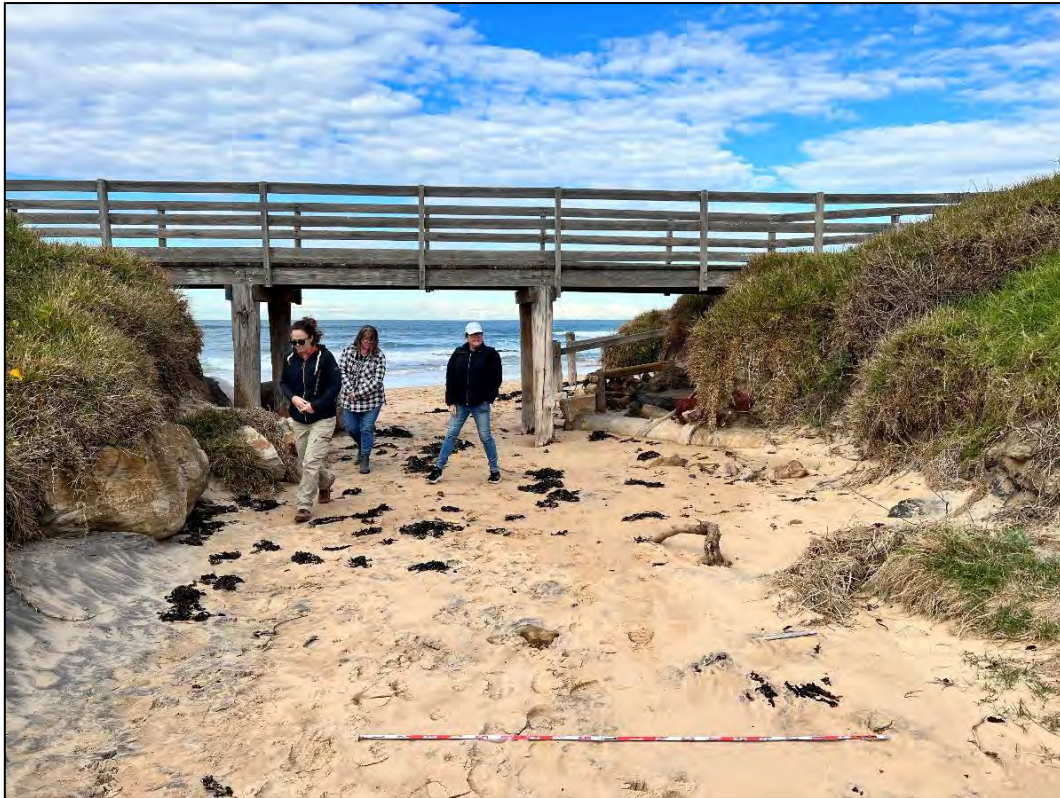
Plate 15: View south of existing bridge over man-made creek that drains the golf course. The east and western banks bordering the drainage line comprise natural and introduced fill.

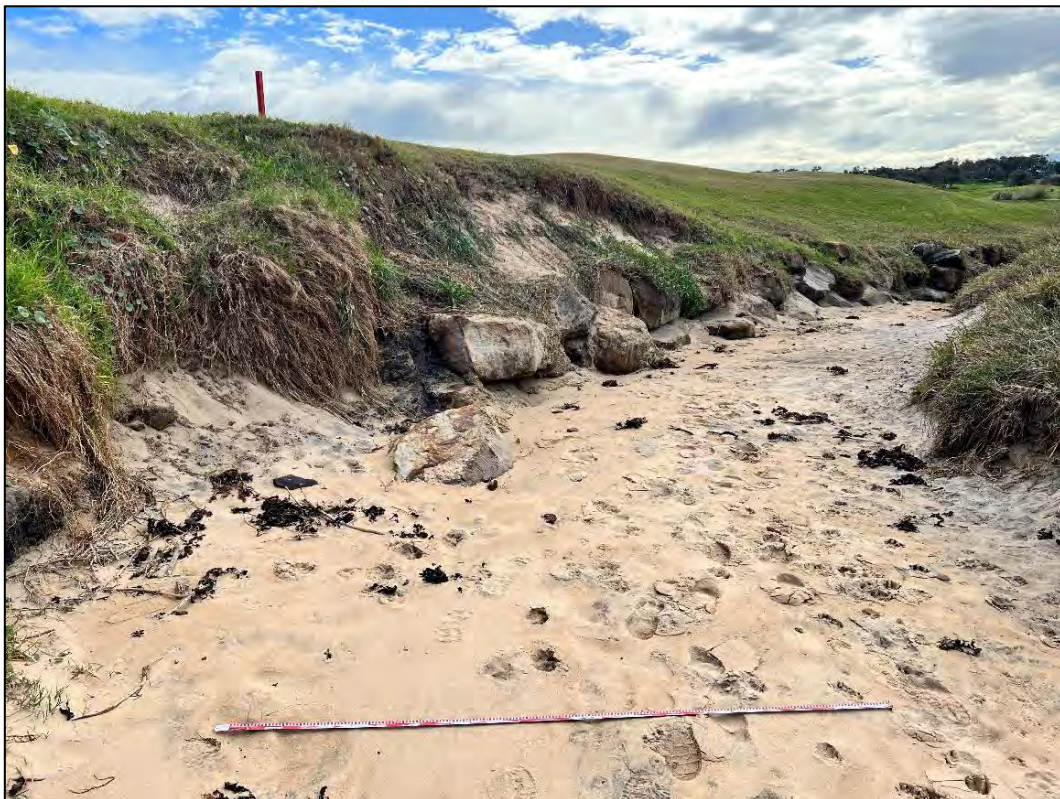
Plate 16: View north within drainage line showing introduced sandstone boulders.

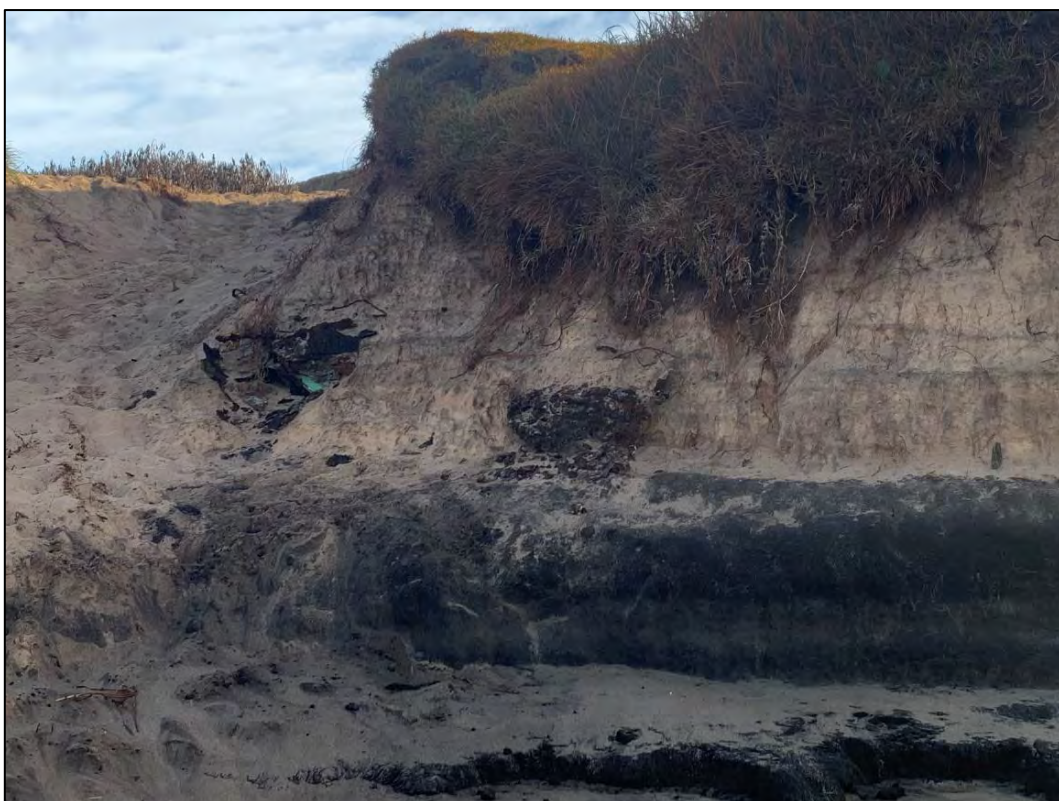
Plate 17: View north showing exposure of a burn even and protruding rubbish at the southwest corner of drainage channel.

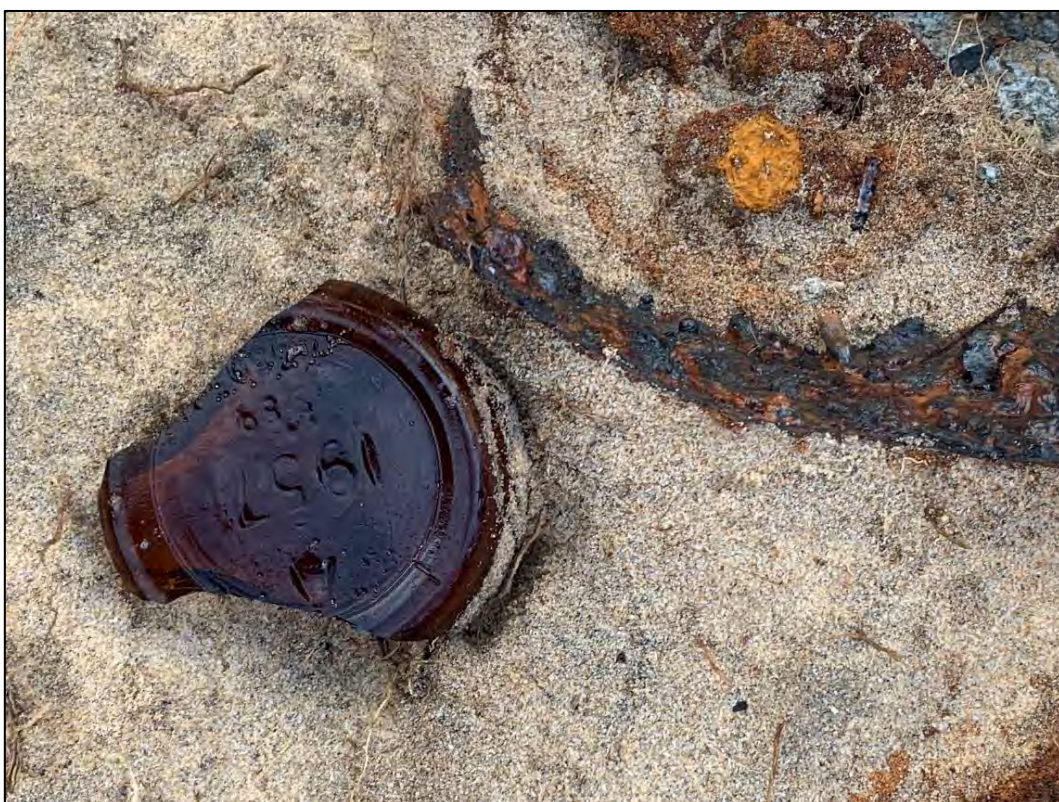
Plate 18: View north showing close up of exposure showing base of bottle with 1957 date stamp.

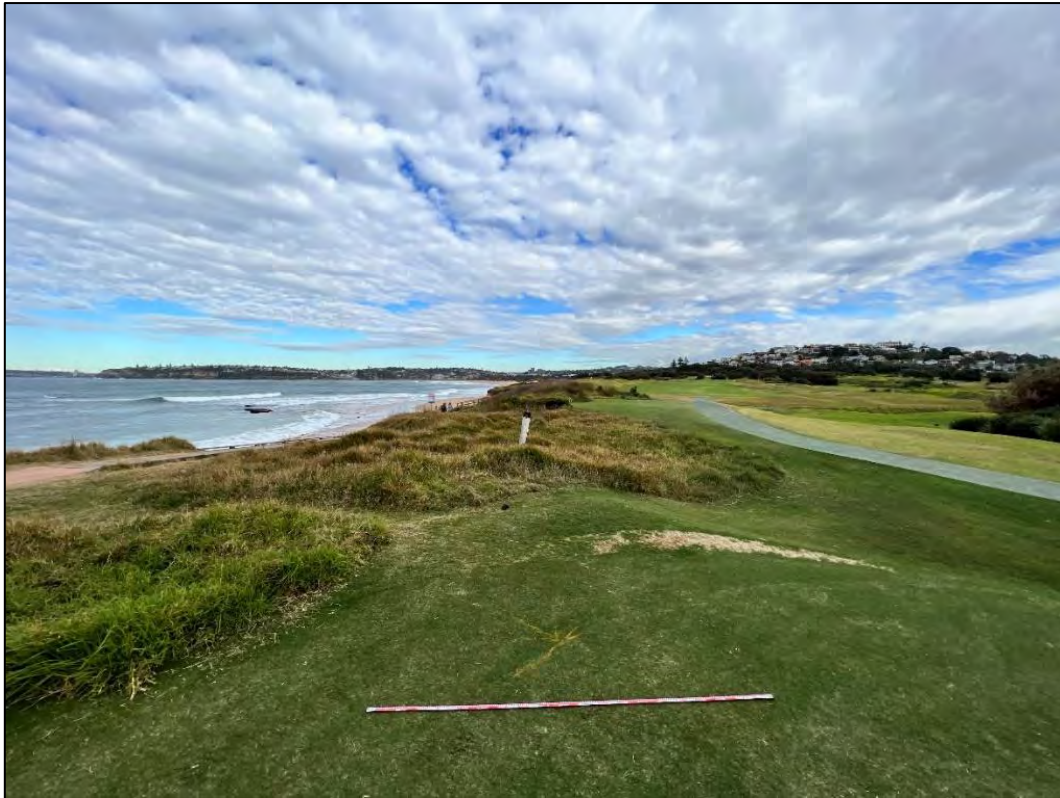
Plate 19: Facing east over green near tees for the 17th hole and walking path to the right of the image.

The portions within the greens on the golf course, including the 17th fairway, the women's and men's 17th tees, and the 'rough' area to the south of the fairway were inspected (Plate 19). These areas were found to be heavily modified from the construction of the golf course and concrete path. These works would have included shallow, moderate and deep subsurface excavation, and the reworking and contouring of the original sand dune systems. Fill may have also been brought into the area from external sources or other areas within the headland.

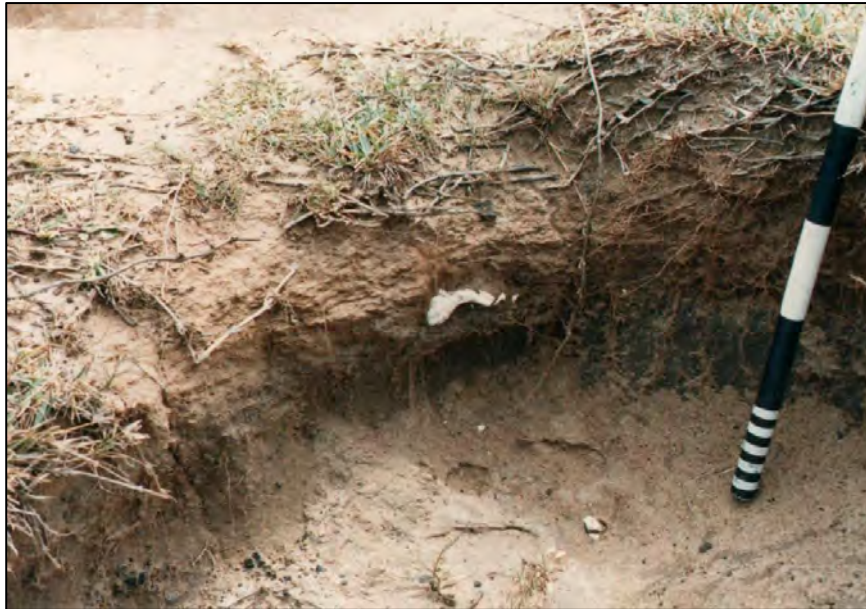
Plate 21: QP3 as recorded in 1987

The AHIMS #45-6-0741 (QP3) shell midden site that was registered as being within the study had been recorded in 1987 and noted on the site card as being in 'poor, eroding badly' condition (Plate 21). The shell was recorded as being along 22 m of the eroded bank and within the interface of a darker soil layer, and lighter soil layer with a house brick in it. Two artefacts were also noted on the site card as being within the gullied and sheet washed area. The site inspection could not relocate the shell midden in the area where it had been mapped (Plate 22). There was no evidence of shell, stone artefacts or faunal remains in the exposed areas. It is suggested that the site has been destroyed by ongoing erosion and possible impacts from the construction of the coastal walk.

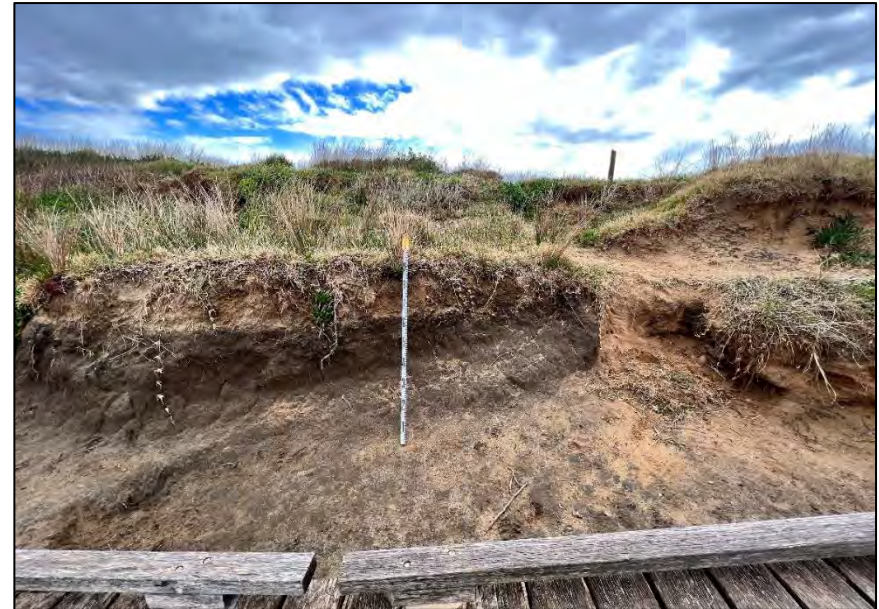
Plate 22: Location of QP3 during current assessment

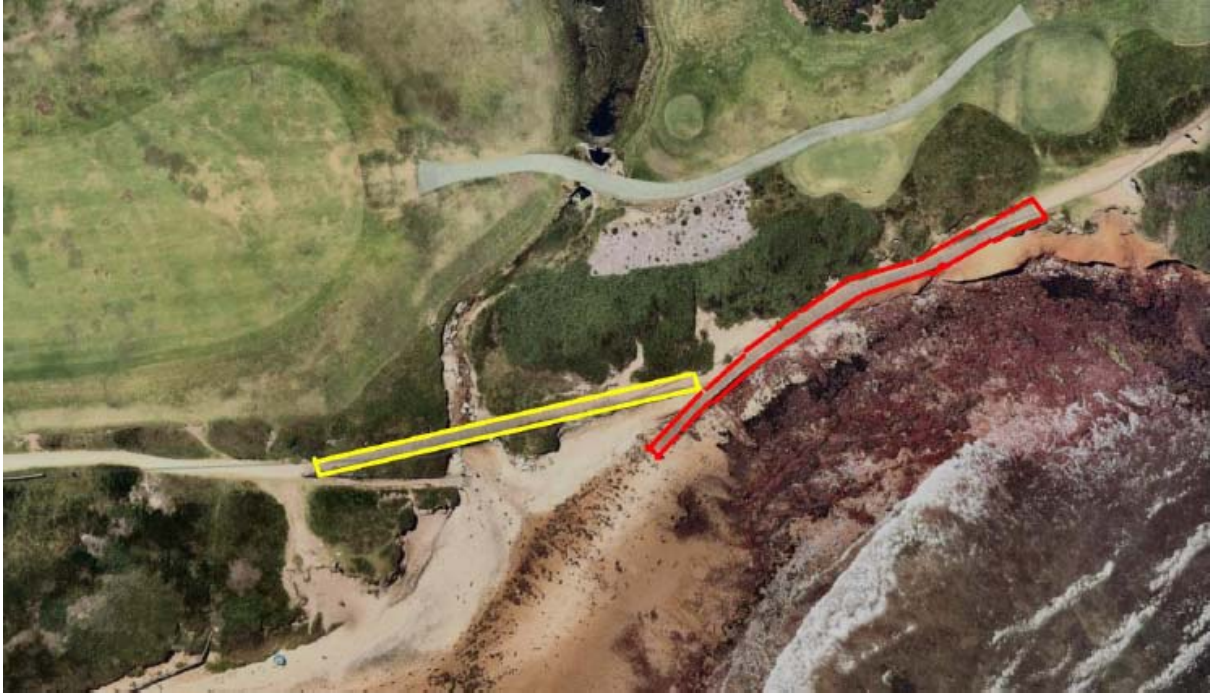
Figure 1 – General Site Layout (Bridge in Yellow and Board Walk in Red)

Figure 1 below shows the site location in relation to the surrounding area.

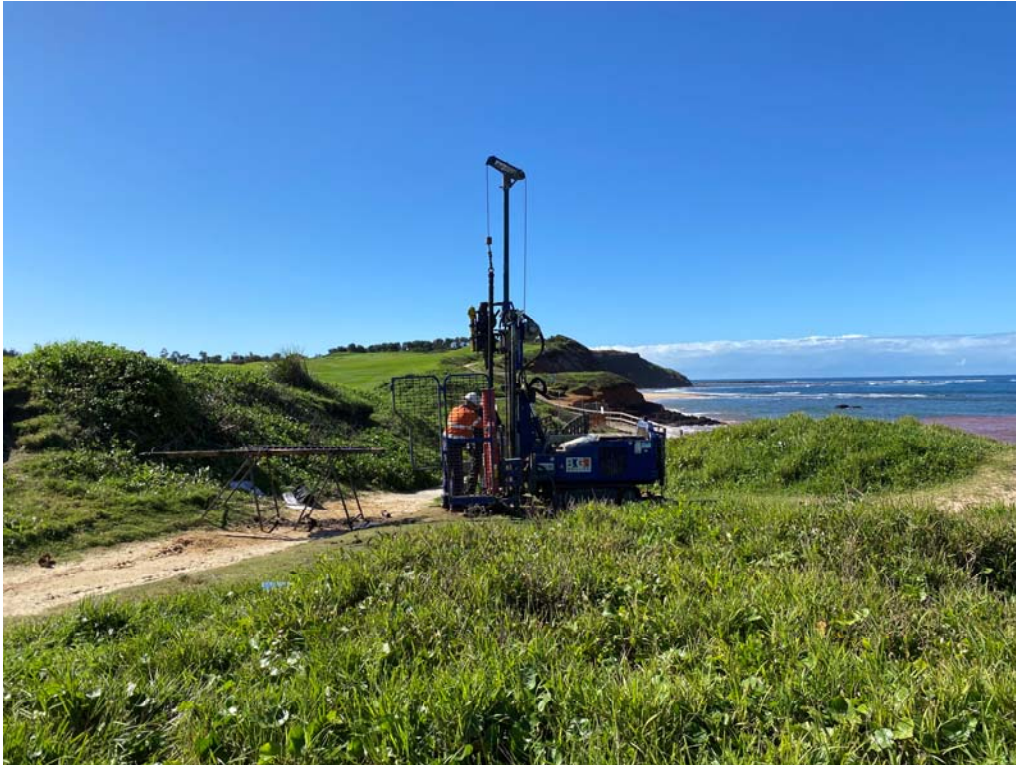
Photo 1 – BH01-LR facing east towards the headland

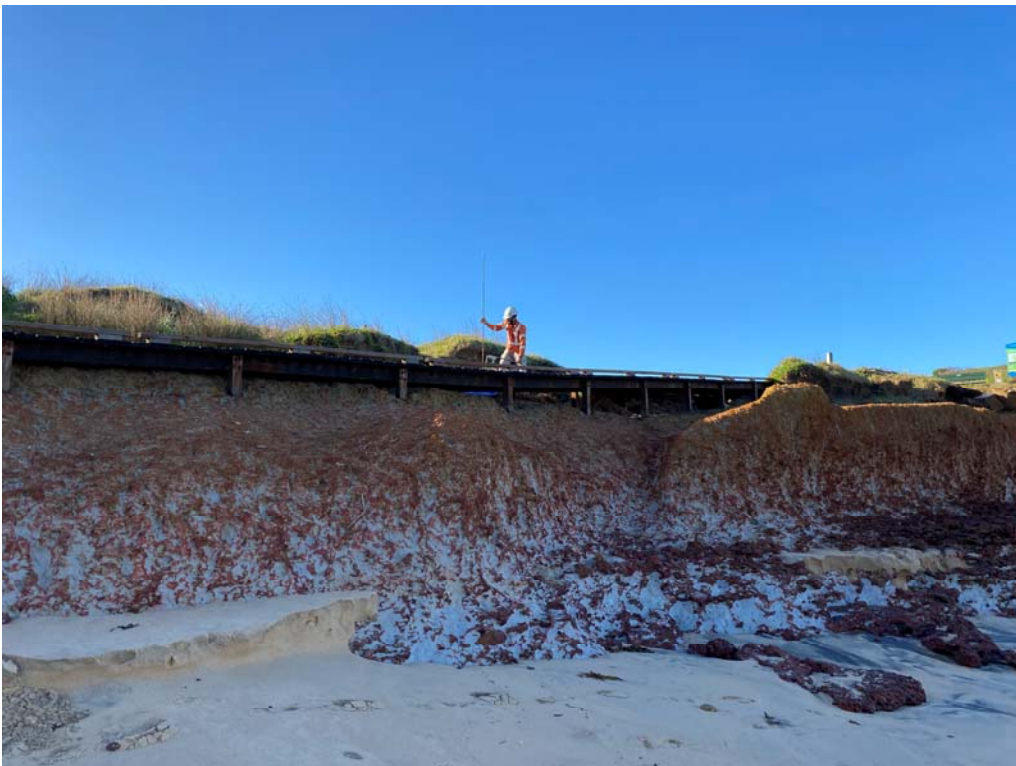
Photo 2 – The existing boardwalk
