Wakehurst Parkway Flood Mitigation Feasibility Study

Client: Northern Beaches Council

Reference: PA1943

Date: 09 March 2021

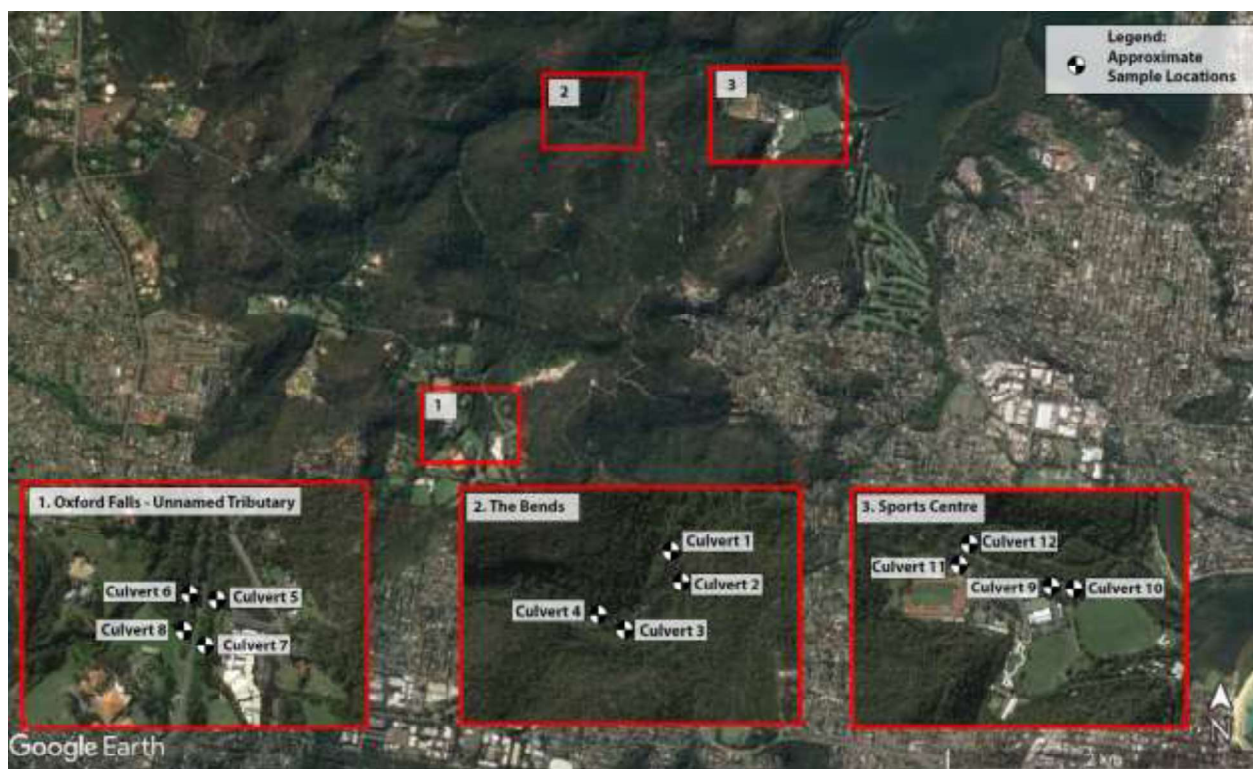
Figure 2: Sampling locations at proposed culvert sites (SESL, 2018)

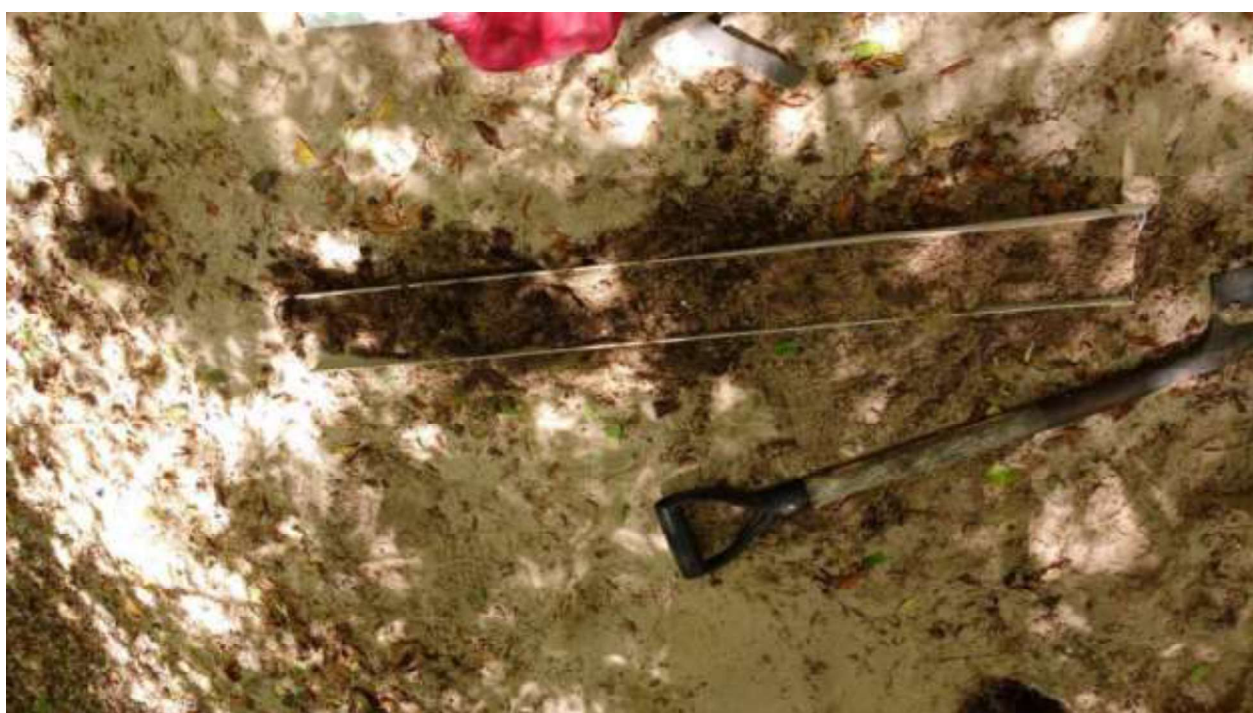
Figure 4: Profile of the material augured at BH1 (SESL, 2018). Phot taken 31/10/2018.

Sample Name	Sample Depth approx. (mm)	Soil Profile Description
BH1	0-200 500-600 800-900	0-700: White/yellow coarse sand 700-800: Dark brown sandy loam
BH2	0-200 500-600 1100-1200	0-200: Coarse sand with significant organics 200-800: Coarse sand 800-1200: Loamy sand
BH3	0-200 200-300 800-900	0-250: Coarse sand 250-300: Brown sandy loam 300-1000: Coarse sand
BH4	0-200 300-400 500-700	0-500: Coarse sand 500-800: Dark brown sandy clay loam
BH5	0-200 500-600 700-800	0-700: Coarse sand with minor loam inclusions 700-800: Dark brown sandy clay loam, plastic inclusions
BH6	0-200 300-400 550-700	0-550: Coarse sand with minor loam inclusions 550-700: Dark brown sandy clay loam
BH7	0-200 400-600 800-1000	0-600: Coarse sand with minor loam inclusions 600-1000: Dark brown sandy clay loam

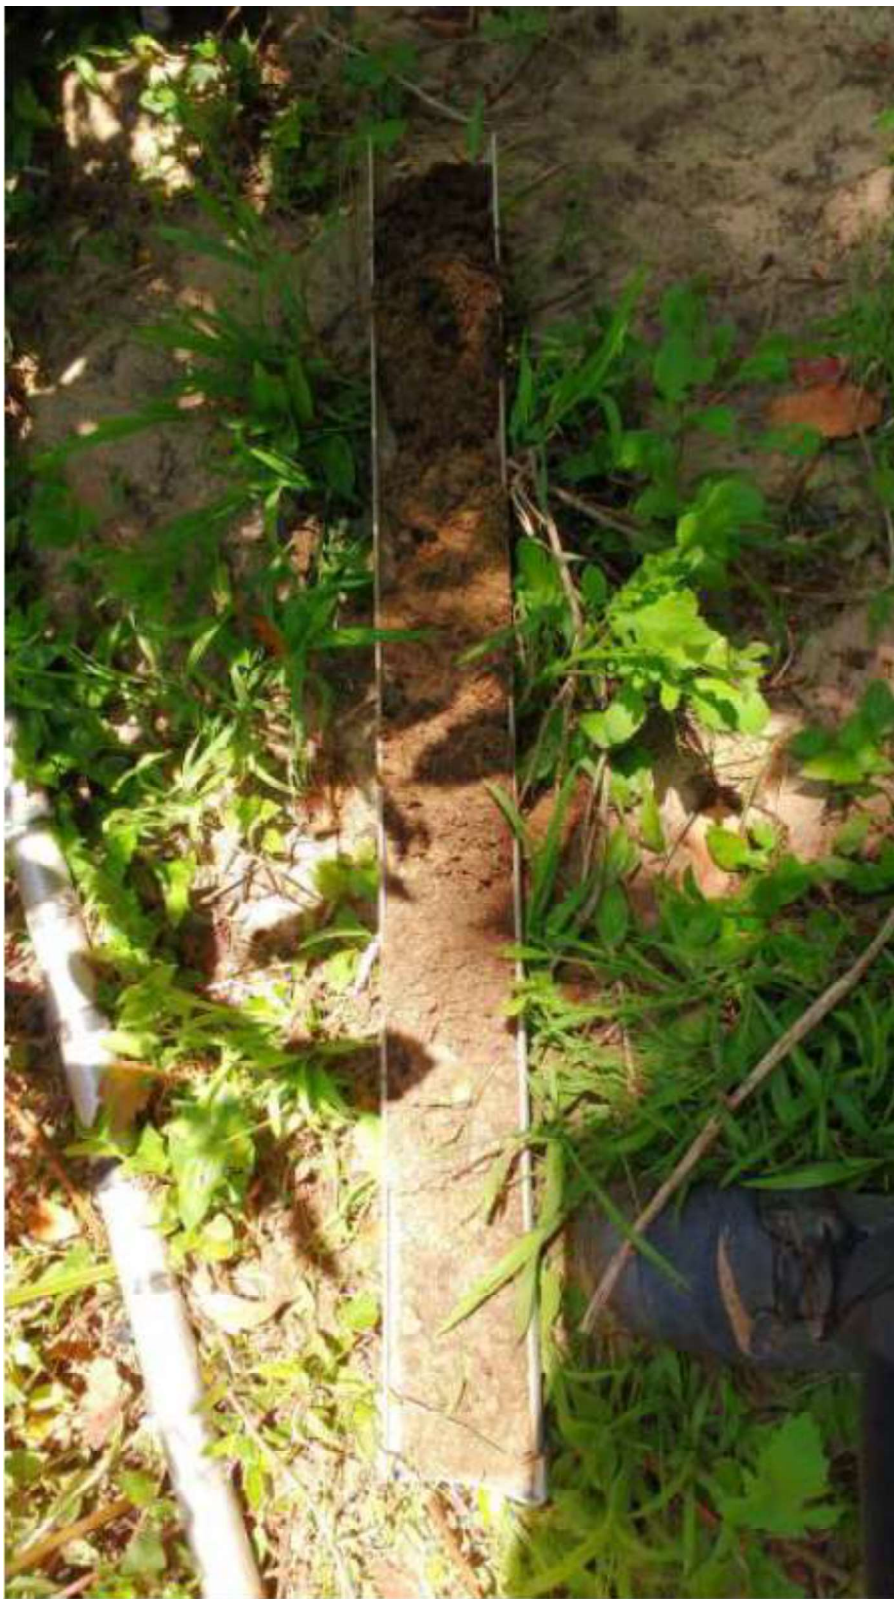
Figure 5: Profile of the material at BH5 (SESL, 2018). Photo taken 31/10/2018.

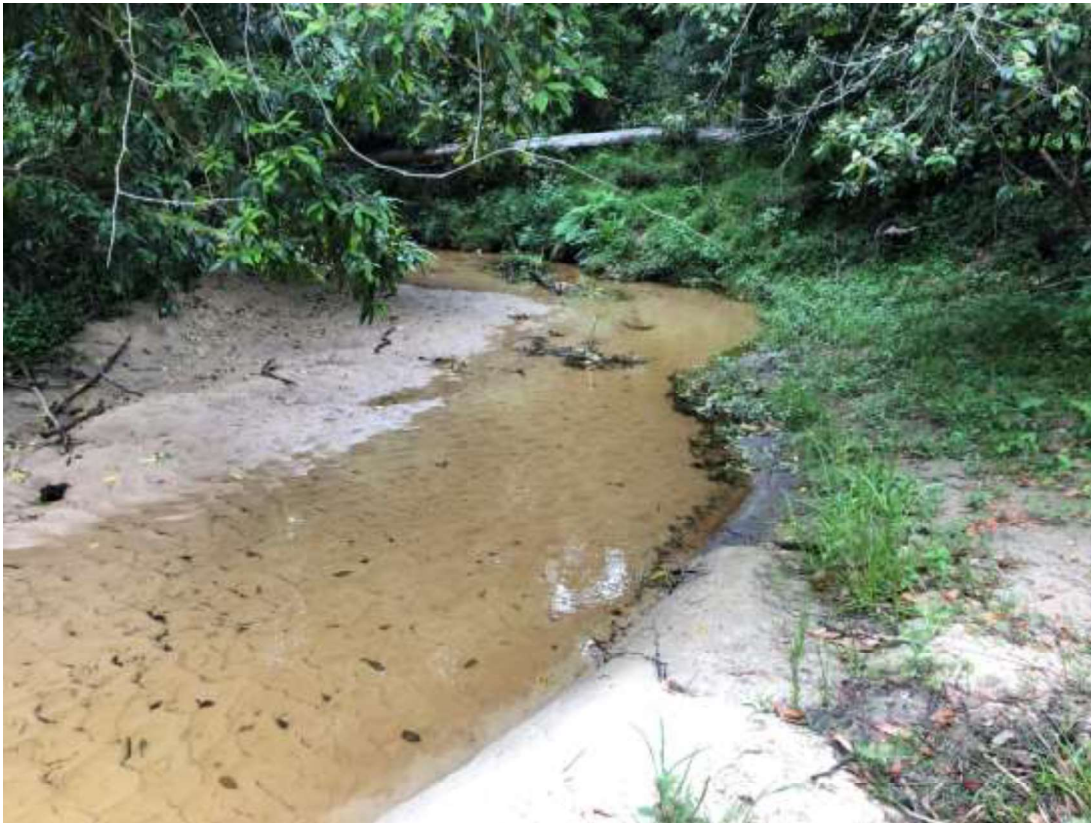
Figure 7: In-creek sand at approximate location of the SESL (2018) BH7. Photo taken looking downstream.

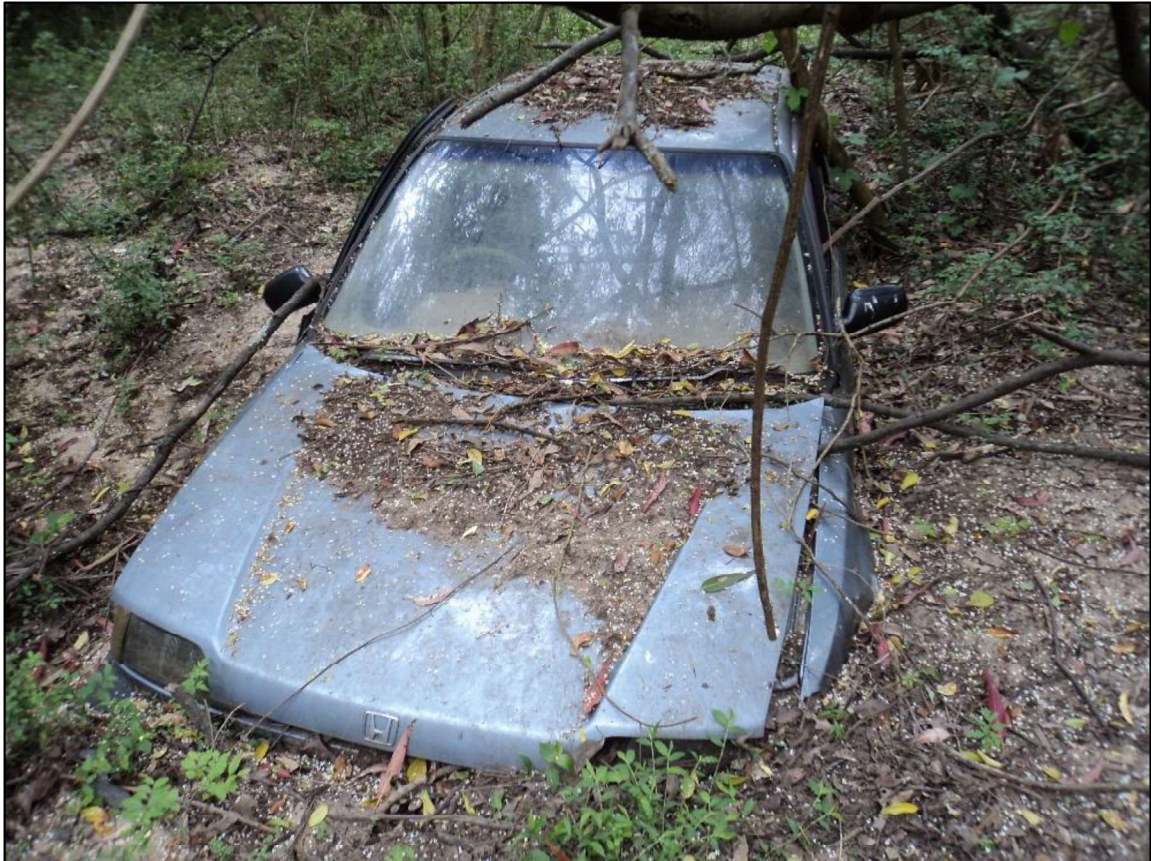
Figure 4.1 Car buried by the high level of recent sediment deposition
