**Subject:** DA Submission regarding Development Application No. DA2019/0699 at 19 Joseph Street, Avalon Beach

**REFERENCE: DA2019/0699**  
**ADDRESS: 19 JOSEPH STREET, AVALON BEACH**

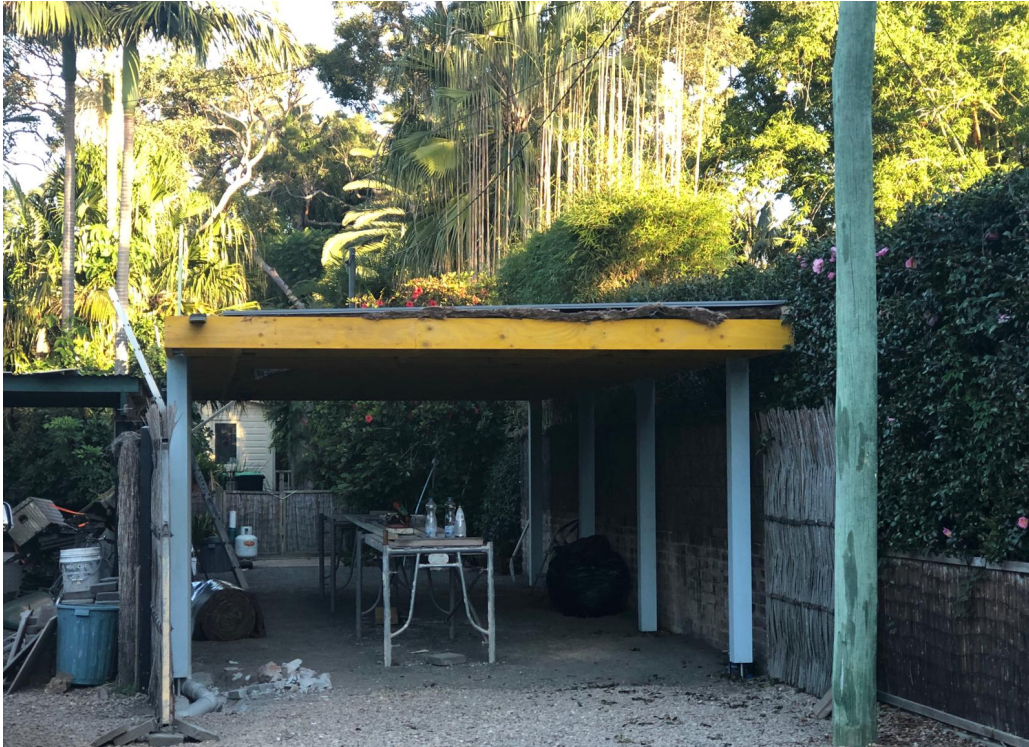
**Figure 1: View of unauthorised carport from Joseph Street, facing south-east**

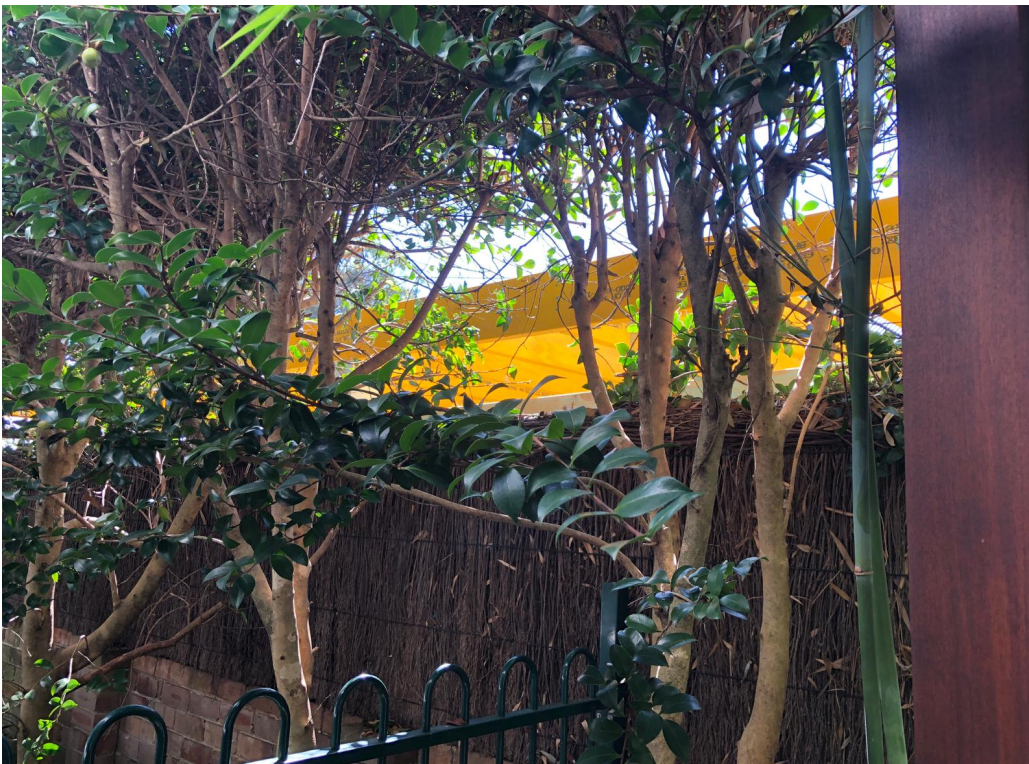
Of particular concern to my client is the bulk and scale of the unauthorised carport as it adjoins the south-western boundary of the site, substantially impacting the internal amenity of my clients' living room (Refer to Figures 2-8).

**Figure 2: View towards carport on subject site, looking north from No. 17 Joseph Street**

Accordingly, we request that the carport be amended to provide a minimum setback of 1.0m from the south-western boundary, with screen planting provided along the boundary.

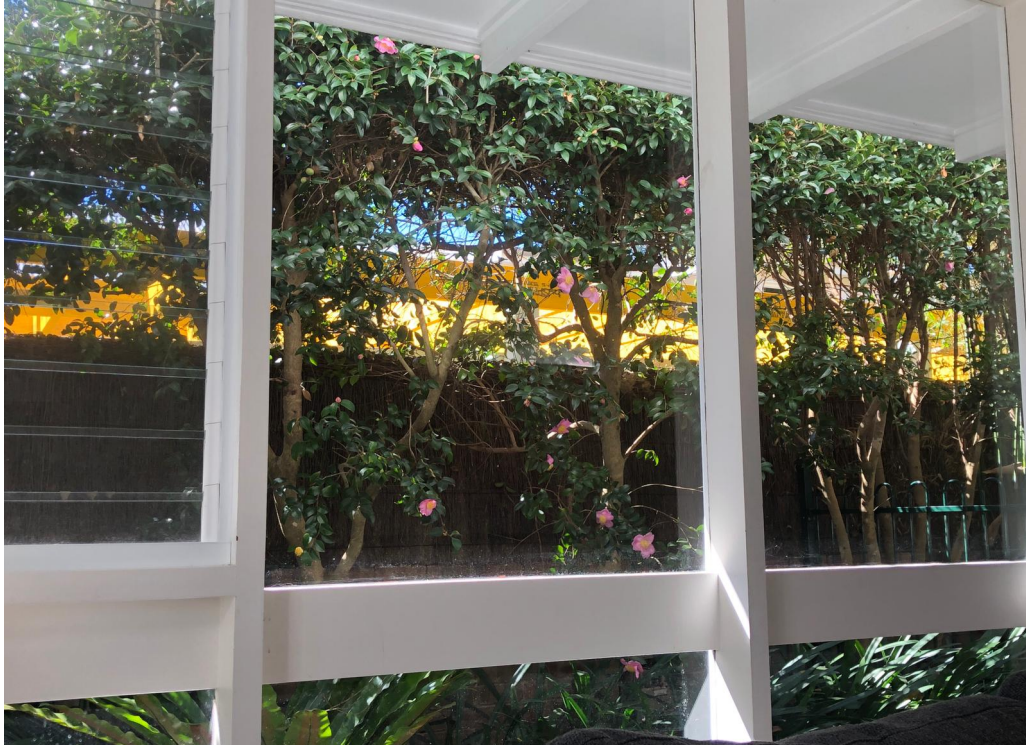
**Figure 3: View towards carport on subject site, looking north-east from the living room of the dwelling at No. 17 Joseph Street**

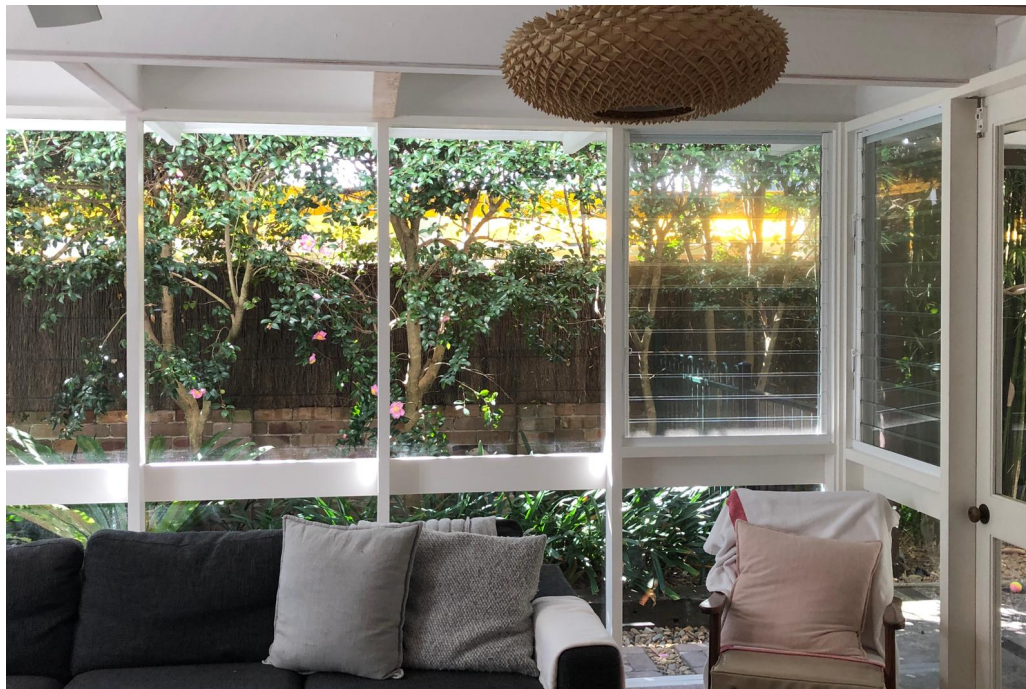
**Figure 4: View towards carport on subject site, looking north-east from the living room of the dwelling at No. 17 Joseph Street**

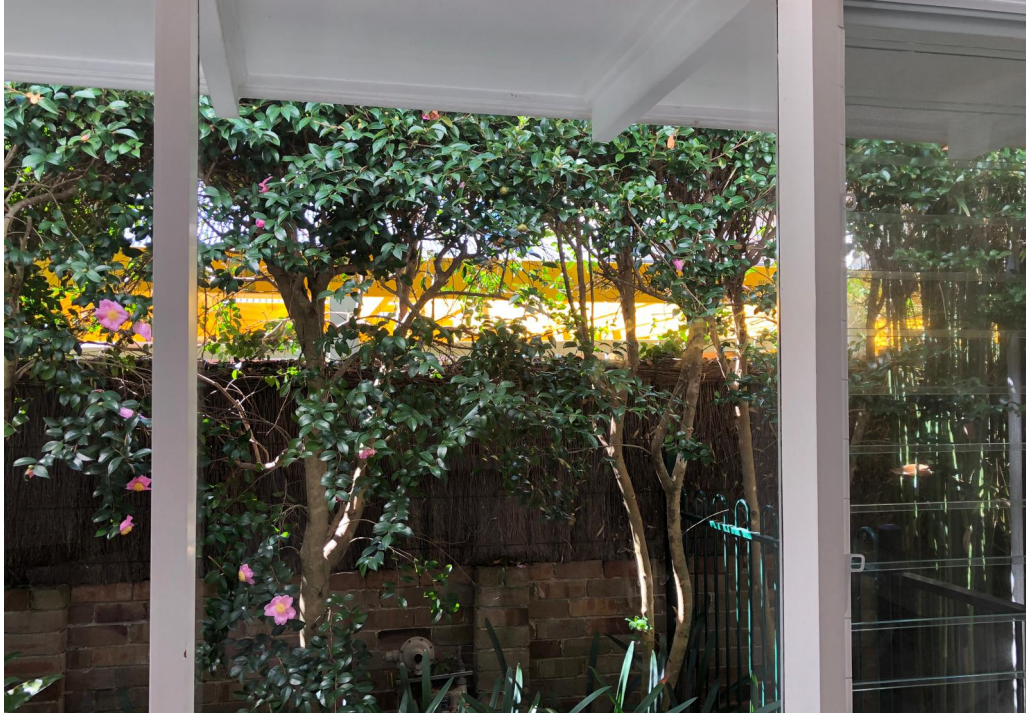
**Figure 5: View towards carport on subject site, looking north-east from the living room of the dwelling at No. 17 Joseph Street**

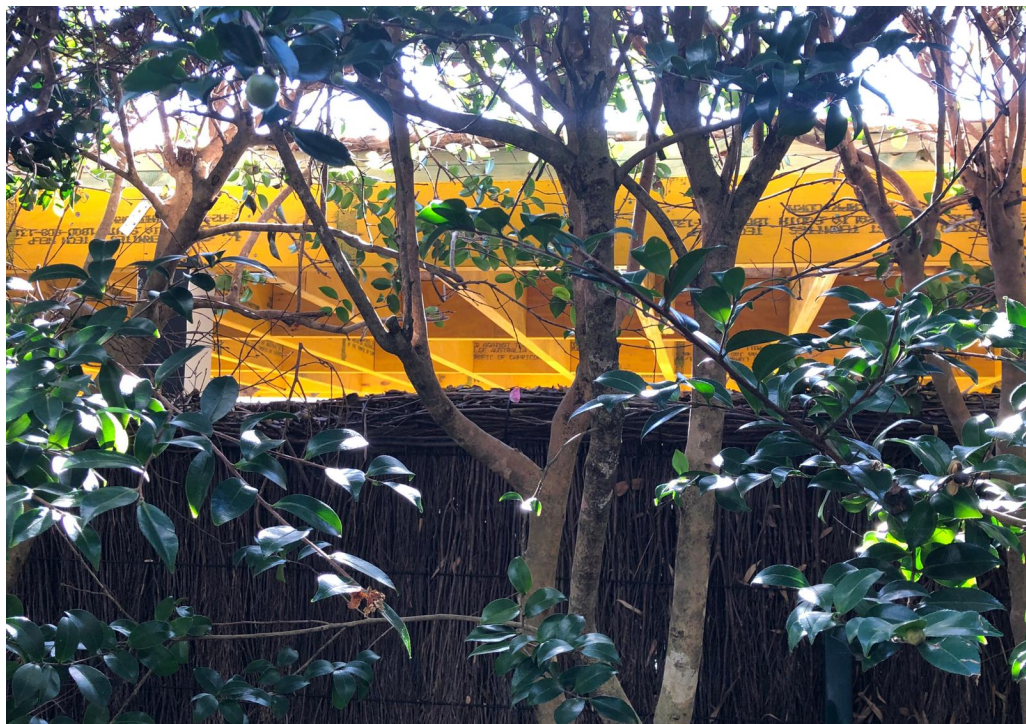
**Figure 6: View towards carport on subject site, looking north-east from the north-eastern side boundary at No. 17 Joseph Street**

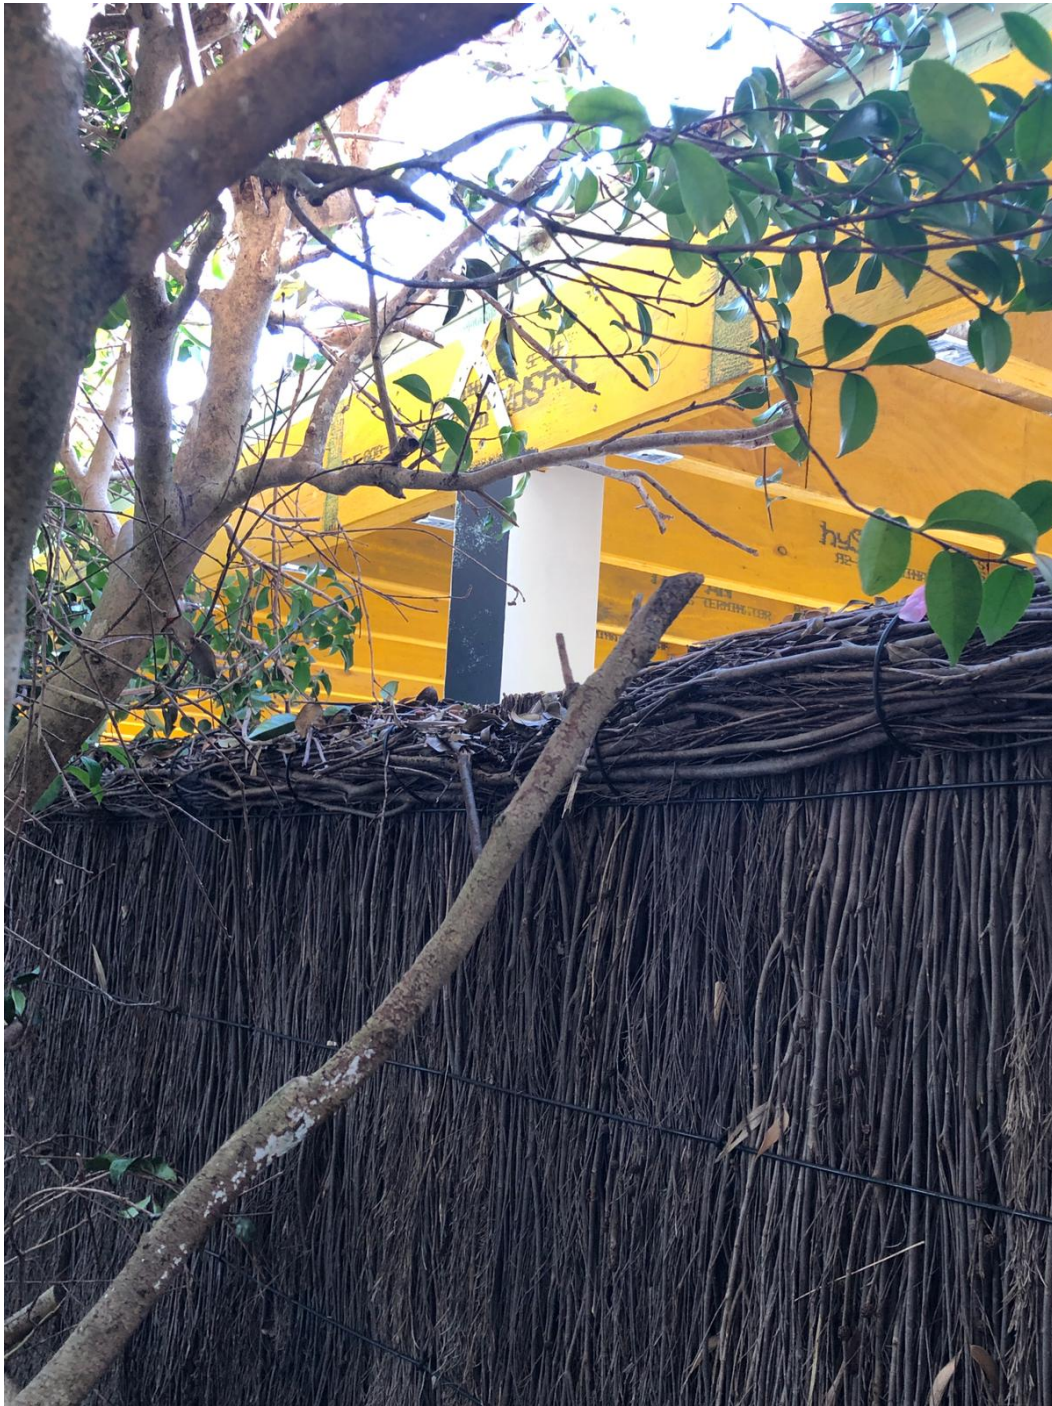
**Figure 7: View towards carport on subject site, looking north from the north-eastern side boundary at No. 17 Joseph Street**

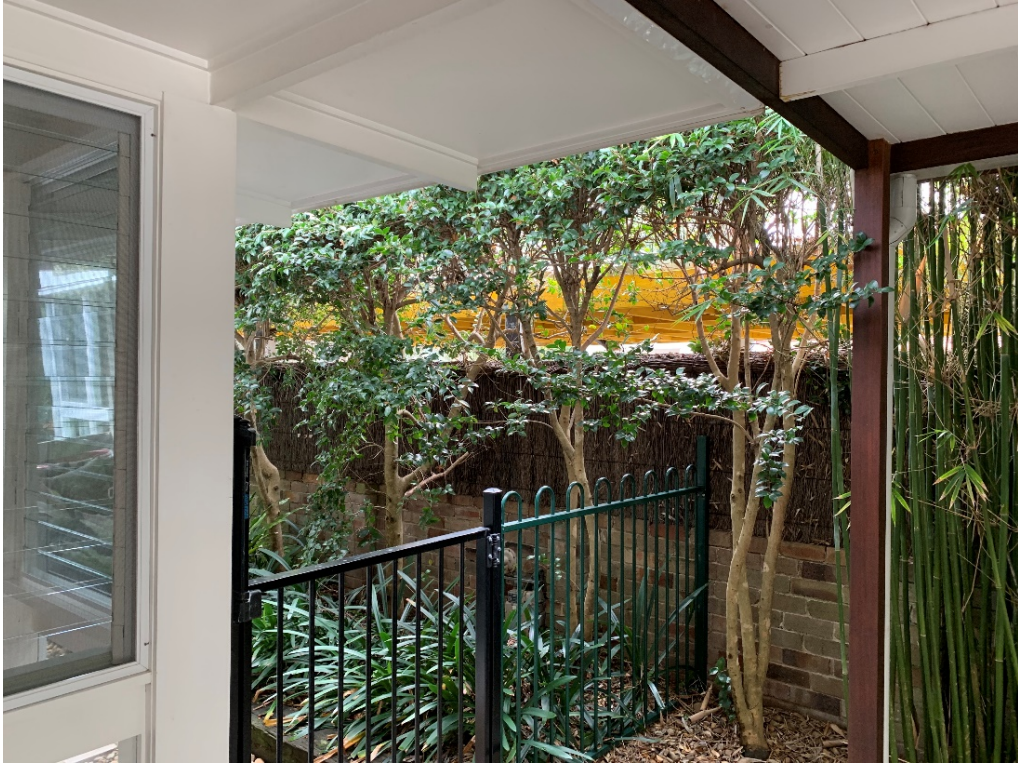
**Figure 8: View towards carport on subject site from outdoor entertaining area of No. 17 Joseph Street, looking north-east**
