Marine Habitat Survey

Address | 22 Rednal Street, Mona Vale

Job Number 25-083-08

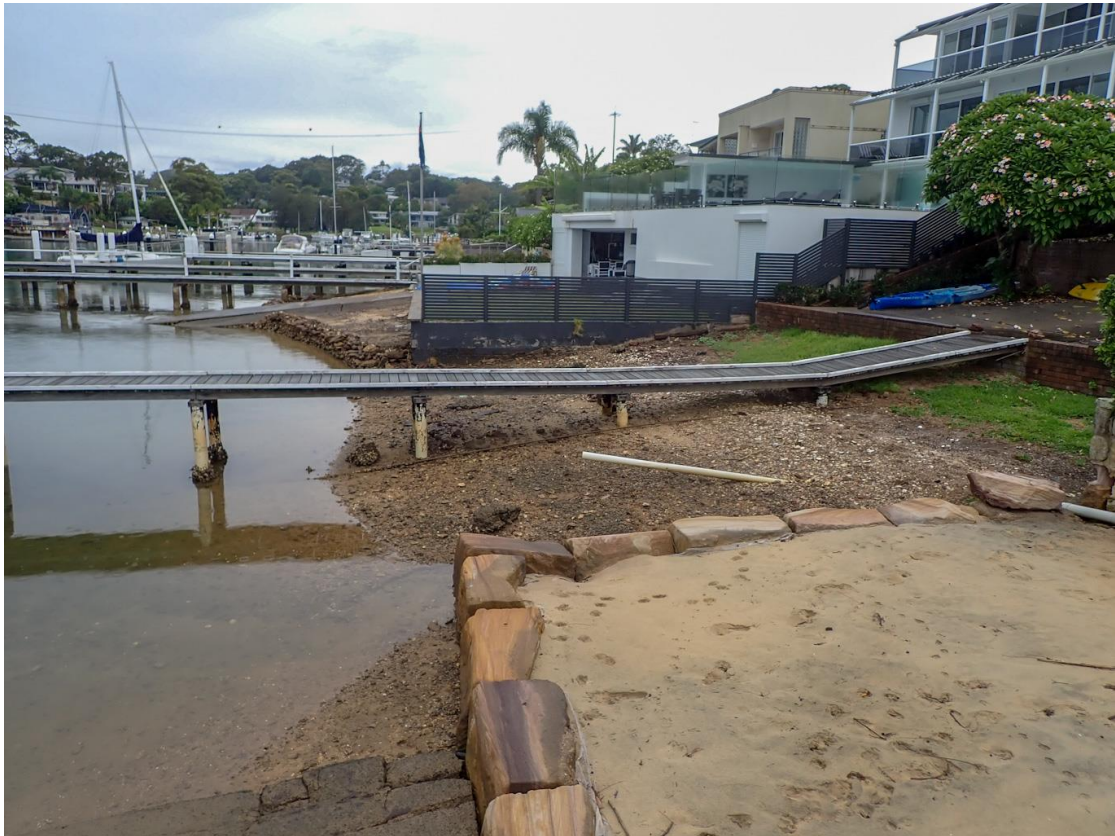
The sandy rocky area (Photo 1) and the sand flat were unvegetated. The intertidal sections of the existing sleeved jetty piers were bare except for the fourth pair of piers (Photo 1) which had a growth of Sydney rock oysters (*Saccostrea glomerata*).

Photo 1. The existing jetty at The Property passing over the sandy and rocky intertidal area.

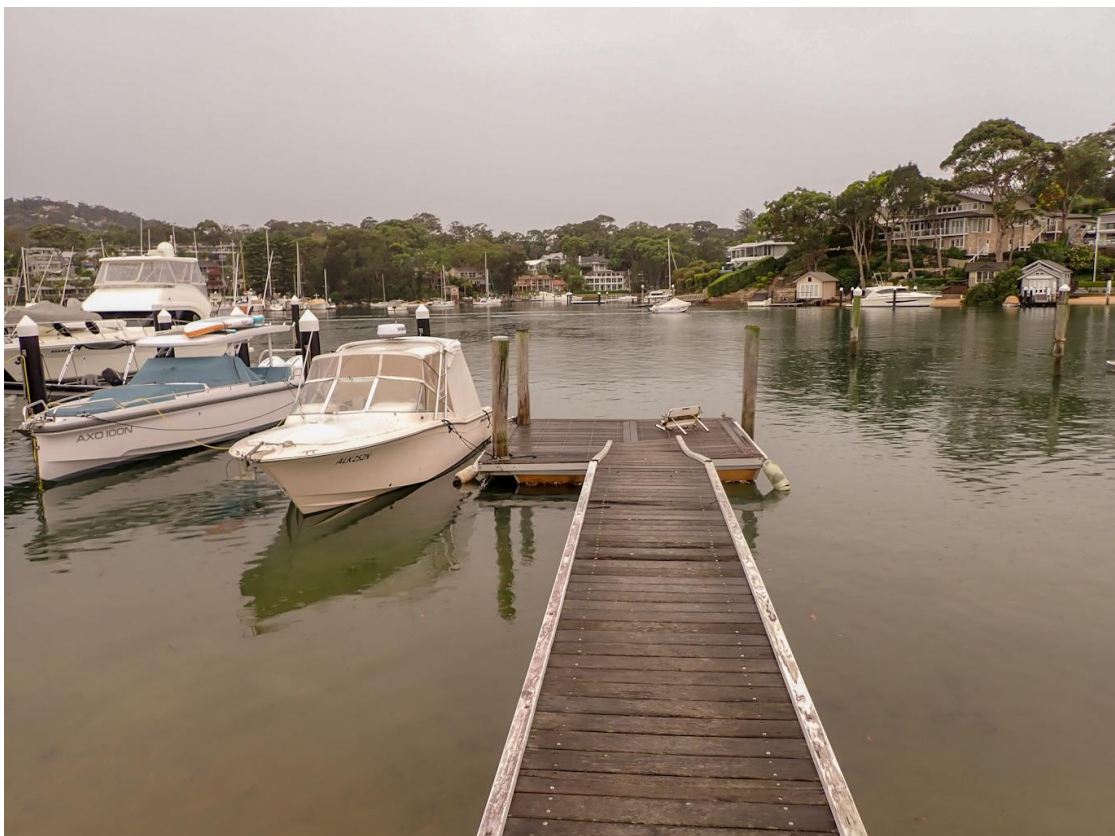
- a timber jetty (19.0 x 1.3 m) supported on 12 PVC sleeved piers;
- a timber ramp (6.0 x 1.3 m);
- a longitudinal pontoon (7.0 x 2.1 m) with two timber stabilising piles on the northern side of the pontoon;
- one fender pile, located on the south-east corner of the pontoon.

Photo 2. The existing timber jetty, ramp, pontoon, pontoon stabilising piles and fender pile – all of these structures are proposed to be removed.

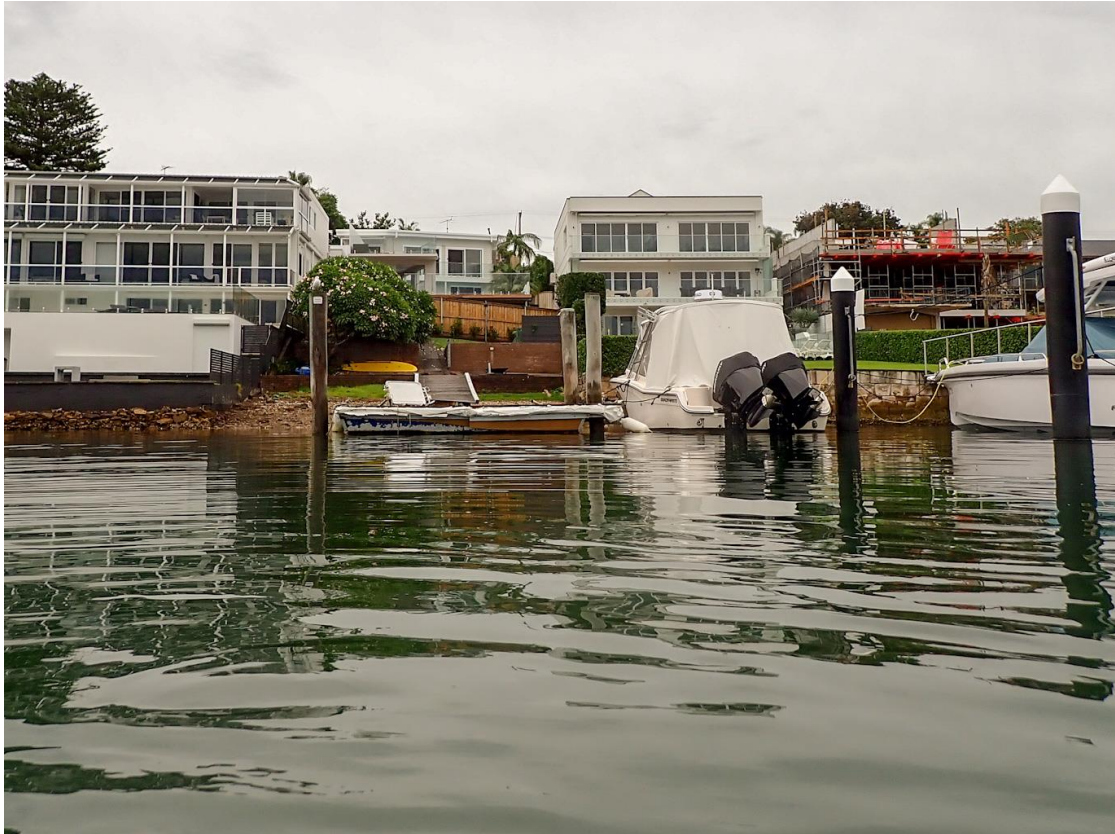
Photo 3. View inshore from the approximate location of the proposed new pontoon.

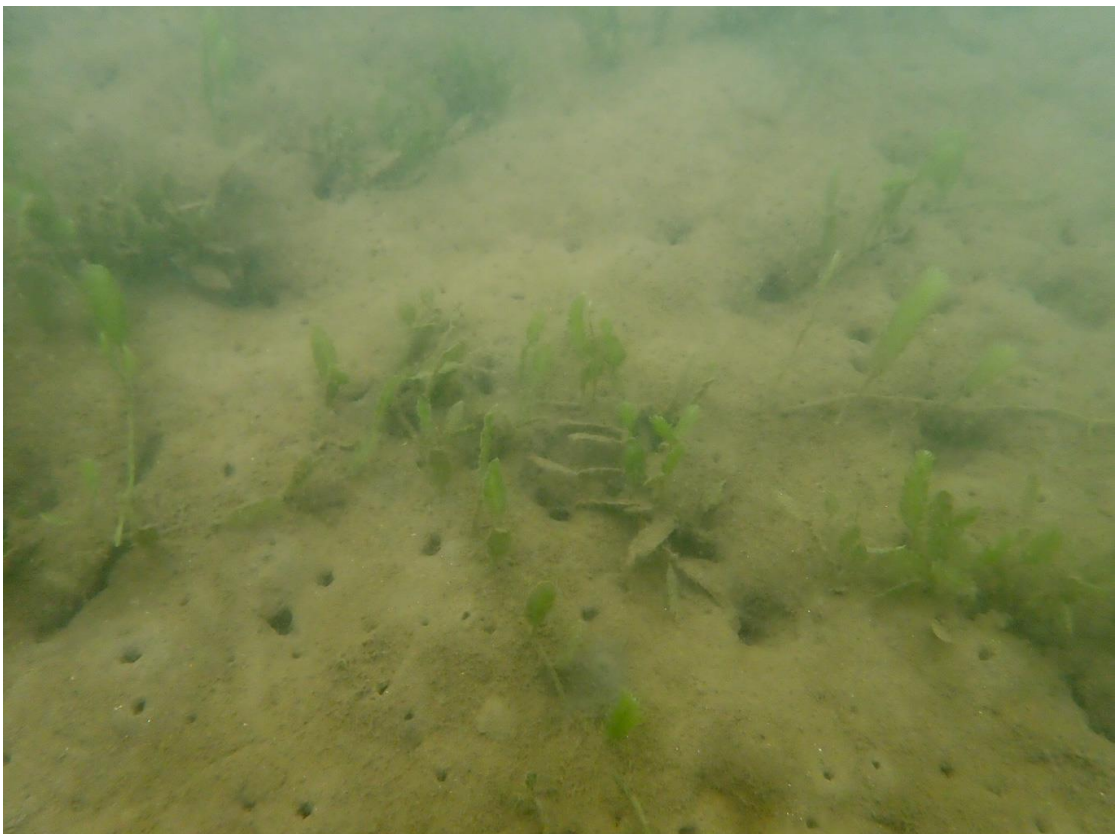
The subtidal zone within the on-site survey area of The Property started approximately 1 m beyond the end of the existing jetty and consisted of a gradually sloping seabed composed of silty sand that transitioned to finer, sandy silt approximately 10 m offshore of the existing pontoon (Photo 4). The gradually sloping sandy silt continued uniformly offshore beyond the survey area (see aquatic habitat mapping in Appendix B). The soft seabed across the whole site was bioturbated from the burrowing activities of benthic fauna (Photo 4).

The soft seabed across much of the site was colonised by a very low density bed of the green pest alga *Caulerpa taxifolia* (Photo 4; see aquatic habitat mapping in Appendix B). The *Caulerpa* started midway along the existing pontoon and continued offshore beyond the proposed new structures.

Photo 4. Low density *Caulerpa* colonising the sandy silt seabed in the location of the proposed new pontoon piles and mooring piles.

It is required that the barge operators take due care to prevent the spread of the pest alga *Caulerpa taxifolia* outside of the site to other bays and waterways, by clearing any *Caulerpa* leaves or fragments from their anchors and equipment.

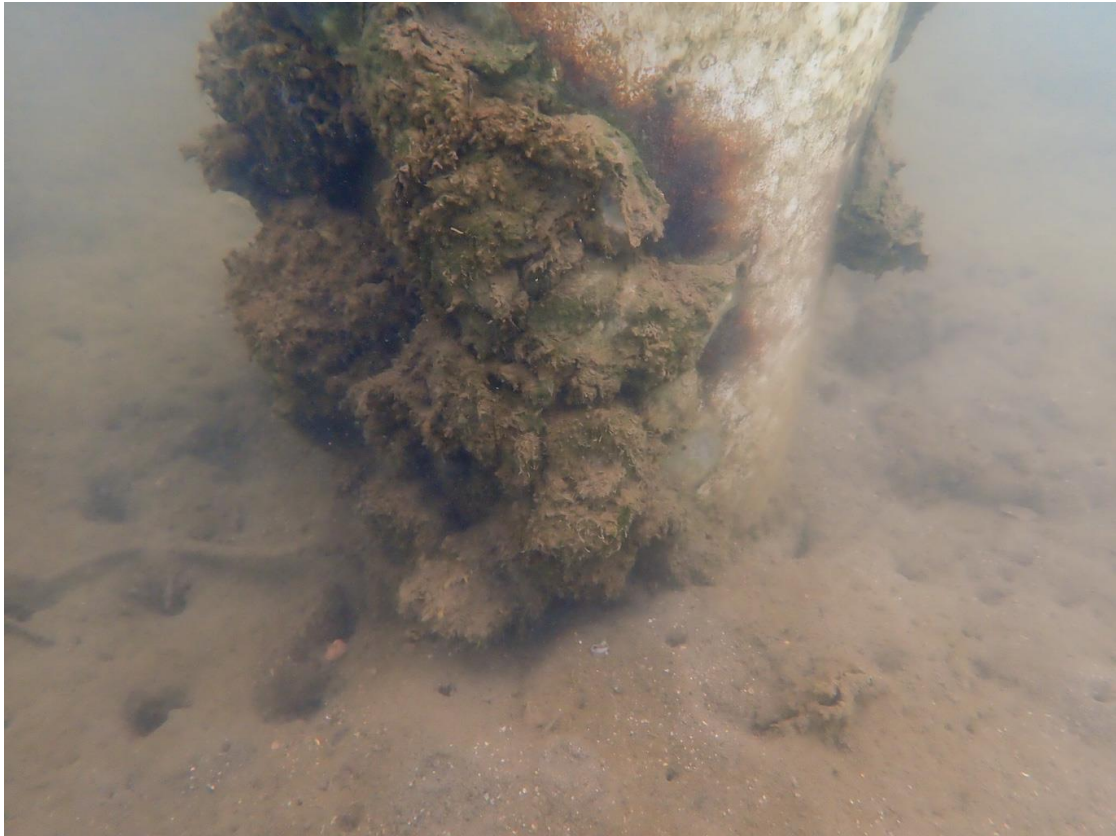
The subtidal sections of the existing pontoon piles and fender pile (Photo 5; proposed to be removed) were colonised by a low density growth of Pacific oysters (*Crassostrea glomerata*), along with a thin layer of brown filamentous alga and sparse white ascidians (*Styela plicata*). The existing pontoon (Photo 6; proposed to be removed) was colonised by a medium density assemblage of subtidal biota, including brown algae (scrollweed *Padina* sp. and filamentous), Pacific oysters, white ascidians (*Styela plicata*) and frilly bryozoa (*Bugula* sp.).

Photo 5. Subtidal biota colonising the base of the existing timber fender pile (proposed to be removed).

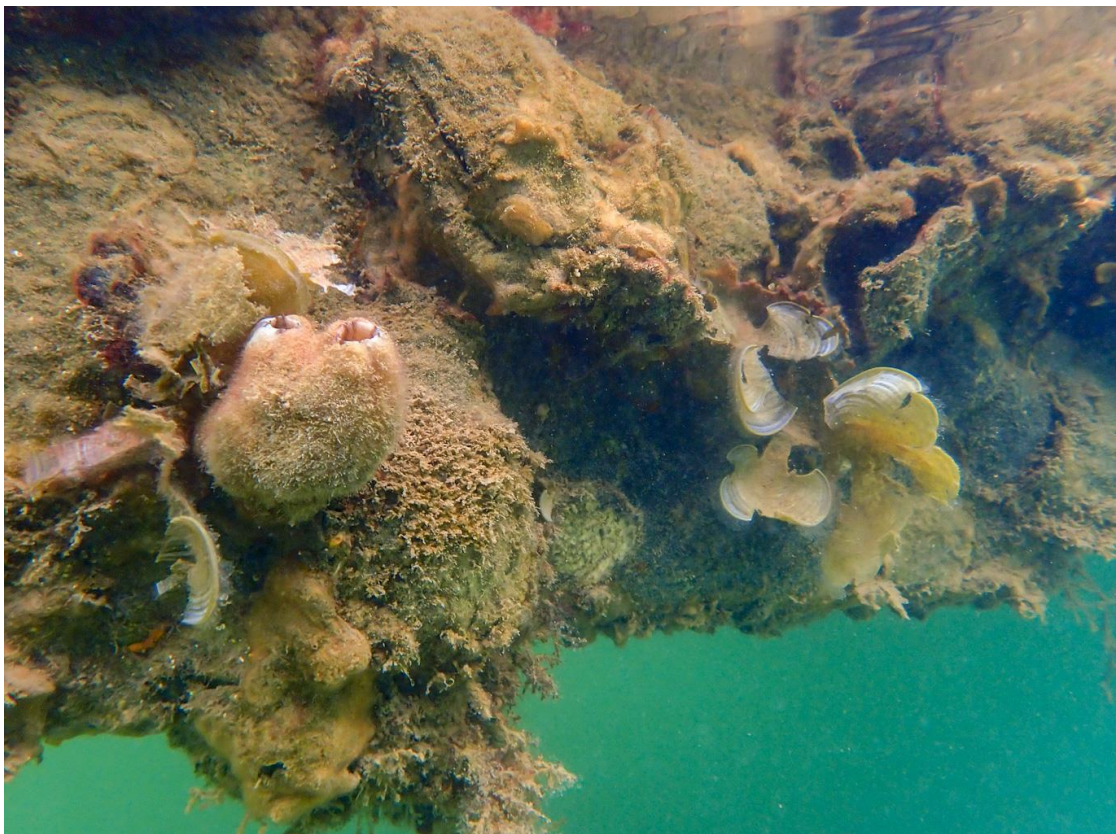
Photo 6. Subtidal biota colonising the existing pontoon (proposed to be removed).
