PRELIMINARY ASSESSMENT: Acid Sulfate For Proposed Works at **1 James Wheeler Place, Wheeler Heights**

1. Proposed Development

5. Field Testing

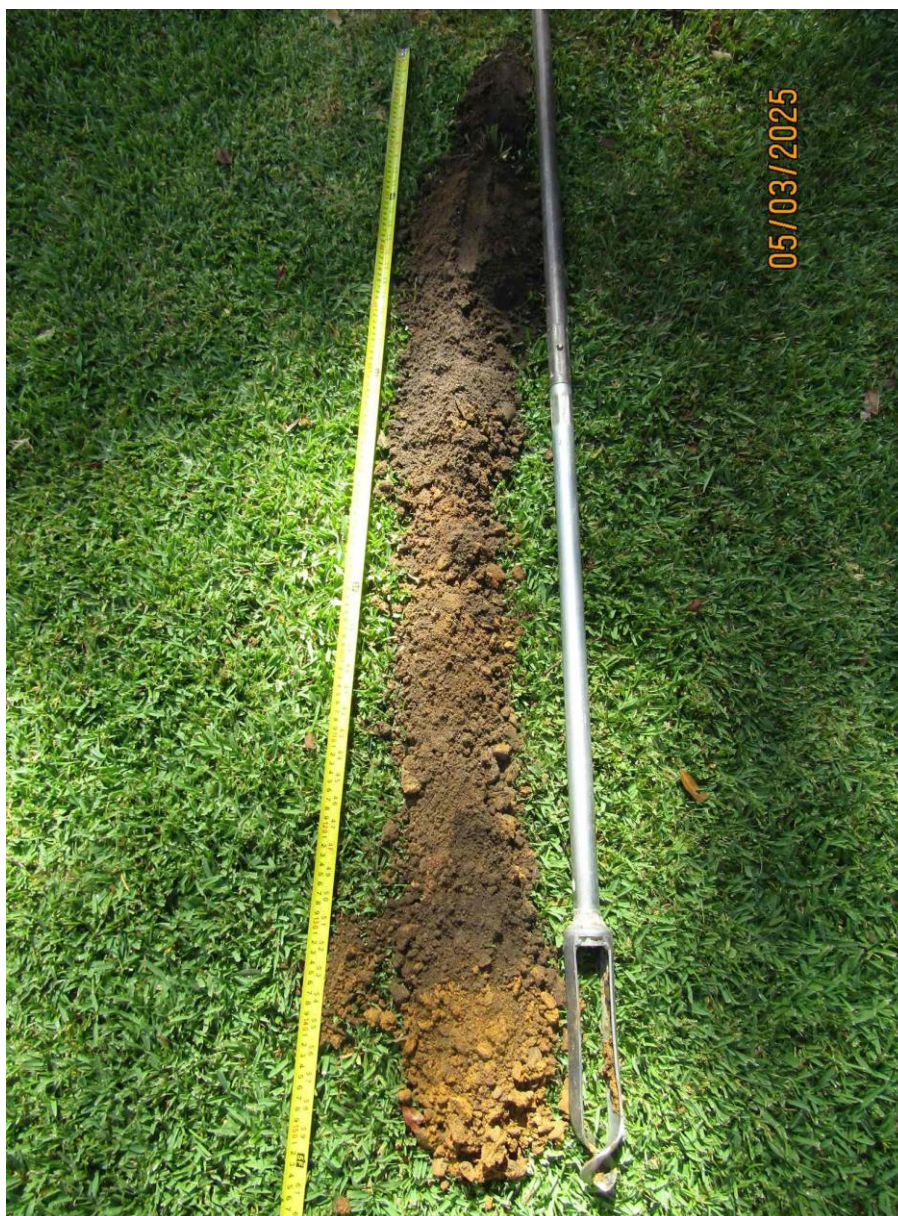
Photo 1: AH1 – Downhole is from top to bottom.

AUGER HOLE 1 (~RL13.9) – AH1 (Photo 1)

| Depth (m) | Material Encountered |
|---|---|
| 0.0 to 1.2 | FILL , sandy soil and clay, with some rock fragments, dark brown, brown, orange, dry to moist, fine to coarse grained. |
| 1.2 to 1.4 | TOPSOIL , sandy soil, dark brown, dry, fine to medium grained. |
| 1.4 to 1.5 | CLAY , orange brown, firm to stiff, dry. |

End of Test @ 1.5m in firm to stiff clay. No Water table encountered.

| TEST: AH1 | FIELD pH & PEROXIDE RESULTS | | | | |
|---|---|---|---|---|---|
| 0.5 | 6.3 | M | 6.1 | 0.2 | - |
| 1.0 | 6.7 | M | 6.6 | 0.1 | - |
| 1.5 | 5.2 | L | 4.6 | 0.6 | - |

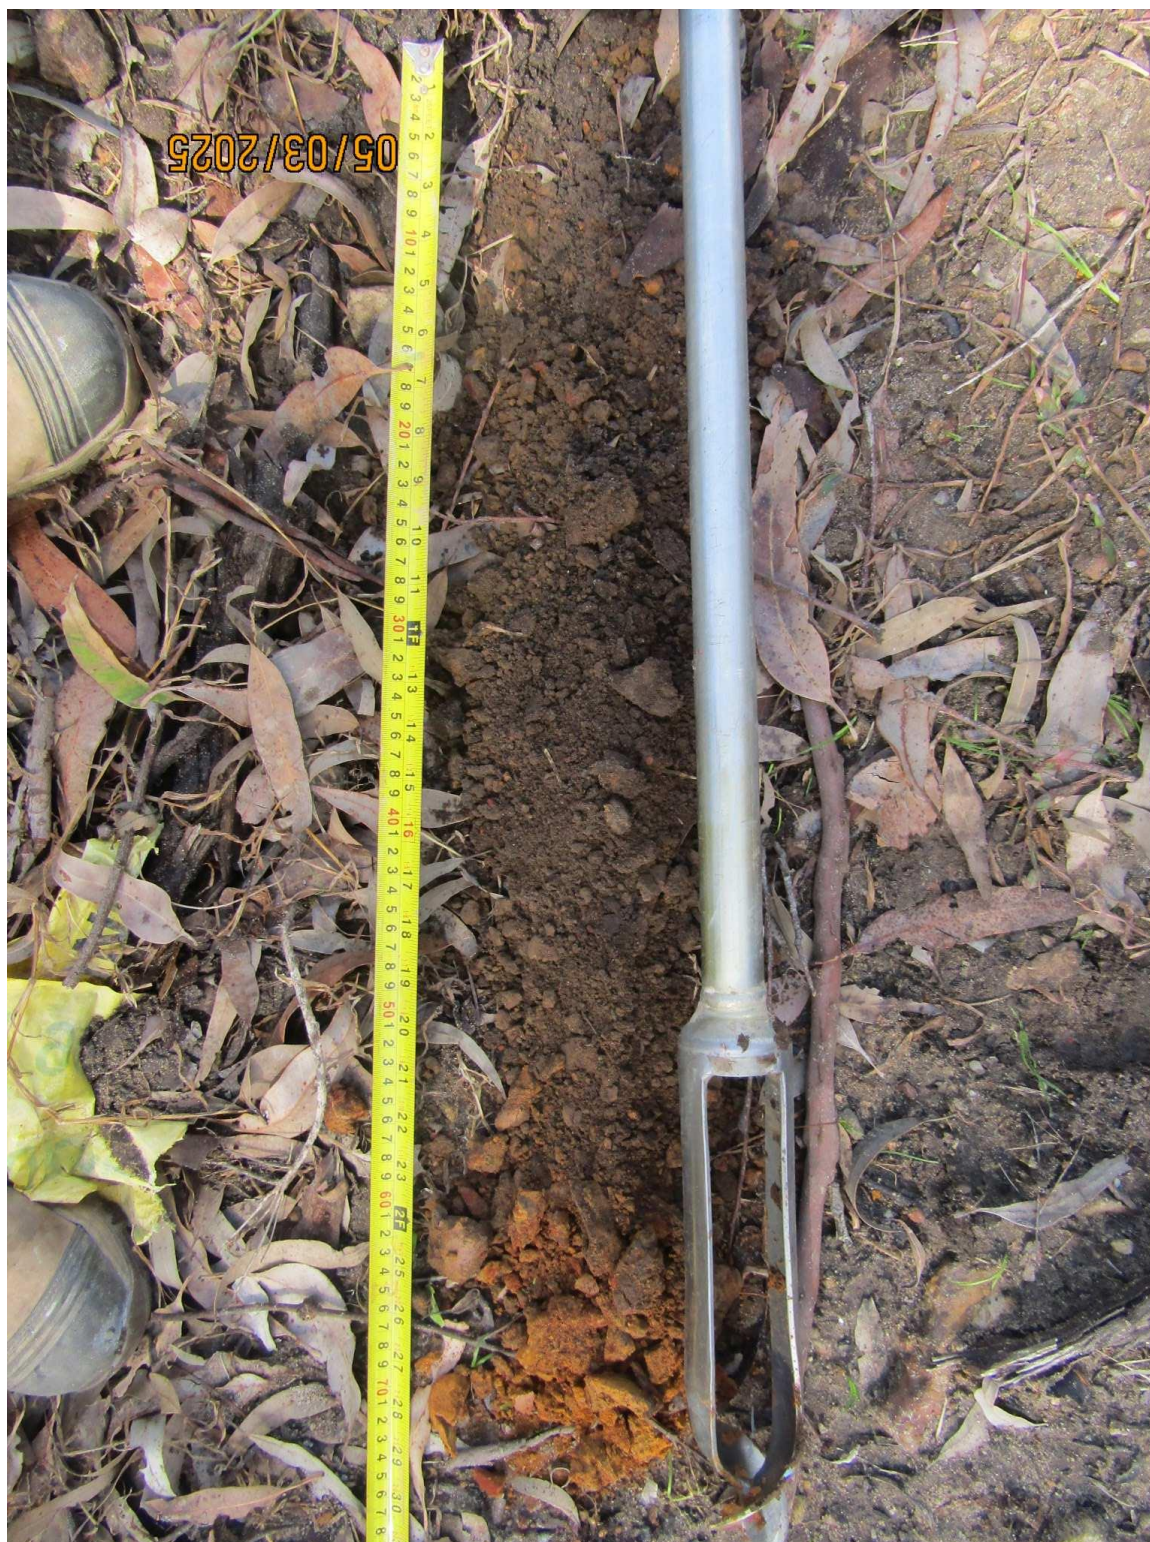
Photo 2: AH2 – Downhole is from top to bottom.

AUGER HOLE 2 (~RL15.7) – AH2 (Photo 2)

| Depth (m) | Material Encountered |
|---|---|
| 0.0 to 0.3 | FILL , sandy soil and clay, with some rock fragments, dark brown, brown, orange, dry to moist, fine to coarse grained. |
| 0.3 to 0.6 | TOPSOIL , sandy soil, dark brown, dry to moist, fine to medium grained. |
| 0.6 to 0.7 | CLAY , orange, firm to stiff, dry. |

End of Test @ 0.7m in firm to stiff clay. No Water table encountered.

| TEST: AH2 | FIELD pH & PEROXIDE RESULTS | | | | |
|---|---|---|---|---|---|
| 0.4 | 6.3 | M | 5.9 | 0.4 | - |
| 0.7 | 6.1 | L | 5.9 | 0.2 | - |

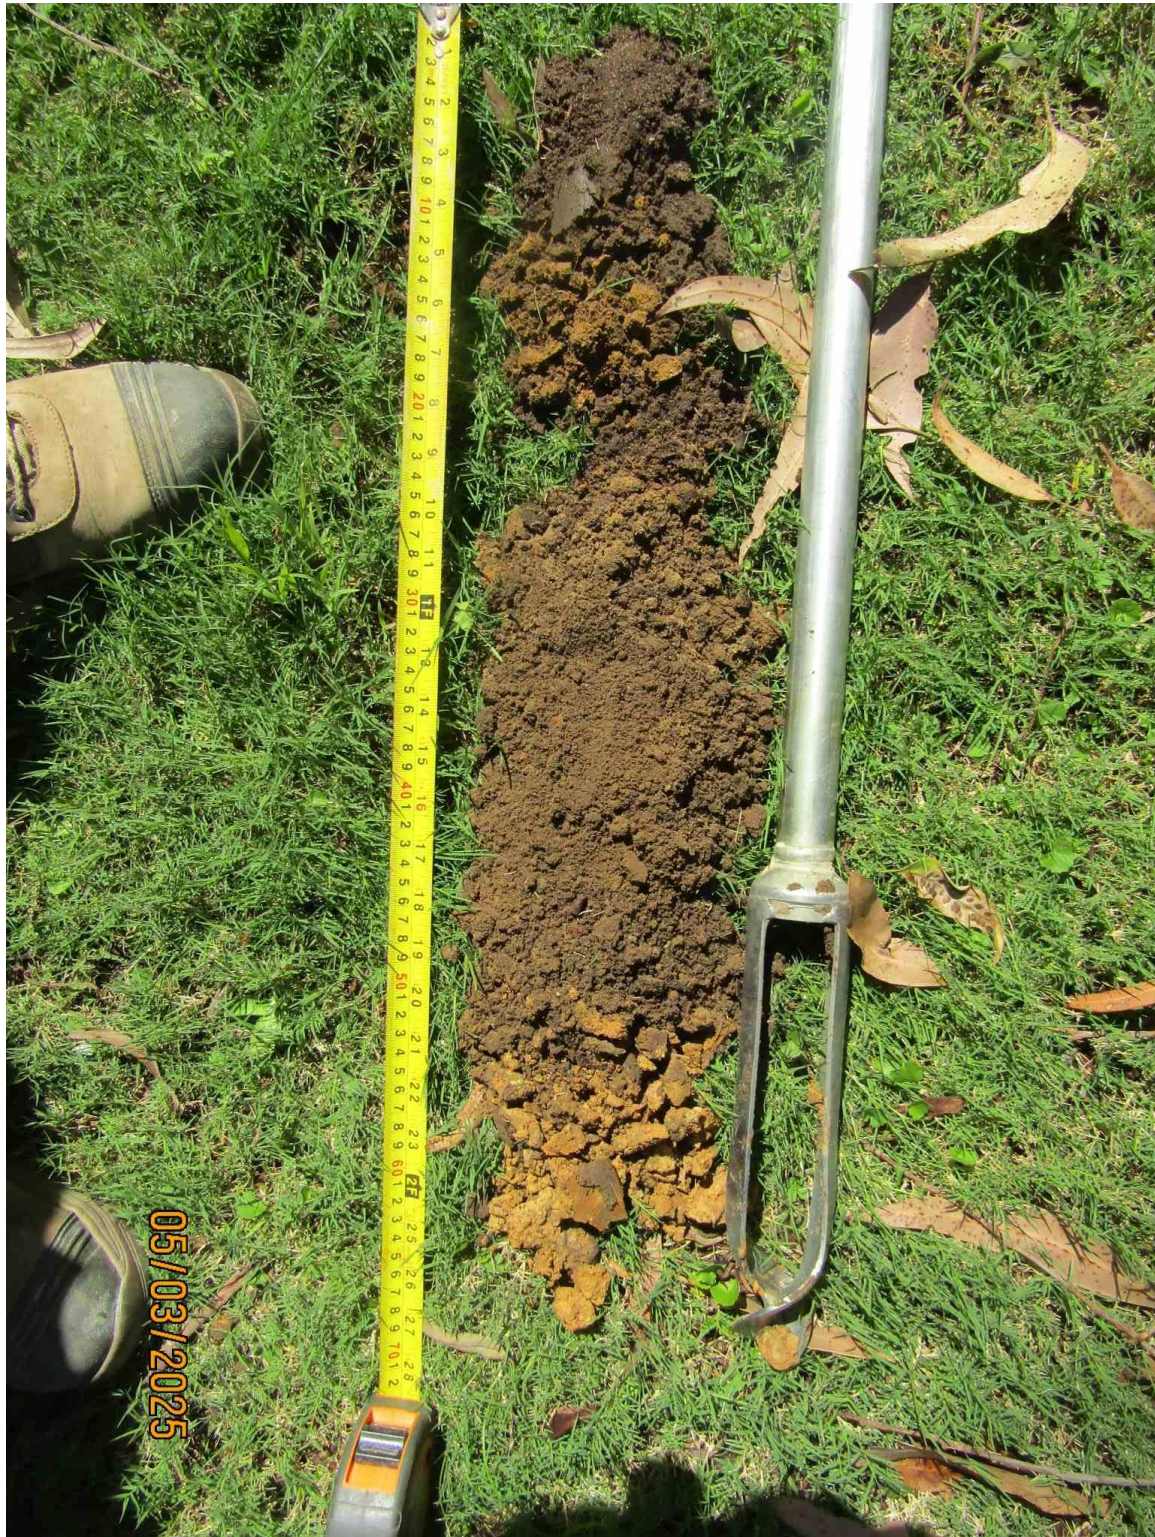
Photo 3: AH3 – Downhole is from top to bottom.

AUGER HOLE 3 (~RL11.6) – AH3 (Photo 3)

| Depth (m) | Material Encountered |
|---|---|
| 0.0 to 0.3 | FILL , sandy soil and clay, with some rock fragments, dark brown, brown, orange, dry to moist, fine to coarse grained. |
| 0.3 to 0.5 | TOPSOIL , sandy soil, dark brown, dry to moist, fine to medium grained. |
| 0.5 to 0.7 | CLAY , orange brown, firm to stiff, dry. |

End of Test @ 0.7m in firm to stiff clay. No Water table encountered.

| TEST: AH3 | FIELD pH & PEROXIDE RESULTS | | | | |
|---|---|---|---|---|---|
| 0.3 | 6.0 | M | 5.6 | 0.4 | - |
| 0.6 | 6.2 | L | 5.8 | 0.4 | - |

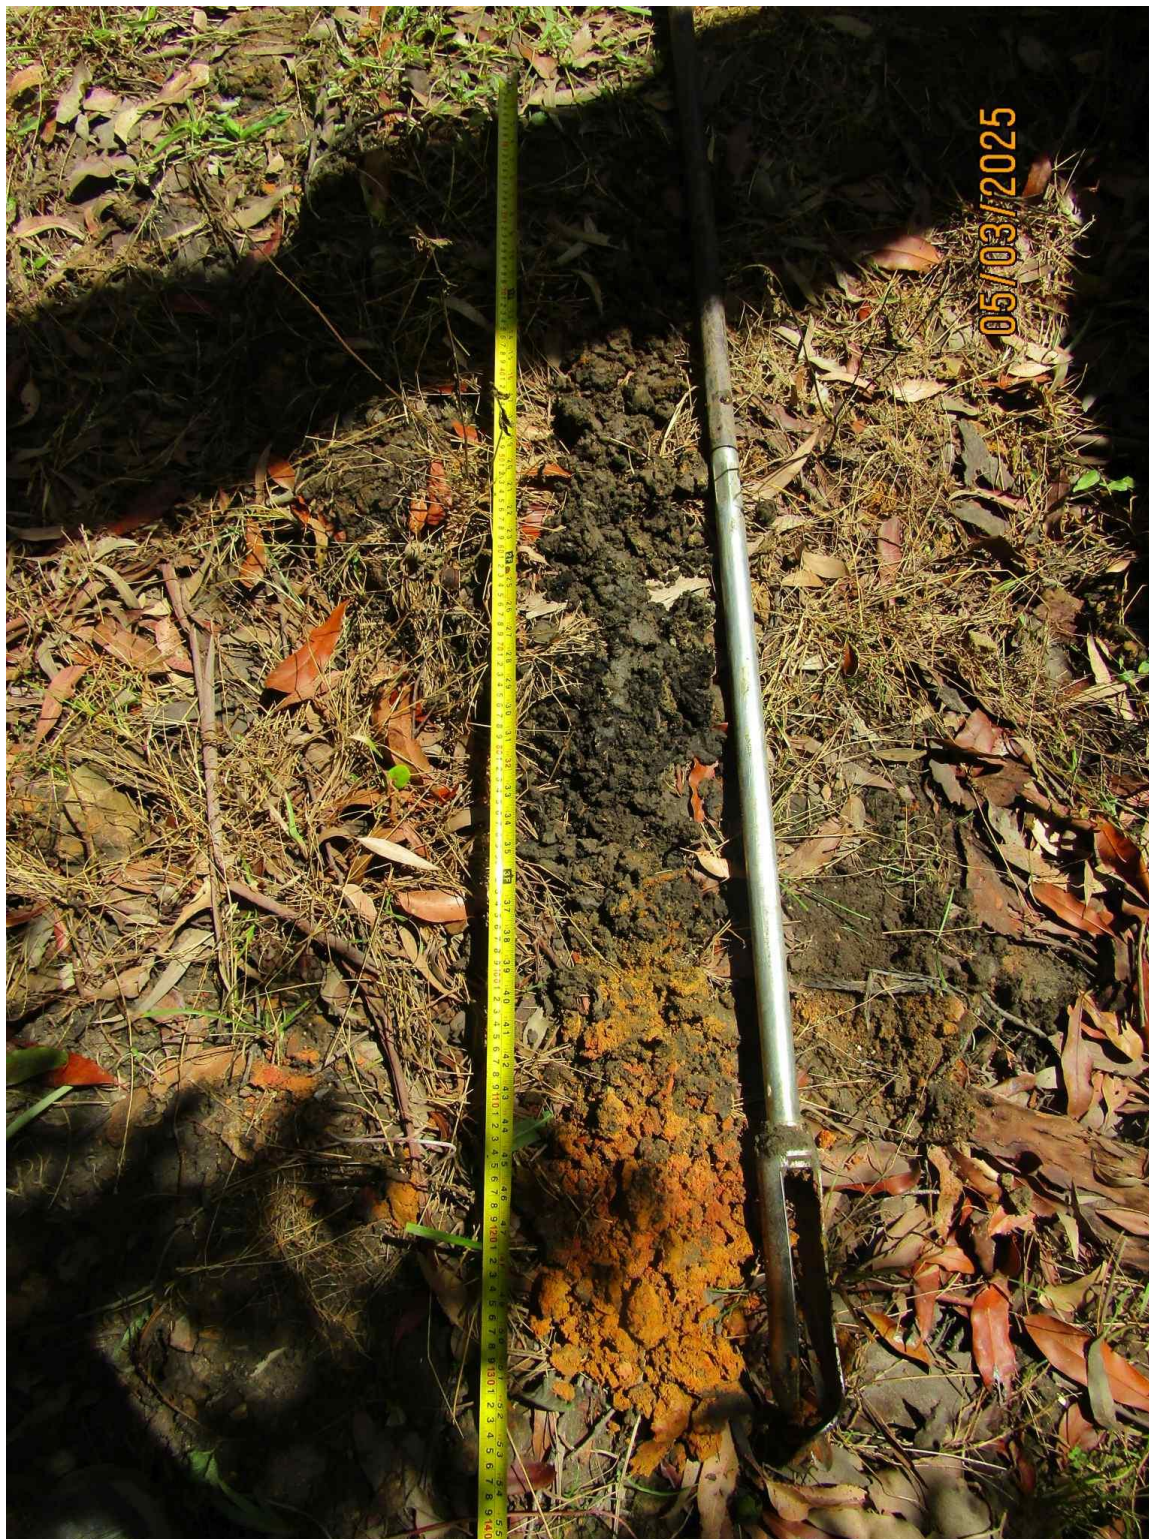
Photo 4: AH4 – Downhole is from top to bottom.

AUGER HOLE 4 (~RL7.5) – AH4 (Photo 4)

| Depth (m) | Material Encountered |
|---|---|
| 0.0 to 1.2 | FILL , sandy soil, clayey soil and sandy clay with some rock fragments, dark grey, dark brown, orange, damp, fine to coarse grained. |
| 1.2 to 1.4 | SANDY CLAY , orange, firm to stiff, dry. |

Refusal @ 1.4m, auger grinding on rock. No Water table encountered.

| TEST: AH4 | FIELD pH & PEROXIDE RESULTS | | | | |
|---|---|---|---|---|---|
| 0.4 | 6.4 | M | 5.7 | 0.7 | 1%R |
| 0.8 | 6.2 | M | 5.4 | 0.8 | 1%R |
| 1.2 | 6.1 | M | 4.9 | 1.2 | 1%R |

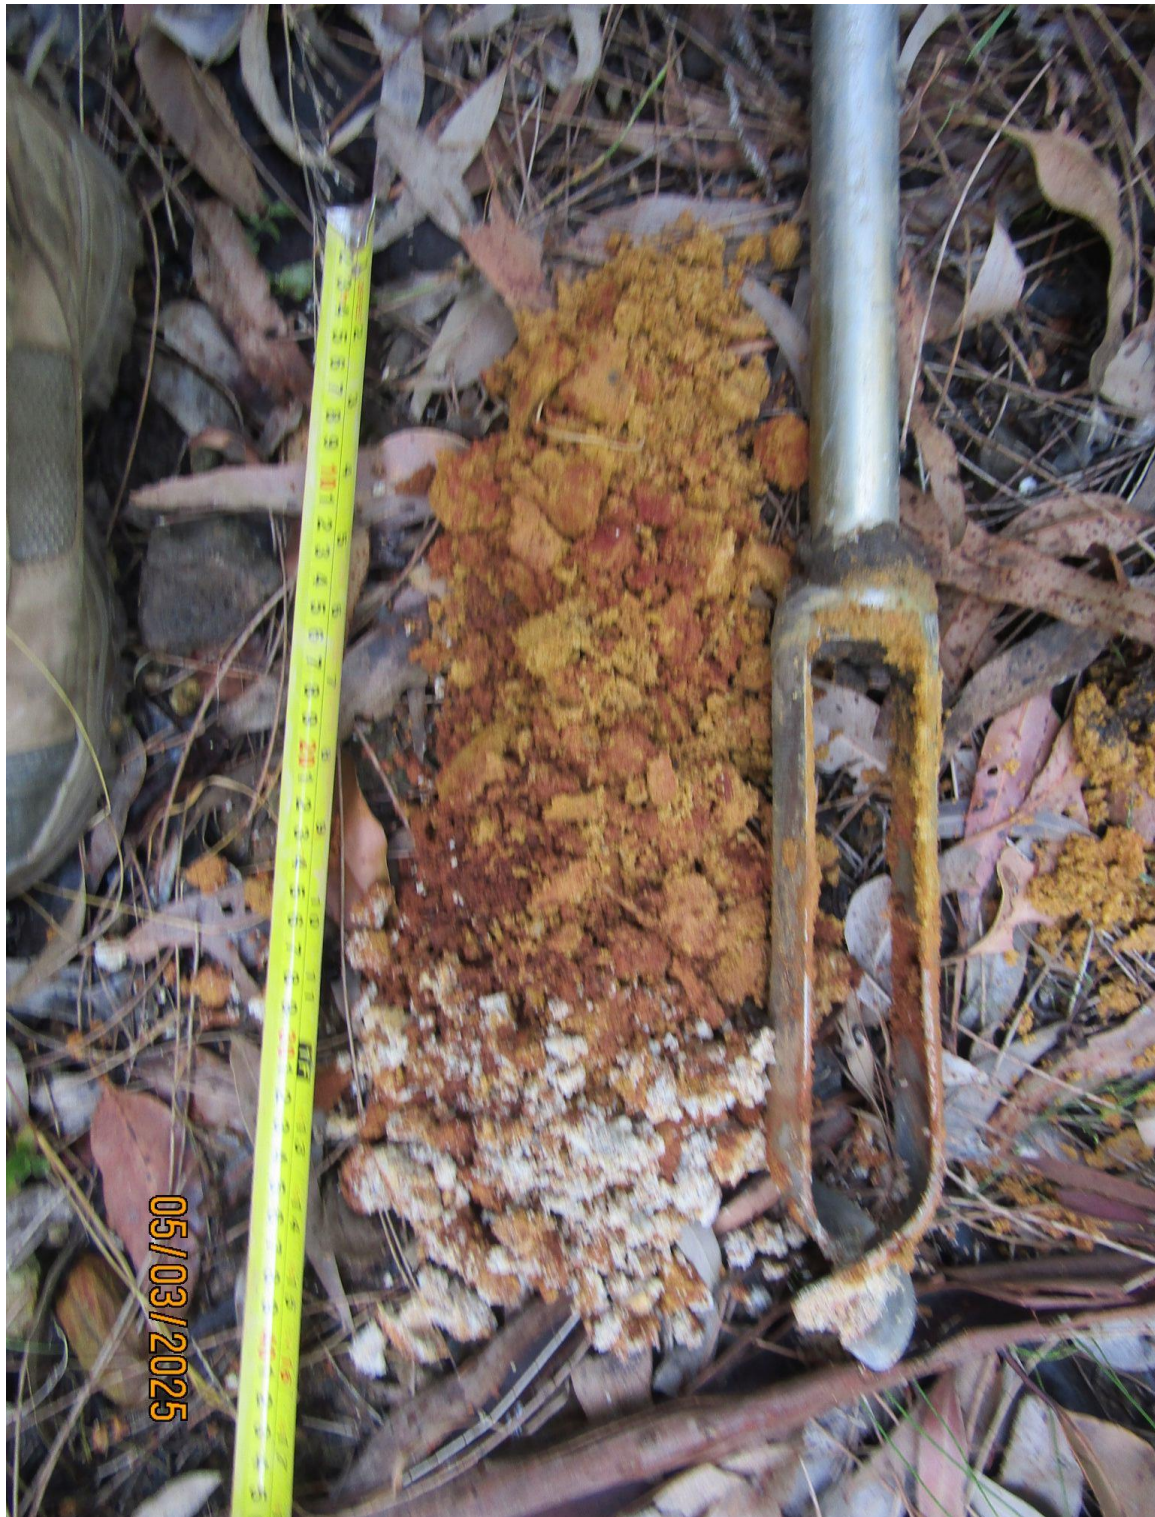
Photo 5: AH5 – Downhole is from top to bottom.

AUGER HOLE 5 (~RL4.7) – AH4 (Photo 5)

| Depth (m) | Material Encountered |
|---|---|
| 0.0 to 0.3 | CLAYEY SAND , orange, maroon, moist, fine to coarse grained. |
| 0.3 to 0.4 | SANDY CLAY , light grey, firm to stiff, moist. |

Refusal @ 0.4m, auger grinding on rock. No Water table encountered.

| TEST: AH4 | FIELD pH & PEROXIDE RESULTS | | | | |
|---|---|---|---|---|---|
| 0.3 | 4.9 | L | 4.8 | 0.1 | - |
