**MARINE HABITAT SURVEY**  
**4 Cabarita Road, Avalon**

**September 2019**

**BIO-ANALYSIS Pty Ltd**

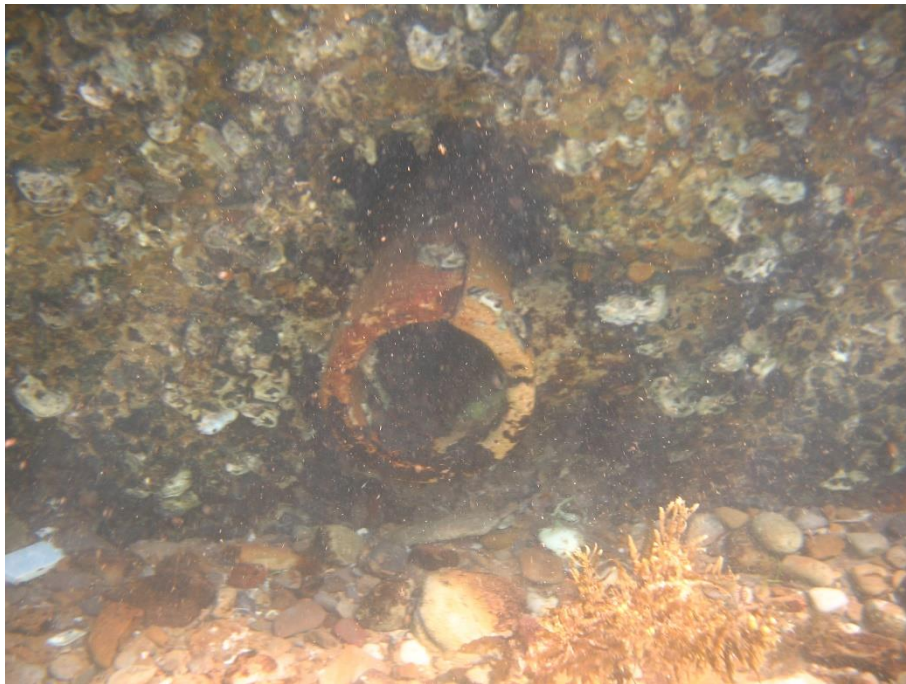
The intertidal area consisted of an artificial concrete seawall, existing jetty piles and artificial slipway and rails (Fig. 4 - 5). The hard substratum was colonised by Sydney rock oysters (*Saccostrea glomerata*), macroalgae (mainly *Hormosira banksii*) and various gastropods (Figs. 4 - 5) and ascidians on the piles.

**Figure 4.** Foreshore: artificial concrete seawall and a drainage outlet (to be upgraded). Structures were colonised by oysters, various gastropods and turfing algae.

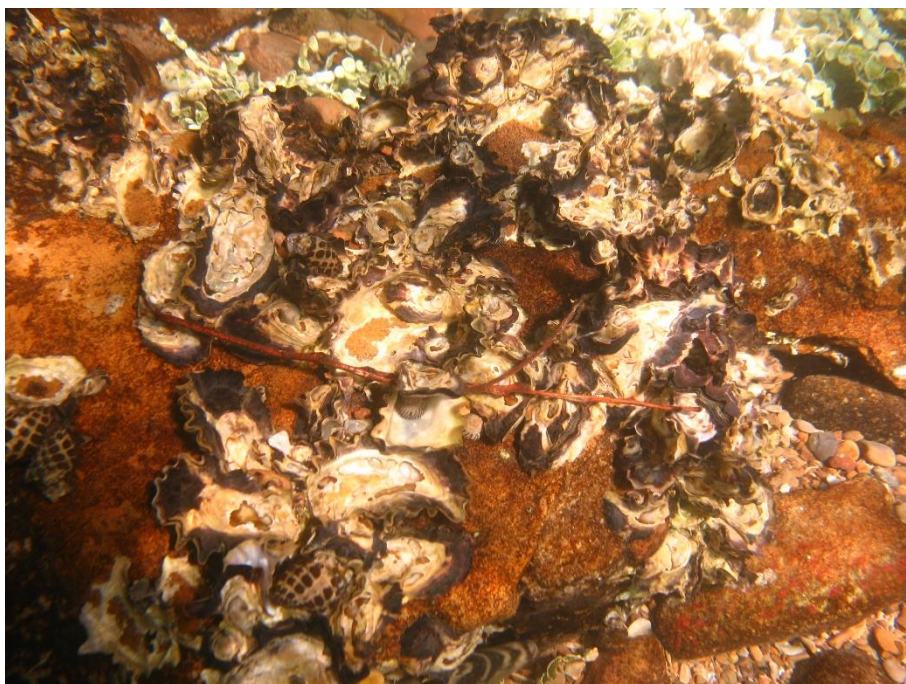
**Figure 5.** Artificial concrete seawall and small intertidal boulders at the base. Structures were colonised by oysters, various gastropods and turfing algae.
