Reddall and Bower Street Apartments Assessment of View Sharing

29-35 Reddall Street and 95 Bower Street, Manly

Report prepared for M Projects

October 2019

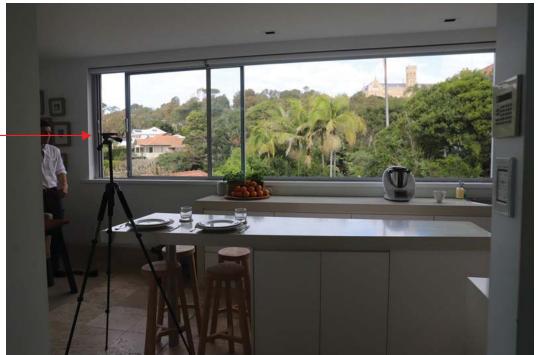
Surveyed View Point 1 – Centre of camera set at 1.6M above floor level.

Photograph taken from this location

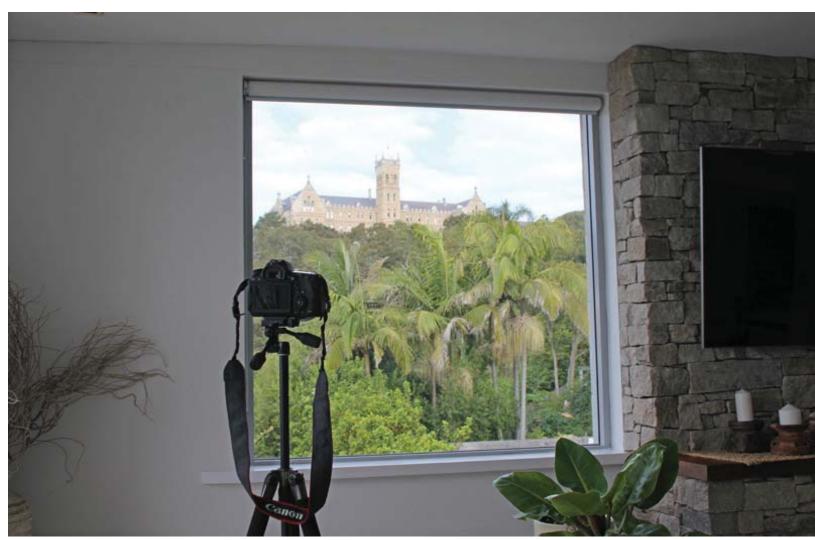
Surveyed View Point 2 – Camera location set at 1.0M back from window and 1.6M above floor level

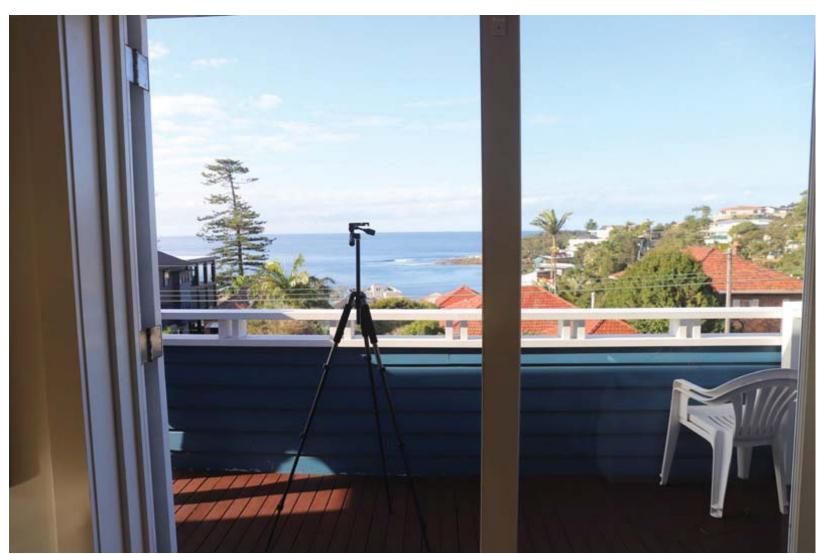
Surveyed View Point 3 – Camera location set at 1.0M back from handrail and 1.6M above balcony floor level

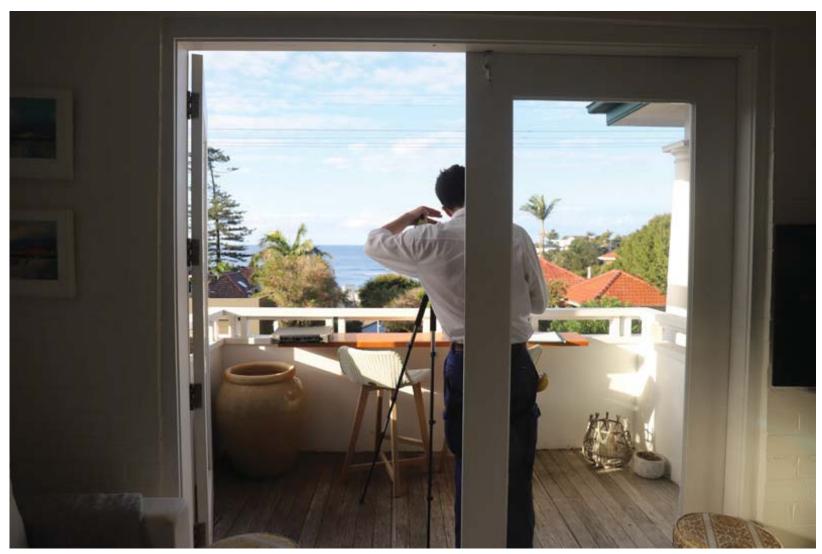
Surveyed View Point 4 – Camera location set at 1.0M back from handrail and 1.6M above balcony floor level

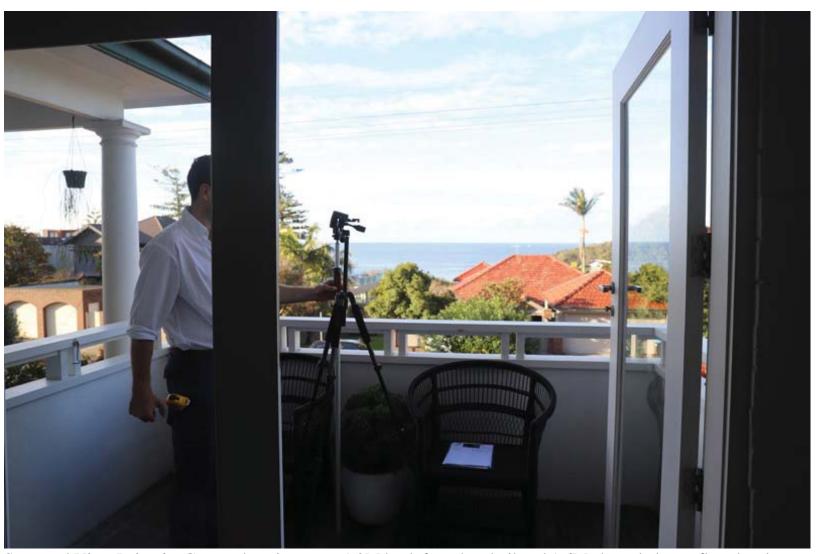
Surveyed View Point 6 – Camera location set at 1.0M back from handrail and 1.6M above balcony floor level

Surveyed View Point 6: Photomontage from Unit 2, No.28 Reddall St main living balcony:

- 7. Photograph of existing development taken from same location with 24mm focal length (35mm equivalent).

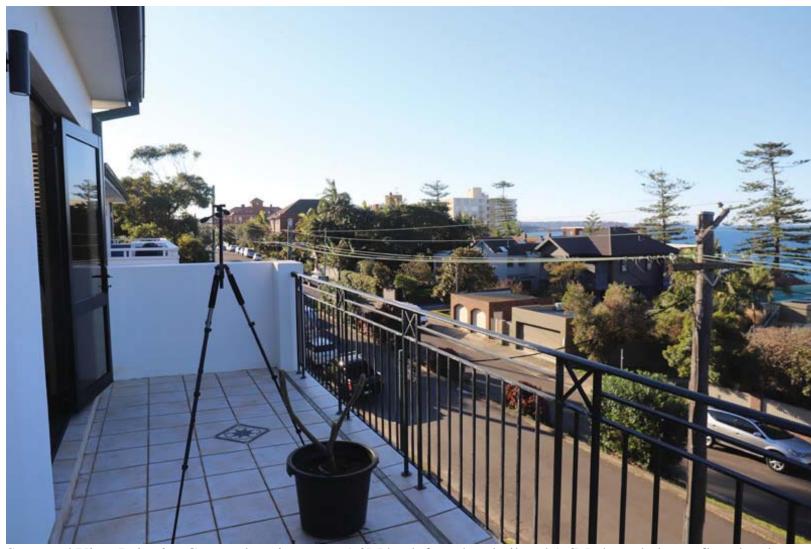
Surveyed View Point 9 – Camera location set at 1.0M back from handrail and 1.6M above balcony floor level

Surveyed View Point 9: Photomontage from No.30 Reddall St upper balcony:

- 7. Photograph of existing development taken from same location with 24mm focal length (35mm equivalent).

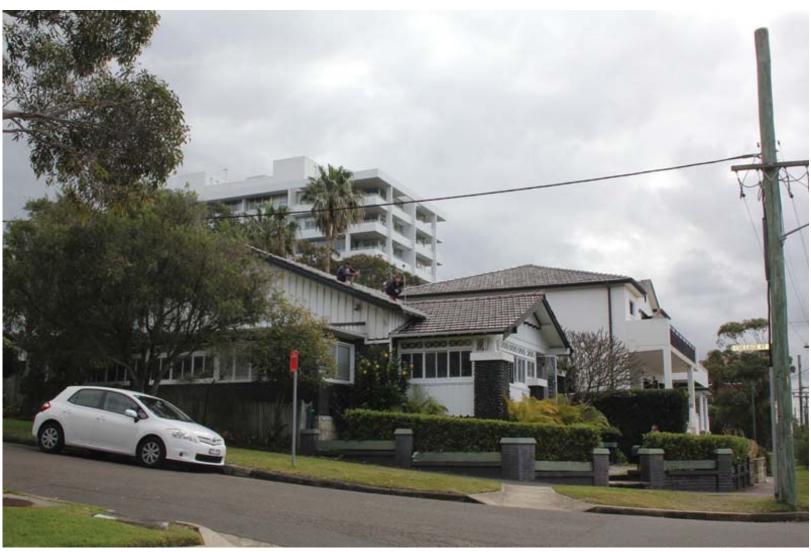
Surveyed View Point 13 – Camera location set in line with existing ridge at surveyed RL31.54

- 7. Photograph of existing development taken from same location with 24mm focal length (35mm equivalent).

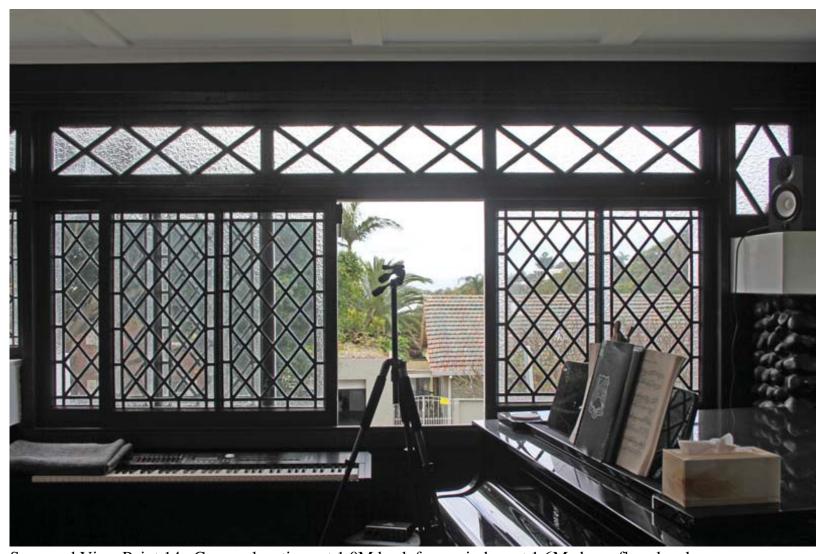
Surveyed View Point 14– Camera location set 1.0M back from window at 1.6M above floor level

- 61. There is only one view position (VP 14, 32 Reddall Street), where the extent of impact on view sharing is assessed as severe. Any complying development would cause severe view loss. The profile of the proposed development as seen in VP14 is lower than is permissible under the LEP. View sharing is considered to be reasonable in the circumstances, given what is permissible under the development standard for building heights and the fact that 32 Reddall Street is a single-storey building, views from which could not be expected to be retained.

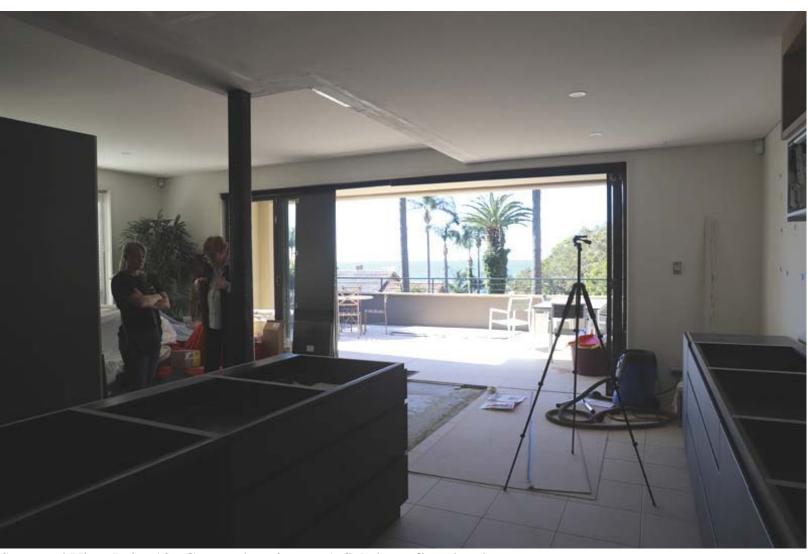
Surveyed View Point 18– Camera location set 1.6M above floor level

- 7. Photograph of existing development taken from same location with 24mm focal length (35mm equivalent).

- 64. One unit at the top level in the south-east part of Building C causes more view loss than any other part of the proposal, causing specific view loss to both VP18 and VP22 and detectable but smaller impacts on some other views from 7 College Street. It may be possible for that component of the building to be cut back to retain a higher proportion of the view of the beach and land-water interface south of Long Reef headland in VP18 and VP22, providing a more skillful design and reducing the extent of impact on these and other views that are slightly but not significantly affected.

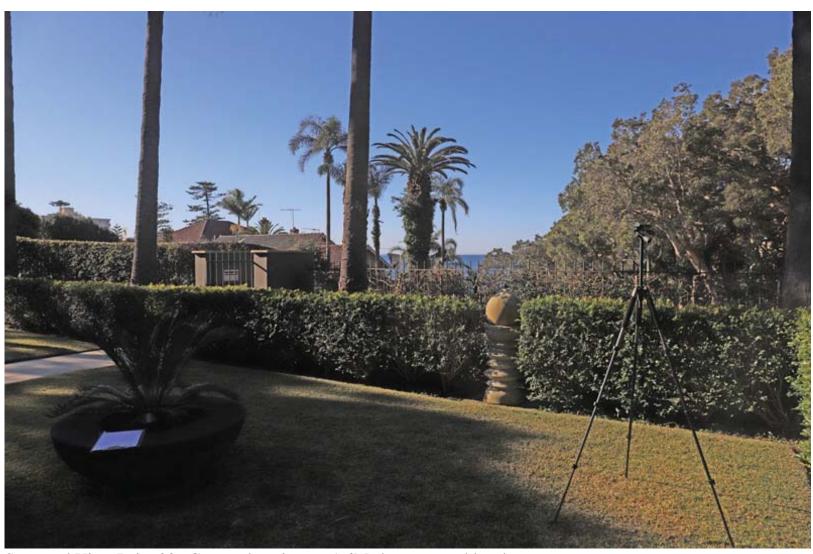
Surveyed View Point 20– Camera location set 1.6M above ground level

- 7. Photograph of existing development taken from same location with 24mm focal length (35mm equivalent).

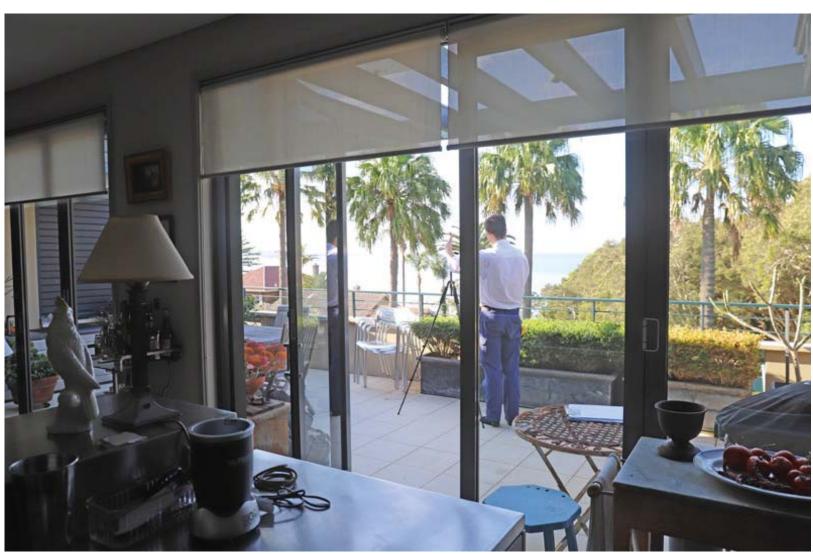
Surveyed View Point 21– Camera location set at 1.0M back from handrail and 1.6M above balcony floor level

- 7. Photograph of existing development taken from same location with 24mm focal length (35mm equivalent).

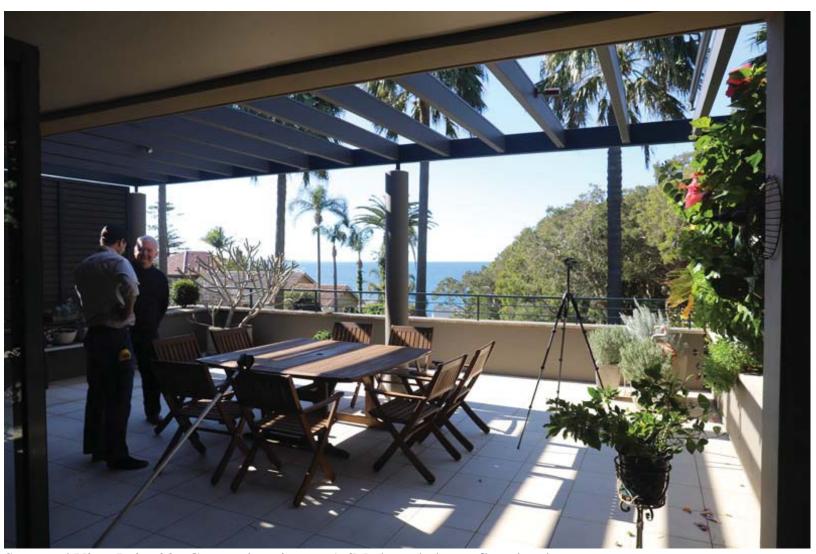
Surveyed View Point 22– Camera location set 1.6M above balcony floor level

- 7. Photograph of existing development taken from same location with 24mm focal length (35mm equivalent).

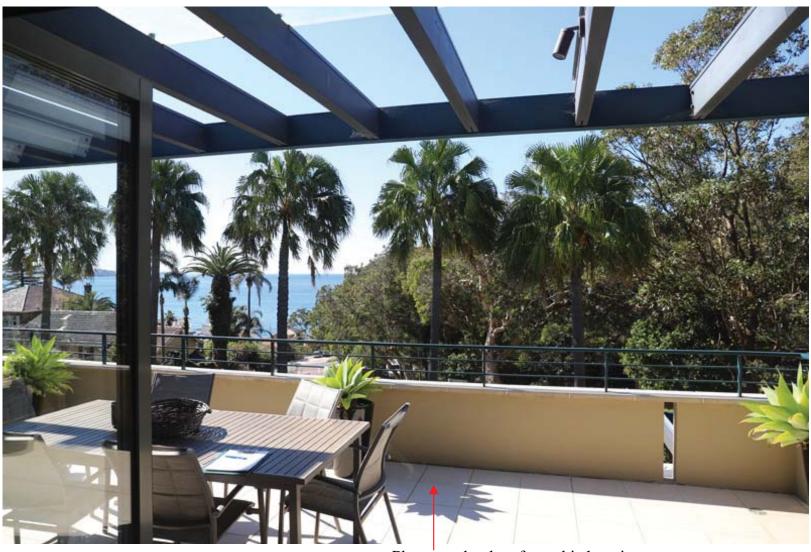
Surveyed View Point 24 - Photograph was taken 1.0M back from balustrade in centre of main area of balcony.

- 7. Photograph of existing development taken from same location with 24mm focal length (35mm equivalent).

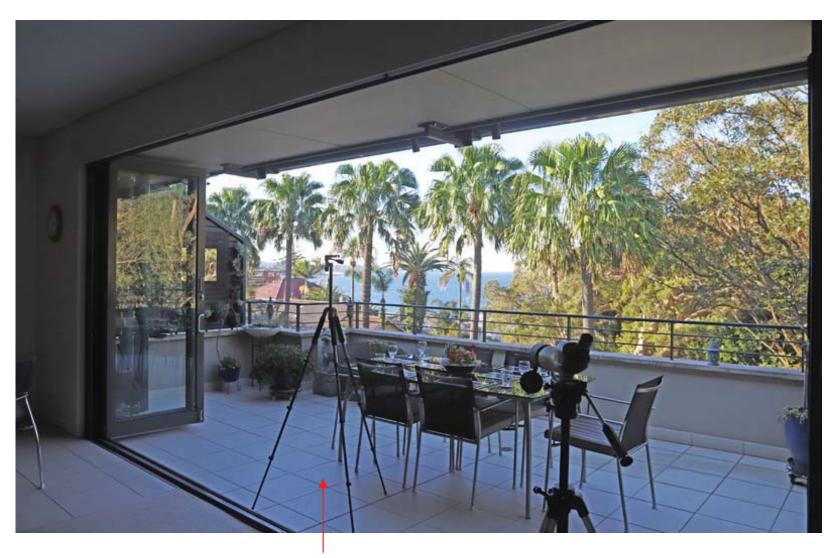
Photograph taken from this location Surveyed View Point 27– Camera location set 1.6M above balcony floor level

- 7. Photograph of existing development taken from same location with 24mm focal length (35mm equivalent).

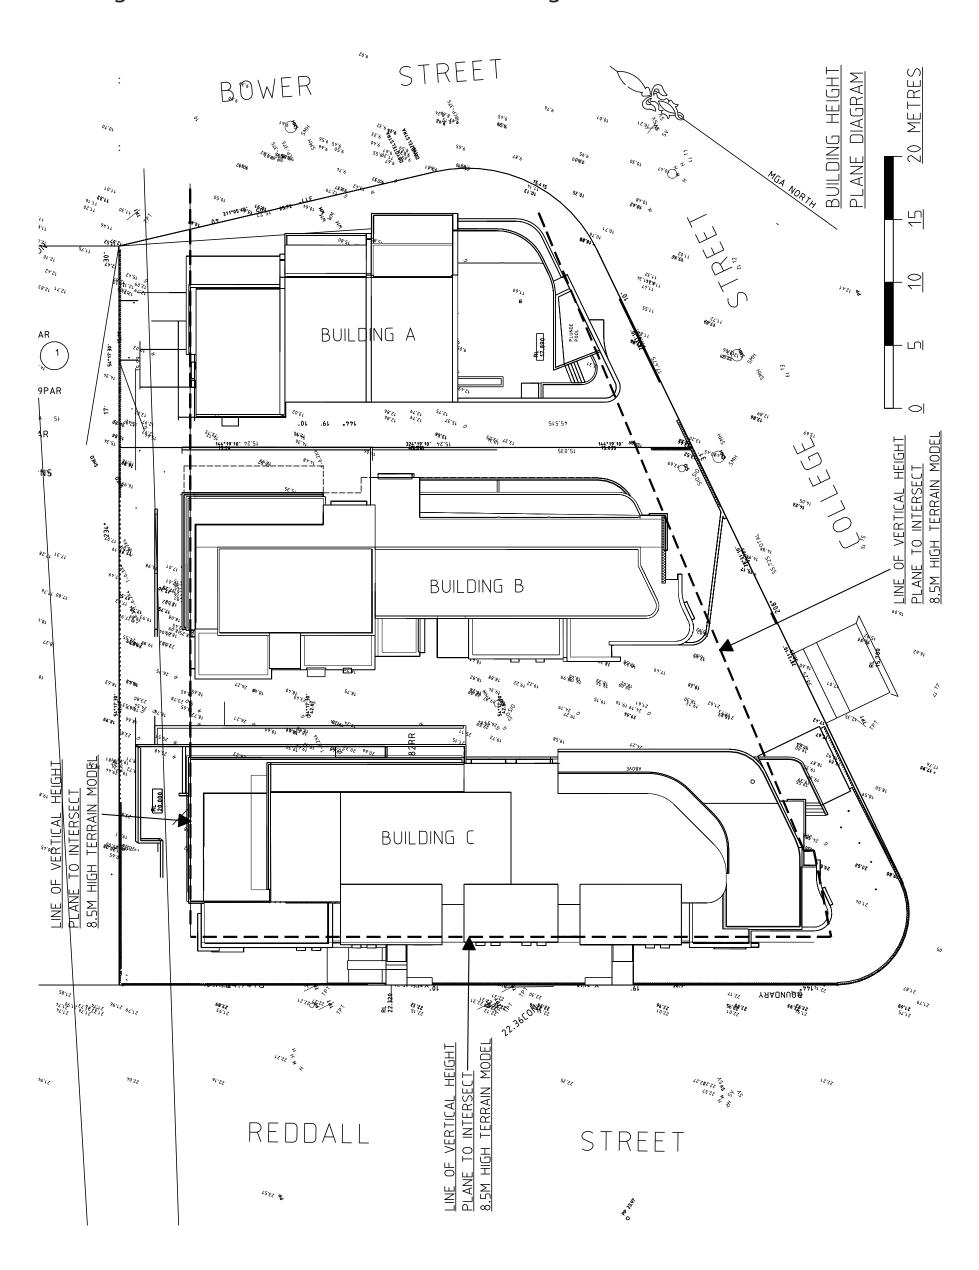
Plan of height plane (shown hatched) indicated on the photomontages by RAWC, showing where 8.5m levels intersect with existing contours and the 3D terrain model

- 26. In addition to this, Pam Walls was also requested to provide a graphic representation of the compliance of the height of the proposed building envelope in relation to compliance with the 8.5m development standard for height of buildings that applies in the LEP. A height line in red at, or as close to the face of the buildings in the streets as possible, is shown in relation to Reddall Street, Bower Street and the south limb of College Street, in relevant photomontages.

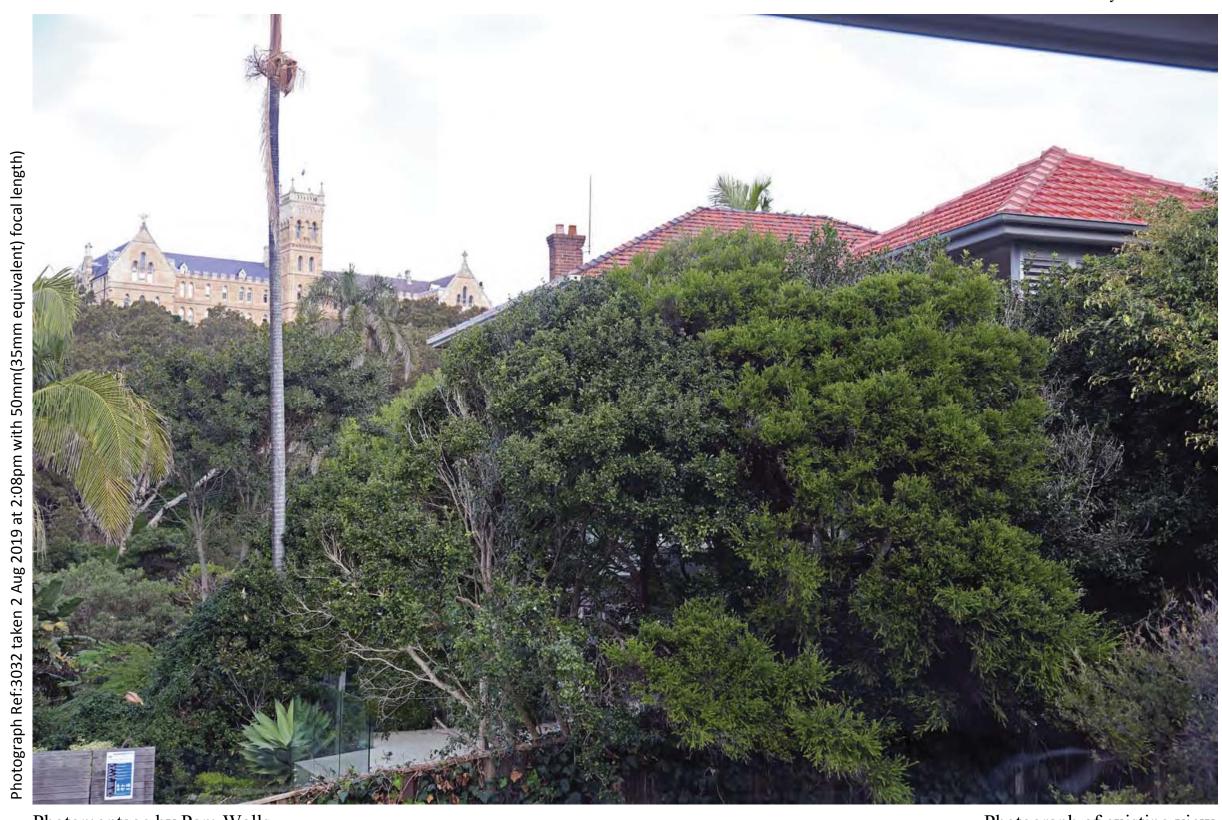
View with proposed overlaid as 3D solid block computer model View from 97 Bower St kitchen side window 29-35 Reddall St & 95 Bower St, Manly

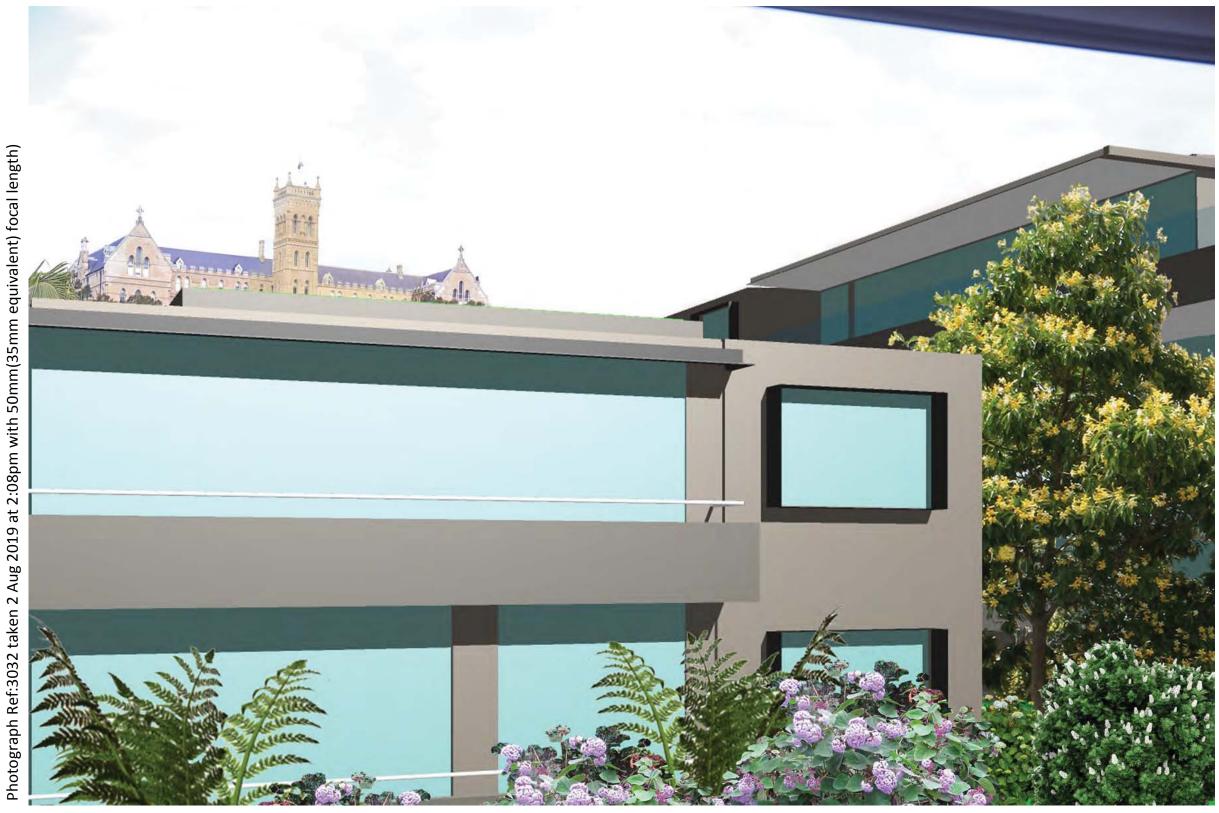
View with proposed overlaid as 3D solid block computer model View from 97 Bower St living room side window 29-35 Reddall St & 95 Bower St, Manly

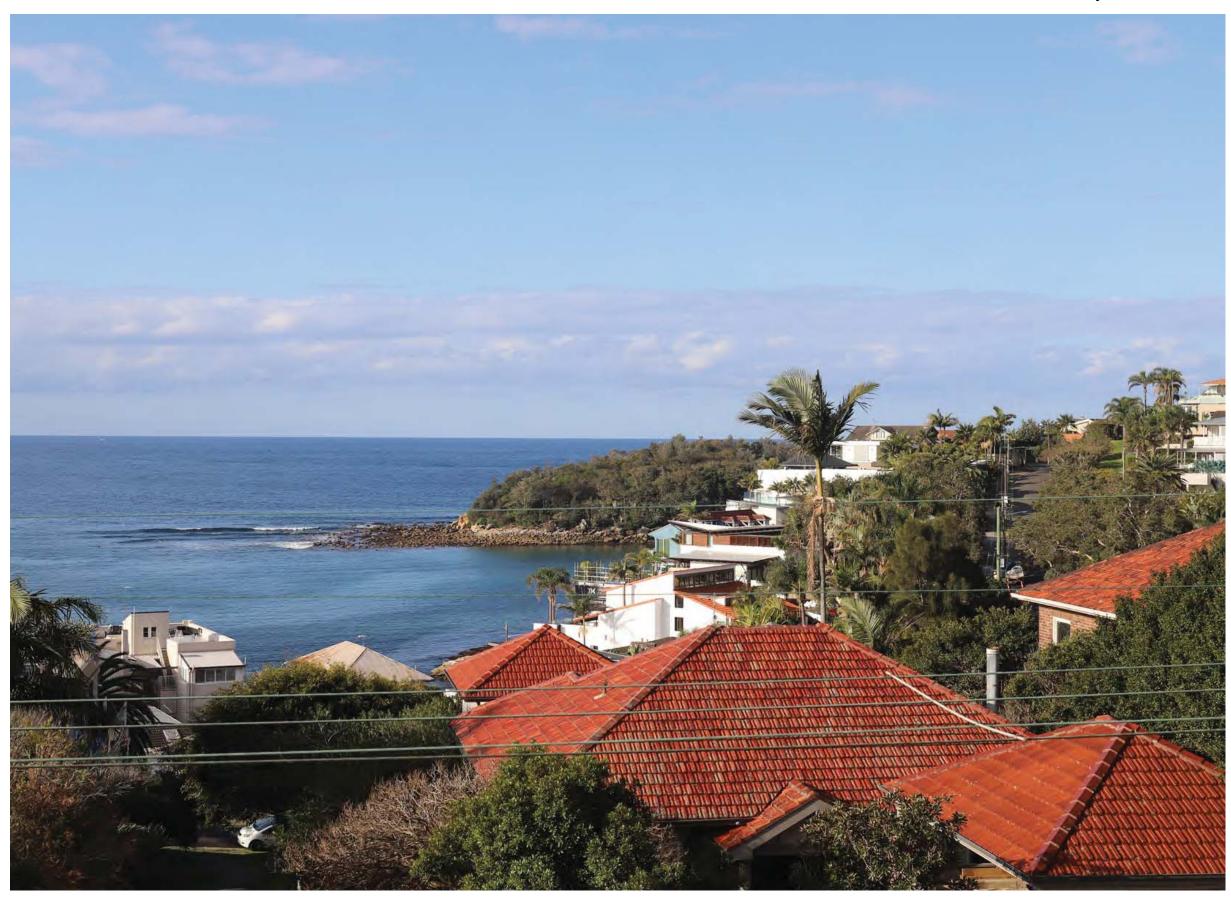
Photograph of e isting view View from 97 Bower St living room side window 29-35 Reddall St & 95 Bower St, Manly

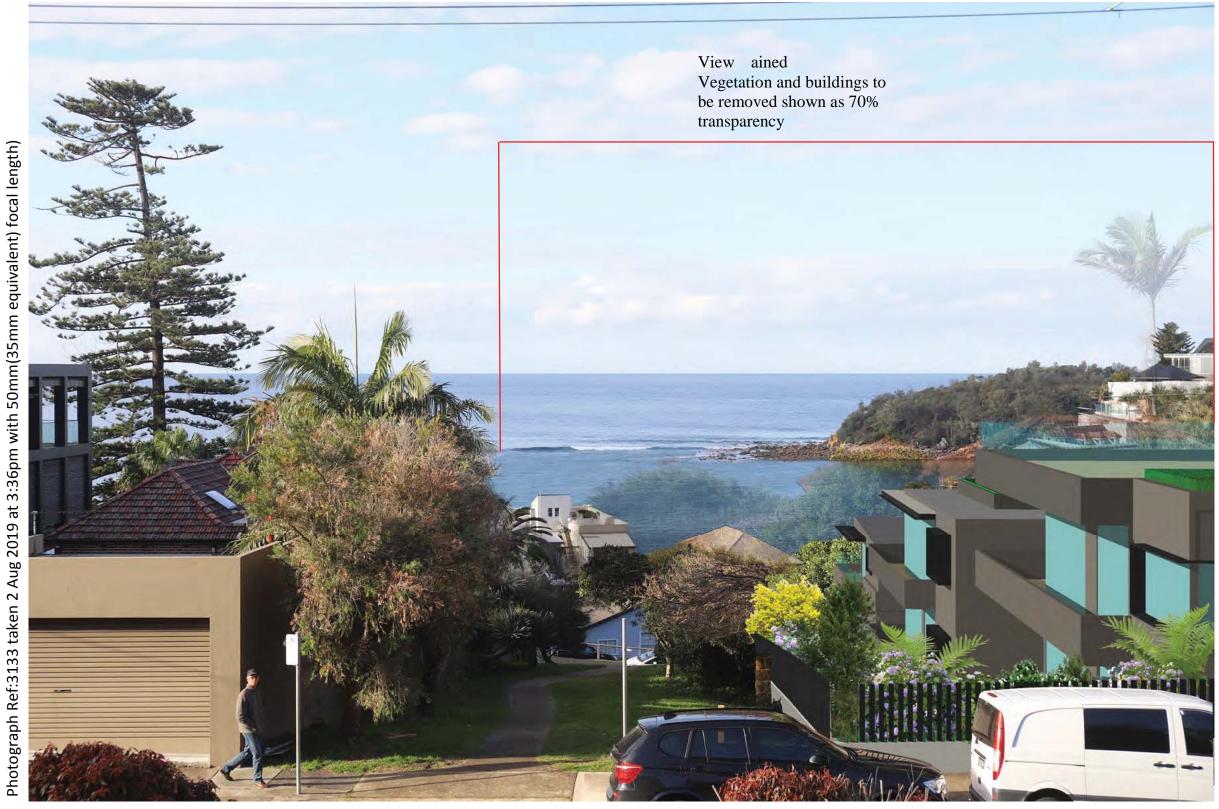
View with proposed overlaid as 3D solid block computer model View from nit 1/28 Reddall St main e ternal living balcony 29-35 Reddall St & 95 Bower St, Manly

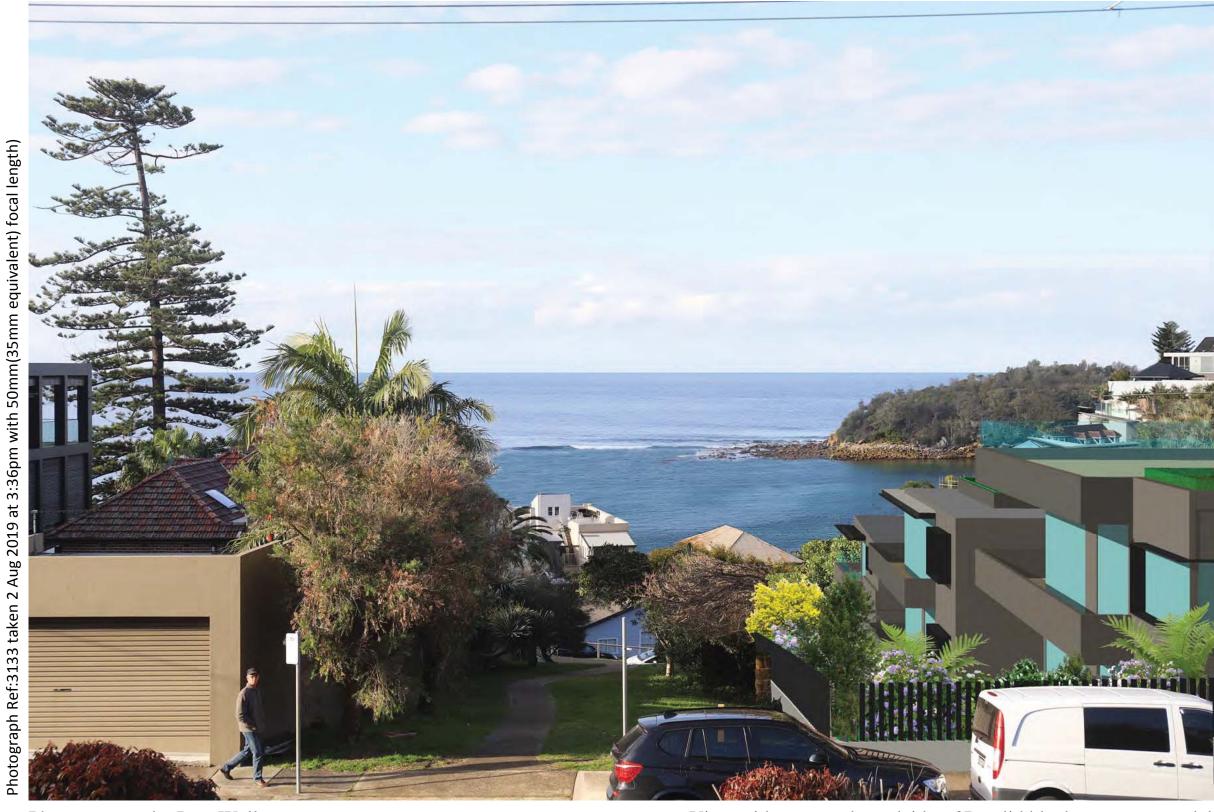
View with proposed overlaid as 3D solid block computer model View from nit 1/28 Reddall St main e ternal living balcony 29-35 Reddall St & 95 Bower St, Manly

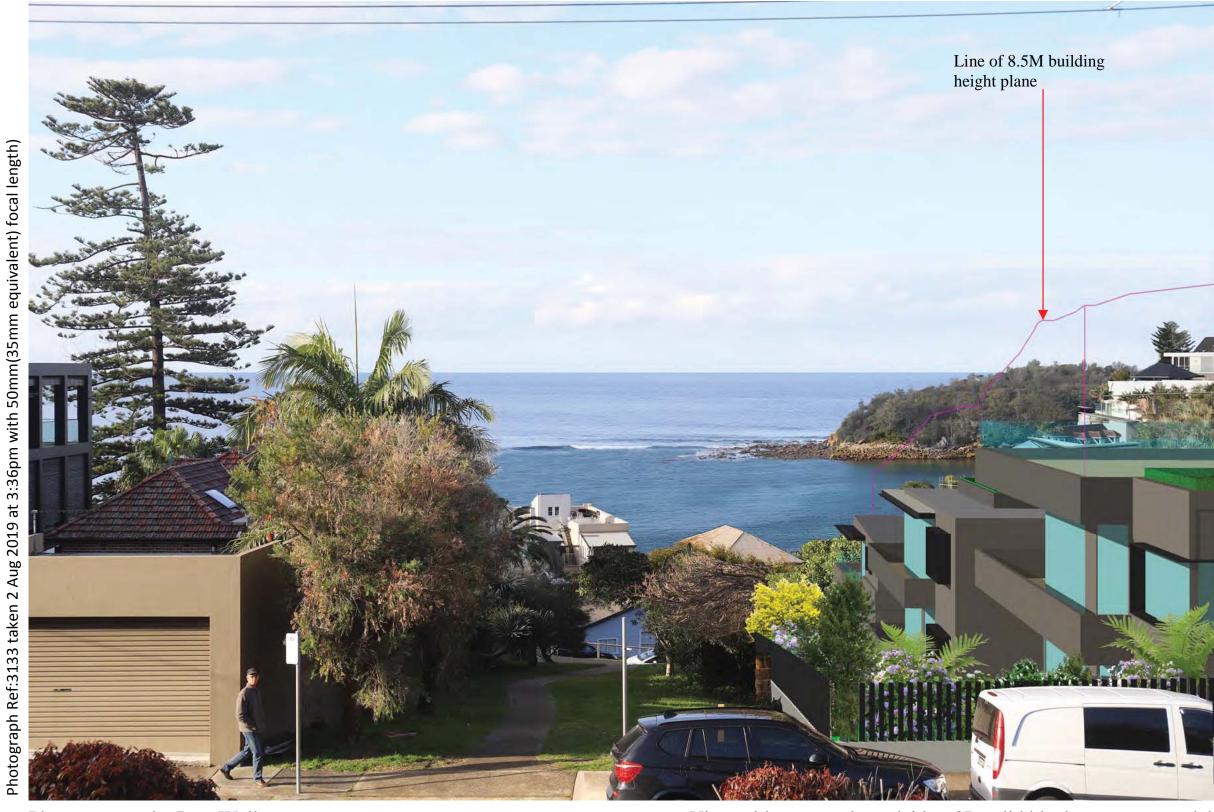
View with proposed overlaid as 3D solid block computer model View from nit 1/28 Reddall St main e ternal living balcony 29-35 Reddall St & 95 Bower St, Manly

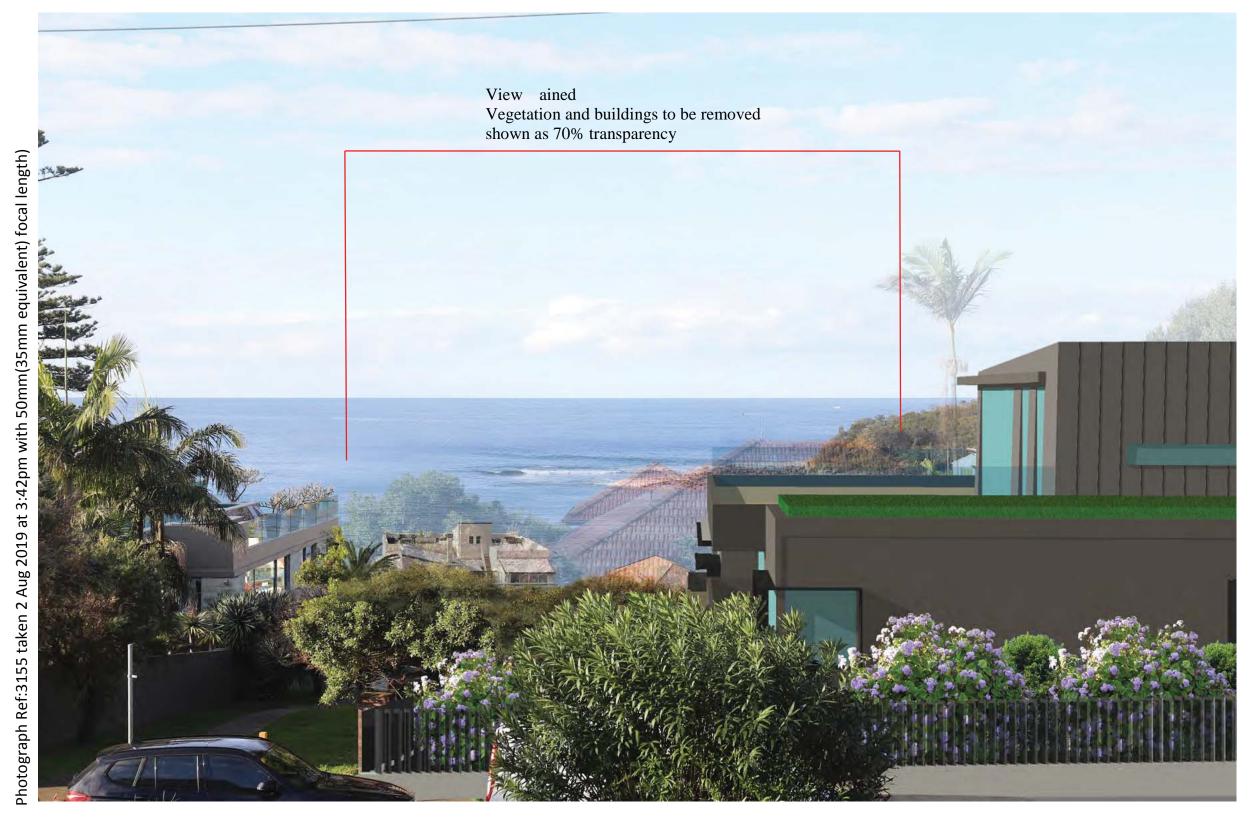
View with 3D computer model of proposed overlaid as 50% transparency View from nit 2/28 Reddall St main e ternal living balcony 29-35 Reddall St & 95 Bower St, Manly

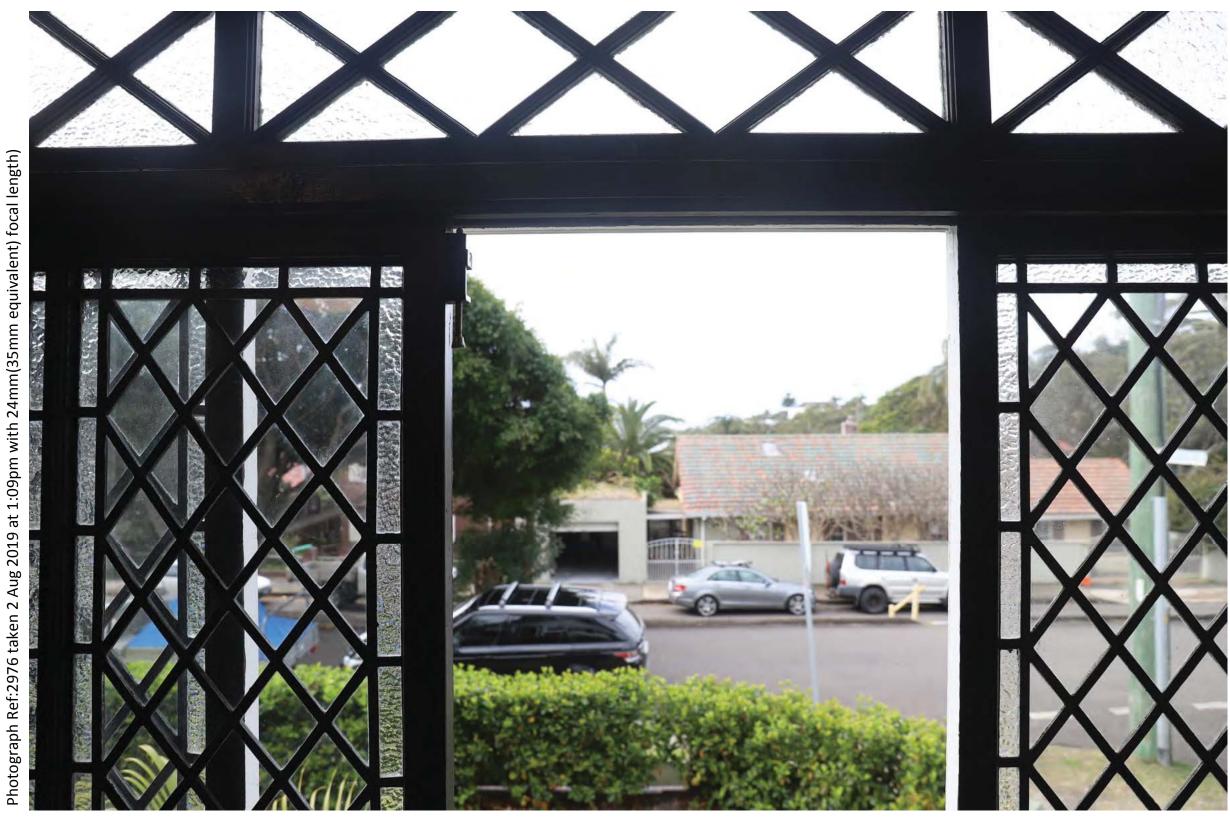
Photograph with 3D computer model of e isting overlaid as 50% transparency View from 32 Reddall St ground floor music room 29-35 Reddall St & 95 Bower St, Manly

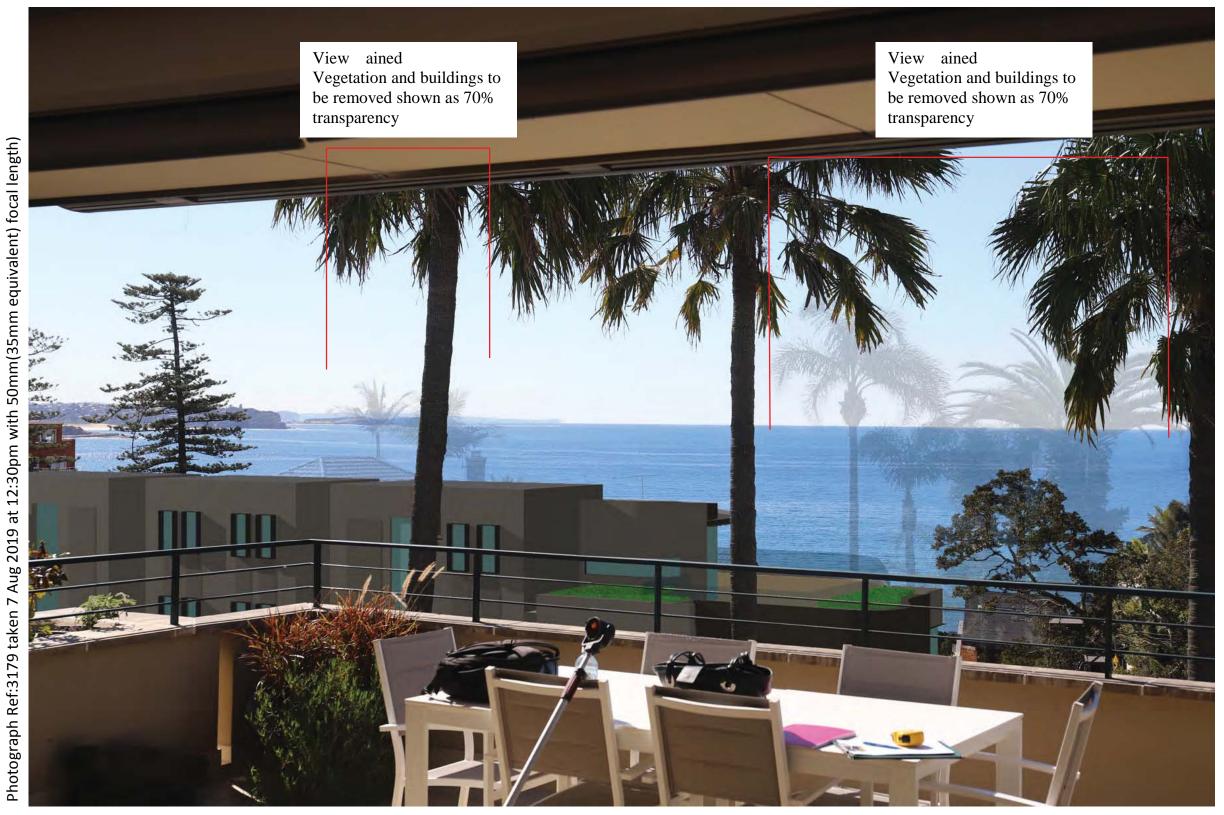
View with 3D computer model of proposed overlaid as 50% transparency
View from nit 10/7 College St kitchen/dining area
29-35 Reddall St & 95 Bower St, Manly

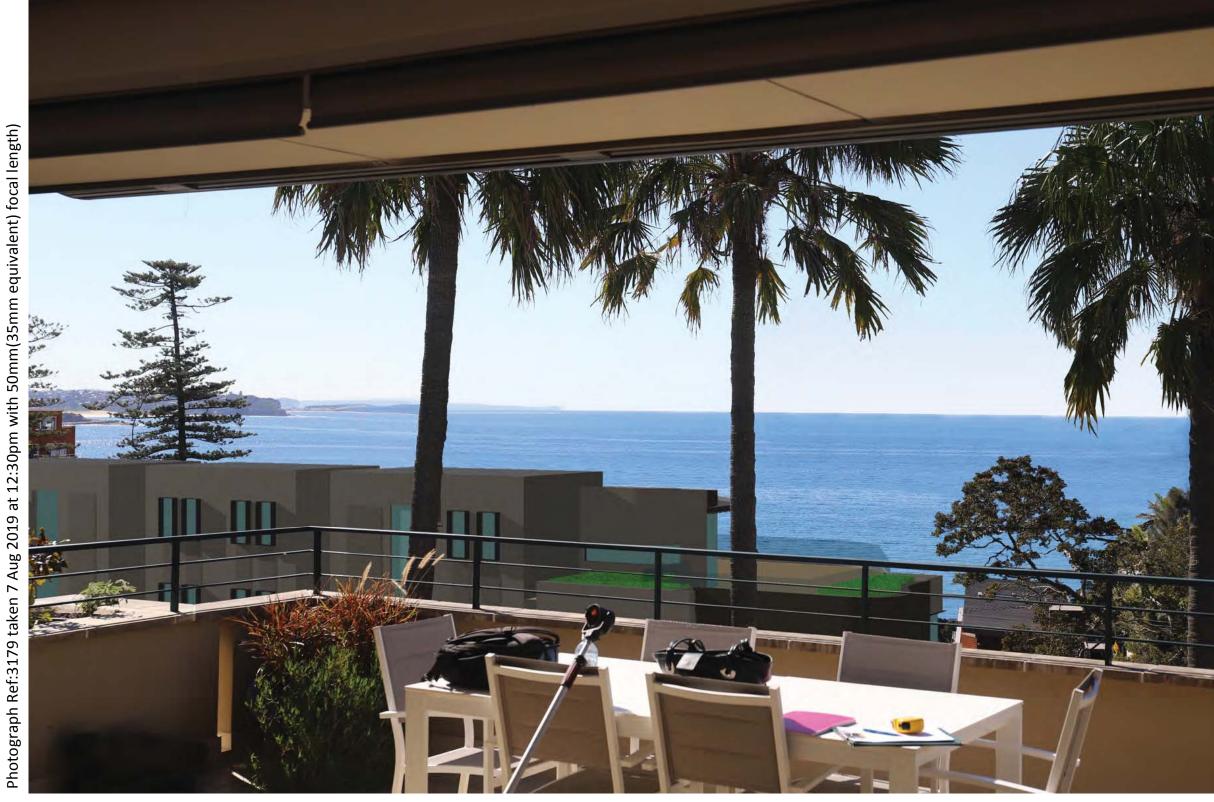
View with proposed overlaid as 3D solid block computer model

View from nit 10/7 College St kitchen/dining area

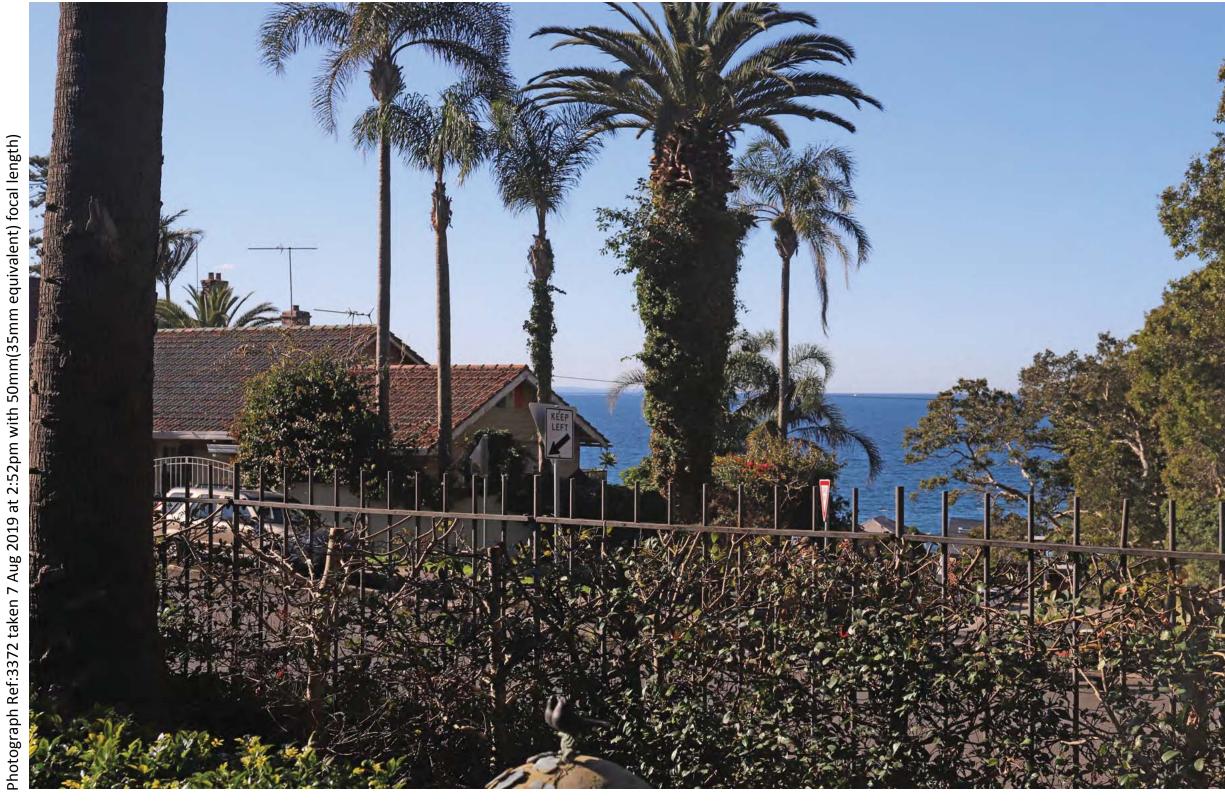
Photograph of e isting view
View from nit 10/7 College St kitchen/dining area
29-35 Reddall St & 95 Bower St, Manly

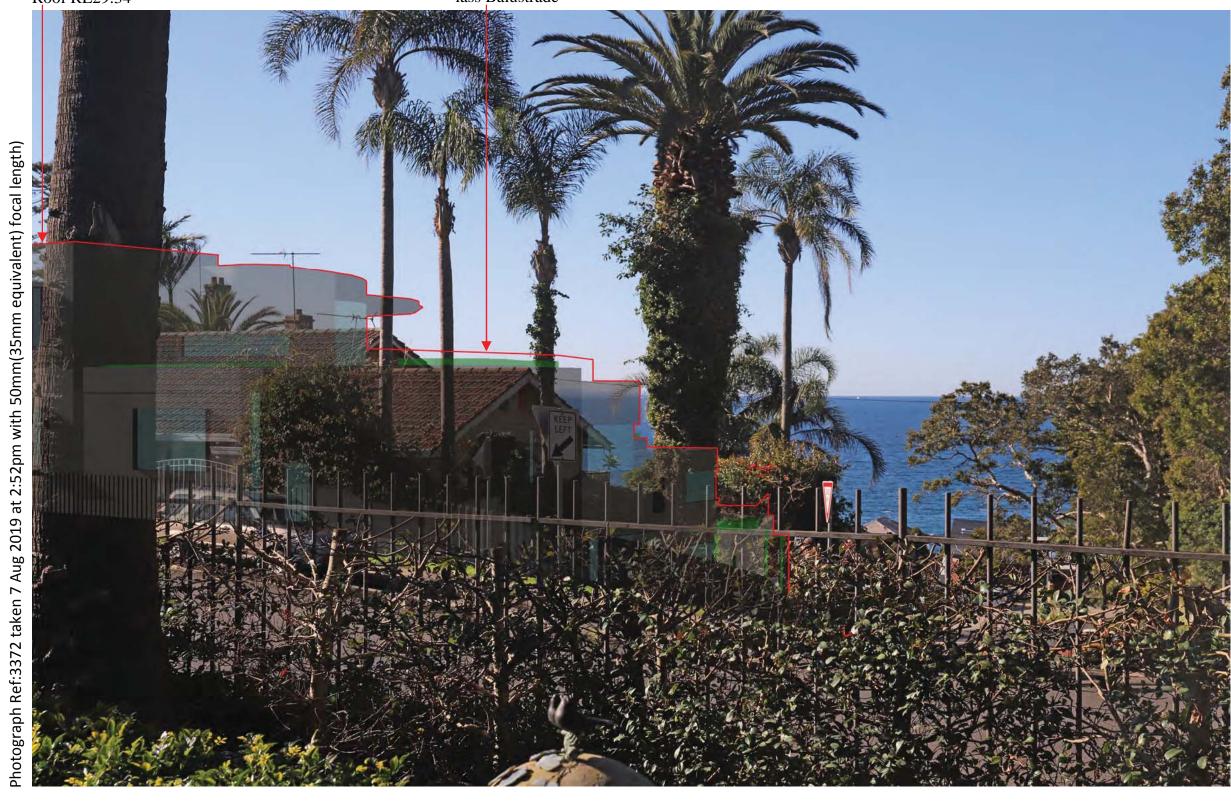
View with 3D computer model of proposed overlaid as 50% transparency View from nit 2/7 College St entry garden area 29-35 Reddall St & 95 Bower St, Manly

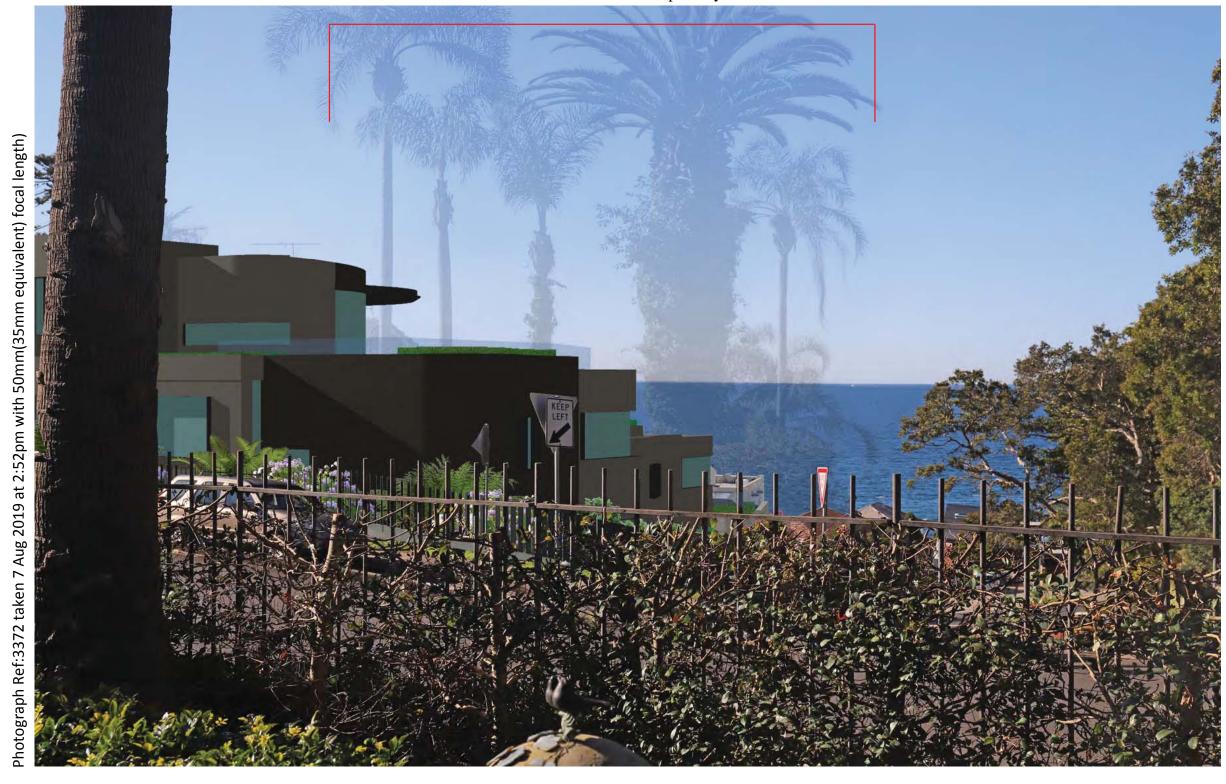
View with proposed overlaid as 3D solid block computer model View from nit 2/7 College St entry garden area 29-35 Reddall St & 95 Bower St, Manly

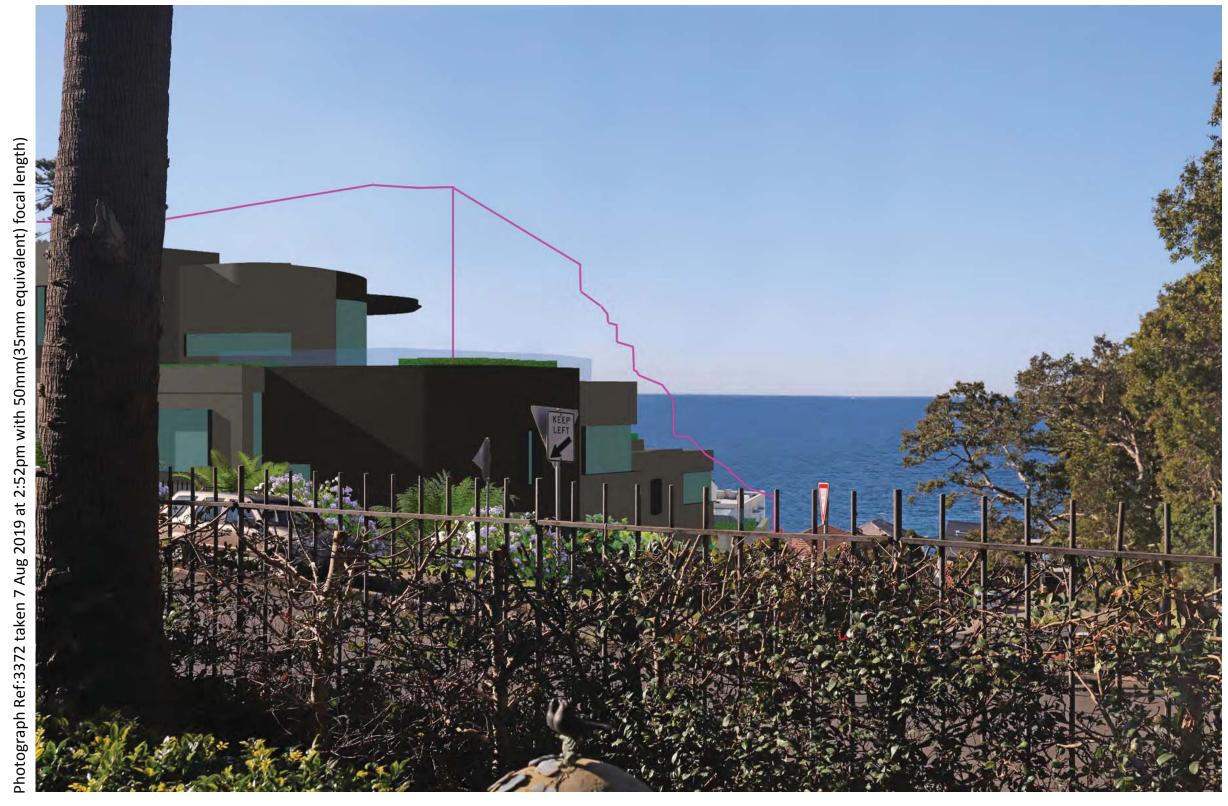
View with proposed overlaid as 3D solid block computer model

View from nit 2/7 College St entry garden area
