Reddall and Bower Street Apartments Assessment of View Sharing

29-35 Reddall Street and 95 Bower Street, Manly

Report prepared for M Projects

October 2019

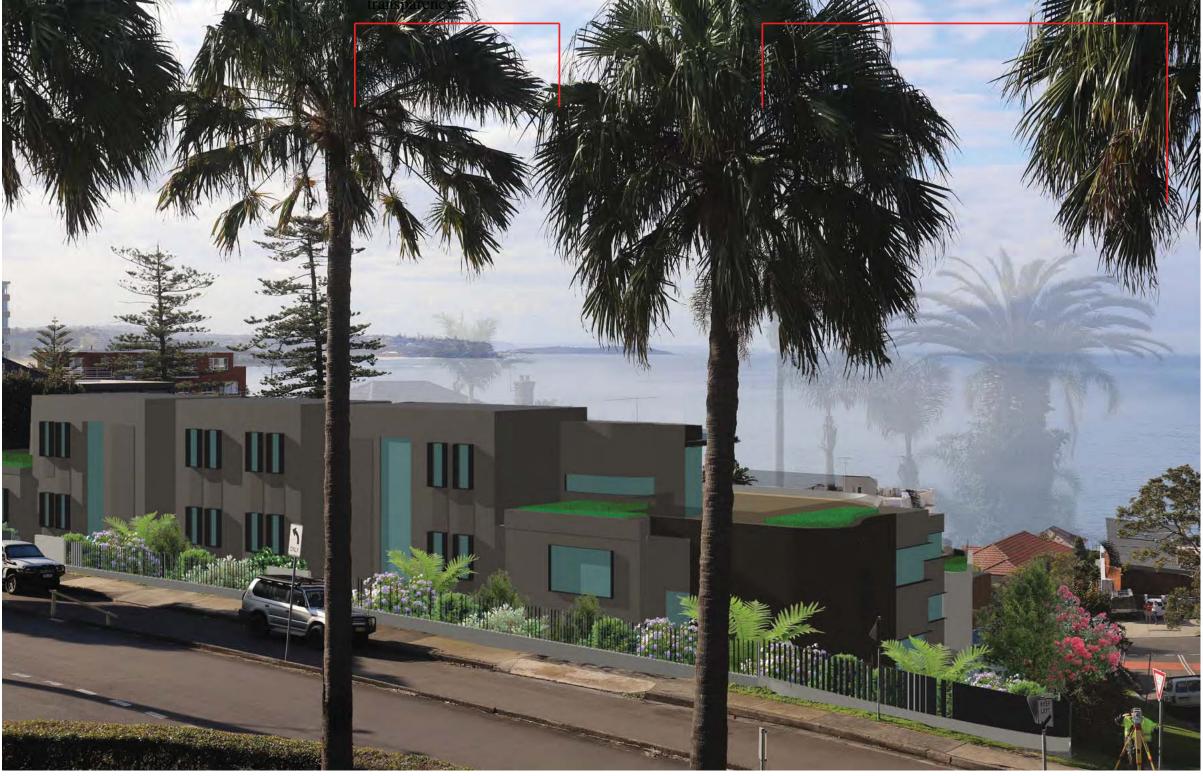
View with 3D computer model of proposed overlaid as 50% transparency View from nit 9/7 College St main e ternal living balcony 29-35 Reddall St & 95 Bower St, Manly

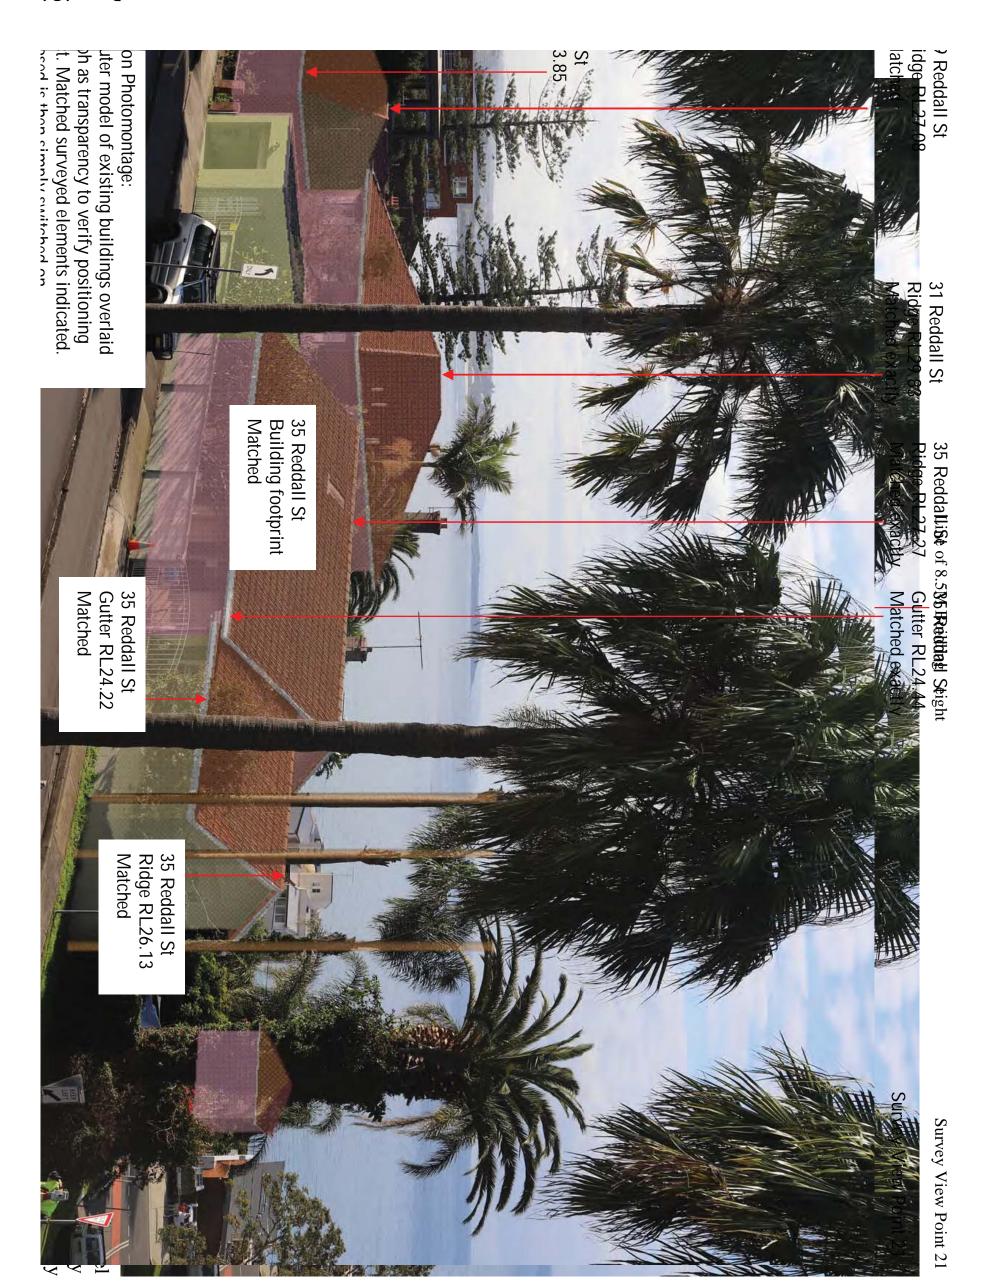
View with proposed overlaid as 3D solid block computer model View from nit 9/7 College St main e ternal living balcony 29-35 Reddall St & 95 Bower St, Manly

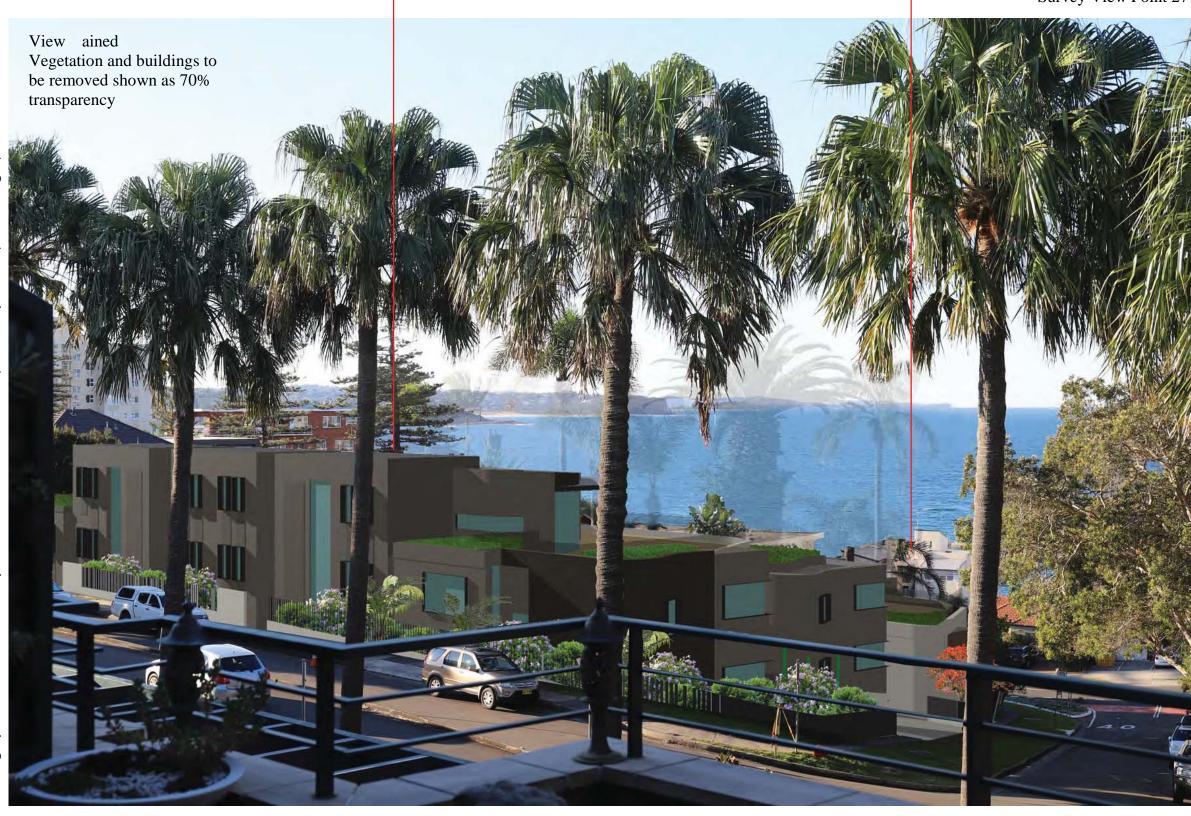
View with 3D computer model of proposed overlaid as 50% transparency View from nit 7/7 College St main e ternal living balcony 29-35 Reddall St & 95 Bower St, Manly

tent of view gained

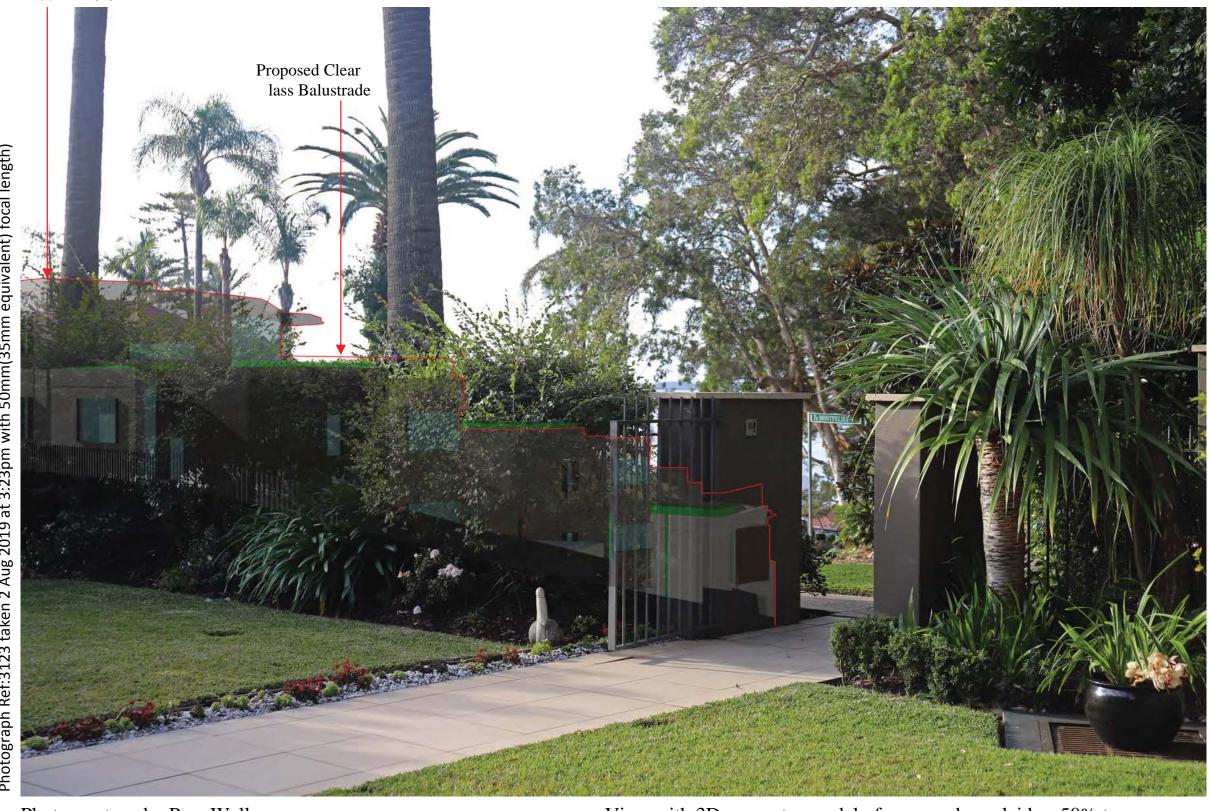
View with 3D computer model of proposed overlaid as 50% transparency View from nit 1/7 College St entry courtyard area 29-35 Reddall St & 95 Bower St, Manly
