GEOTECHNICAL RISK MANAGEMENT POLICY FOR PITTWATER
FORM NO. 1 – To be submitted with Development Application

Report Title: Geotechnical Report 231 – 233 McCarrs Creek Road, Church Point
Report Date: 4/4/25

GEOTECHNICAL INVESTIGATION:

New House at **231 – 233 McCarrs Creek Road, Church Point**

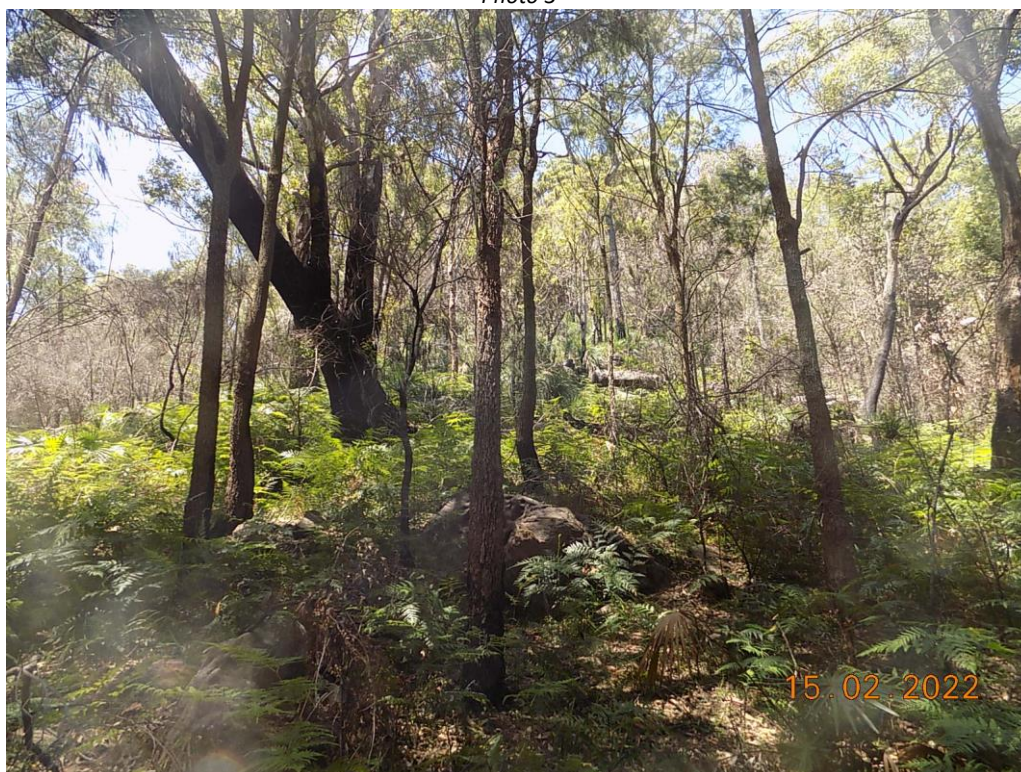
Photo 4

- 2.1** The site was inspected on the 15th February, 2022.
- 2.2** This vacant lot is on the high side of the road and has a NW aspect. It is located on the moderate to steeply graded lower reaches of a hillslope. The natural slope rises across the property at an average angle of ~17°. The slope above and below the property continues at similar angles.
- 2.3** The natural slope rises up a steep embankment above McCarrs Creek Road (Photo 1). The slope across and above the property is well vegetated (Photos 2 & 3). Sandstone joint blocks are embedded in stable positions in the slope (Photo 4). Densely vegetated bushland extends and continues beyond the upper boundary.

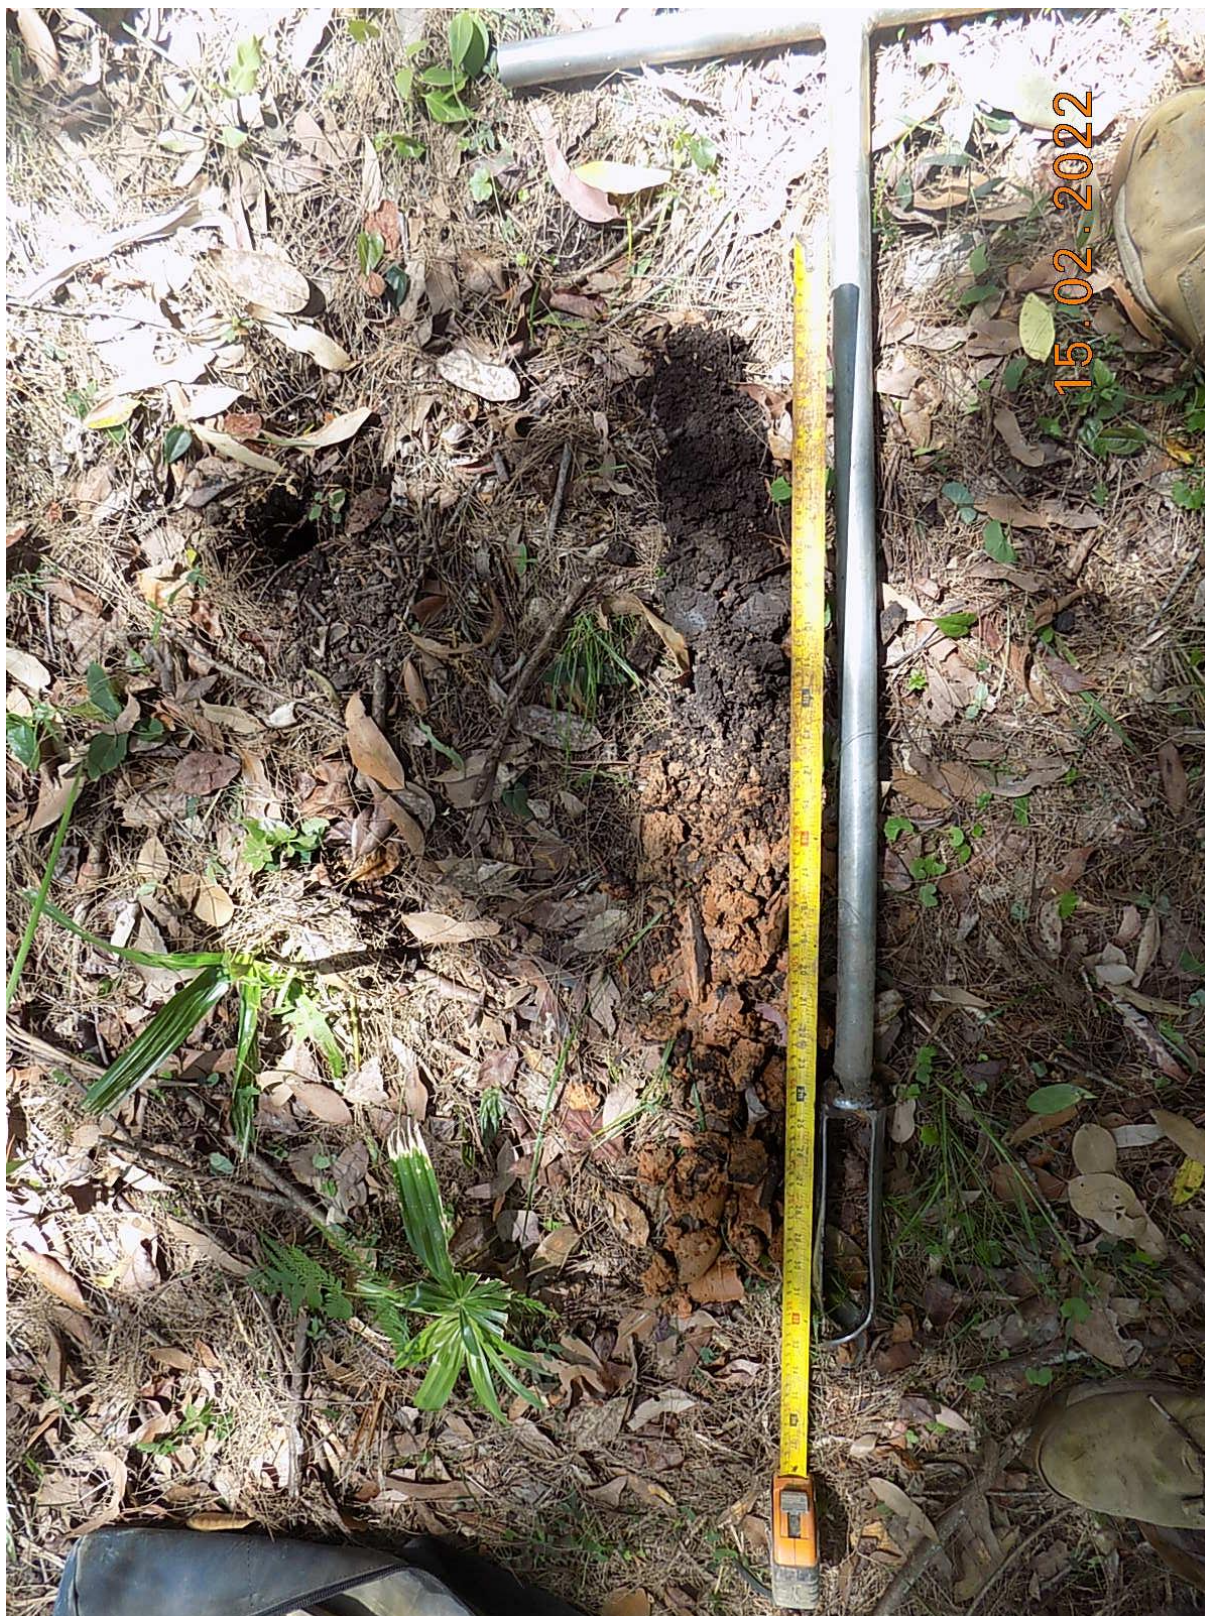
Photo 5 (Top to Bottom)

AUGER HOLE 1 (~RL26.5) – AH1 (Photo 5)

| Depth (m) | Material Encountered |
|---|---|
| 0.0 to 0.2 | TOPSOIL , dark brown and black, clayey soil, medium grained, loose, fine trace of organic matter, dry. |
| 0.2 to 0.8 | CLAY , orange, fine grained, stiff to hard, dry. |

End of test @ 0.8m. No water table encountered.
