| Report Title: RISK ANALYSIS & MANAGEMENT FOR PROPOSED ADDITIONS & ALTERATIONS AT 7 ROCK BATH ROAD PALM BEACH – MT 31598 |

**RISK ANALYSIS & MANAGEMENT  
FOR  
PROPOSED ADDITIONS AND ALTERATIONS  
AT  
7 ROCK BATH ROAD PALM BEACH**

MT 31598

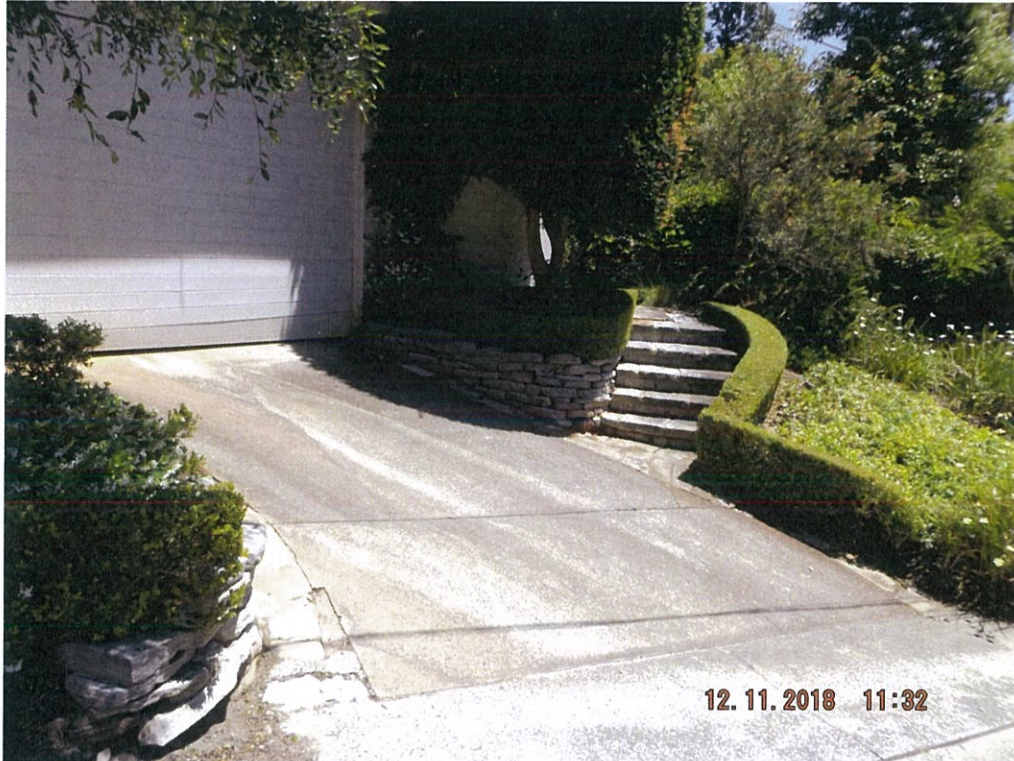
**Photo 1**

3.3 Vehicular access to the property is via a short concrete to the existing double garage on the north eastern corner of the property, Photo 1. Pedestrian access is via a pathway and stairs that leave the northern side of the driveway and lead up the slope towards the existing residence, Photo 2. Outcropping sandstone in the form of displaced joints blocks (rock floaters) are at the rear of the garage, Photo 3. A timber sleeper retaining wall is to the south of the existing garage and is in poor condition requiring replacement, Photo 4. The existing swimming pool forms a terraced level at the ground floor level, Photo 5. Another terrace steps up to the south, level with the existing first floor, Photo 6. A high feature masonry wall runs adjacent the southern boundary of the southern side of the existing residence, Photo 7. Settlement of the sandstone paving was observed on the south eastern corner of the swimming pool terrace, Photo 8. Another timber sleeper retaining wall supports the pool terrace and is in poor condition requiring replacement, Photo 9. Outcropping sandstone bedrock and displaced joints blocks (rock floaters) were observed to the north of the front entry door, Photo 10. A small masonry retaining wall creates a planter at the rear of the existing residence on the northern side of the existing residence with a surface drainage system between this retaining wall and the existing residence, Photo 11. Another small masonry retaining wall along the rear boundary on the southern side of the existing residence support the neighbouring property again with surface drainage system between the retaining wall and the existing residence, Photo 12. These rear retaining walls were observed to be stable at the time of our inspection.
