# 34 Coasters Retreat Photographic Analysis

*Ecological Consultants Australia Pty Ltd*

October 2016

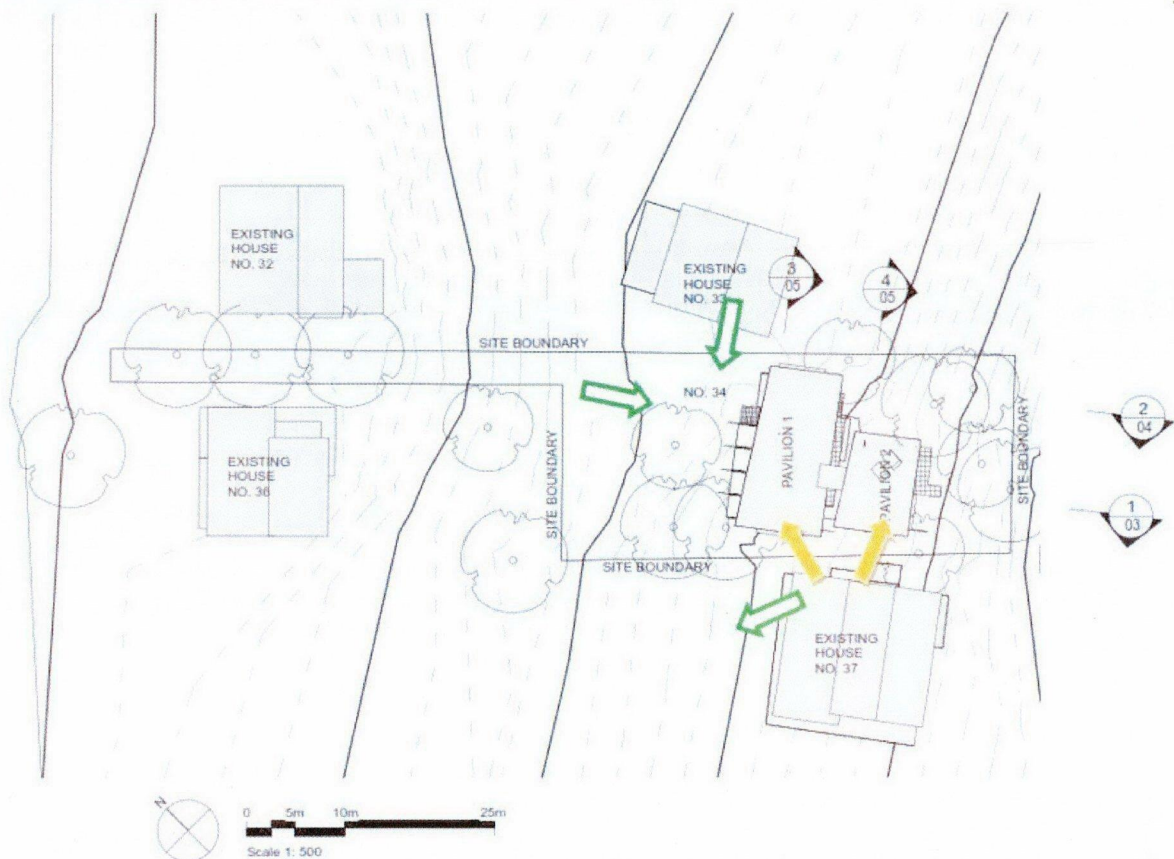
**Figure 1 Visual Analysis areas of focus**

Figure 1 assists in seeing the focus area for this visual analysis.

Source of underlying drawing Troppo Architects October 2016. Arrows added as part of this Visual Assessment study.

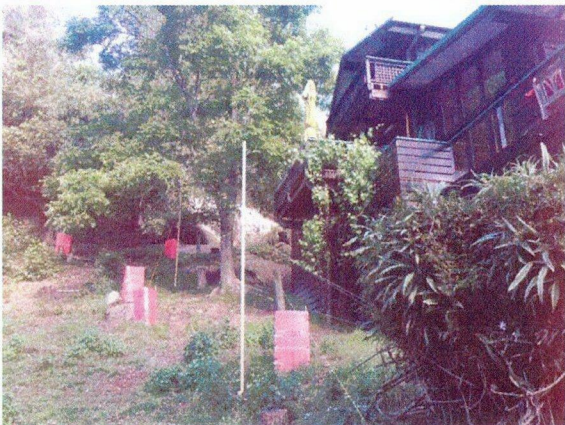
Plate 3. View along the NW boundary looking at the rear pole of the northern pavilion up to the highest (furthest back) pavilion roof pole. NB this section of roof has now been moved away from the tree. This tree provides screen of the NW boundary from the number 37.

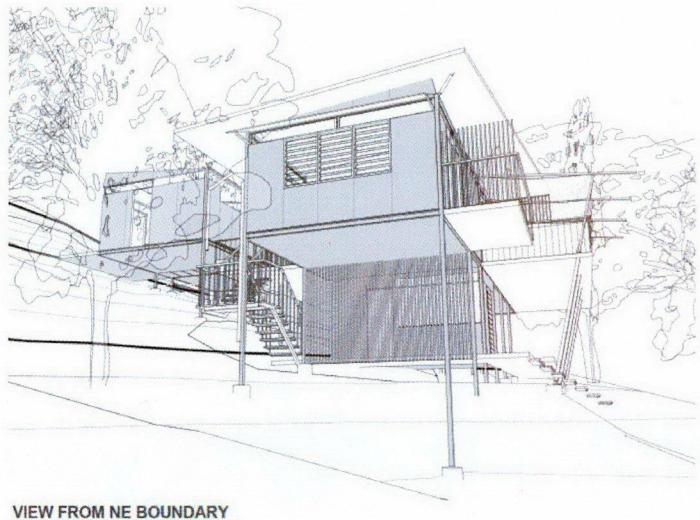
Figure 4. Side view from NE boundary of the proposed development Source: Troppo 2016

Currently there is no dwelling looking over the NE boundary and there are trees, most of which are being retained, that soften the view from this direction. While this is the highest height pole this is due to the drop in land RL just in this section.

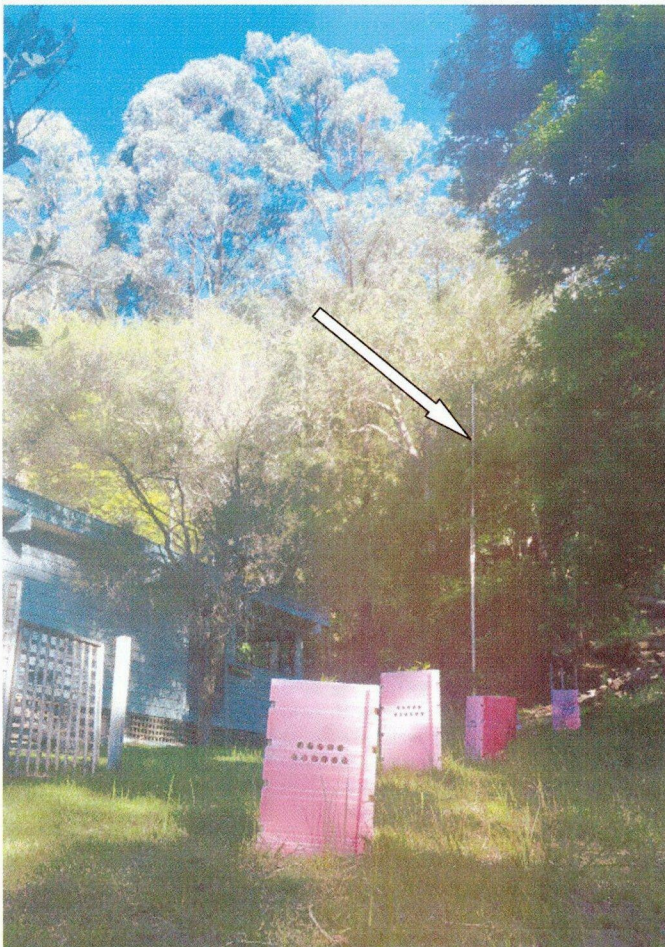
Plate 4. View from the front of the proposed development showing the NE boundary and house number 33.

This pole is the highest and shows the proposed pavilion roof area. The development is wholly behind (up-slope) of this point and thus not adjacent to this existing dwelling seen in the left of the image.

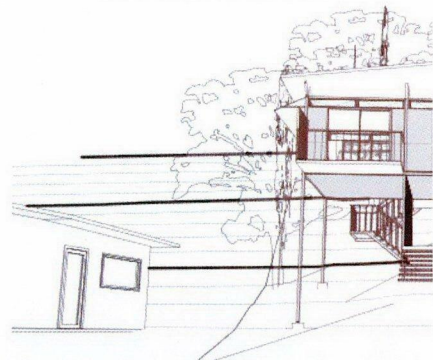
The design drawing below shows that the built form is minimal in this area and the pole height is to make up for the uneven ground rather than additional bulk.

Source: Troppo 2016 extract from perspectives drawings

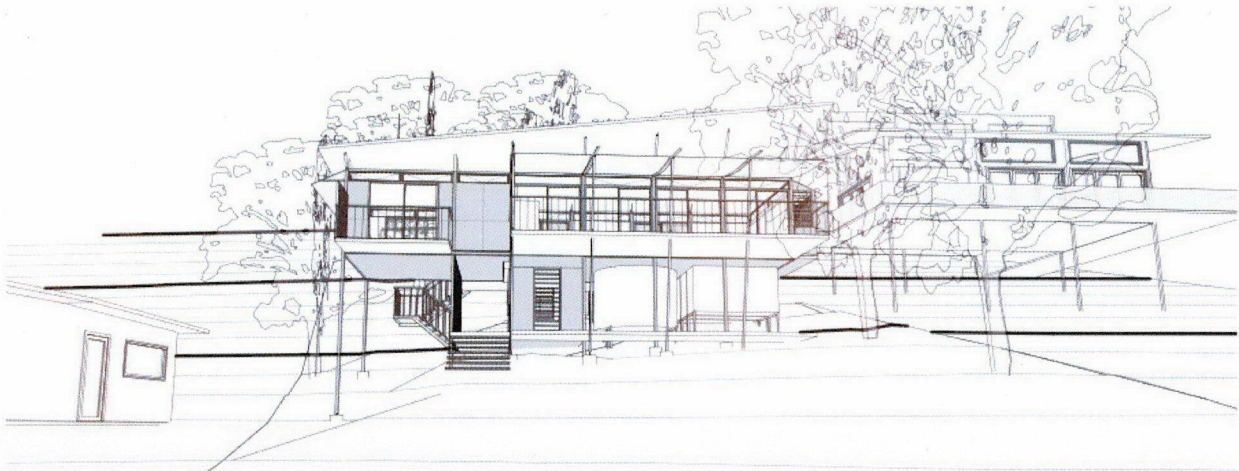
VIEW FROM FRONT

The area in front of the proposed development currently has trees that will provide screening from this view point. The land drops away steeply in front of the proposed building location.

Providing trees are retained or planted to replace natural loss then this side of the proposed development will remain mostly screened from the water. It will not be any more visible than existing homes in this area.
