Our reference: PA3332\_CA report-Queenscliff

**3 PAVILION STREET, QUEENSCLIFF - ALTERATIONS AND ADDITIONS  
COASTAL ASSESSMENT REPORT**

Further to our recent discussions, we are pleased to set out in this letter the Coastal Assessment Report for the proposed alterations and additions at 3 Pavilion Street, Queenscliff.

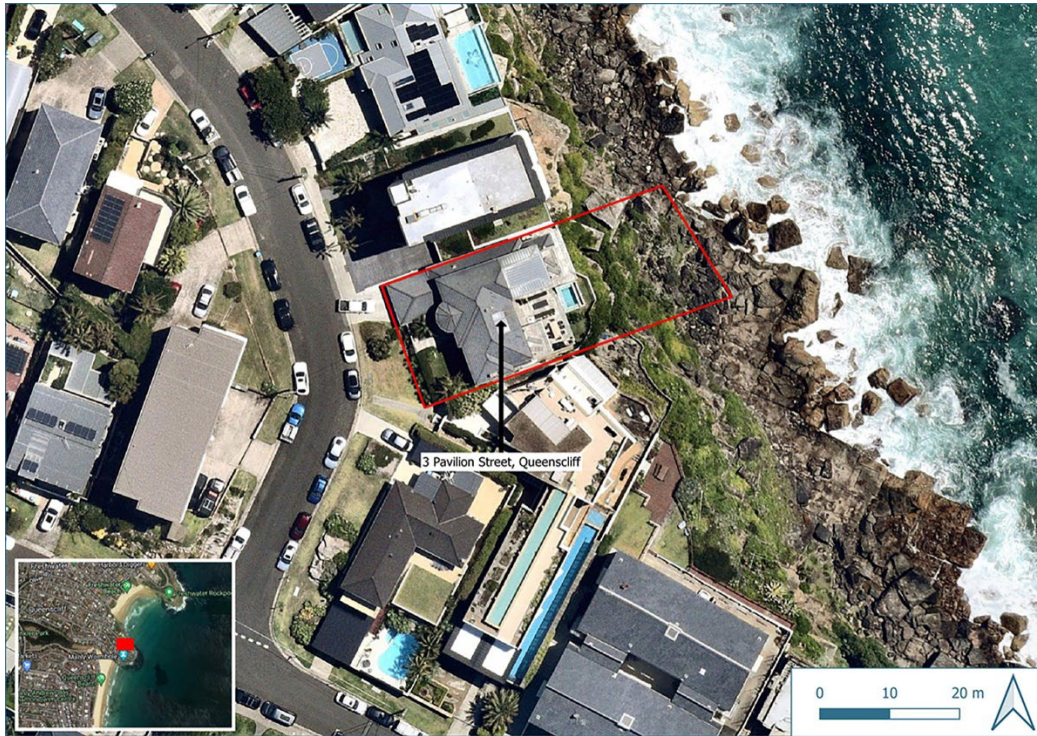
Figure 1-1 Location of 3 Pavilion Street, Queenscliff (source: Nearmap, photo date 9/01/2023)

Of relevance to the Coastal Assessment is that the site is located near the crest of an approximately 25m high sandstone cliff face on Queenscliff headland, with a lower ground level of the building situated at 32.95m above Australian Height Datum (32.95m AHD). AHD is approximately the level of mean sea level at present.

The location of 3 Pavilion Street, Queenscliff relative to the cliff face and surrounding development is shown in Figure 1-1.

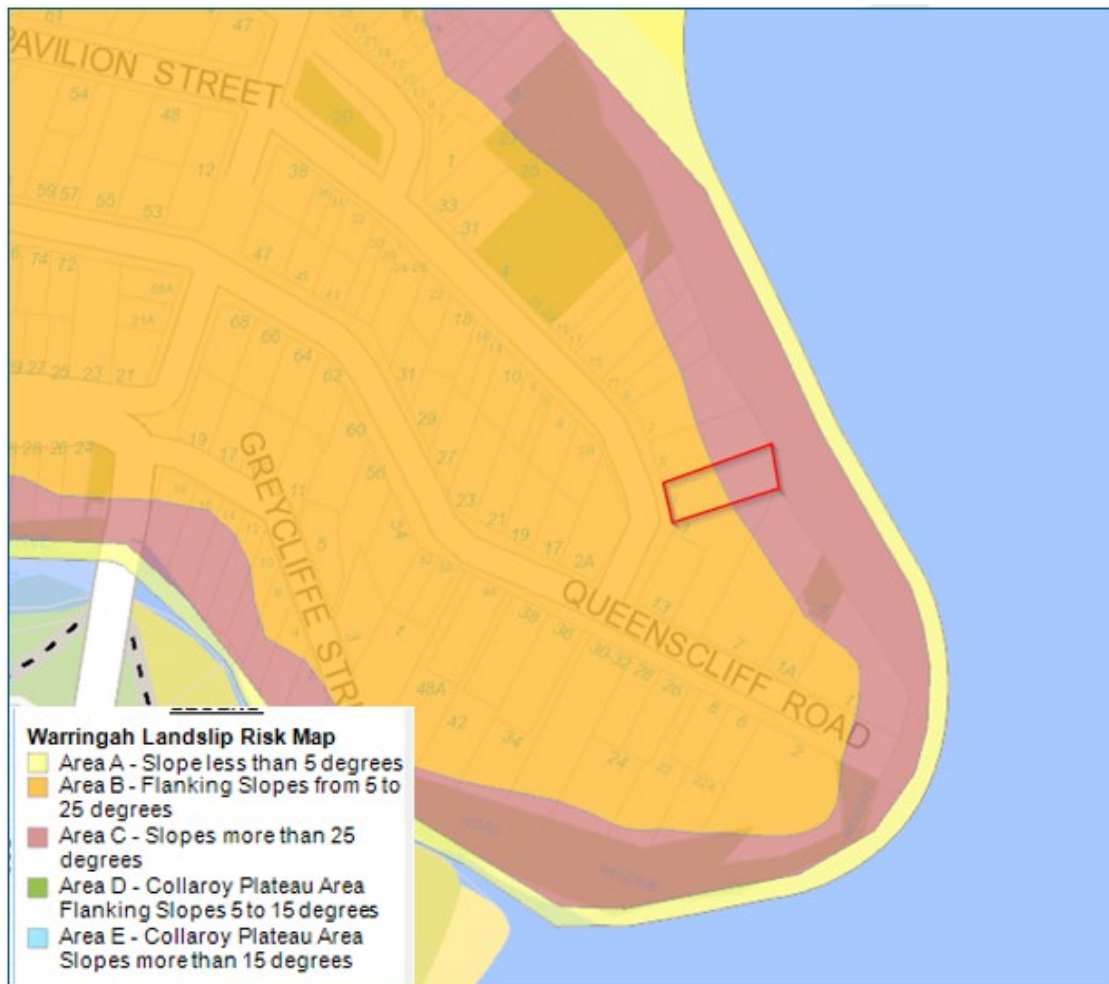
The location of the subject land is shown superimposed on Landslip Risk Map – Sheet LSR\_010 in Figure 1-2 and straddles Area B and Area C. The location of the land relative to the different Areas on the Landslip Risk Map govern the need for geotechnical and hydrological reporting. These reports are outside the scope of the coastal assessment and are being managed by Collins and Turner.

Figure 1-2: Landslip Risk Map – Sheet LSR\_010 with 3 Pavilion Street, Queenscliff superimposed
