# Results of Geotechnical Investigation

14 Aquatic Drive, Frenchs Forest

PSM4864-005R Rev 3      30 April 2025

Goodman Property Services Australia Pty Ltd

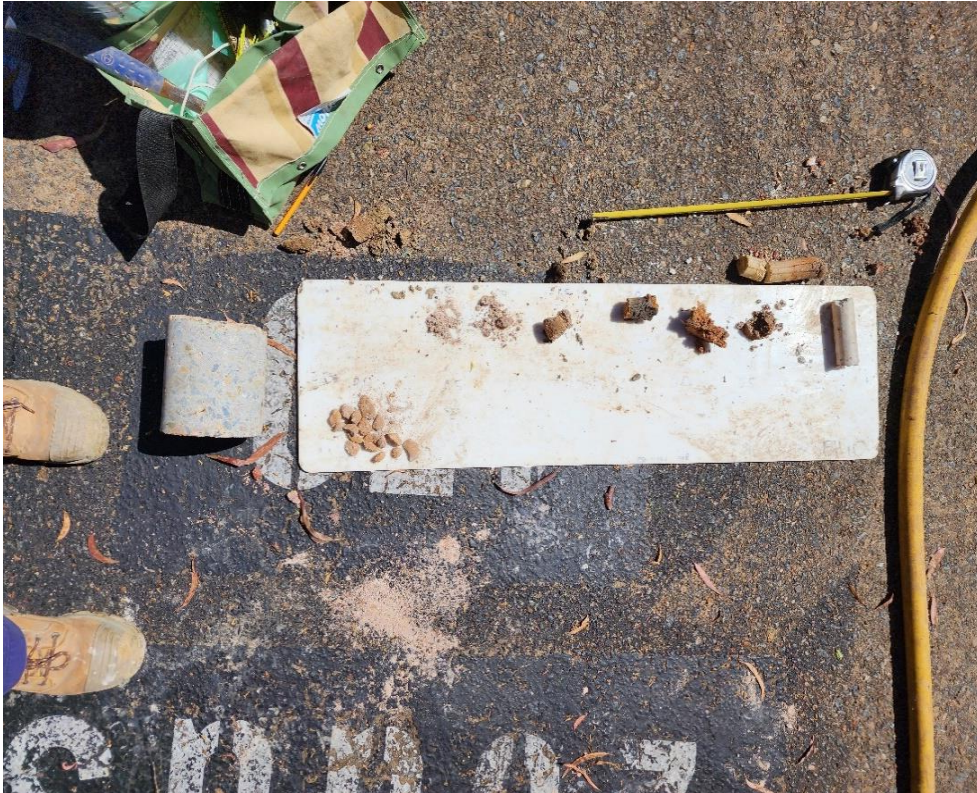
Photo 7 - Soil Profile from CBH01

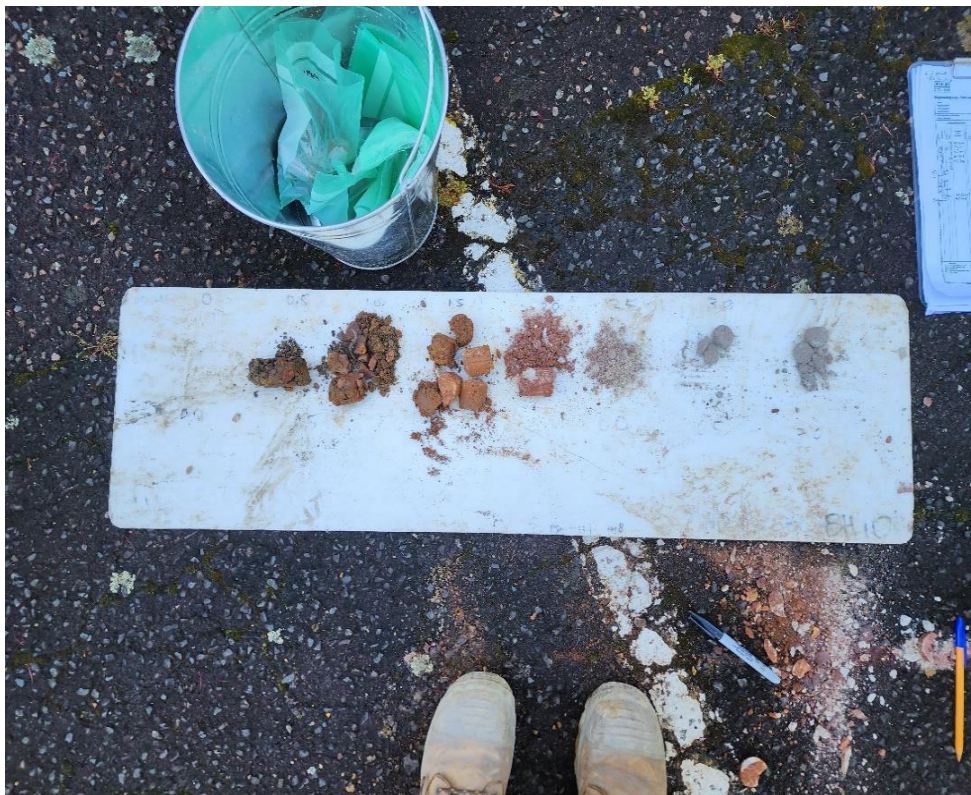
Photo 8 - Soil Profile from ABH01

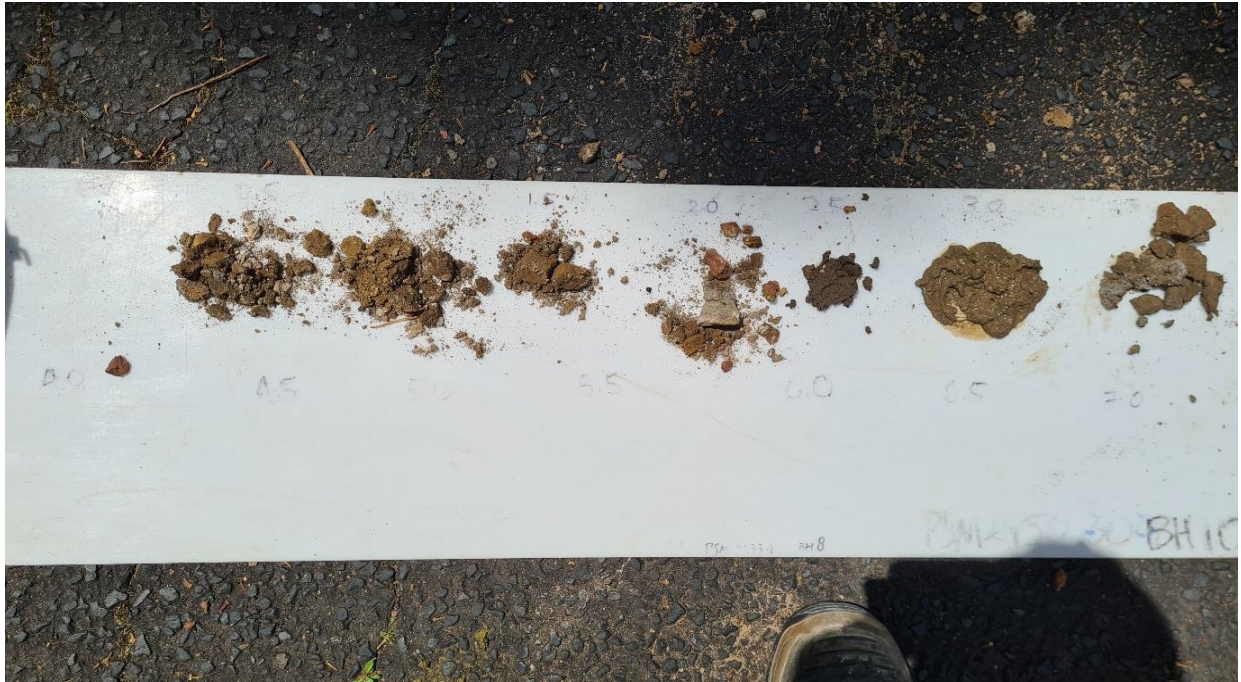
Photo 9 - Soil Profile from ABH02

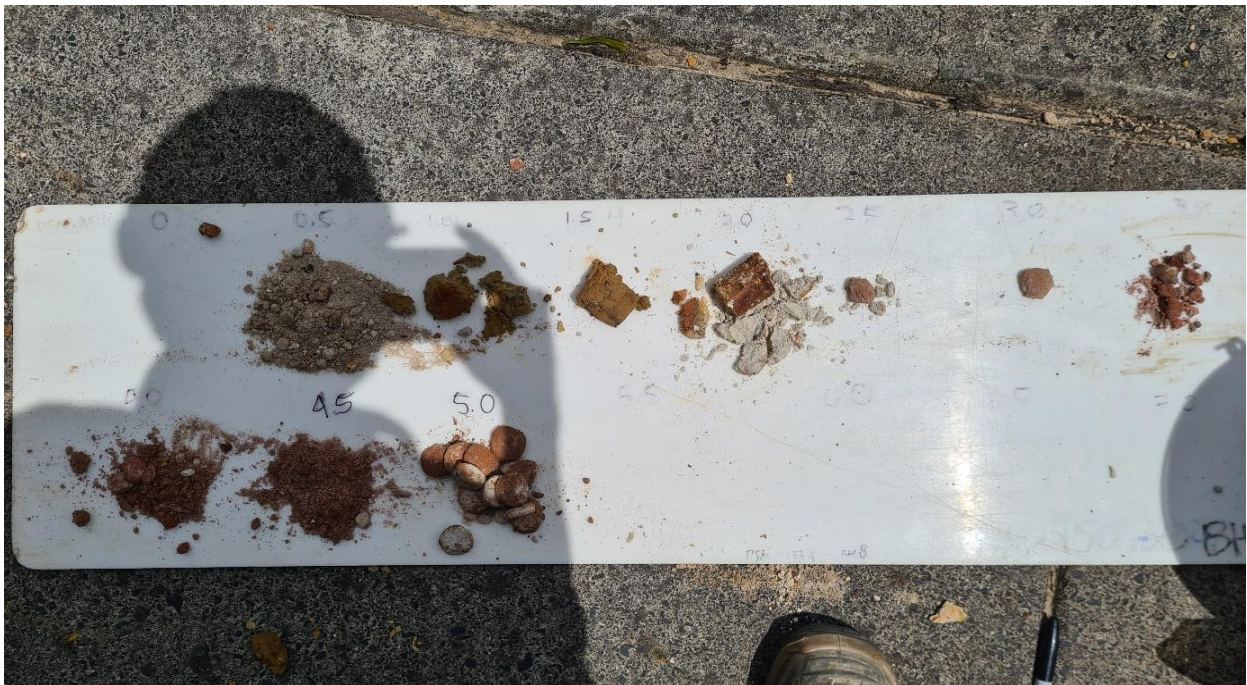
Photo 10 - Soil Profile from ABH03

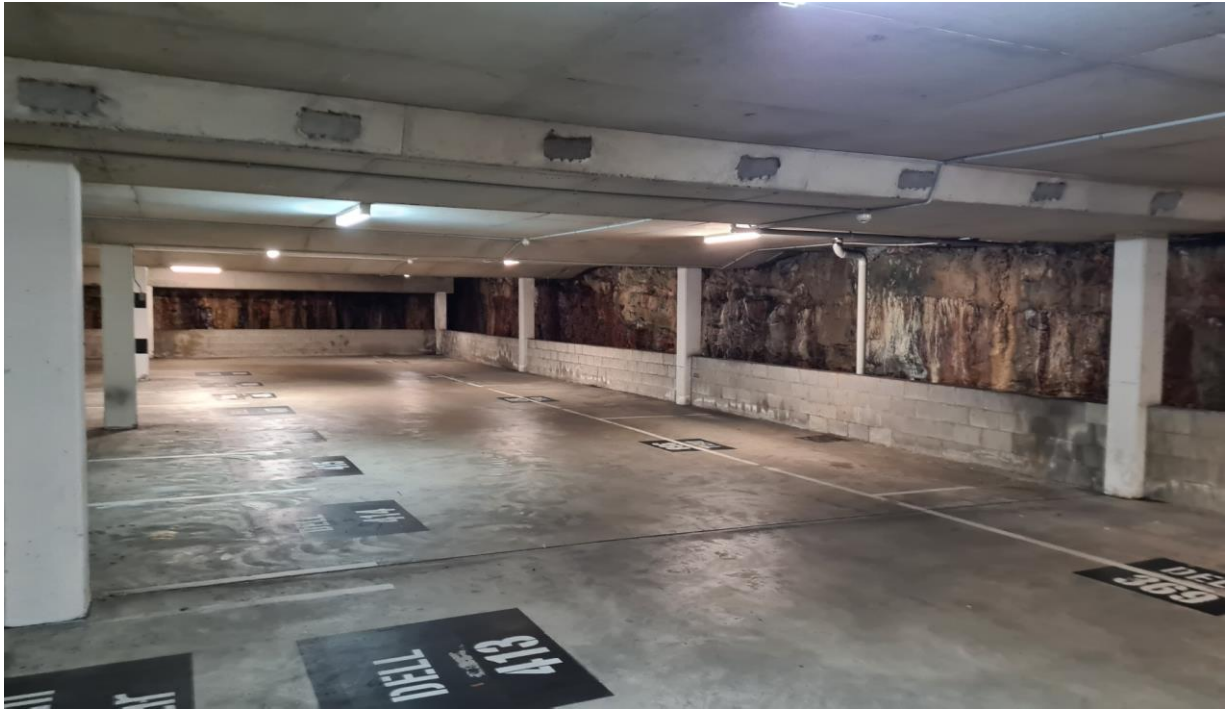
Photo 11 - BEDROCK Unit Observed in B2

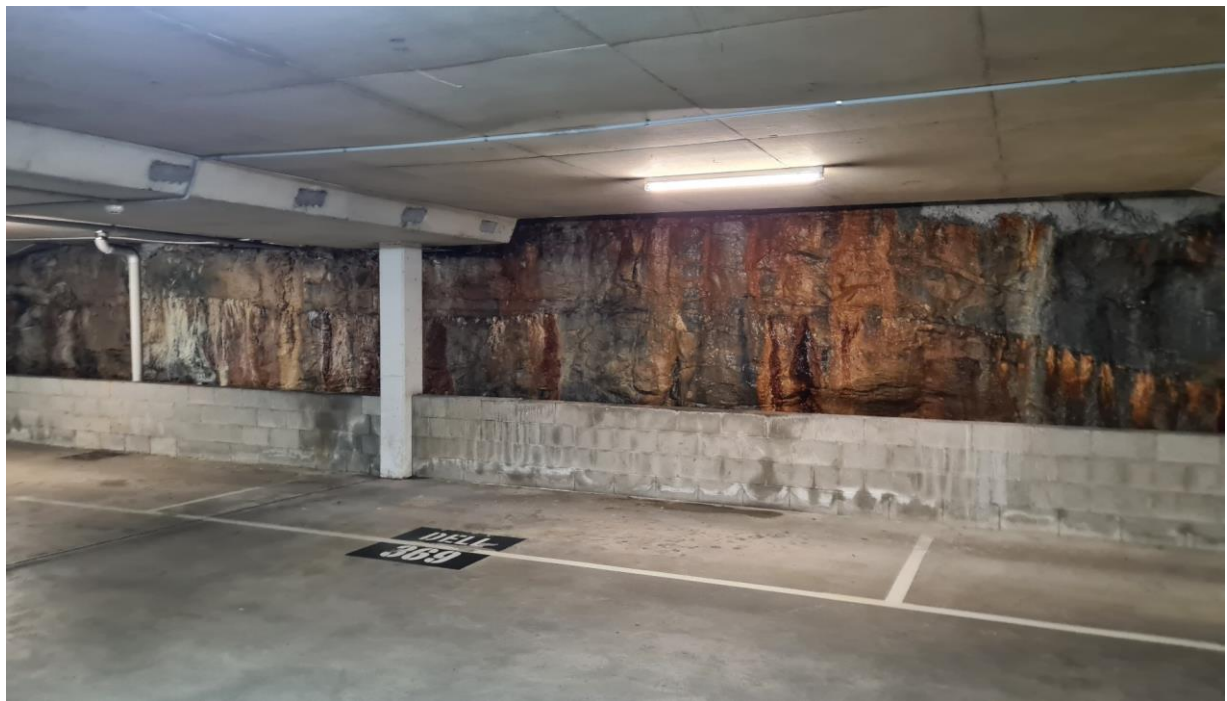
Photo 12 - BEDROCK Unit Observed in B2

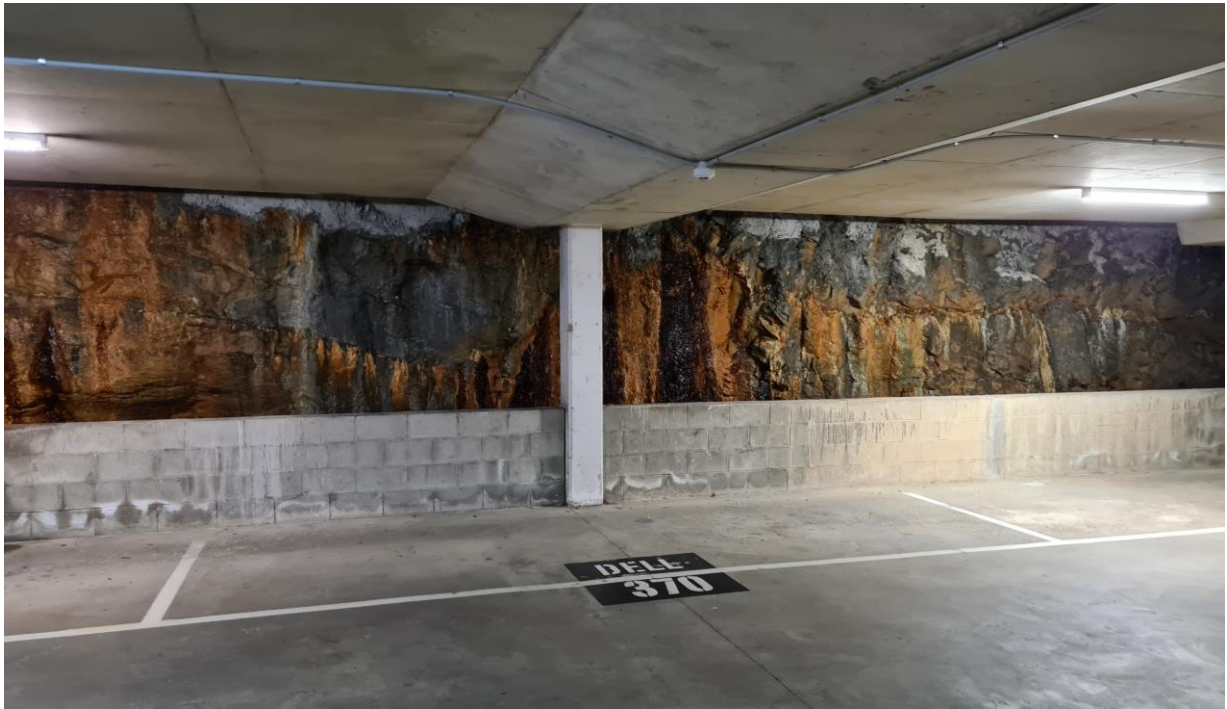
Photo 13 - BEDROCK Unit Observed in B2

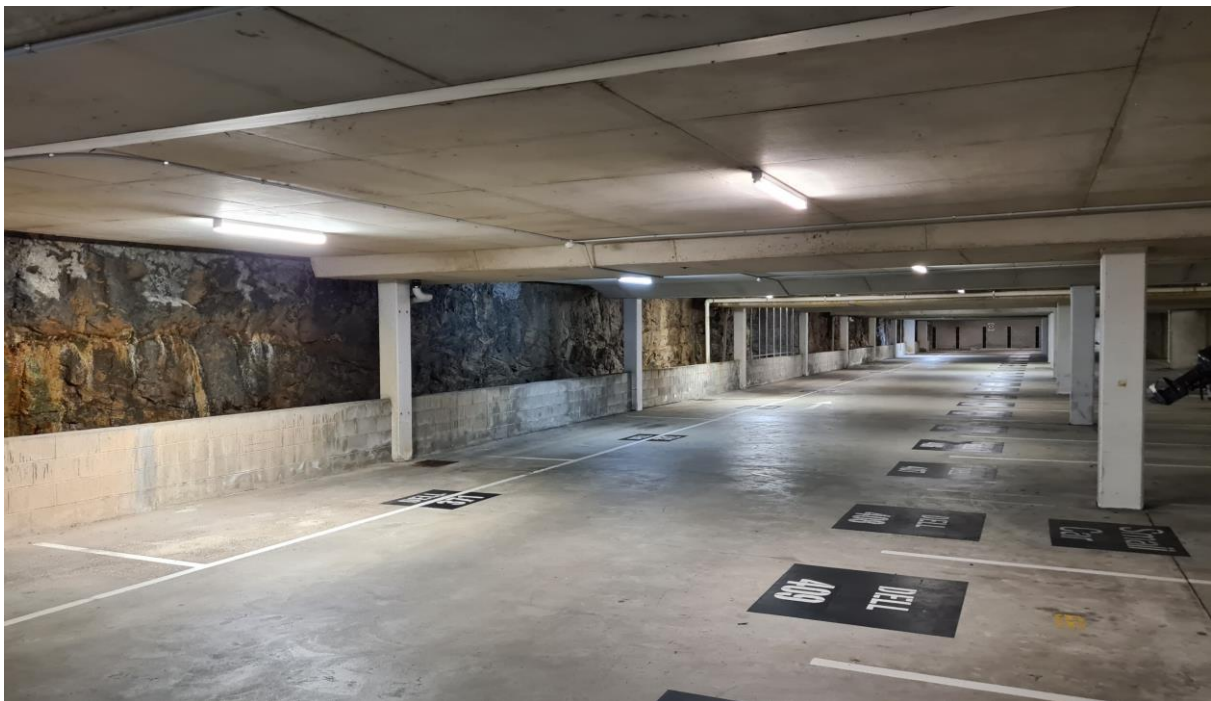
Photo 14 - BEDROCK Unit Observed in B2

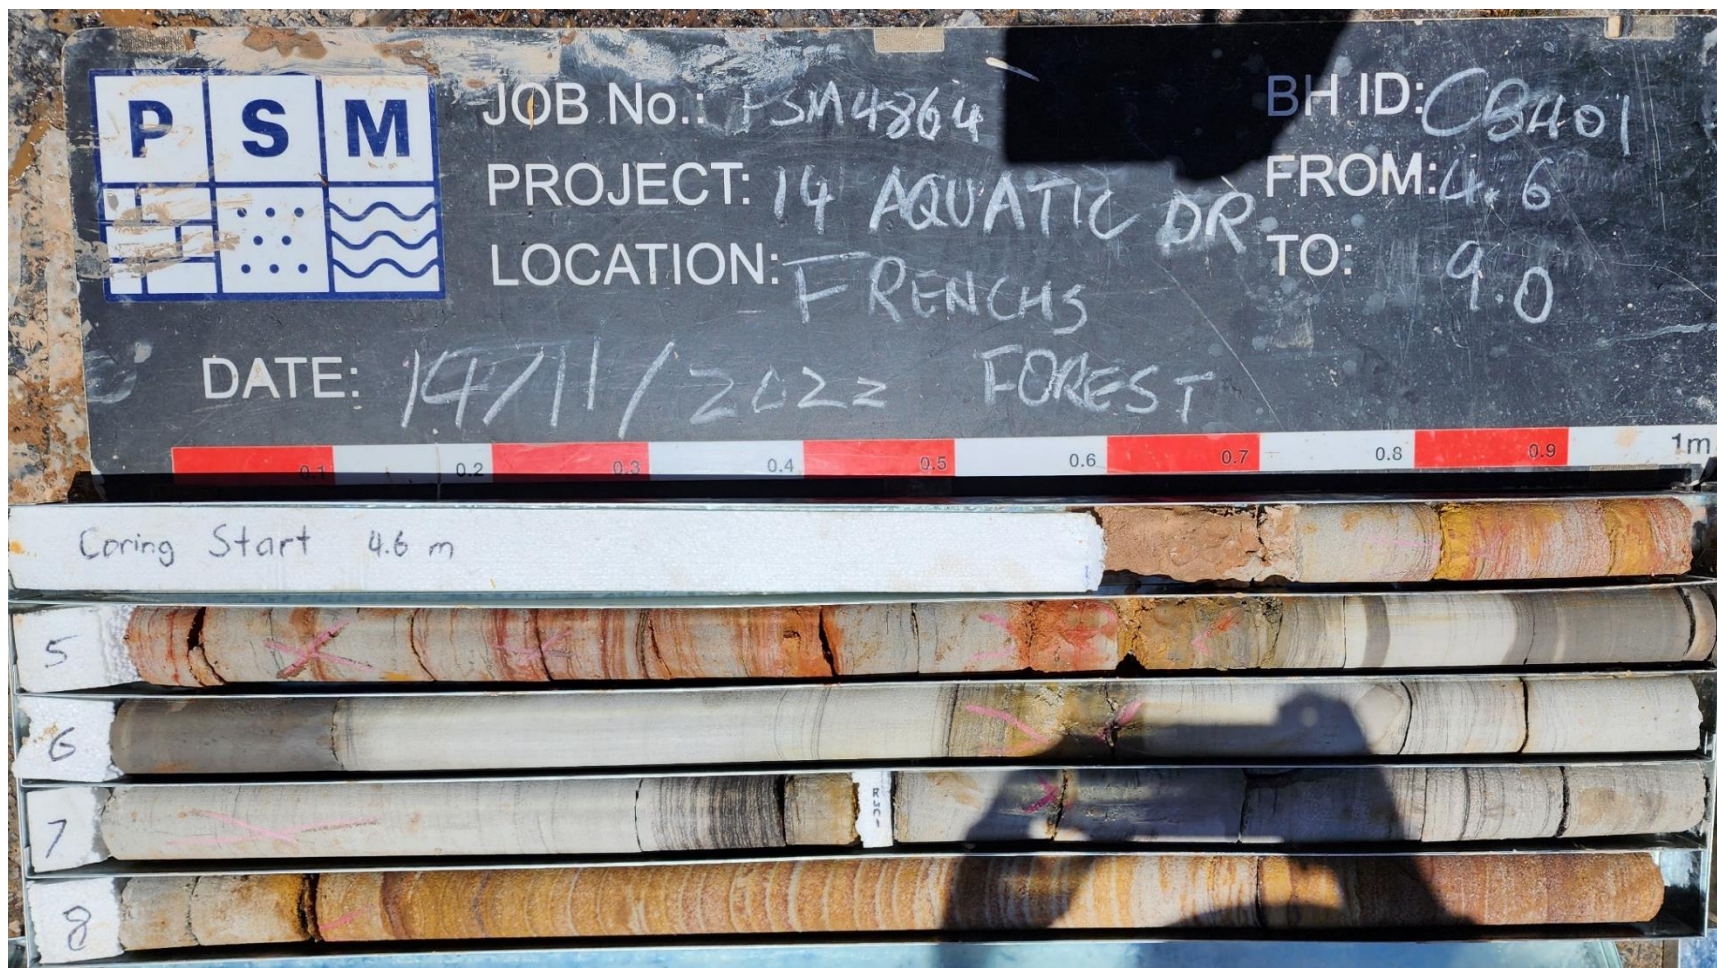
CBH01 - 4.6 - 9.0 m

Defects are marked in red

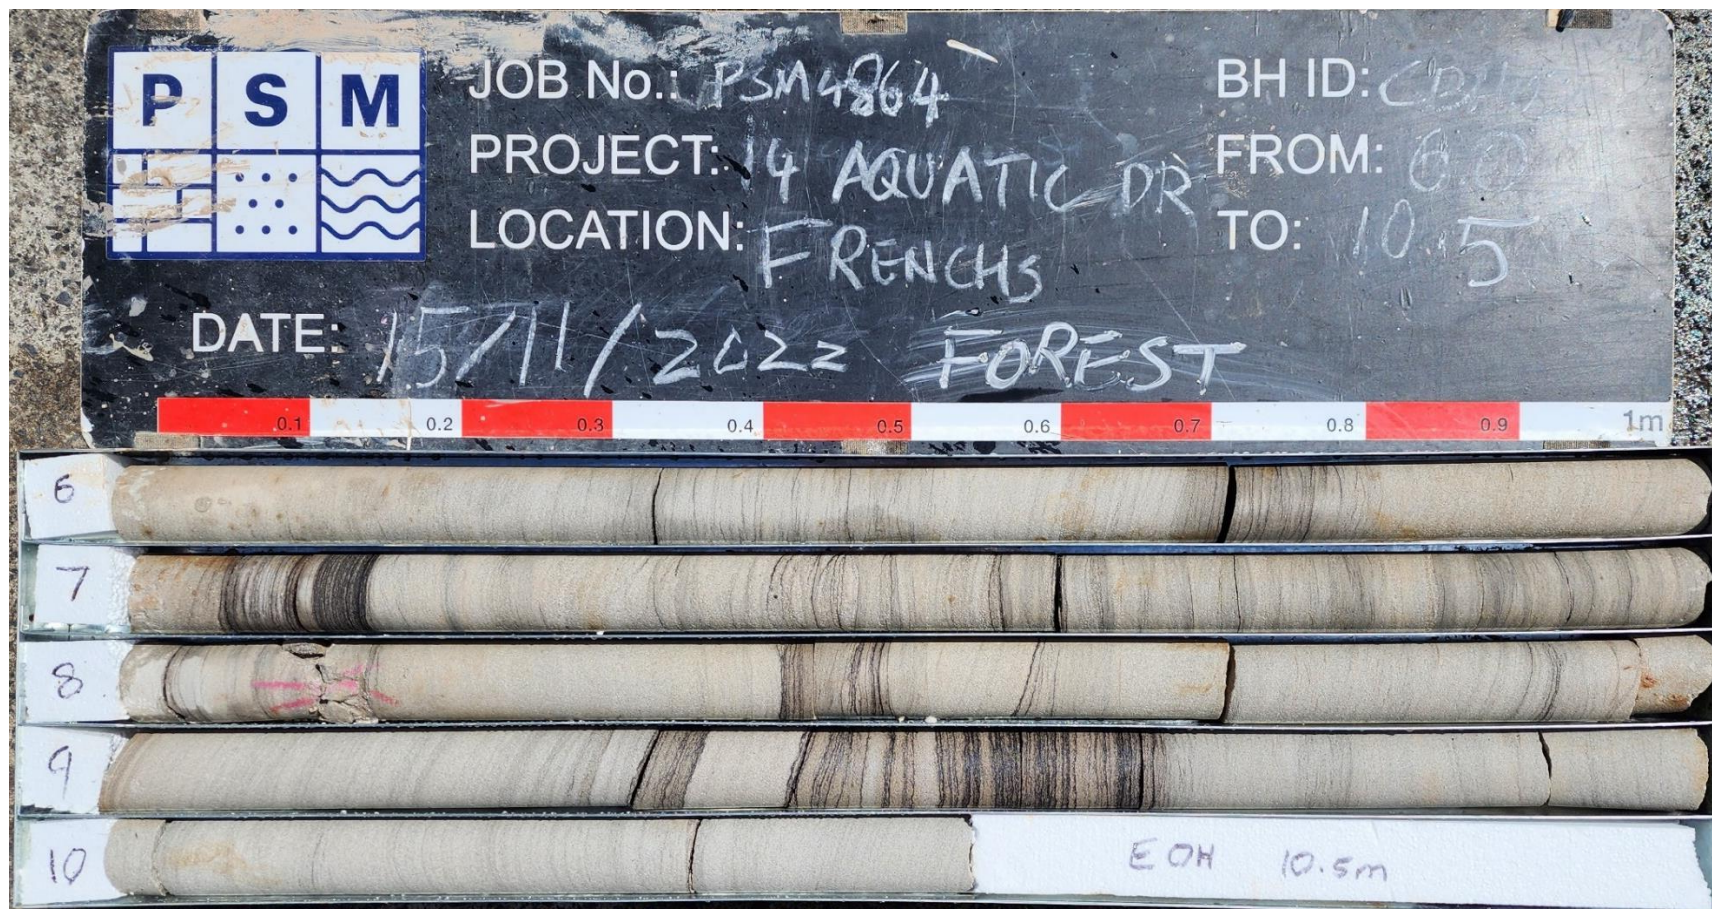
CBH02 - 6.0 - 10.5 m

Defects are marked in red
