Report on  
Geotechnical Investigation

Proposed Collaroy Vet Project  
1121 Pittwater Road, Collaroy

Prepared for  
BigCity Design Pty Ltd

Project 99918.00  
December 2020

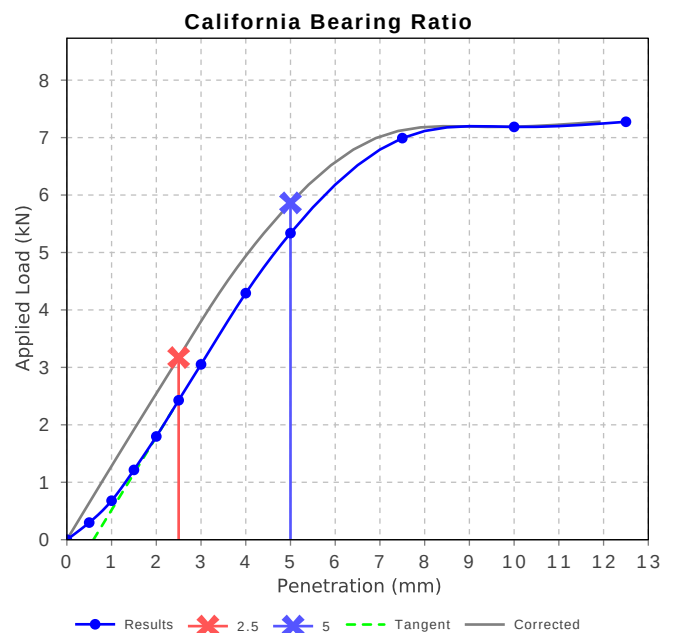
**Report Number:** 99918.00-1  
**Issue Number:** 1  
**Date Issued:** 16/12/2020  
**Client:** BigCity Design Pty Ltd  
 PO Box 526, Turrumurra NSW 2074  
**Contact:** Dimitra Lomis  
**Project Number:** 99918.00  
**Project Name:** Proposed Collaroy Vet Project  
**Project Location:** 1121 Pittwater Road, Collaroy  
**Work Request:** 7193  
**Sample Number:** SY-7193B  
**Date Sampled:** 07/12/2020  
**Dates Tested:** 08/12/2020 - 15/12/2020  
**Sampling Method:** Sampled by Engineering Department  
 The results apply to the sample as received  
**Sample Location:** BH2 (0.35-0.6m)  
**Material:** Clayey SAND: yellow brown

| California Bearing Ratio (AS 1289 6.1.1 & 2.1.1) | | Min | Max |
|---|---|---|---|
| Optimum Moisture Content (%) | 16.0 | | |
| Laboratory Moisture Ratio (%) | 102.0 | | |
| Field Moisture Content (%) | 19.7 | | |
