**MARINE HABITAT SURVEY**  
**316 Hudson Parade, Clareville**

**April 2021**

**BIO-ANALYSIS Pty Ltd**

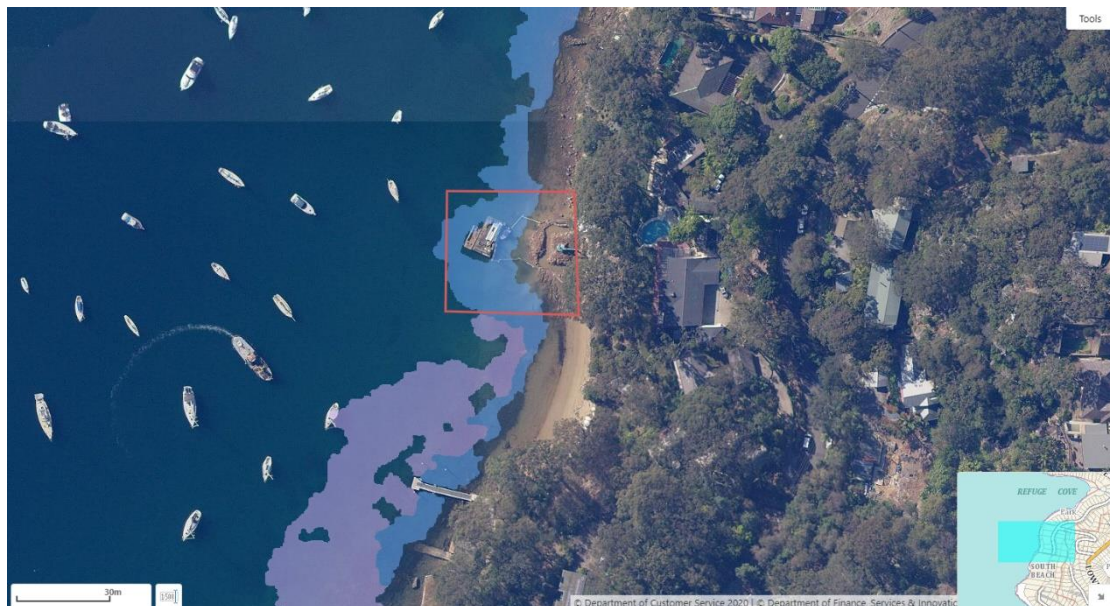
The seagrass (*Posidonia australis*) listed as endangered ecological communities under the EPBC “*Posidonia australis* seagrass meadows of the Manning-Hawkesbury ecoregion” (Department of the Environment (2018)) has been mapped in the vicinity of the survey area (Fisheries NSW Spatial Data Portal ; Creese *et al.*, 2009). The seagrass *Zostera capricorni* has been reported within the survey area (NSW DPI - Creese *et al.*, 2009) (Fig. 2).

**Figure 2.** Estuarine macrophytes mapped by NSW DPI. The red rectangle delimits the survey area. Blue polygons: *Zostera capricorni*. Purple polygons: *Posidonia australis* and *Zostera capricorni* (Source: NSW DPI - Fisheries NSW Spatial Data Portal 25/04/2021).

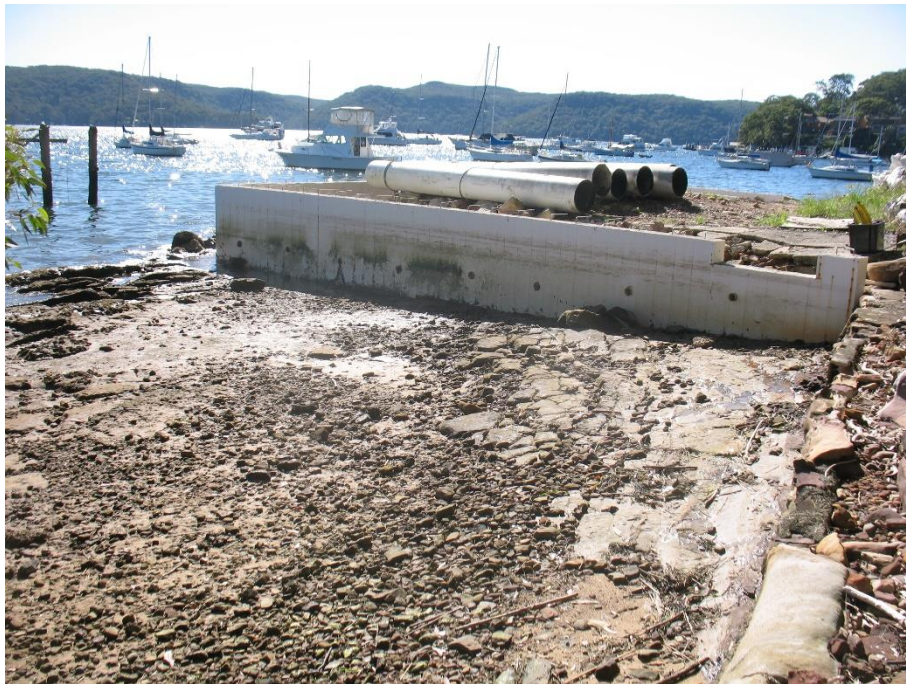
The intertidal area consisted of an artificial sandstone retaining wall, which extended parallel to the shoreline and the foundation walls (Dintel) supporting the proposed structures (jetties, boatshed and ramp) (Figs. 4 to 6). Furthermore, intertidal areas consisted of a natural sandstone platform partially covered by pebbles and fine sand and silt to the south of the foundation walls, and boulders and sand to the north of the proposal (Figs. 4 to 6). A sandy beach was present further to the south. In addition, four piles were present offshore (Fig. 5). The natural hard substratum (sandstone platform and boulders) was colonised by Sydney rock oysters (*Saccostrea glomerata*), various gastropods and macroalgae (mainly *Hormosira banksii*) (Figs. 4 to 7).

**Figure 4.** Foreshore: artificial sandstone retaining wall and foundation wall, natural sandstone platform (southern side).

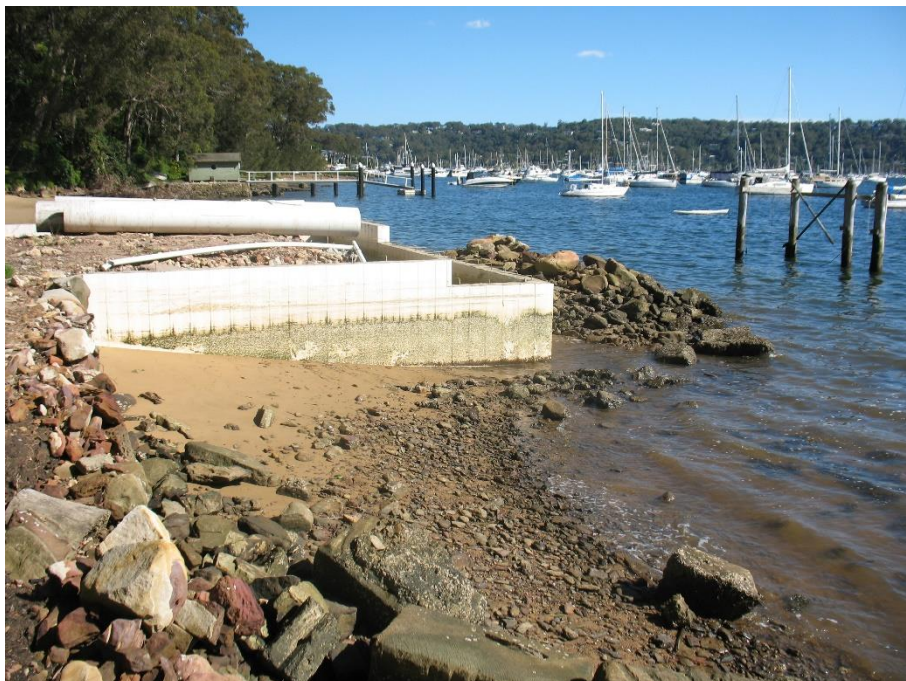
**Figure 5.** Foreshore: artificial sandstone retaining wall, foundation walls and pile of boulders (northern side). Four piles of the former jetty were present offshore.

It is recommended that the foundations walls not be removed as this will expose the fill that was beneath the now demolished boatshed and concrete jetty to tidal and wave action that may cause the fill to be deposited on the surrounding seagrass beds.

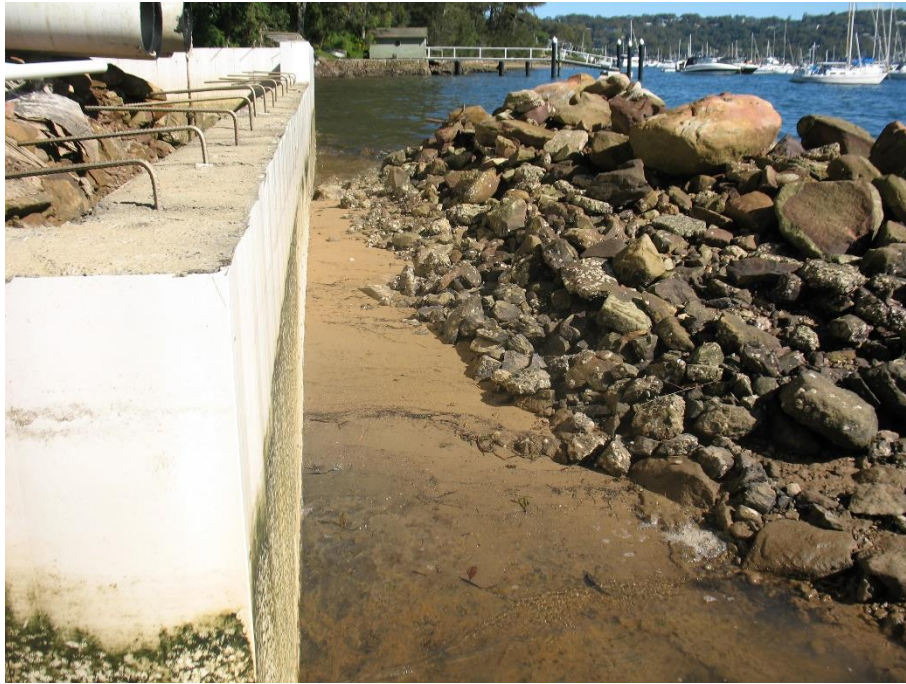
**Figure 6.** Foundation walls and pile of boulders (western side).

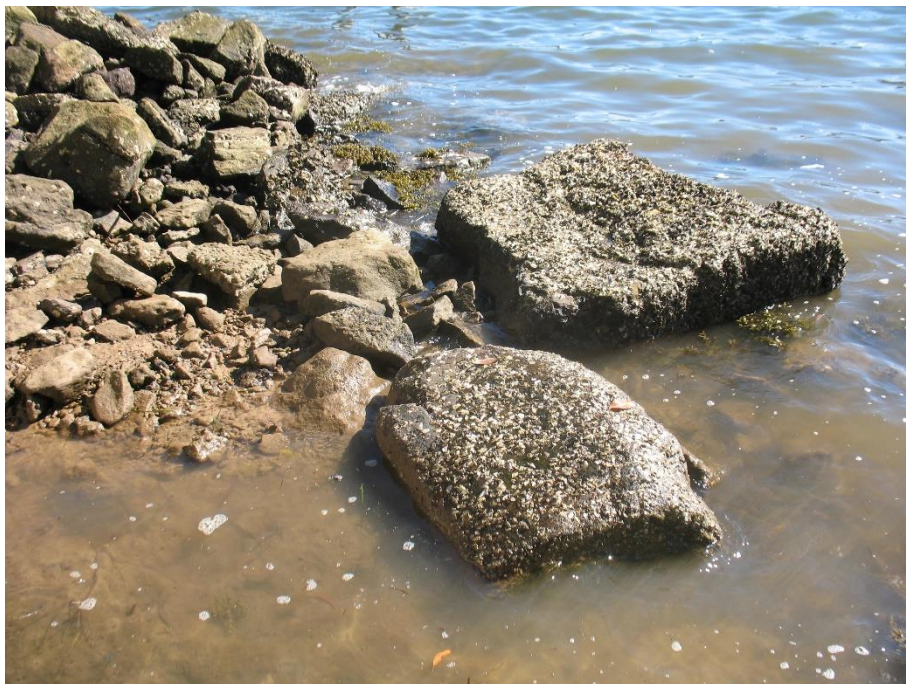
**Figure 7.** Hard intertidal substratum was colonised by macroalgae (*Hormosira banksii*) and sessile fauna (oysters).

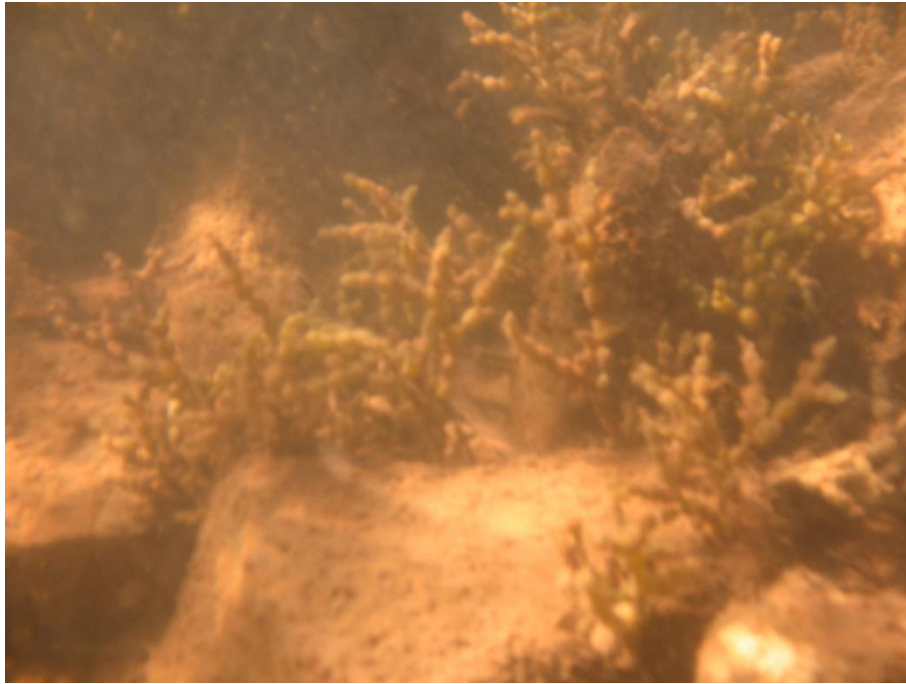
The subtidal habitat extended seaward in the form of a sandstone platform, boulders, pebbles and sand patches, up to 20 m (south side) and 17 m (north side) from the foundation walls (Figs. 8 and 9).

Macroalgae were found growing on the sandstone platform and boulders and included an algal turf, whilst the main macroalgal species was *Hormosira banksia* in the shallows (up to 10% cover) (Fig. 7 and 8) and *Sargassum* sp. in deeper water (up to 5% cover) (Fig. 9). *Sargassum* sp. was also present on the scattered boulders (Fig. 10).

**Figure 8.** Boulders colonised by *Hormosira banksii* and algal turf.

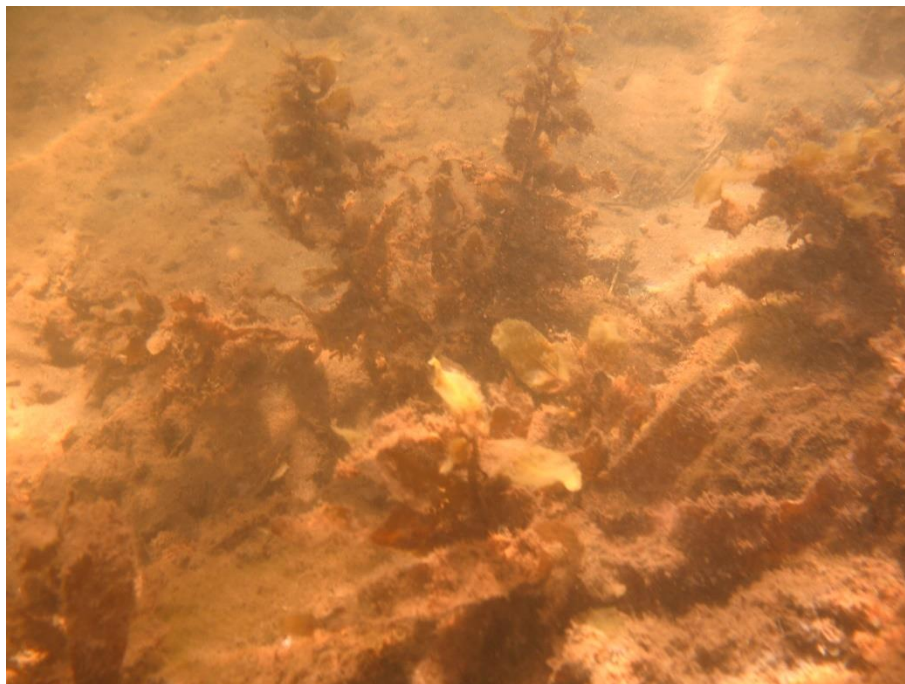
**Figure 9.** Subtidal boulders colonised by *Sargassum* sp. and algal turf.

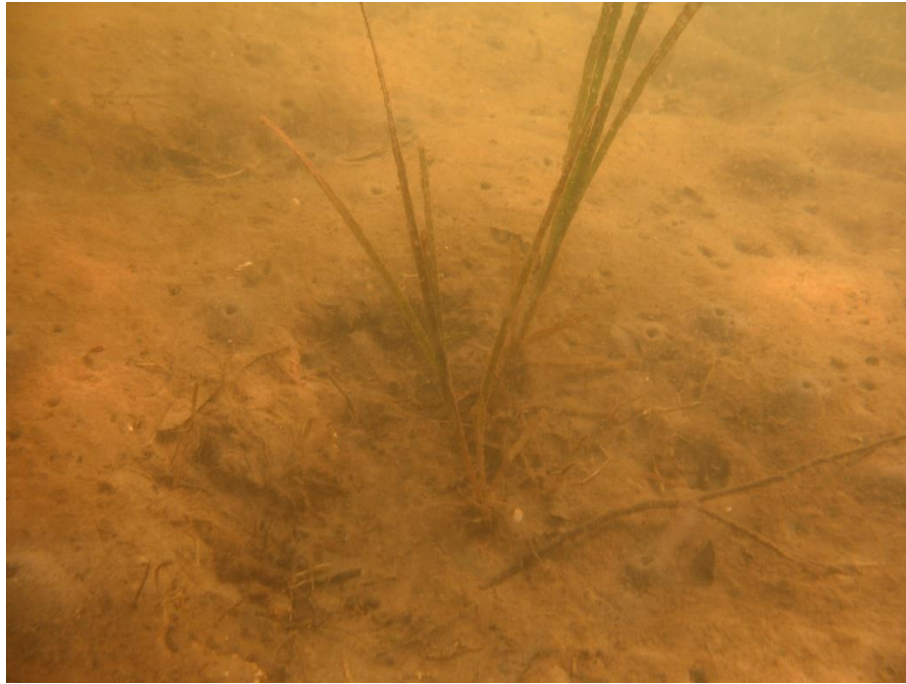
Further offshore, the seabed consisted of soft sediment, fine sand and silt, with the proportion of the latter increasing with depth (Fig. 10). Scattered small boulders were found on the soft sediment (Fig. 11). The offshore piles (remnants from the former jetty) were colonised by sessile fauna (ascidians and bryozoans) and by algal turf (Fig. 12). The subtidal hard substratum and soft sediment were colonised by marine vegetation (see “marine vegetation section”).

Three species of seagrasses were present within the survey area. Sparse *Zostera capricorni* (5% cover) was present in the subject site, seaward of the partially demolished ramp in front of the western foundation wall (Figs. 10, 13 and 14). In this area, *Zostera capricorni* appeared in poor condition and scattered among the live plants there was evidence of dead rhizomes. This indicates the presence of former plants and potential degradation of the seagrasses. Further offshore and north and south of the proposal, *Zostera capricorni* was found to be forming a continuous seagrass bed with percentage covers ranging from 20-30% (offshore) and up to 40-70% inshore (0.4 to 1.2 m depth) (Figs. 14 to 15). *Zostera capricorni* leaf-length was ~15 cm in the shallow dense bed and ~20 cm in the deeper bed. The epiphyte load on the seagrass was medium (Figs. 13 and 15).

**Figure 10.** Soft sediments with sparse seagrass (*Zostera capricorni*) and dead *Zostera* rhizomes.

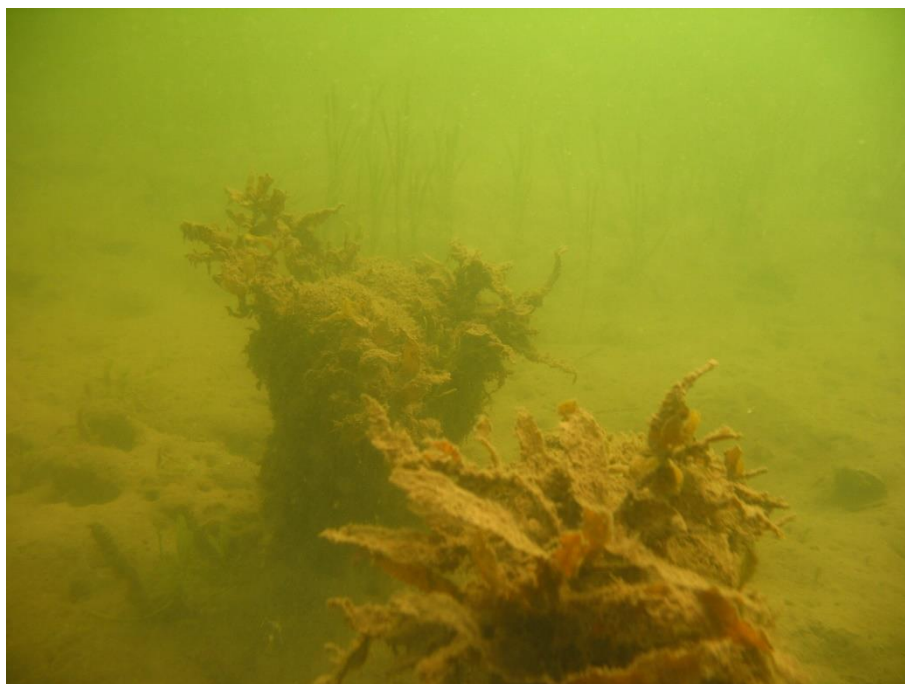
**Figure 11.** Soft sediments with sparse boulders colonised by *Sargassum* sp. and *Caulerpa taxifolia* (bottom left) and the seagrass (*Zostera capricorni*) at the back.

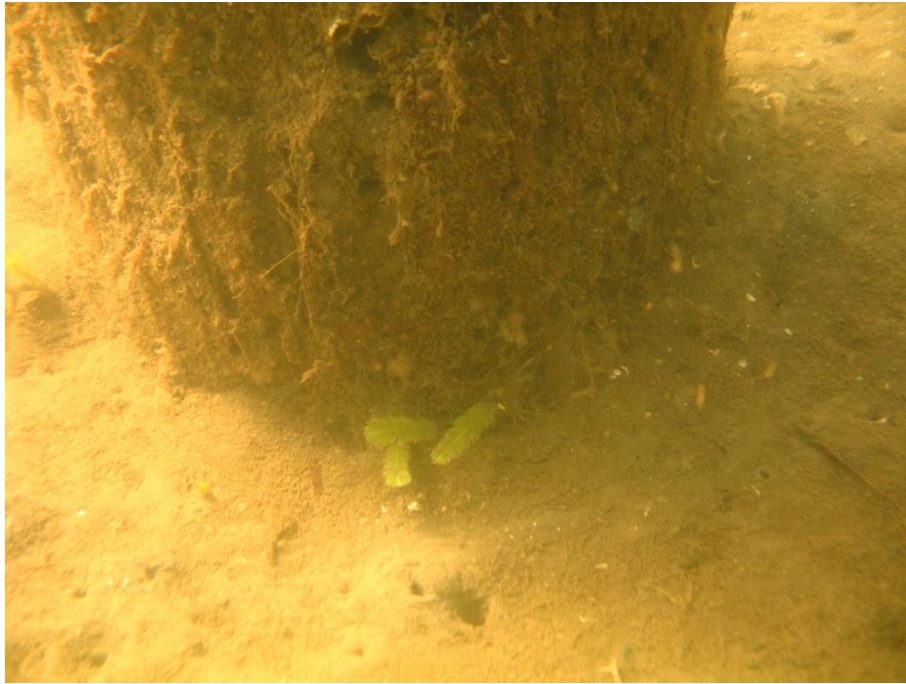
**Figure 12.** Old jetty pile with sessile fauna (ascidians and bryozoans), algal turf and the noxious *Caulerpa taxifolia*.

The noxious algae *Caulerpa taxifolia* was found within the survey area, including where the new works are to occur. Great attention should be made to minimise further dispersion of this invasive species during the works. Barge anchorage, removal of old structures, pile driving, and dragging equipment across the bottom should be avoided in the areas where *Caulerpa taxifolia* is present. It will be important to inspect anchors, chains and other equipment that could have been in contact with *Caulerpa taxifolia* and, if found, remove and dispose of any fragments of this algae using adequate methods approved by NSW DPI to avoid contamination of other areas.

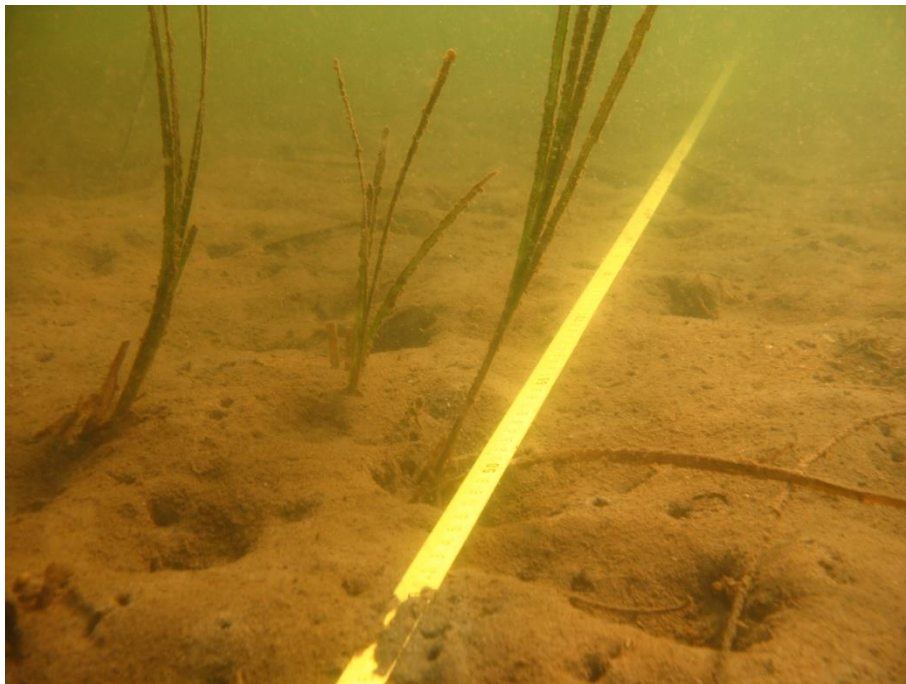
**Figure 13.** Sparse *Zostera capricorni* found in front of the exiting stockpile of boulders.

It is recommended that during the different construction work phases, any potential direct and indirect impacts on seagrasses such as anchoring, heavy equipment laid/dragged and the deposition of material on the seafloor should be avoided in vegetated areas.

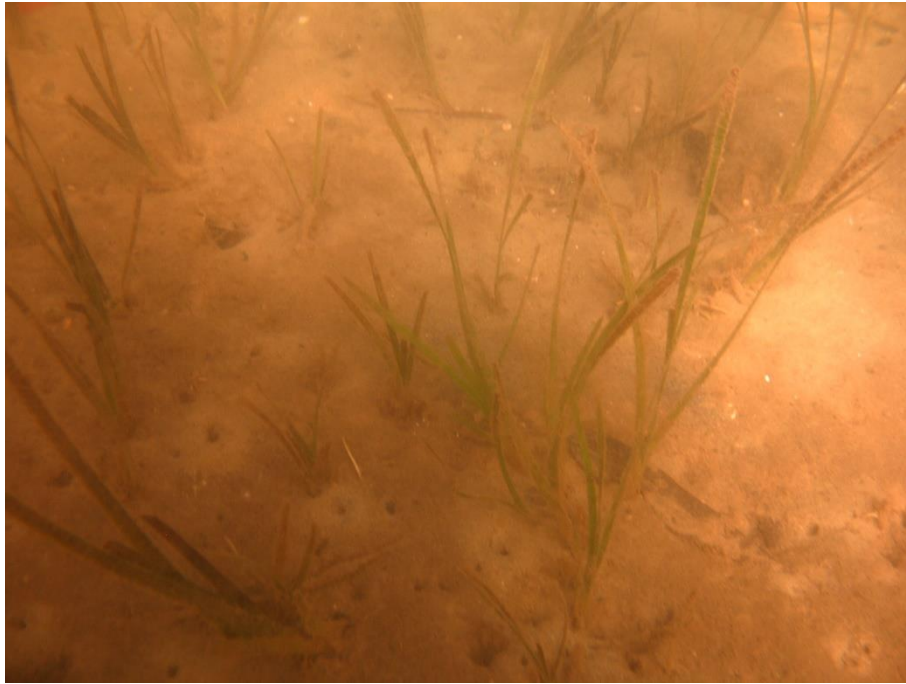
**Figure 15.** *Zostera capricorni* in deeper water to the north and south.

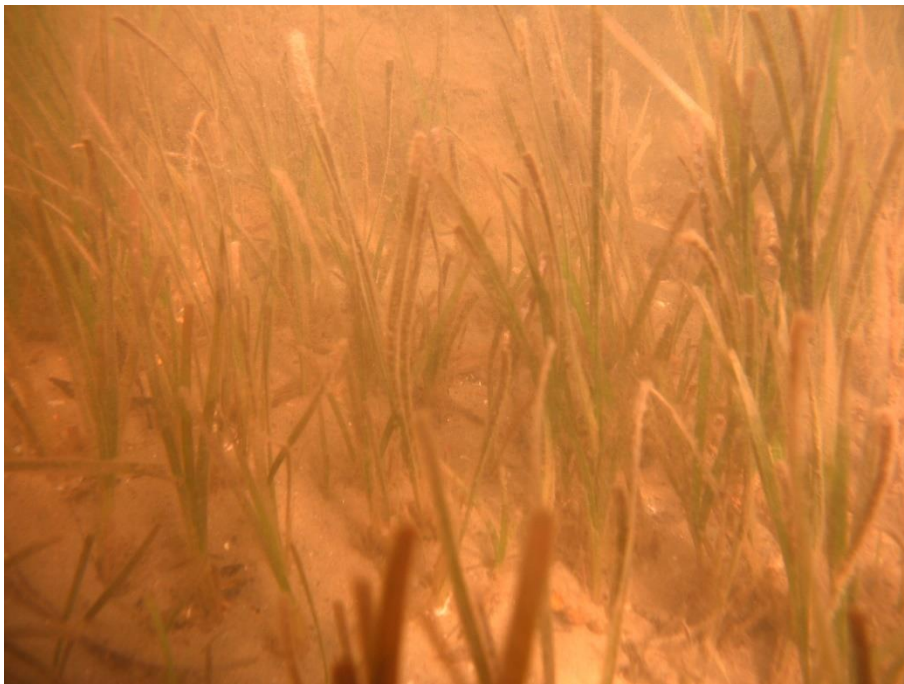
**Figure 16.** Dense *Zostera capricorni* in shallow water to the north and south.

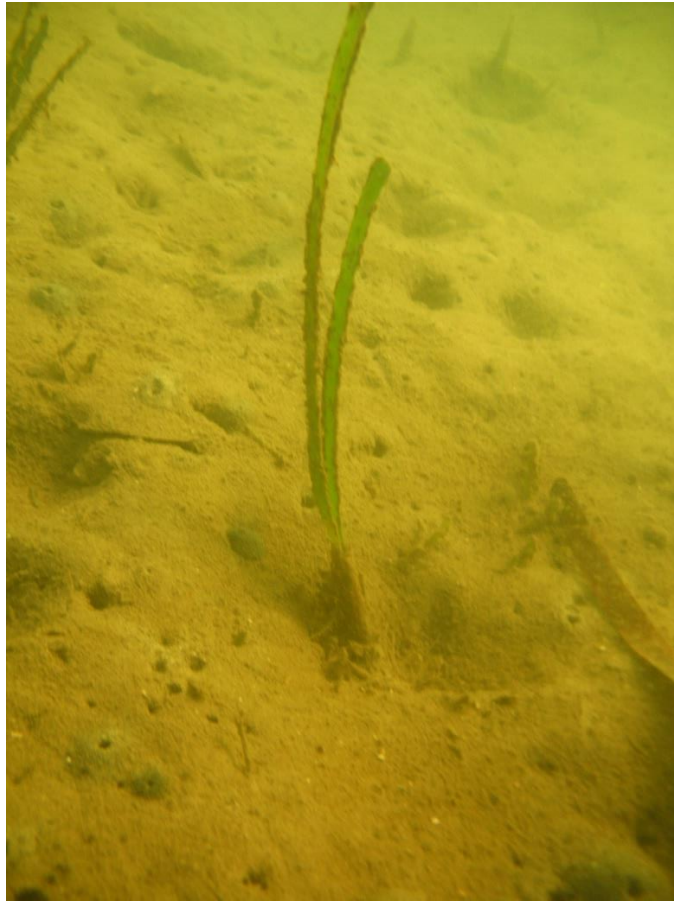
*Posidonia australis* and *Halophila* sp. were found mixed within the offshore *Zostera capricorni* bed. *Posidonia australis* was present in the form of sparse rhizomes from ~3 m depth, with leaf-length of 30 - 40 cm and a medium epiphyte load (Figs. 14 and 17). *Halophila* sp. was sparse (5 - 10%) with a leaf-length averaging ~8 cm (Fig. 17).

**Figure 17.** Isolated rhizome of *Posidonia australis*.

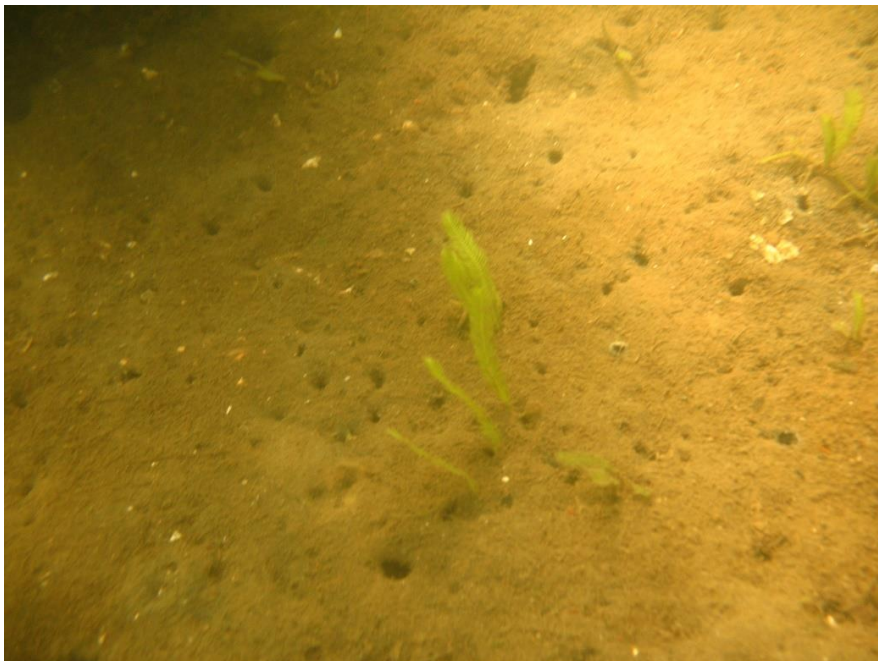
**Figure 18.** The invasive and noxious algae *Caulerpa taxifolia*.
