# Arboricultural Impact Assessment Report (Revision B)

139-141 Riverview Road  
Avalon Beach  
NSW 2107

Prepared by: Martin Peacock Tree Care

Date: 10th July 2025

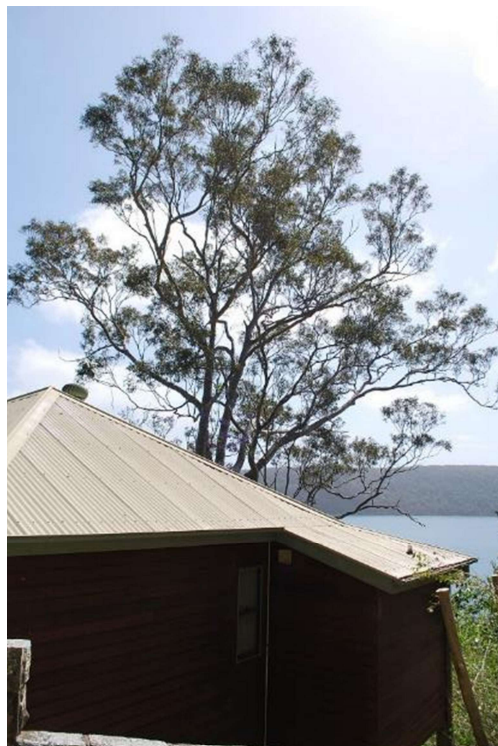
4: Tree T33

Tree T33 will be subject to a Major Encroachment within the TPZ area from the proposed swimming pool. However, the section of the pool located within the SRZ has been designed to cantilever above existing grade, and the pool terrace and wall is to be constructed above existing grade. The encroachment from excavation for the pool represents a Minor Encroachment only (8.3%).

- 8.4 The installation of fill within a tree's root zone reduces soil oxygen levels and decreases rate of carbon dioxide diffusion through the soil profile, both of which impact tree root function. Based on the above, the area below the pool terrace within the TPZ areas of Tree T33 should be left as an open void. Where this is not appropriate due to the potential accumulation of debris, the void should be filled with a large sized aggregate that maintains the permeability of the underlying subgrade. A permanent irrigation system should also be installed below the terrace to maintain soil moisture levels.

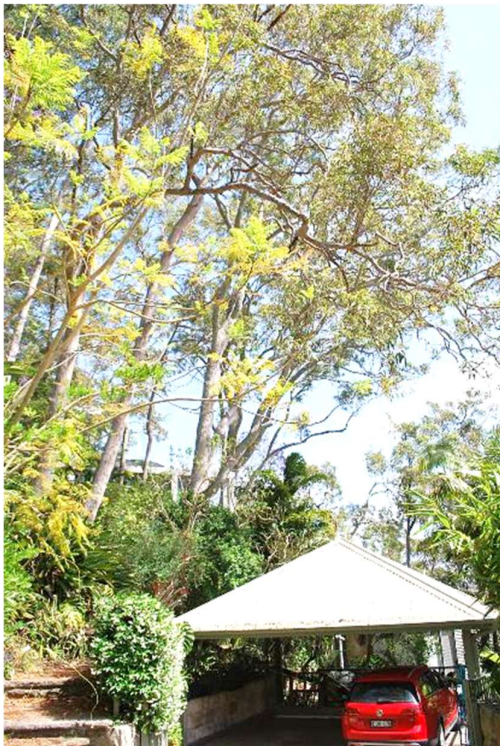
Trees P, Q and S (growing within 137 Riverview Road) will be subject to varying degrees of encroachment within their Tree Protection Zone (TPZ) areas as detailed below.

Tree P will be subject to a Major Encroachment (15%) within the TPZ area from the proposed dwelling and stairs. However, as the works are on one side of the TPZ area only the extent of the encroachment should not significantly impact the tree where irrigation and mulch are installed to support the health of the tree during the construction stage of the project.

7: Trees P-S and adjacent retaining wall

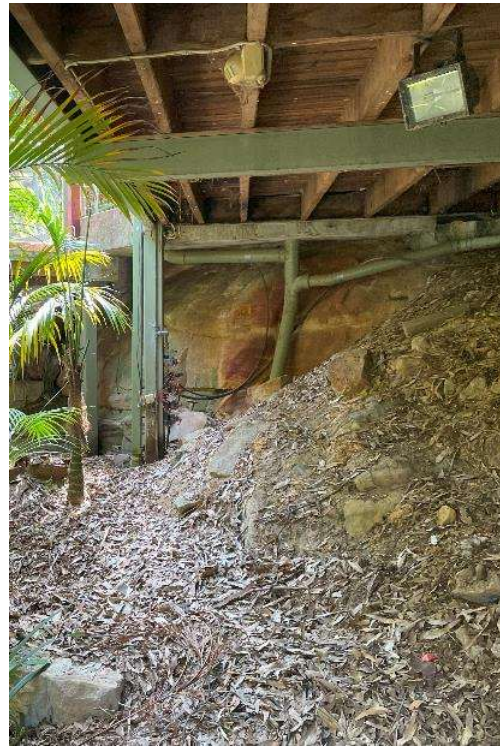
Tree Q will be subject to a Major Encroachment from the proposed dwelling and stairs. However, in accordance with AS4970 - *3.3.4 TPZ encroachment considerations (g), 'the presence of existing or past structures or obstacles affecting root growth'* has been considered when determining the impact of the proposed development. A number of existing retaining walls are located in the garden area between the site boundary and the existing carport. The footings of these walls should have influenced the tree's root spread within the site to some extent. In addition, the existing carport slab within the TPZ area of Tree Q sits above a large section of exposed rock where no root growth is present (refer: Appendix B – Photographs).

8: Showing exposed rock outcrop/carport within the TPZ area of Tree Q

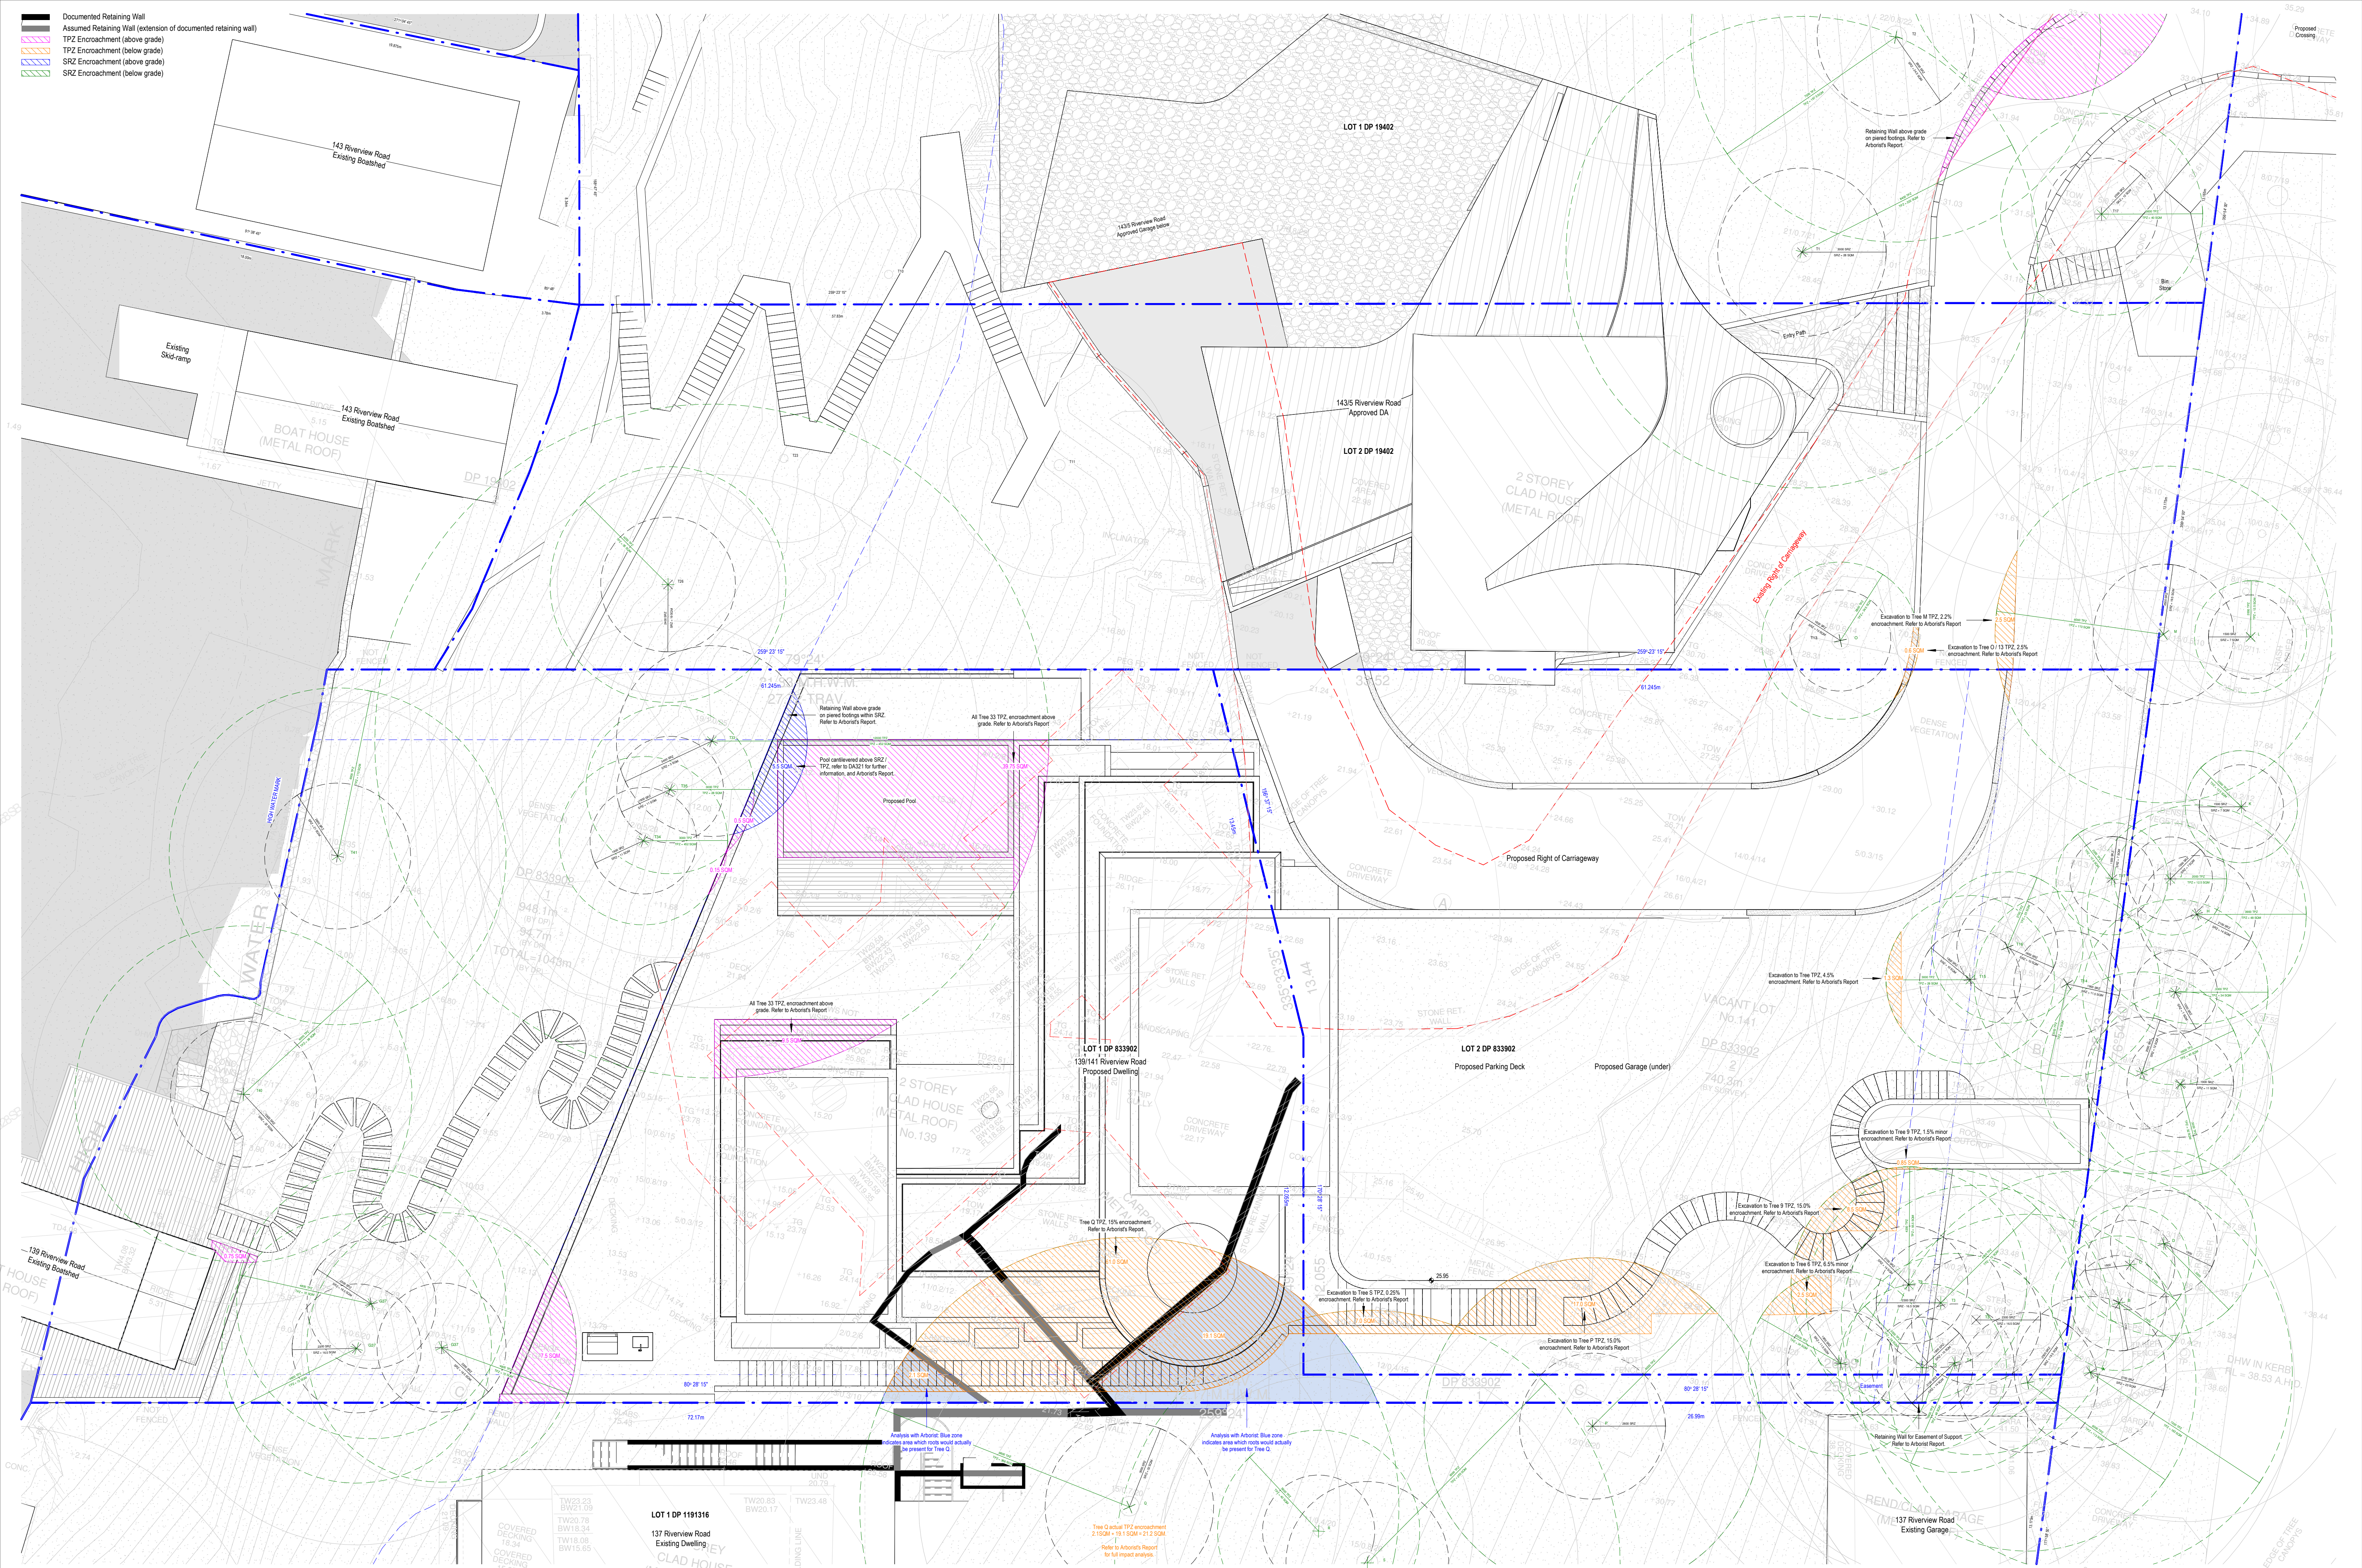
## **Appendix E - Site Plan (Tree Analysis)**

A Minor Encroachment should not significantly impact the tree, whilst a Major Encroachment requires a range of factors to be considered and in some cases further investigations, to determine the potential impact of the encroachment. Typically, tree sensitive design and construction methods will be required where development works represent a Major Encroachment. To assist in determining the extent of potential tree impacts from the development proposal the Architect has prepared a plan which highlights where TPZ encroachments occur. The encroachments are divided into two types, those that will require excavation (hatched orange), and those that will be above existing grade (hatched purple).

The supplied plans show Trees T1-T6, T9, T14-T17, T33-T35, G37, T40 and T41 will be subject to varying degrees of encroachment within their Tree Protection Zone (TPZ) areas as detailed below.
