Report Title: Geotechnical Report 168 Whale Beach Road, Whale Beach

Report Date: 10/2/21

## **GEOTECHNICAL INVESTIGATION:**

### **New House & Pool at 168 Whale Beach Road, Whale Beach**

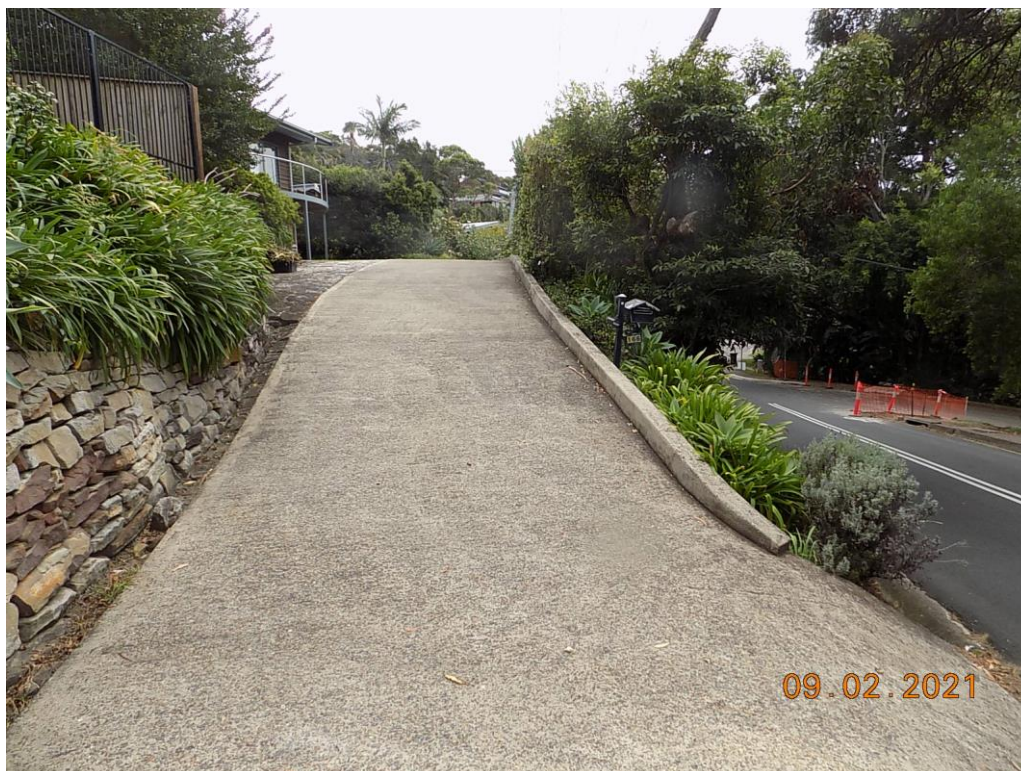
Photo 1

- 2.3** At the road frontage, a concrete Right of Carriageway (ROW) runs up the slope to a parking area on the downhill side of the vacant property (Photos 1 & 2). A steep, densely vegetated slope rises from the parking area to the crest of the slope (Photo 3). Some sandstone boulders were observed to be embedded in the slope in stable positions (Photo 4). Additionally, outcrops of sandstone bedrock were observed

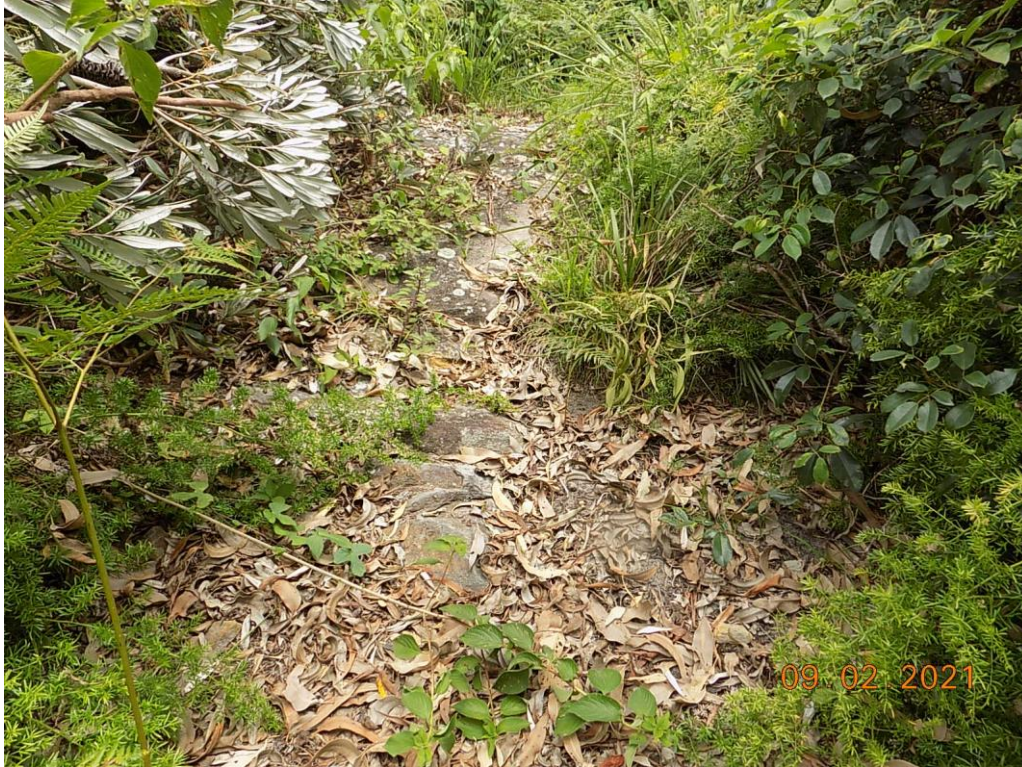
Photo 5

through the thick vegetation near and on the crest of the slope (Photos 5 & 6). These outcrops continued over the ridge where a similar steep and densely vegetated slope falls to the W common boundary. We were unable to assess this portion of the slope during the site visit due to the very thick vegetation.

Medium Strength Sandstone outcrops on the crest of the ridge and slightly down each flank (Photos 5 & 6). The outcropping sandstone is interpreted to be a band of sandstone through the otherwise shale-dominated profile. Where sandstone was not exposed at the crest of the ridge, it was encountered at a maximum depth of ~1.1m below the current surface.

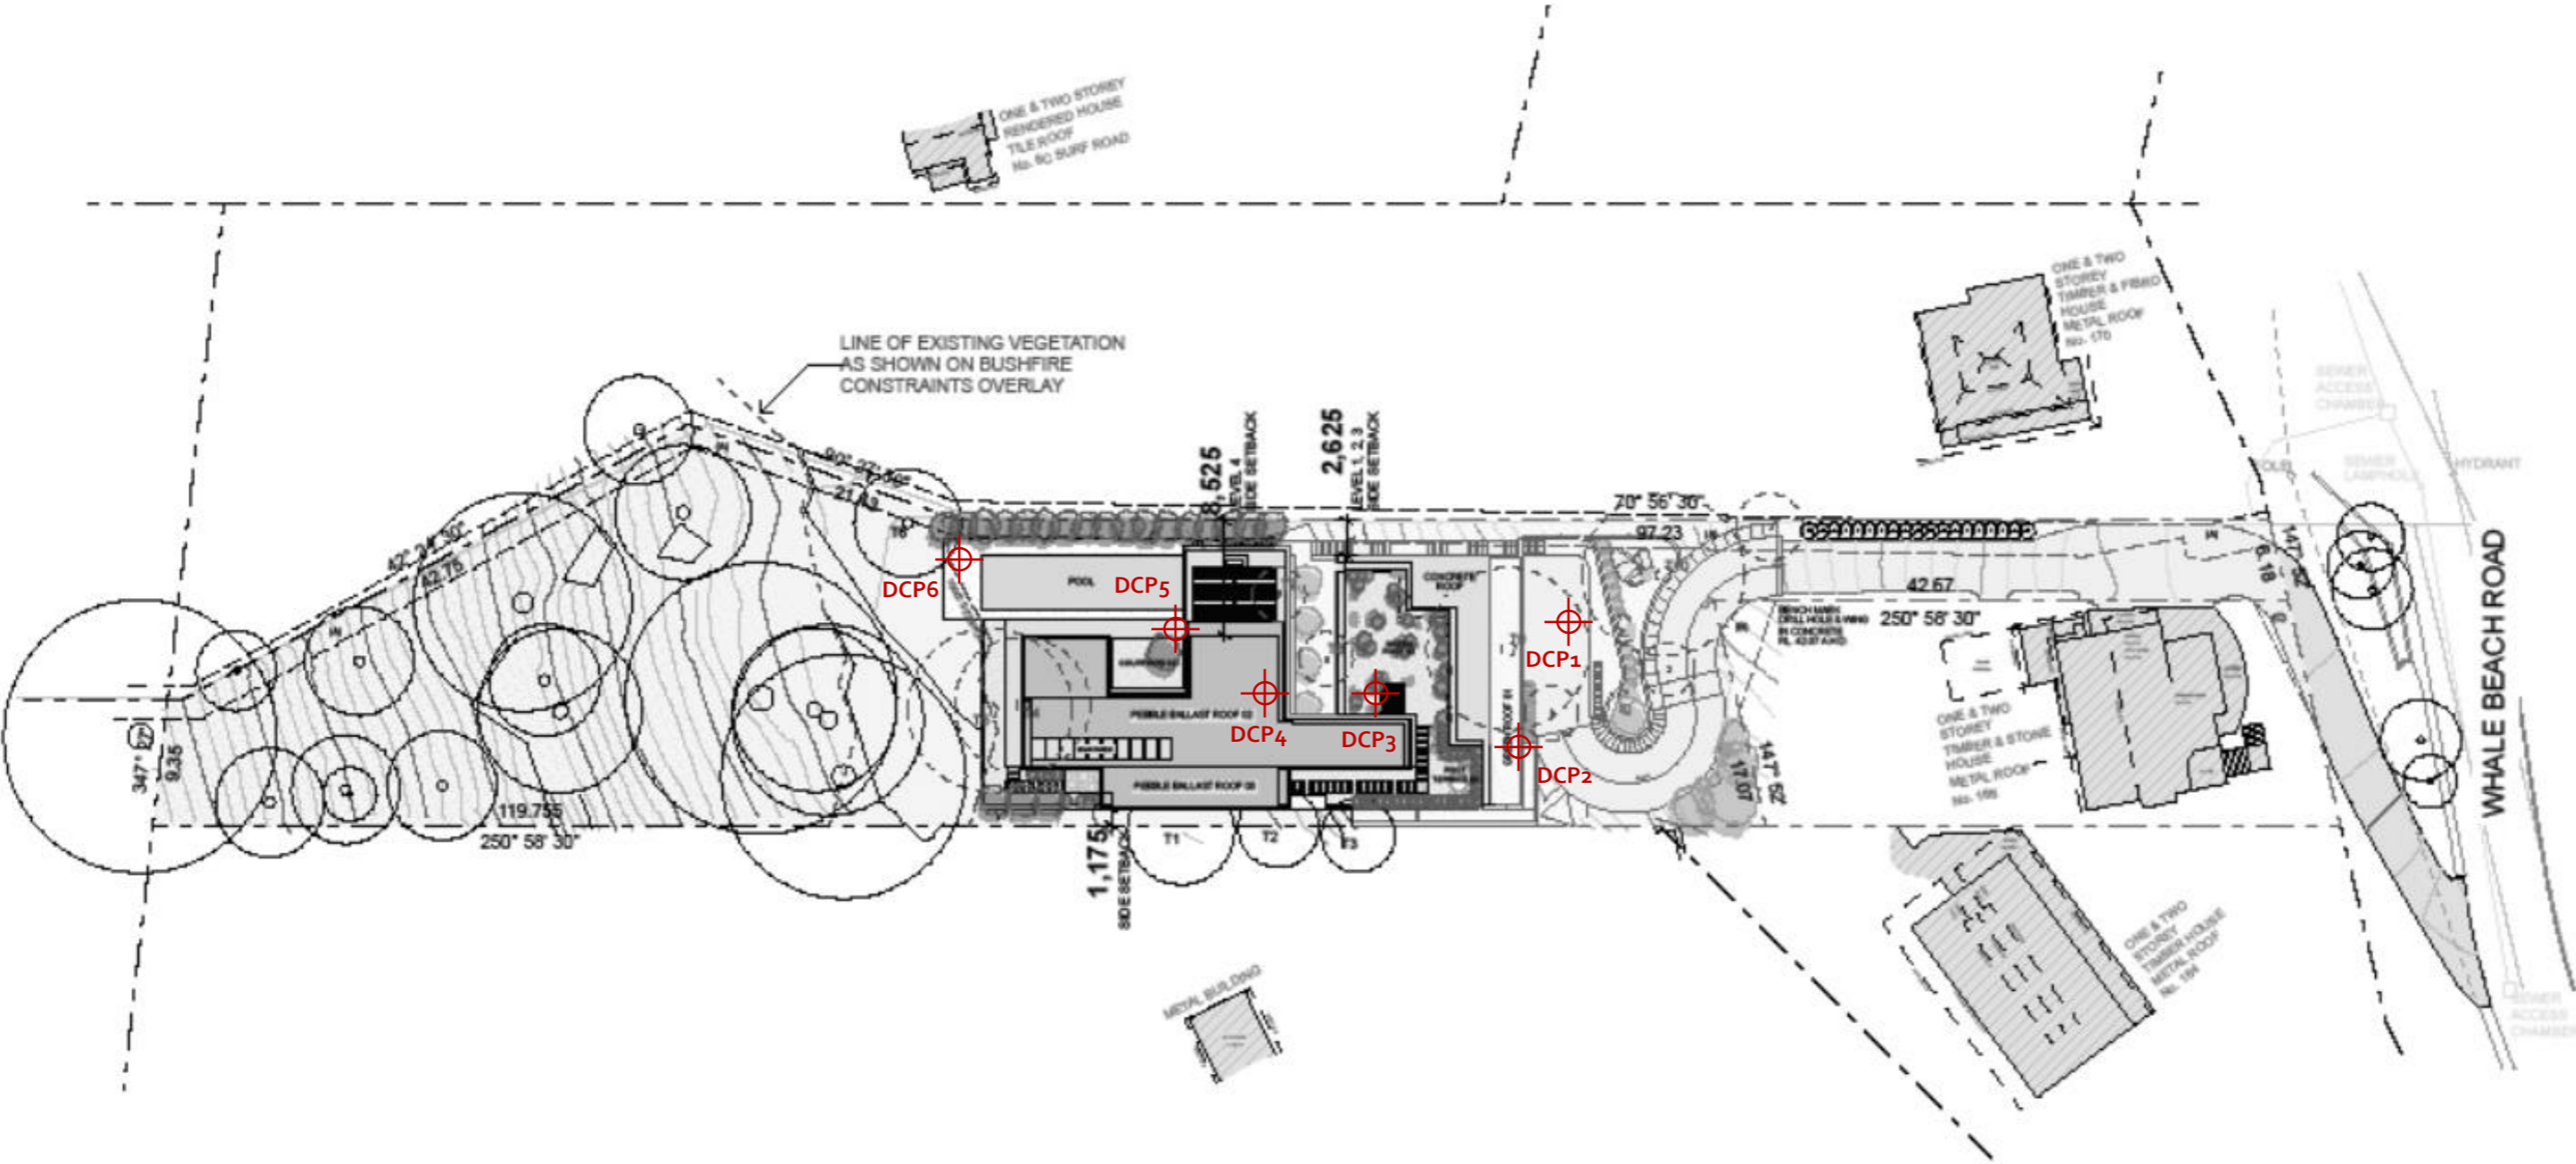
SITE PLAN – showing test locations

Six DCP (Dynamic Cone Penetrometer) tests were put down to determine the relative density of the overlying soil and the depth to bedrock. The locations of the tests are shown on the site plan attached. It should be noted that a level of caution should be applied when interpreting DCP test results. The test will not pass through hard buried objects so in some instances it can be difficult to determine whether refusal has occurred on an obstruction in the profile or on the natural rock surface. This is not expected to be an issue for the testing on this site. However, excavation and foundation budgets should always allow for the possibility that the interpreted ground conditions in this report vary from those encountered during excavations. See the appended "Important information about your report" for a more comprehensive explanation. The results are as follows:

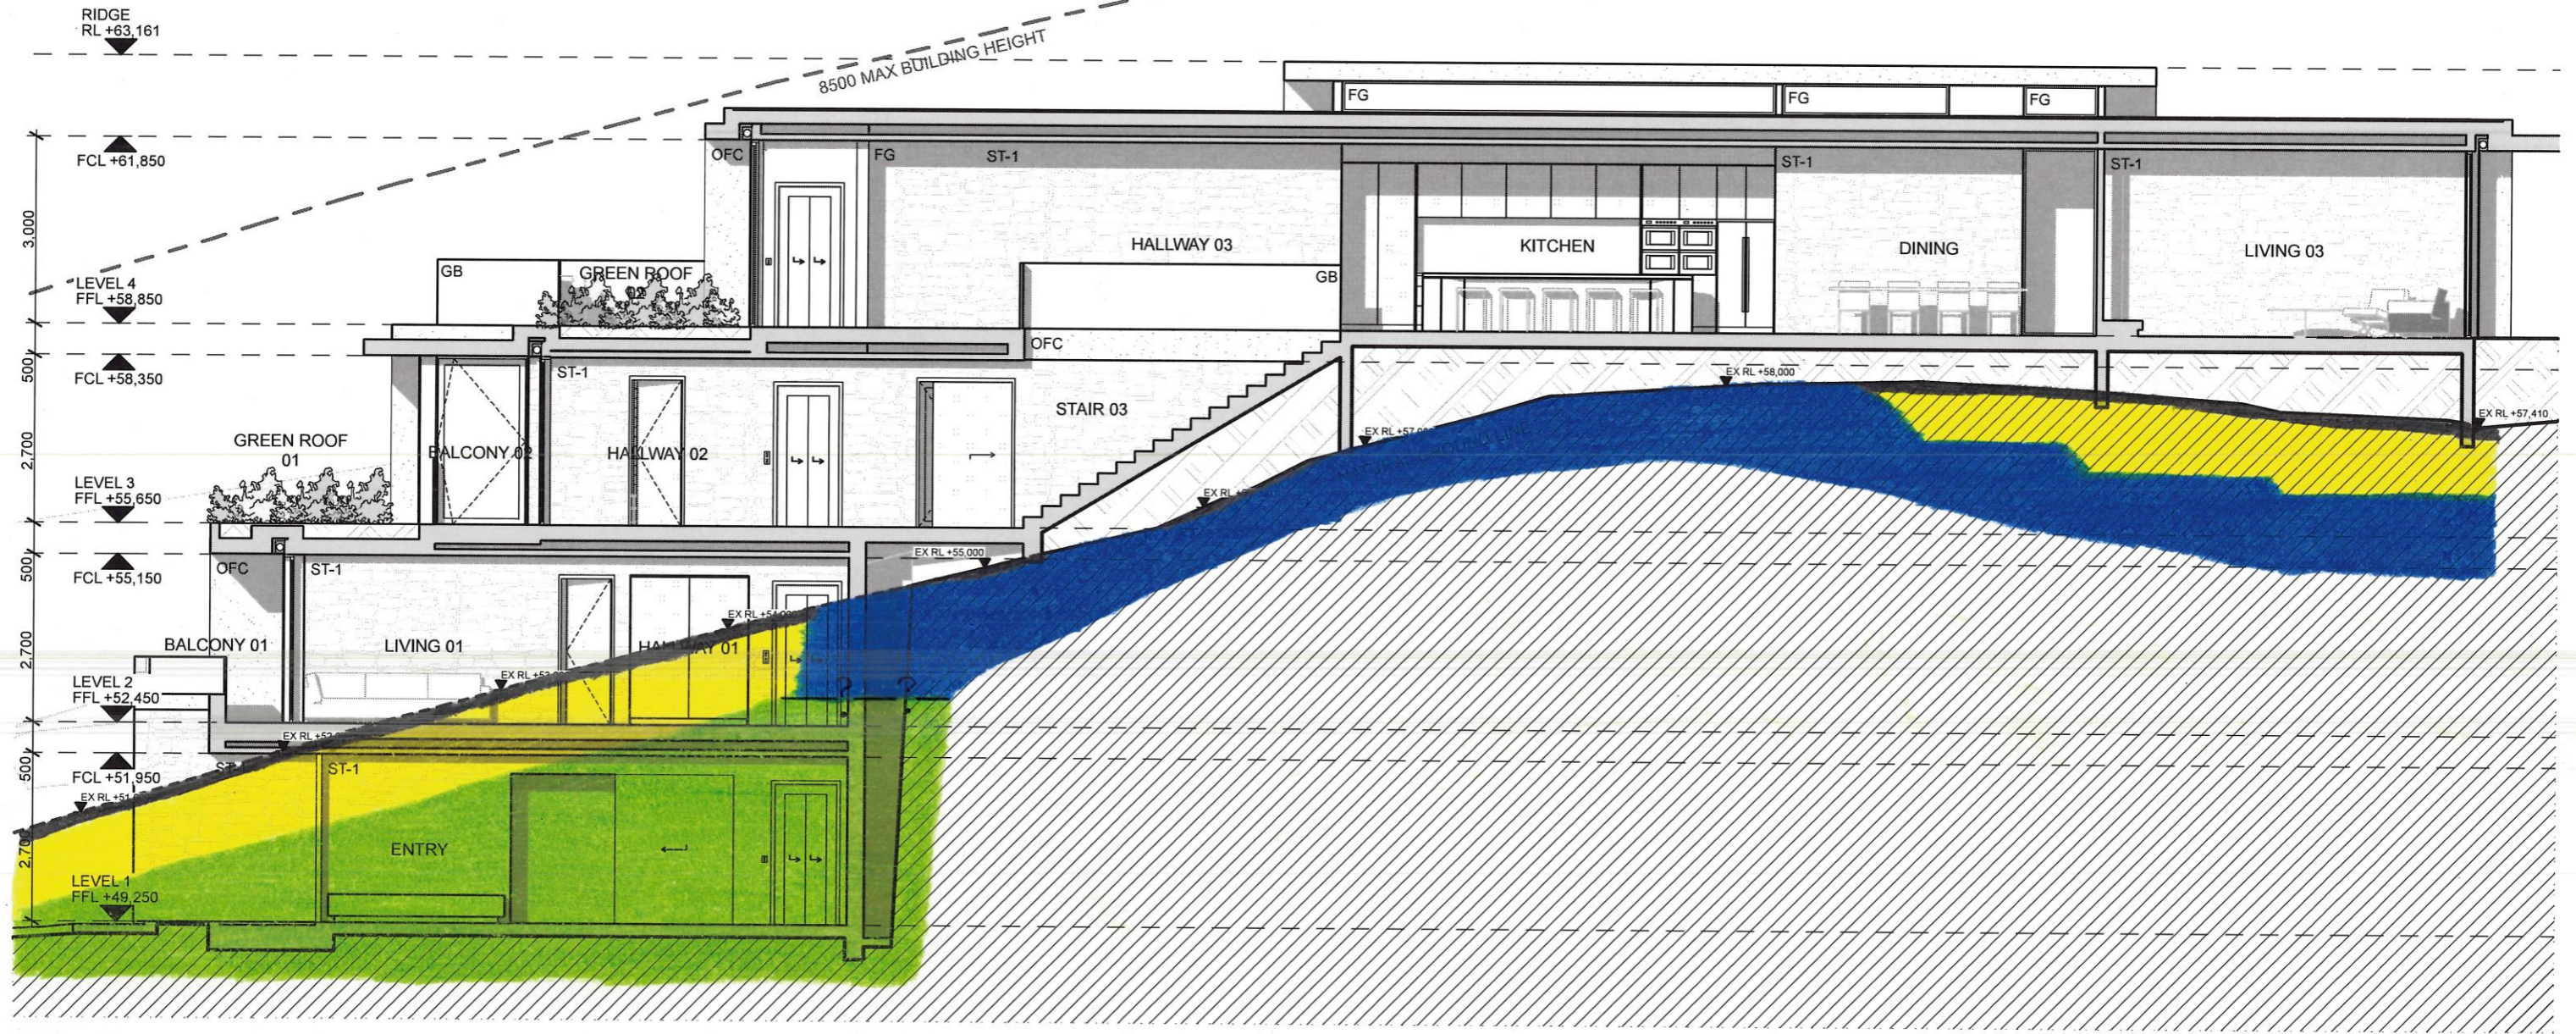
## TYPE SECTION – Diagrammatic Interpretation of expected Ground Materials

stiff clays. In the test locations, weathered rock was encountered at an average depth of ~1.2m below the current surface. The weathered rock was interpreted to be Extremely Low Strength Shale that generally becomes progressively stronger with depth. See Type Section attached for a diagrammatical representation of the expected ground materials.

Topsoil

Clay – Firm to Stiff

Sandstone Band – Medium Strength. Extent of band is not known.

Narrabeen Group Rocks – Extremely Low Strength Shale - after being cut up by excavation equipment can resemble a stiff to hard clay.
