Our Ref: 304600719/001/L001:PDT  
Contact: Doug Treloar

2 December 2022

**PROPOSED REDEVELOPMENT AT 518 BARRENJOEY ROAD, AVALON –  
COASTAL PROCESSES ASSESSMENT**

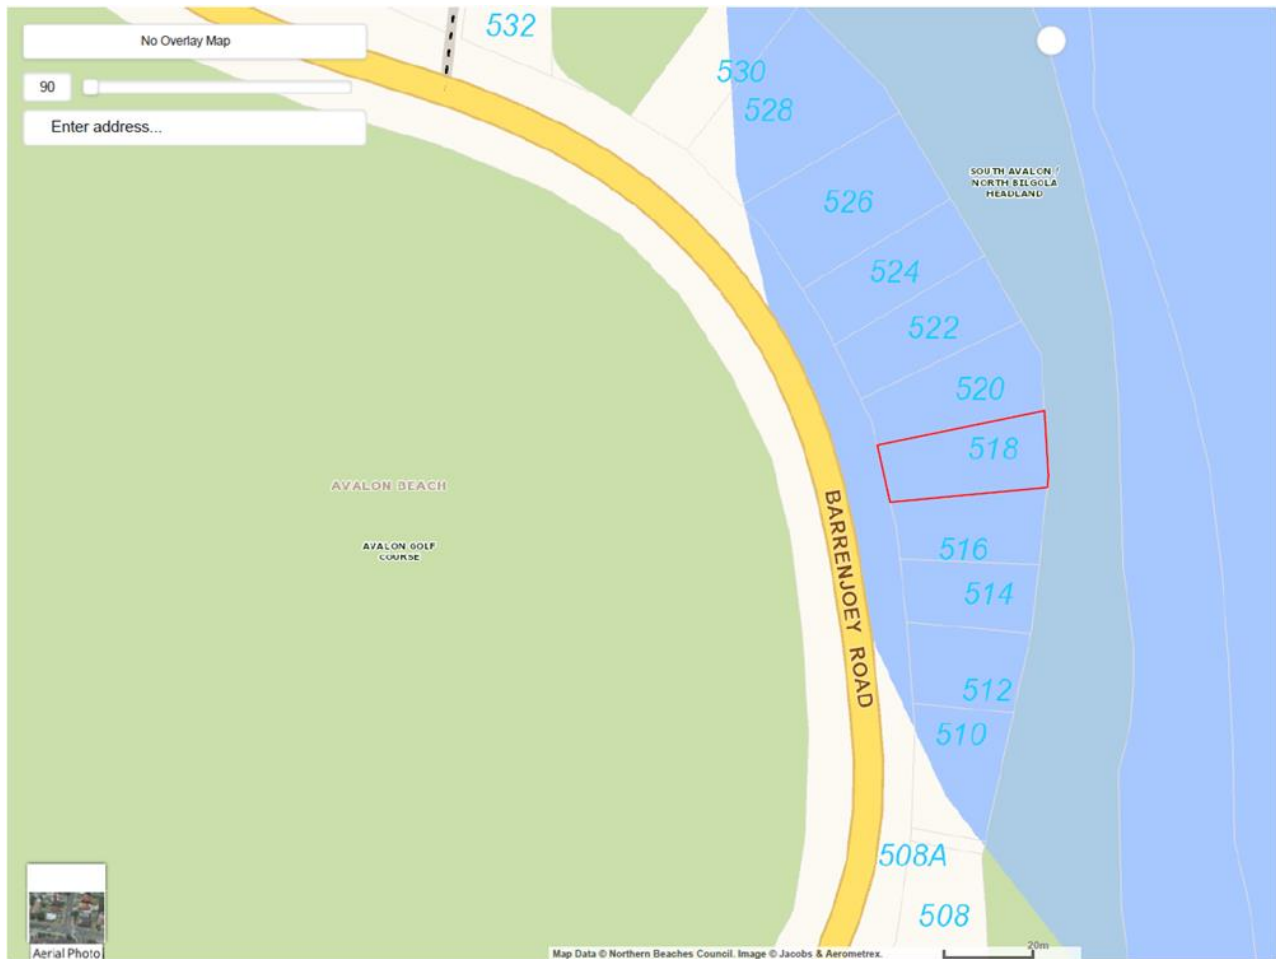
Figure 2 Northern Beaches Coastal Risk Planning Map

**Figure 2** was obtained from NBC's online hazard mapping web site. However, no specific hazards are noted on that image for this site. This figure shows that the site is not affected by coastal processes, but geotechnical matters may need to be addressed. The seaward shoreline is formed of a rough rocky cliff that has a vegetated top surface.

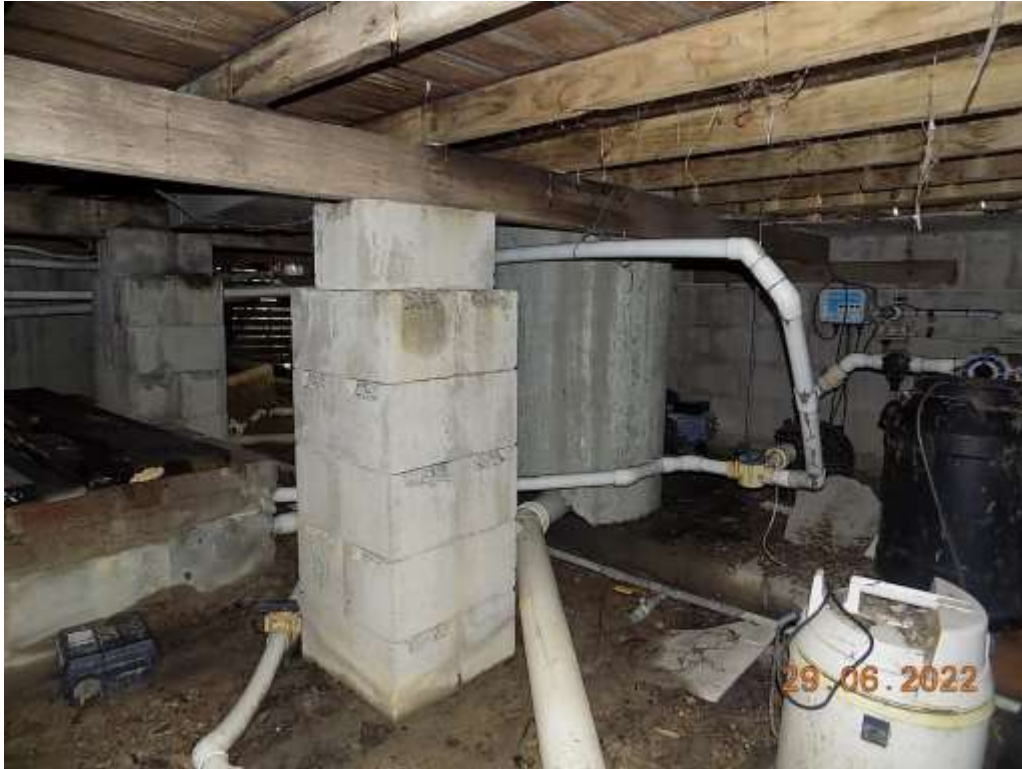
Photo 3

block walls and concrete block piers (Photo 3). The concrete block walls show no significant signs of movement and the visible concrete piers stand vertical. A level lawn area extends from the E side of the property to the E boundary (Photo 4). A ~1.5m high timber crib wall that encompasses the N common boundary and the E boundary supports the fill for this lawn area (Photo 5). The crib wall is almost entirely obscured by dense vegetation and could not be adequately assessed. A gentle to moderately sloping lawn extends shortly beyond the E boundary before dropping ~37m at vertical angles to a rock platform below (Photo 6). The cliff line is obscured by thick vegetation. From below it can be seen to be made up of thinly bedded shale and thicker bedded sandstone (Photo 7). The base of the cliff is armoured from the undercutting action of the waves by the rock platform and a build-up of slope debris (Photo 8). The cliff face to the north of the property has been undercut to ~2.0m across its base but adjacent to the subject property the cliff face has no significant defects (Photo 9). In the unlikely event of a failure the undercut will not impact the subject property. The weathering process of the cliff face occurs when the harder beds are undercut by the softer beds. Because the beds are relatively thin and jointed the resulting failures are small in scale. This weathering process is extremely slow, measured from the geological record to be in the order of 7 to 12 mm/year. The proposed works will be at least 8m from the uphill edge of the cliff. The estimated wave run-up height will reach 6.9AHD; ignoring any cliff face roughness. This is well below the site of the proposed works and only very minor spray would affect the site, as per the coastal report referenced above.

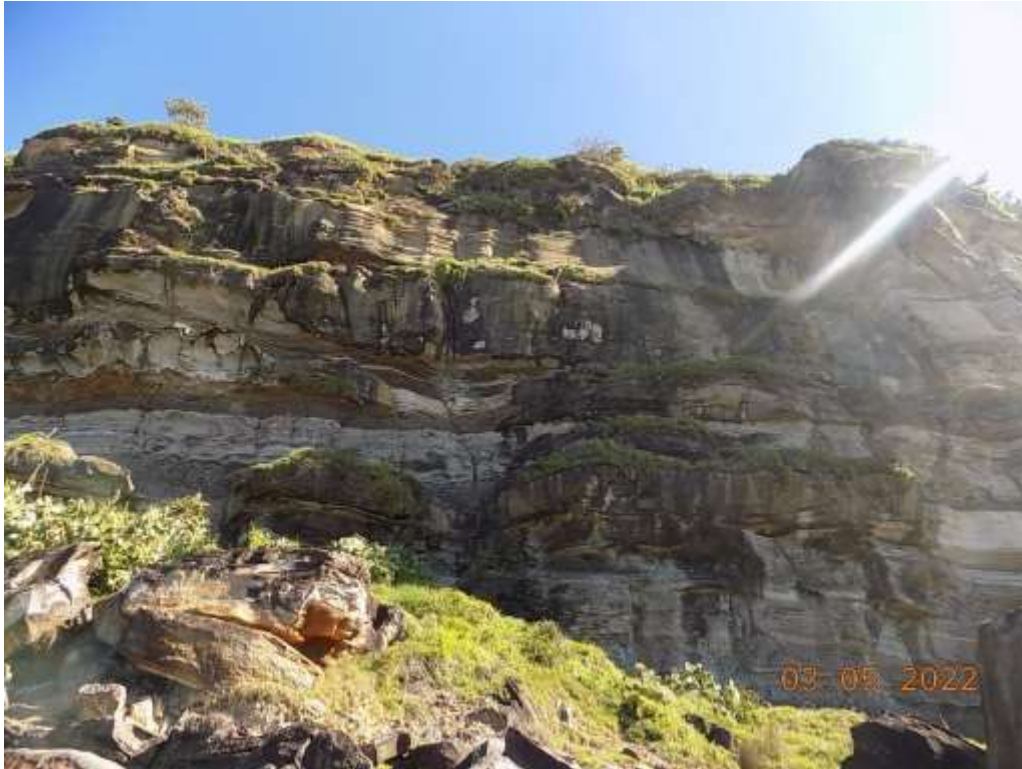
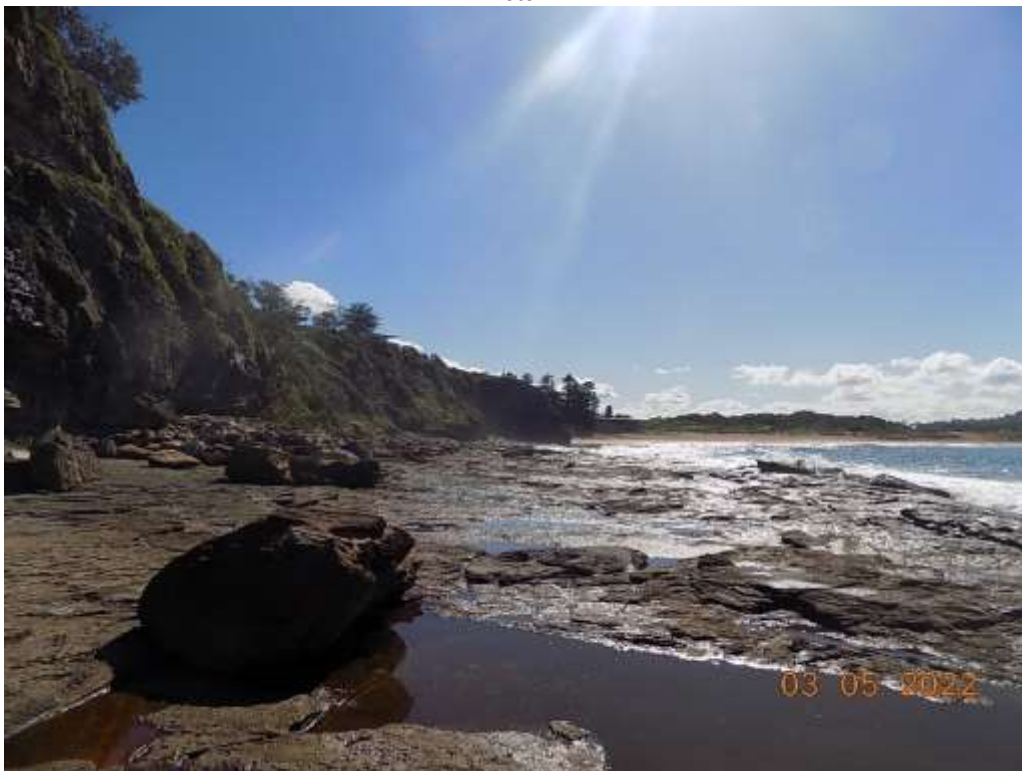
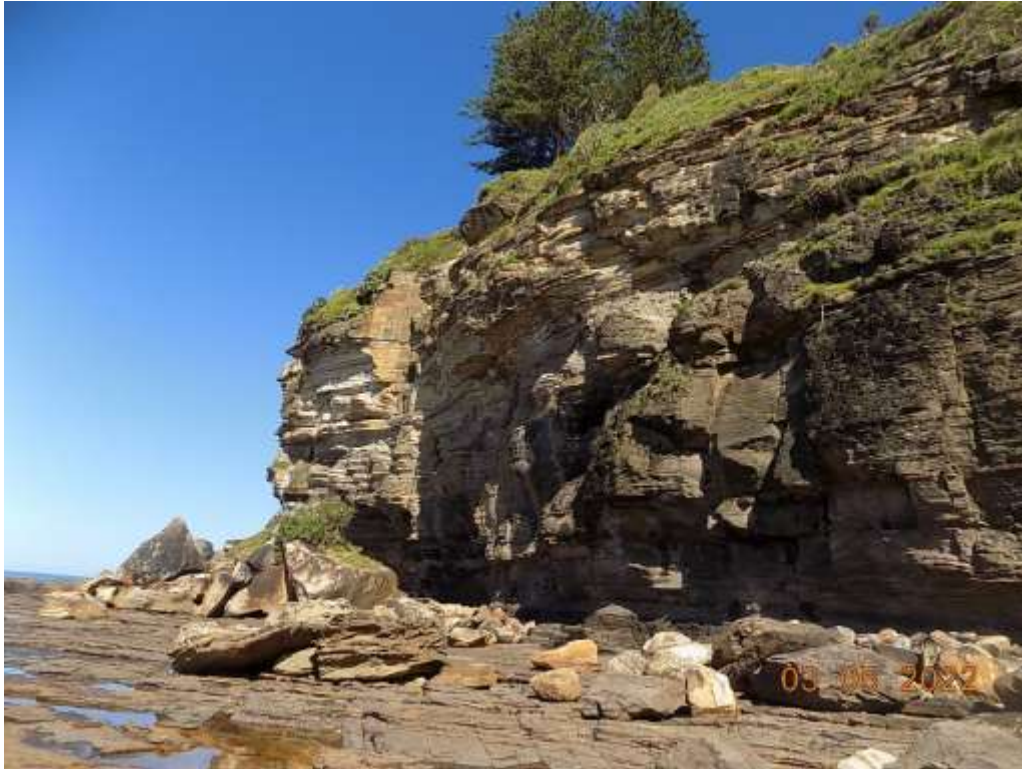
The White Geotechnical report provides images at the cliff base, please refer to photographs 7, 8 and 9, of their report in **Annexure B**. In terms of potential cliff stability failure, White Geotechnical have advised that the cliff face below the property is absent of any major undercutting or joints. Hence, apart from any minor failures, they consider the cliff face at this site to be stable.

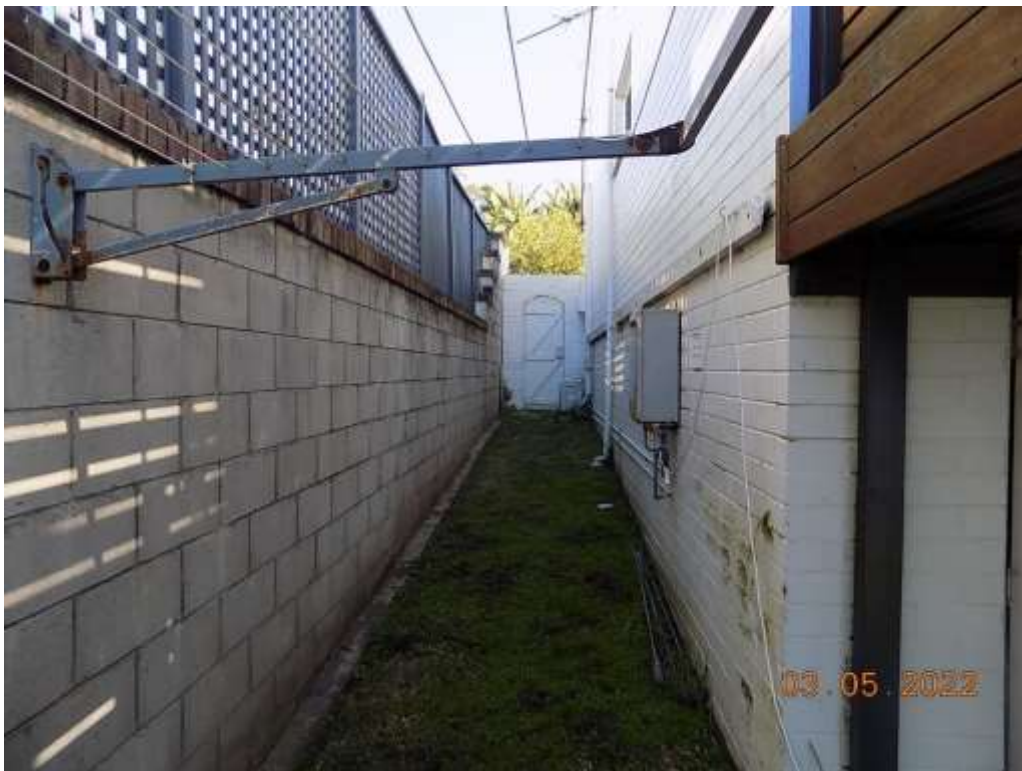
Photo 10

No geotechnical hazards were observed above or beside the property. The gently graded slope that rises and falls across the property and continues below is a potential hazard (**Hazard One**). The large sea cliff that drops vertically below the lower boundary of the property is a potential hazard (**Hazard Two**). The additional surcharge loads from the proposed extension acting on the existing N boundary wall is a potential hazard (Photo 10) (**Hazard Three**).

| HAZARDS | Hazard One | Hazard Two | Hazard Three |
|---|---|---|---|
| TYPE | The gentle slope that rises and falls across the property and continues below failing and impacting on the proposed works. | A large failure occurring in the sea cliff that impacts proposed works. | The additional surcharge loads from the extension transferring onto the existing concrete block retaining wall causing damage and instability (Photo 10). |

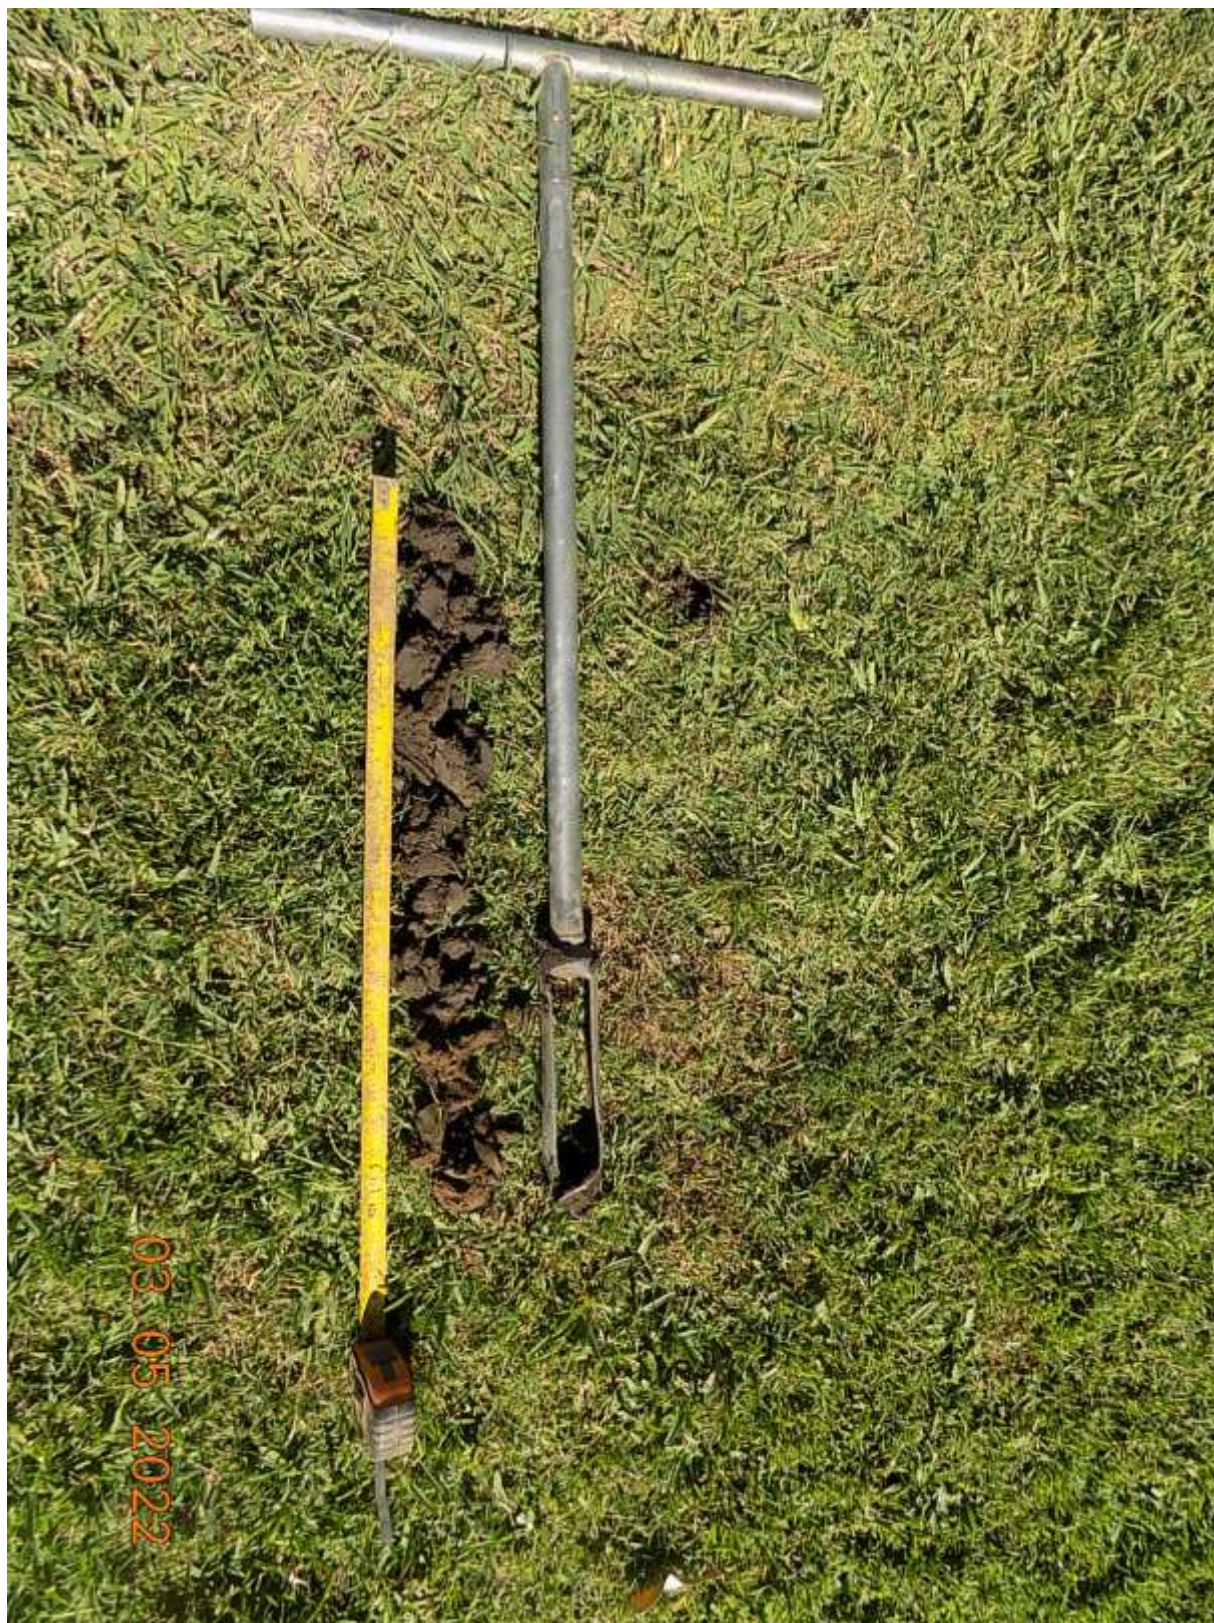
Photo 11 (Top to Bottom)

##### AUGER HOLE 1 (~RL39.2) – AH1 (Photo 11)

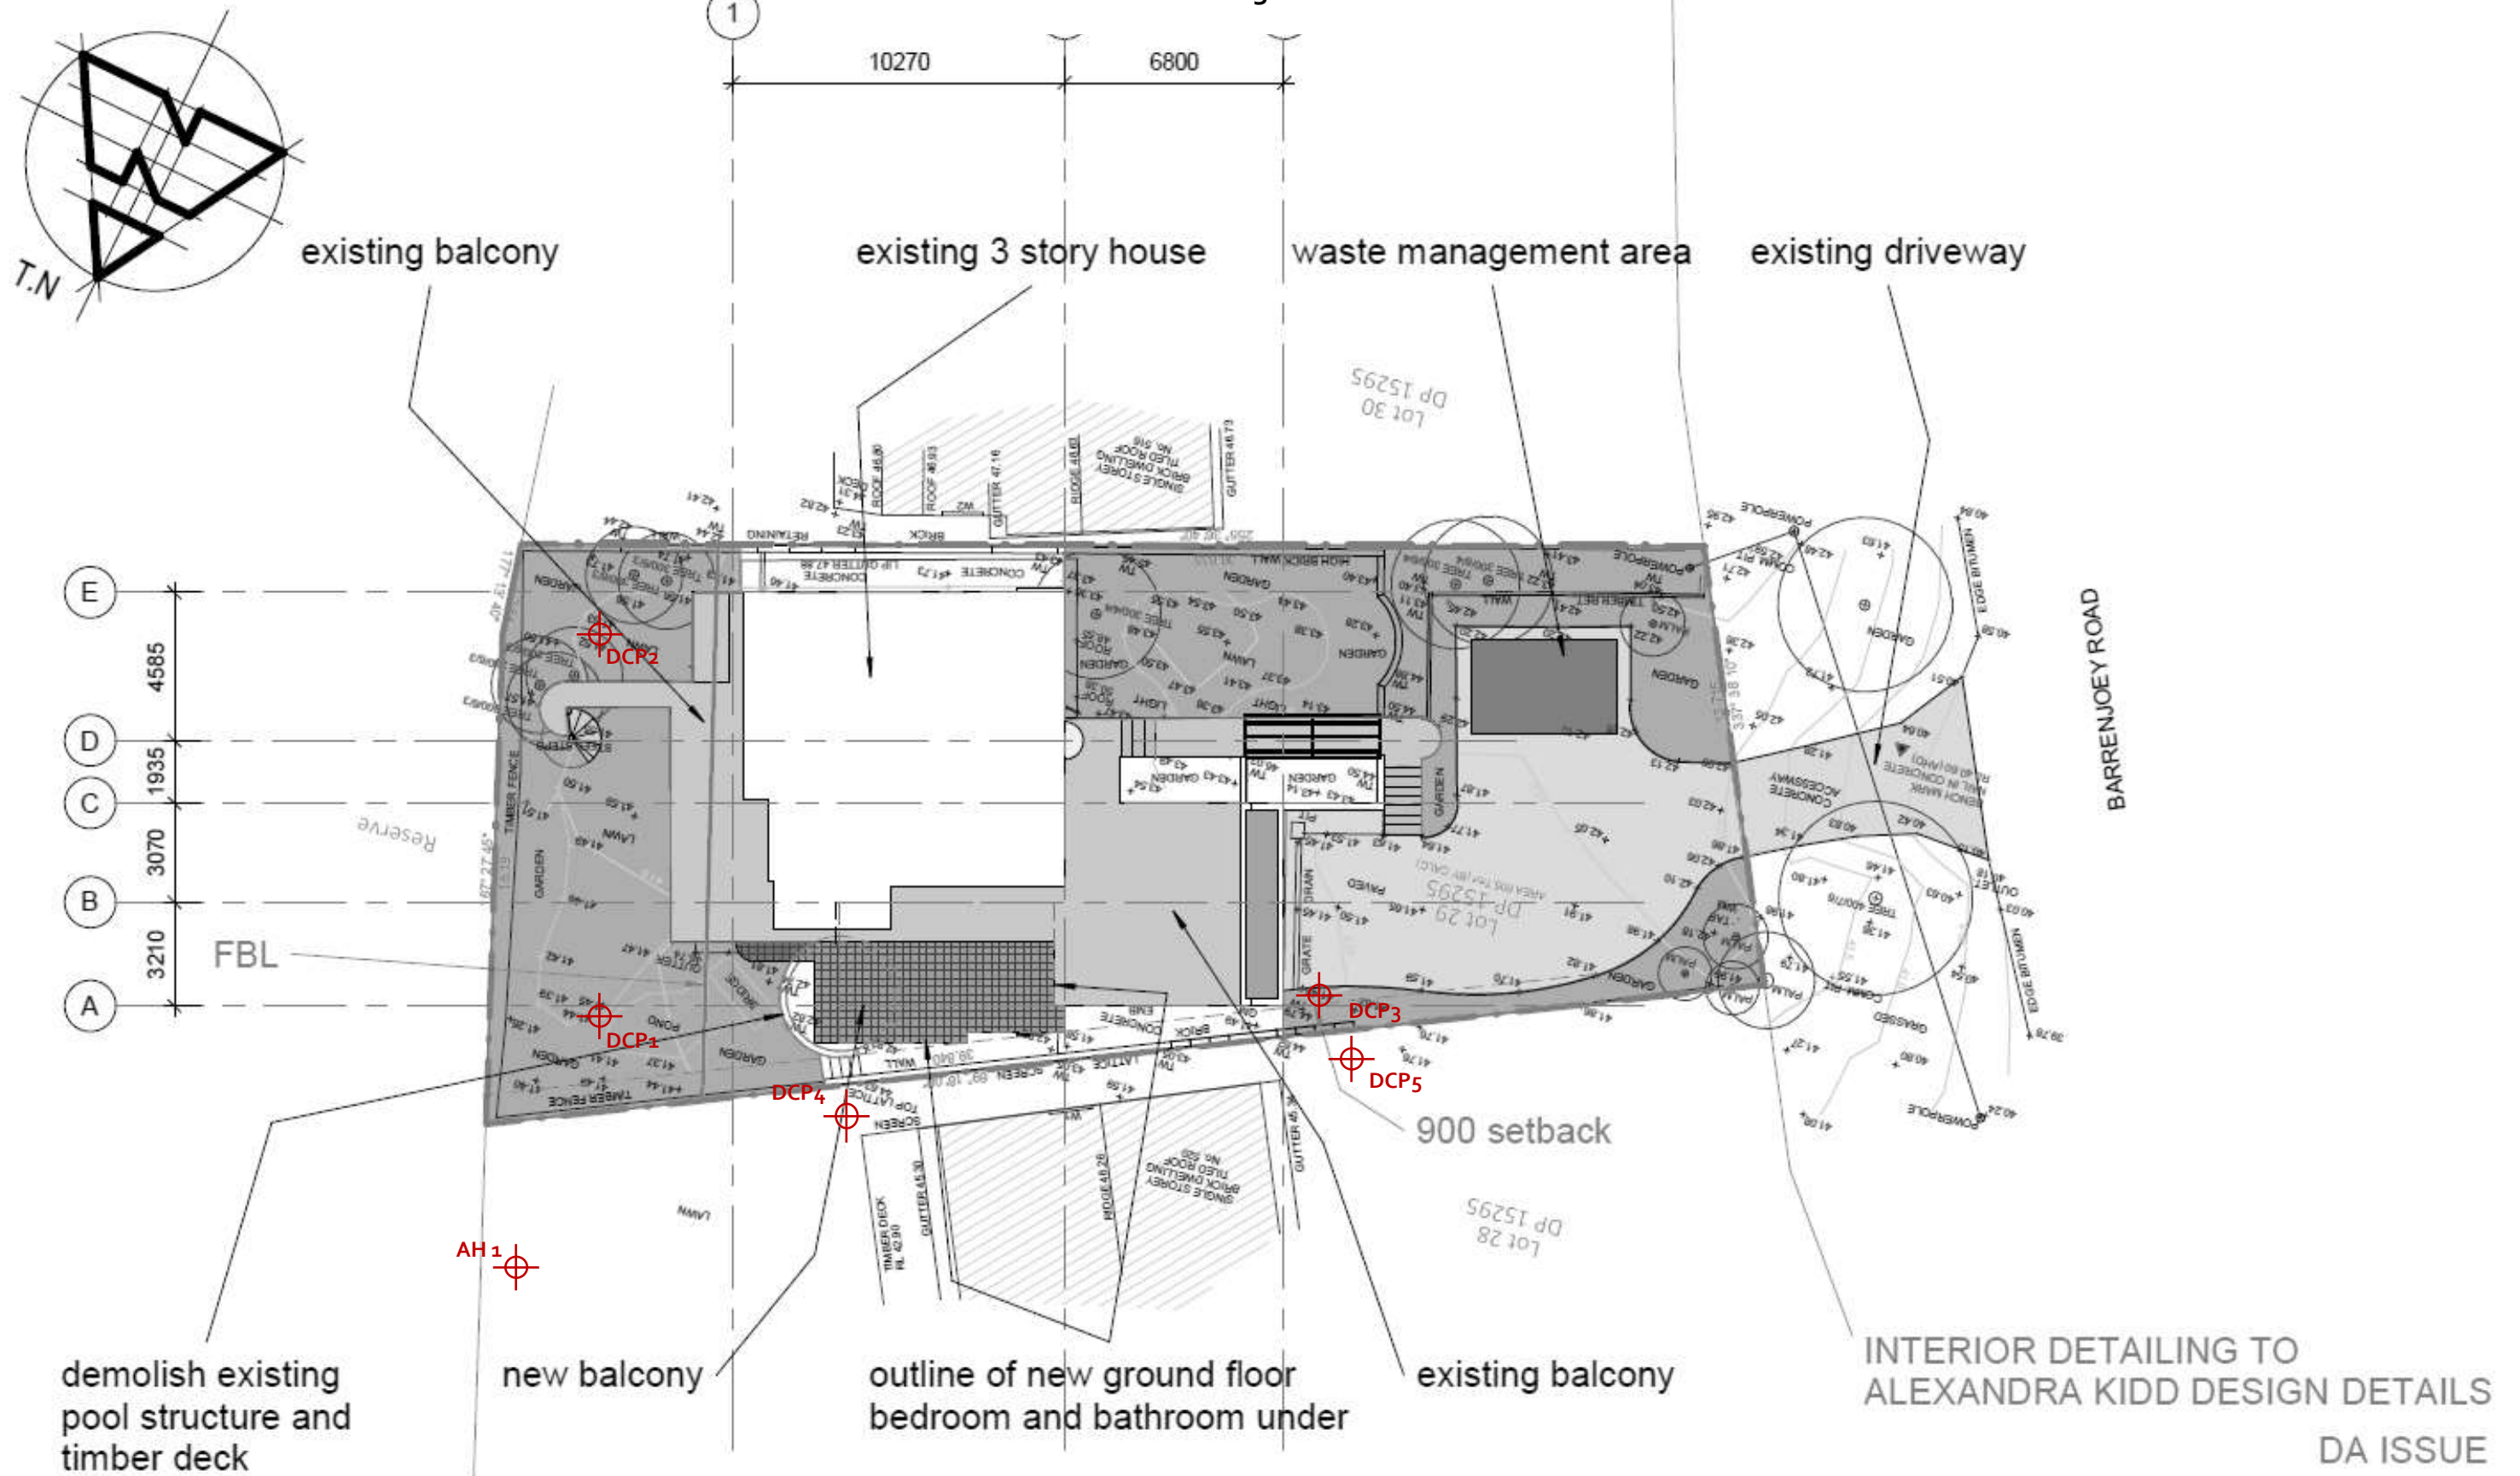
# SITE PLAN – showing test locations

One hand Auger Hole (AH) was put down on the neighbouring property to identify soil materials. Five Dynamic Cone Penetrometer (DCP) tests were put down to determine the relative density of the overlying soil and the depth to weathered rock. The locations of the tests are shown on the site plan attached. It should be noted that a level of caution should be applied when interpreting DCP test results. The test will not pass through hard buried objects so in some instances it can be difficult to determine whether refusal has occurred on an obstruction in the profile or on the natural rock surface. This is not expected to be an issue for the testing on this site. However, excavation and foundation budgets should always allow for the possibility that the interpreted ground conditions in this report vary from those encountered during excavations. See the appended "Important information about your report" for a more comprehensive explanation. The results are as follows:

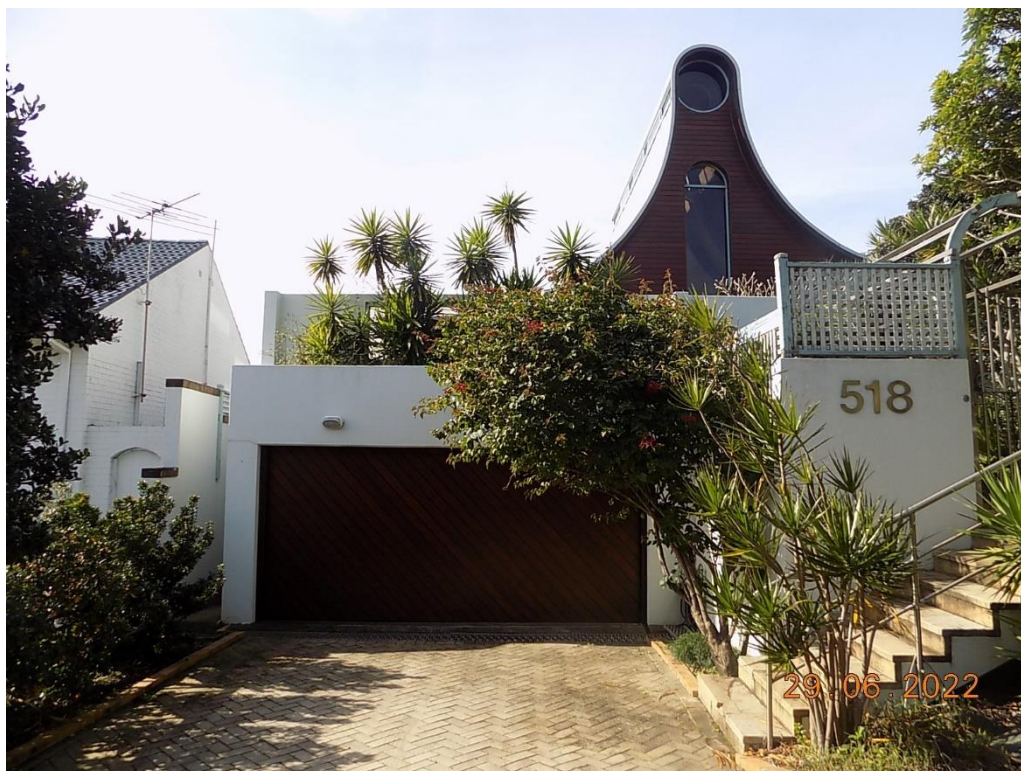
Photo 1

- 2.3** At the road frontage, a concrete driveway runs past a parking area to a garage attached to the W side of the house (Photo 1). A stable ~1.3m high timber crib wall supports a cut for the parking area and a fill for the level lawn area (Photo 2). The part three-storey steel framed and rendered masonry house is supported on concrete block walls and concrete block piers (Photo 3). The concrete block walls show no significant signs of movement and the visible concrete piers stand vertical. A level lawn area extends from the E side of the property to the E boundary (Photo 4). A

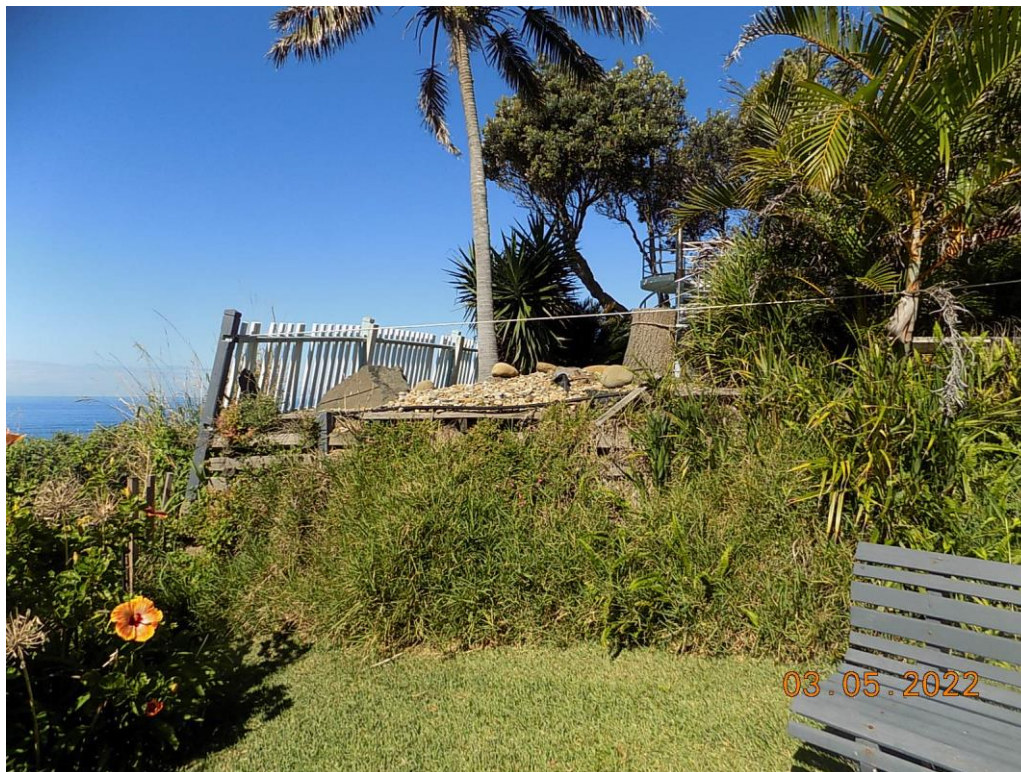
Photo 5

~1.5m high timber crib wall that encompasses the N common boundary and the E boundary supports the fill for this lawn area (Photo 5). The crib wall is almost entirely obscured by dense vegetation and could not be adequately assessed. A gentle to moderately sloping lawn extends shortly beyond the E boundary before dropping ~37m at vertical angles to a rock platform below (Photo 6). The cliff line is obscured by thick vegetation. From below it can be seen to be made up of thinly bedded shale and thicker bedded sandstone (Photo 7). The base of the cliff is armoured from the undercutting action of the waves by the rock platform and a build-up of slope debris (Photo 8). The cliff face to the north of the property has been undercut to ~2.0m across its base but adjacent to the subject property the cliff face has no significant defects (Photo 9). In the unlikely event of a failure the undercut will not impact the subject property. The weathering process of the cliff face occurs when the harder beds are undercut by the softer beds. Because the beds are relatively thin and jointed the resulting failures are small in scale. This weathering process is extremely slow, measured from the geological record to be in the order of 7 to 12 mm/year. The proposed works will be at least 8m from the uphill edge of the cliff.

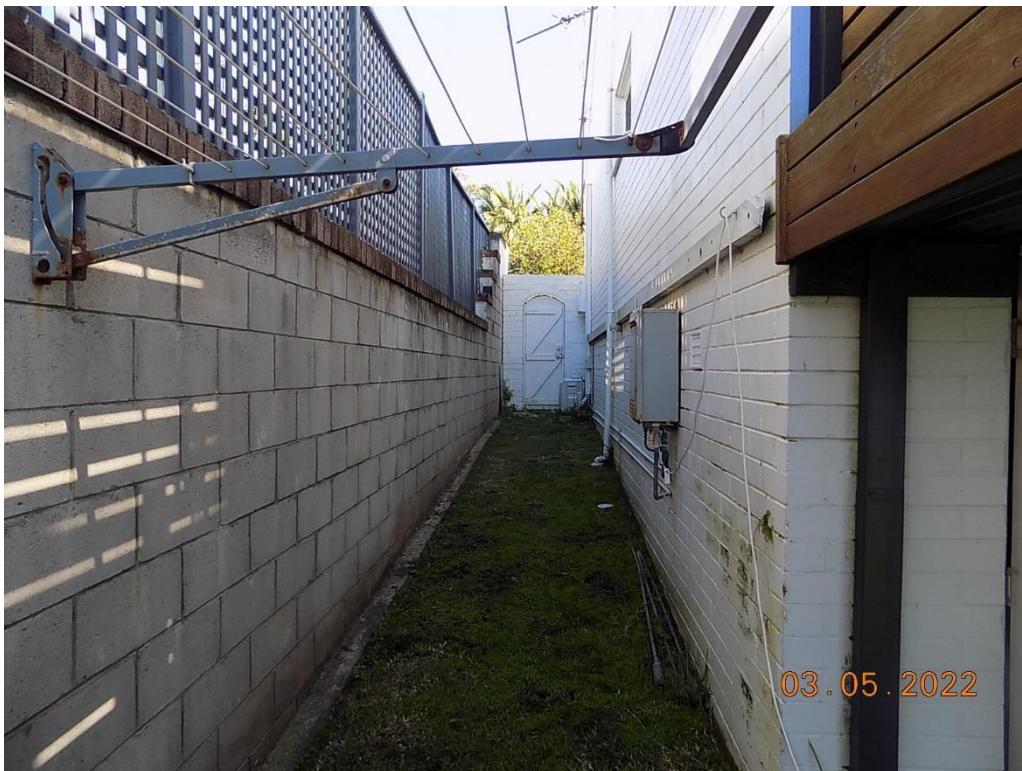
Photo 10

proposed extension acting on the existing N boundary wall is a potential hazard (Photo 10) (Hazard Three).

| HAZARDS | Hazard One | Hazard Two | Hazard Three |
|---|---|---|---|
| TYPE | The gentle slope that rises and falls across the property and continues below failing and impacting on the proposed works. | A large failure occurring in the sea cliff that impacts proposed pool and house. | The additional surcharge loads from the extension transferring onto the existing concrete block retaining wall causing damage and instability (Photo 10). |

To avoid transferring any surcharge loads from the proposed extension onto the existing concrete block retaining wall that runs along the N common boundary, all piers will need to be taken to below the zone of influence of the concrete block retaining wall (Photo 10).

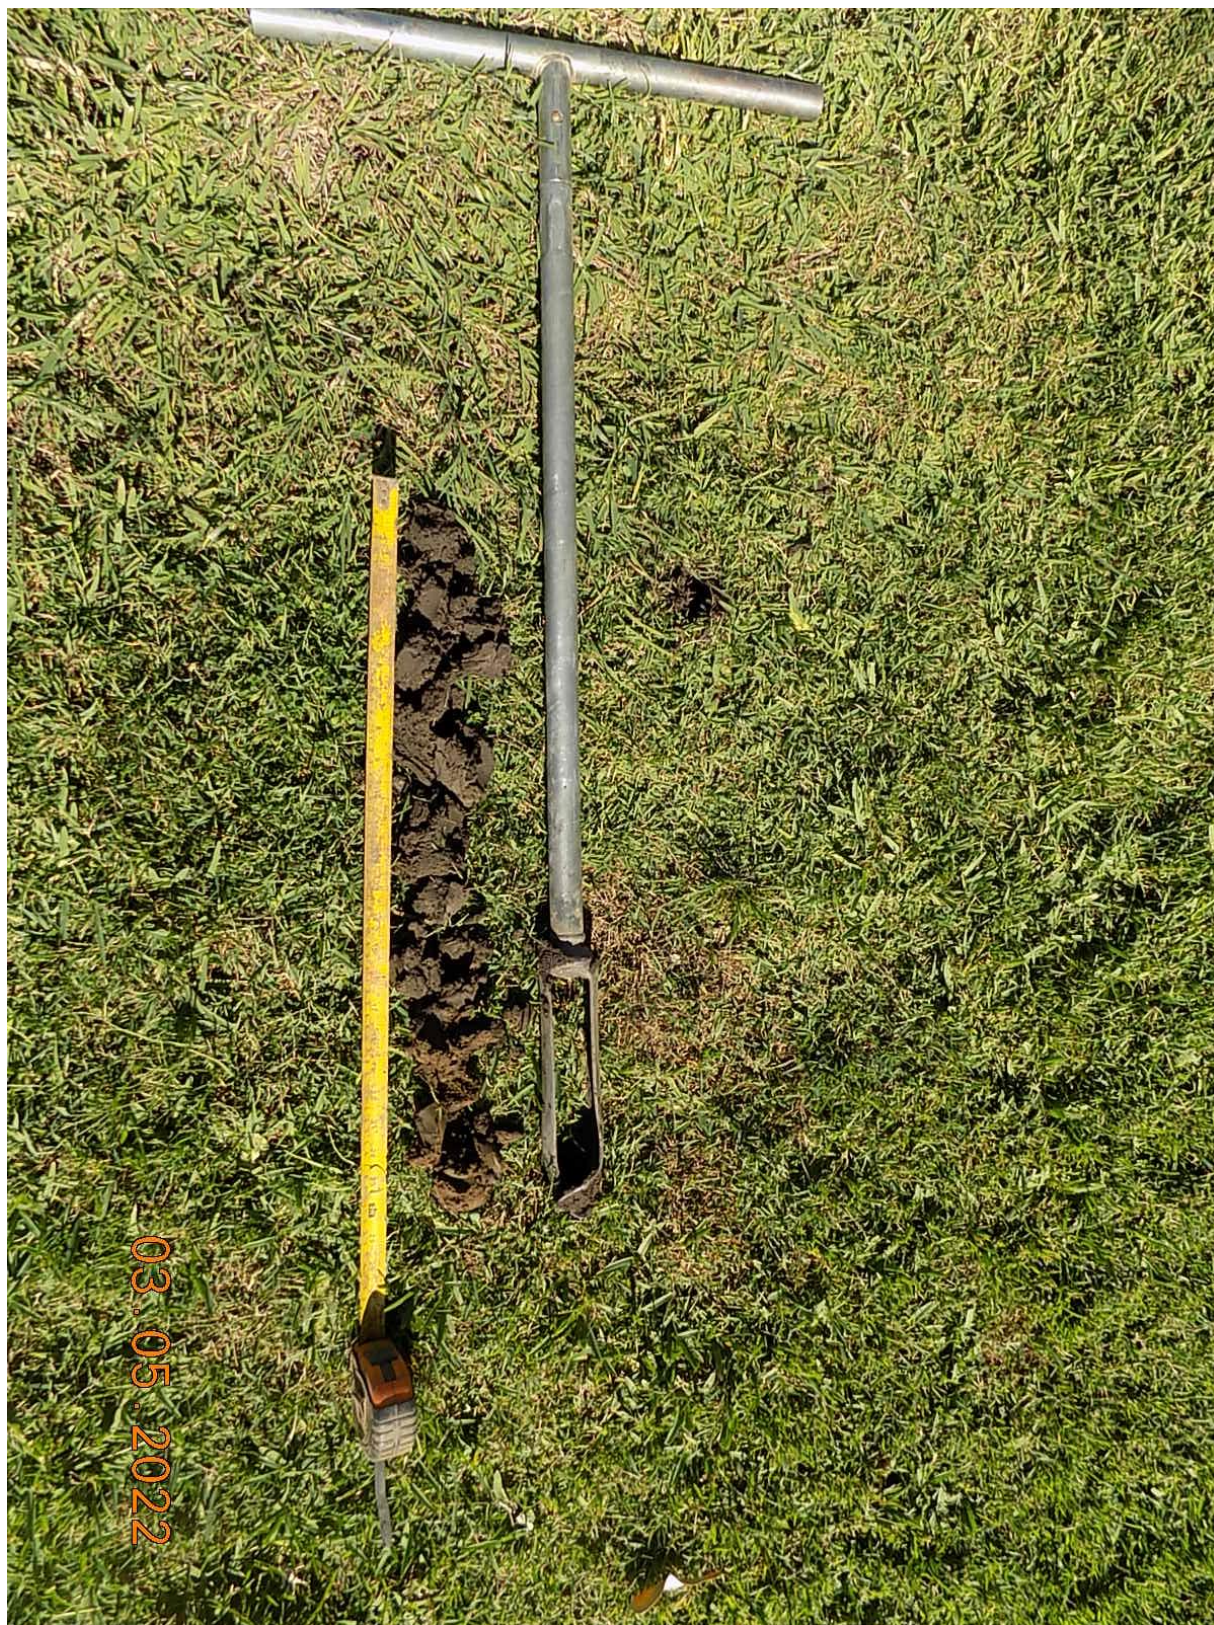
Photo 11 (Top to Bottom)

#### AUGER HOLE 1 (~RL39.2) – AH1 (Photo 11)

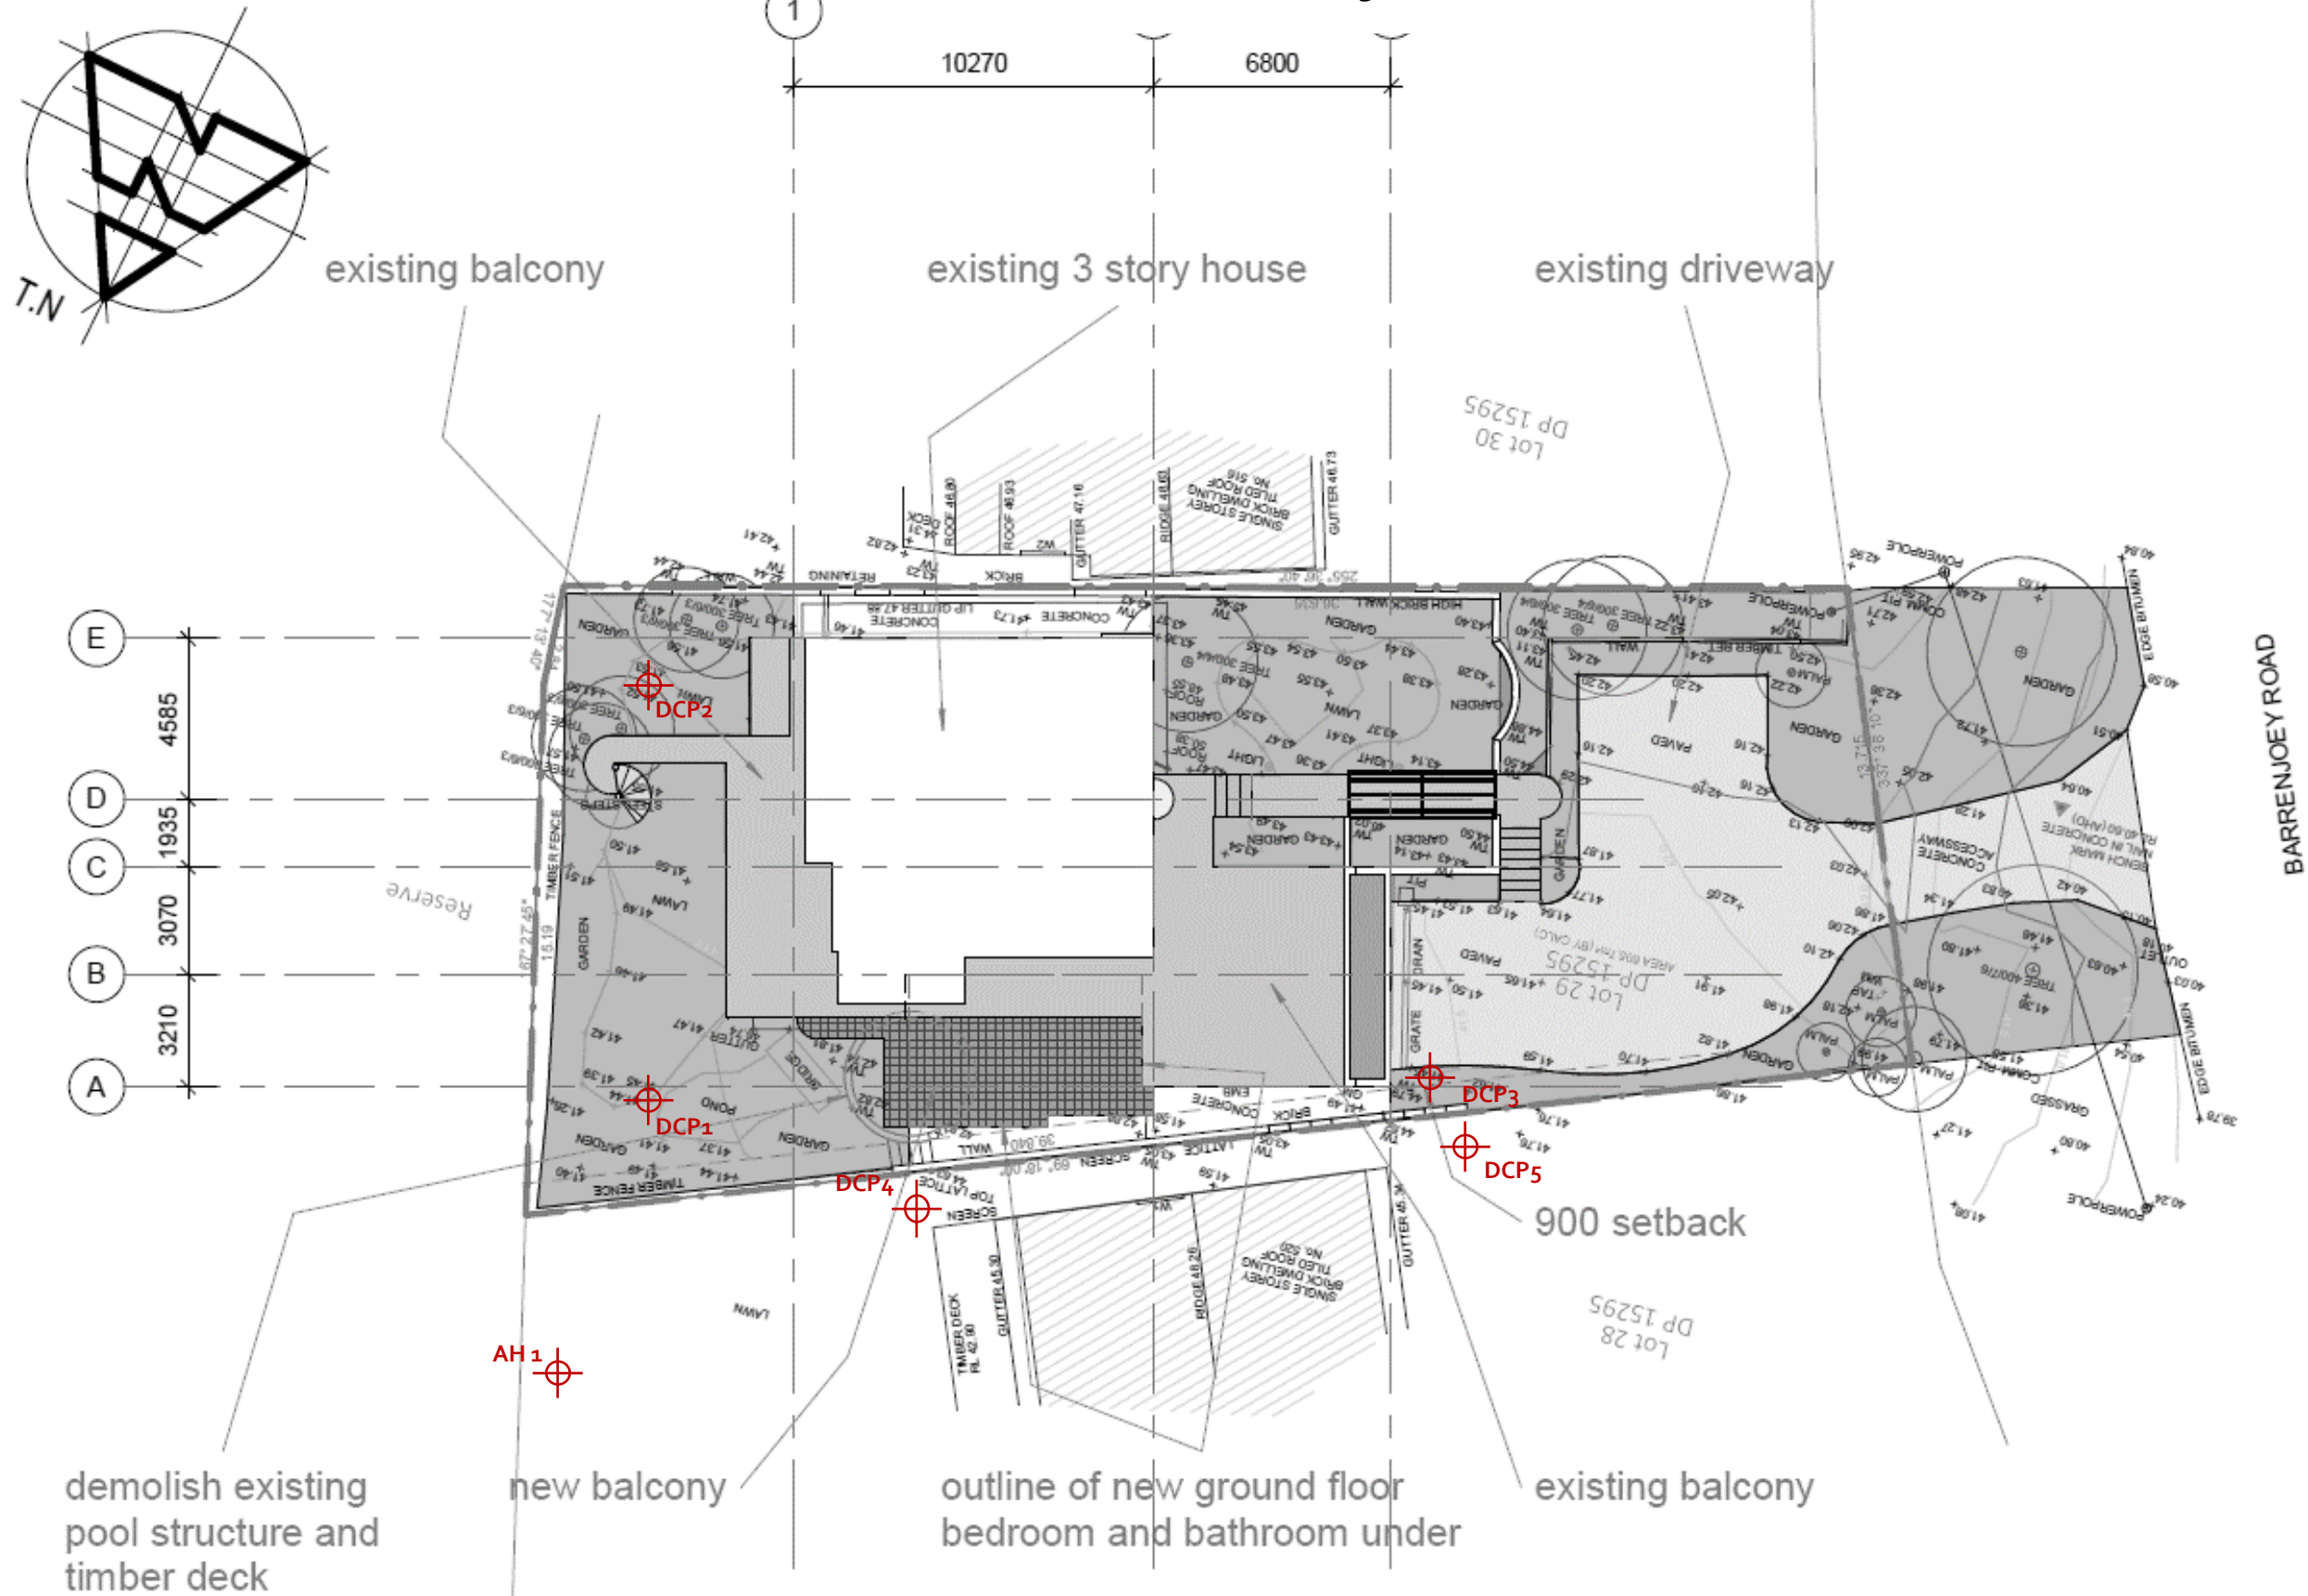
# SITE PLAN – showing test locations

One hand Auger Hole (AH) was put down on the neighbouring property to identify soil materials. Five Dynamic Cone Penetrometer (DCP) tests were put down to determine the relative density of the overlying soil and the depth to weathered rock. The locations of the tests are shown on the site plan attached. It should be noted that a level of caution should be applied when interpreting DCP test results. The test will not pass through hard buried objects so in some instances it can be difficult to determine whether refusal has occurred on an
