Our Ref: 304600719/001/L001:PDT  
Contact: Doug Treloar

2 December 2022

**PROPOSED REDEVELOPMENT AT 518 BARRENJOEY ROAD, AVALON –  
COASTAL PROCESSES ASSESSMENT**

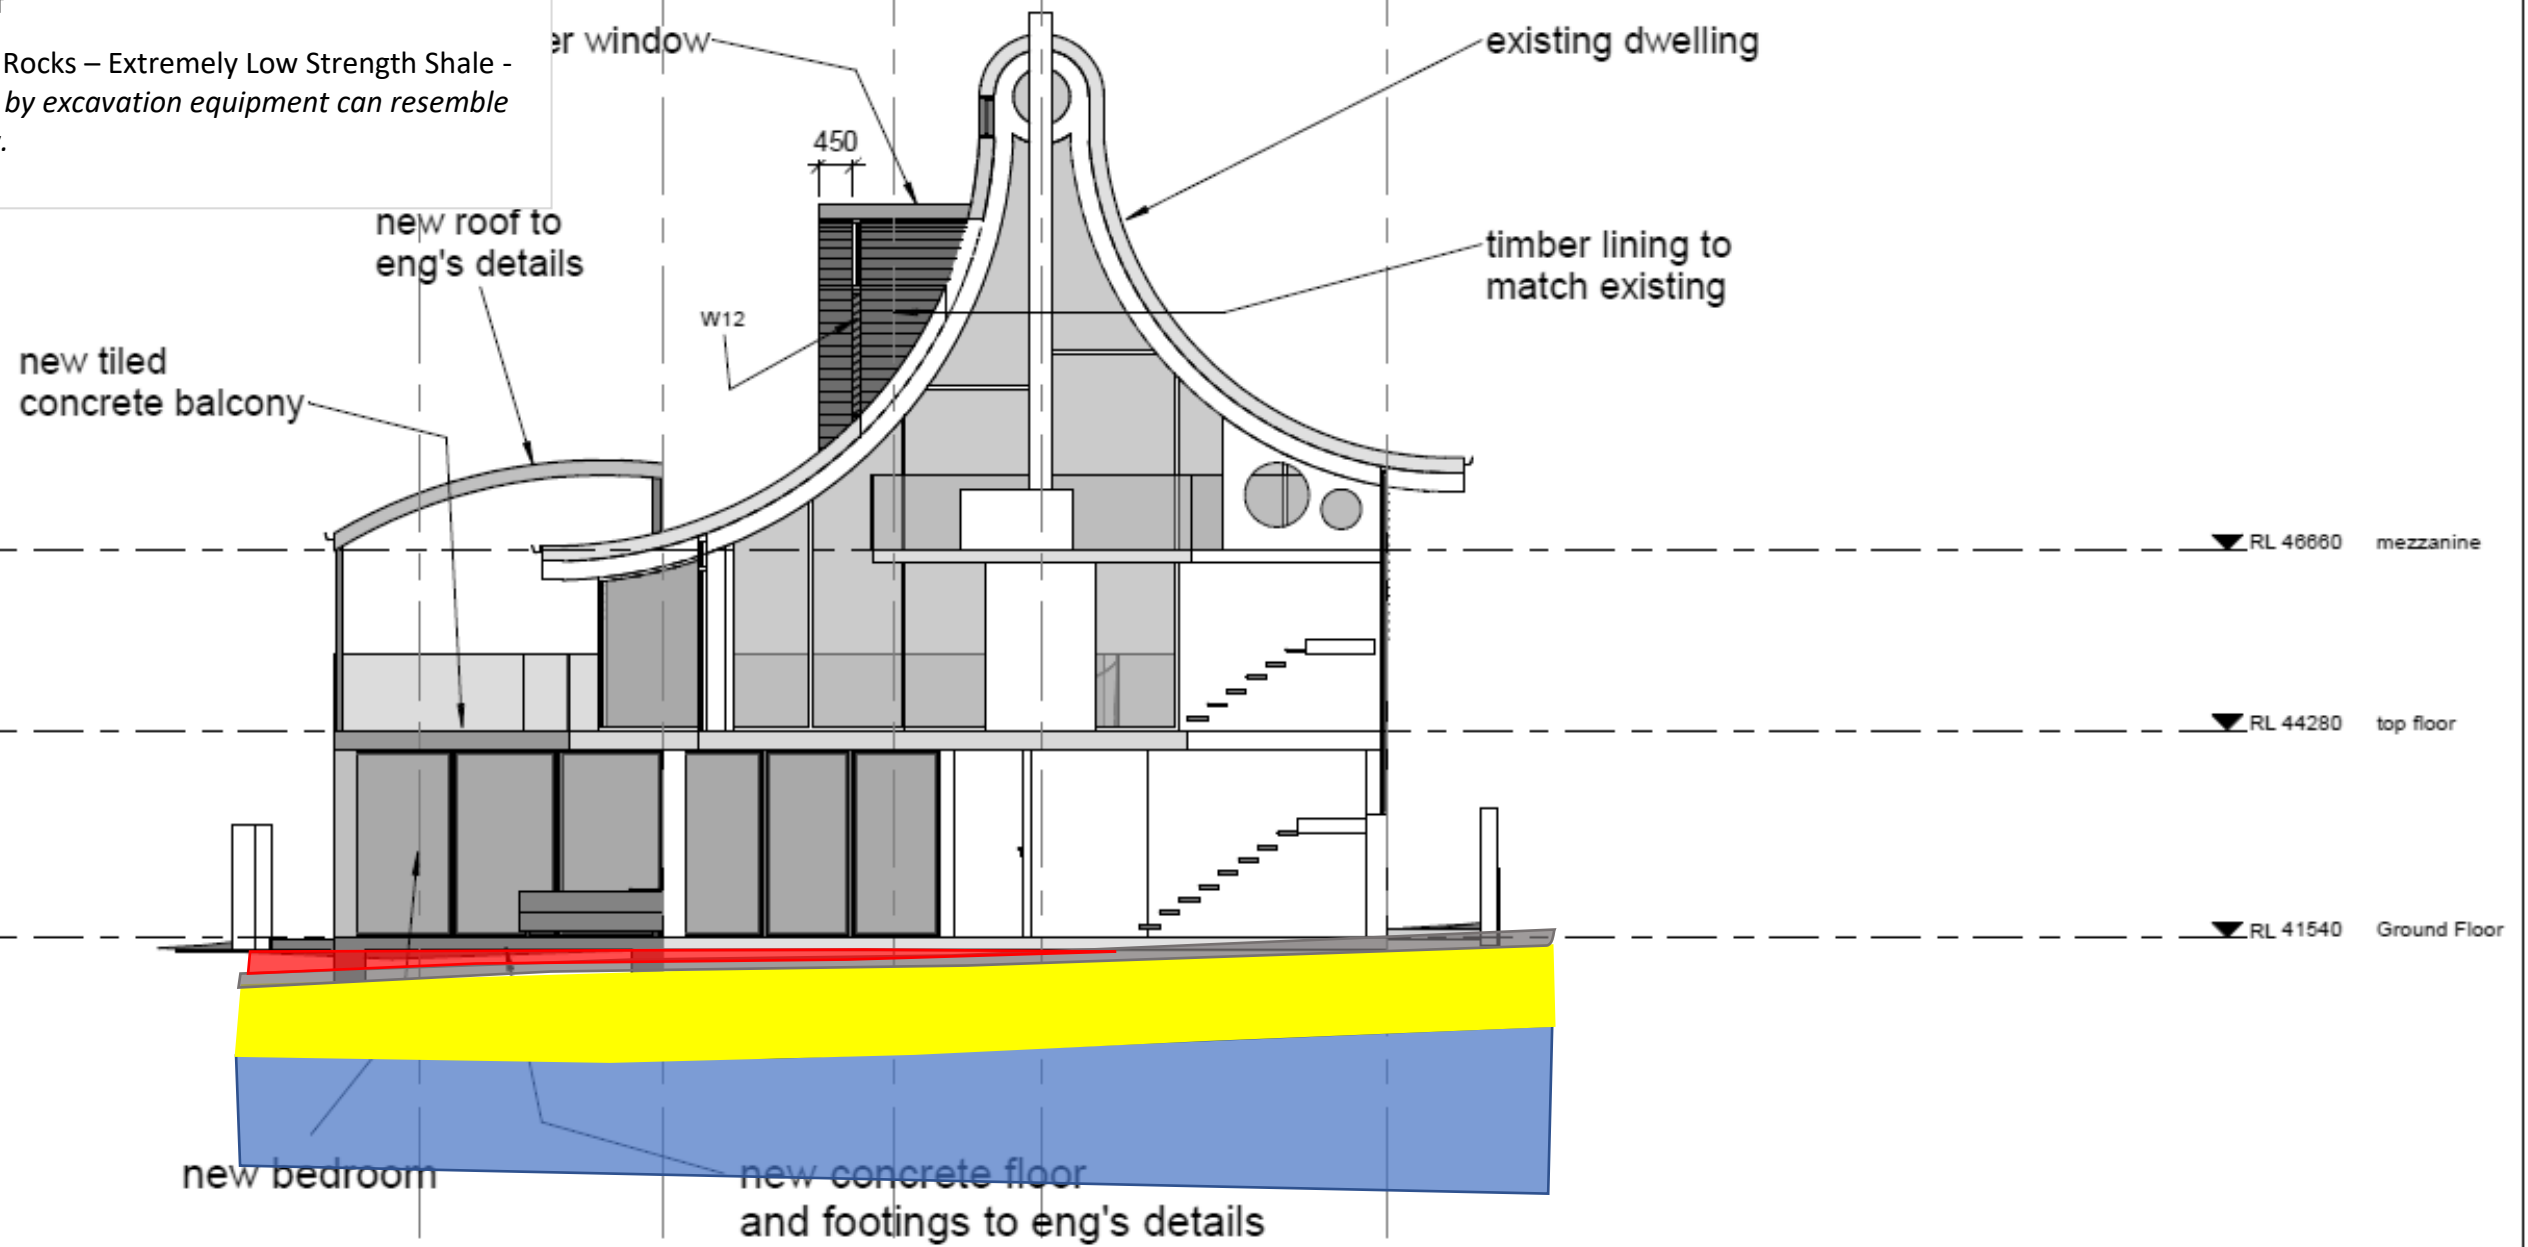
# TYPE SECTION – Diagrammatical Interpretation of expected Ground Materials

- Expected Ground Materials**
- Fill
  - Topsoil
  - Clay – Firm to Stiff
  - Narrabeen Group Rocks – Extremely Low Strength Shale - after being cut up by excavation equipment can resemble a stiff to hard clay.
