**MARINE HABITAT SURVEY**  
**4 Cabarita Road, Avalon**

**September 2019**

**BIO-ANALYSIS Pty Ltd**

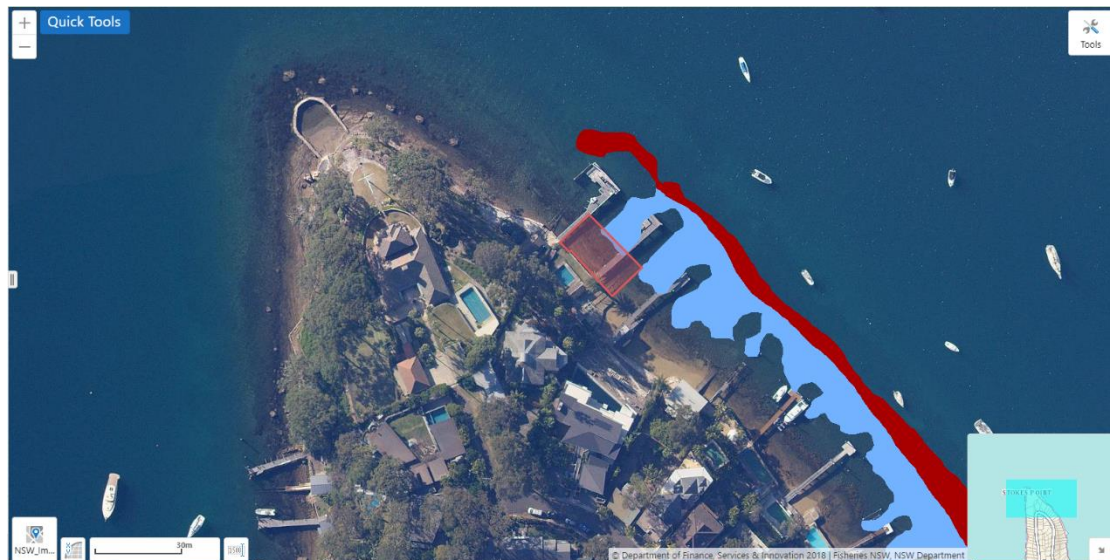
The seagrass (*Posidonia australis*) listed as endangered ecological communities under the EPBC “*Posidonia australis* seagrass meadows of the Manning-Hawkesbury ecoregion” (Department of the Environment (2018)) has been mapped in the vicinity of the survey area (Fisheries NSW Spatial Data Portal ; Creese *et al.*, 2009). The seagrass *Zostera capricorni* has been reported within the survey area (NSW DPI - Creese *et al.*, 2009) (Fig. 2).

**Figure 2.** Estuarine macrophytes mapped by NSW DPI. The red rectangle delimits the survey area. (Source: NSW DPI - Fisheries NSW Spatial Data Portal 06/09/2019).

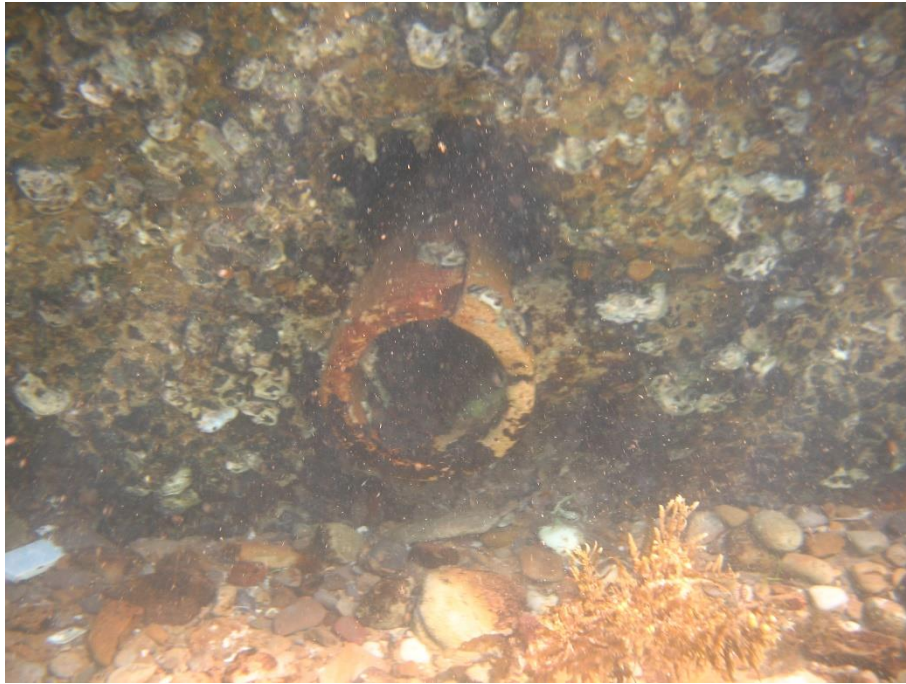
The intertidal area consisted of an artificial concrete seawall, existing jetty piles and artificial slipway and rails (Fig. 4 - 5). The hard substratum was colonised by Sydney rock oysters (*Saccostrea glomerata*), macroalgae (mainly *Hormosira banksii*) and various gastropods (Figs. 4 - 5) and ascidians on the piles.

**Figure 4.** Foreshore: artificial concrete seawall and a drainage outlet (to be upgraded). Structures were colonised by oysters, various gastropods and turfing algae.

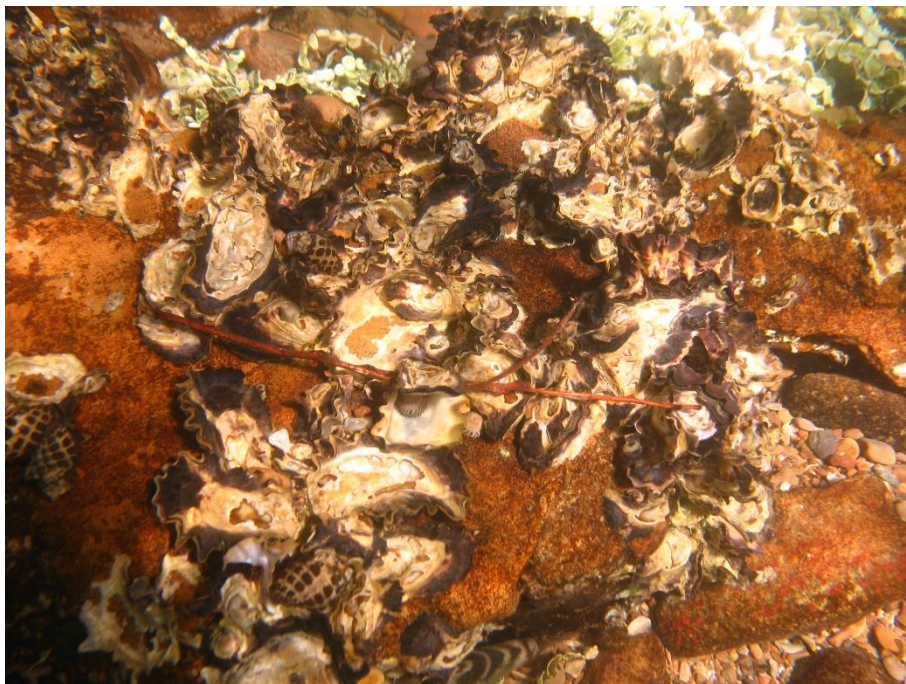
**Figure 5.** Artificial concrete seawall and small intertidal boulders at the base. Structures were colonised by oysters, various gastropods and turfing algae.

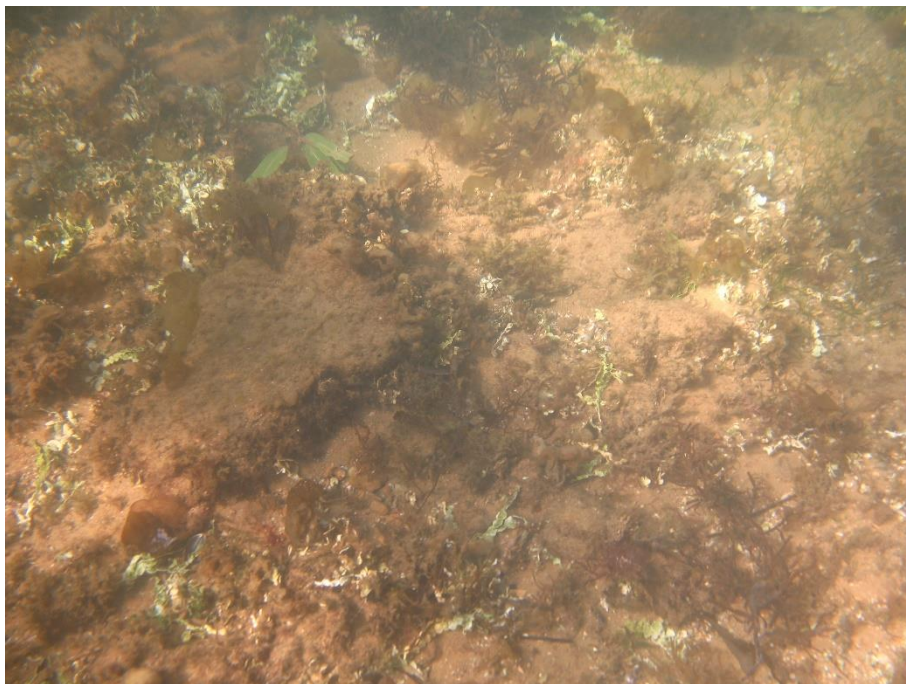
The subtidal habitat extended seaward from the seawall to the lower sections of the piles supporting the jetty. From the base of the seawall and up to 10 to 13 m seaward (1.3 m depth), pebbles, small boulders and sand were present overlying rocky sandstone reef (Figs. 6 - 7).

From 10 to 13 m distance from the seawall, the seabed consisted of soft sediment, fine sand and silt, with the proportion of the latter increasing with depth. Scattered small boulders were found on the soft sediment (Figs. 6 - 7).

**Figure 7.** Subtidal sand, pebbles, small boulders. The hard substratum was colonised by macroalgae and turfing algae.

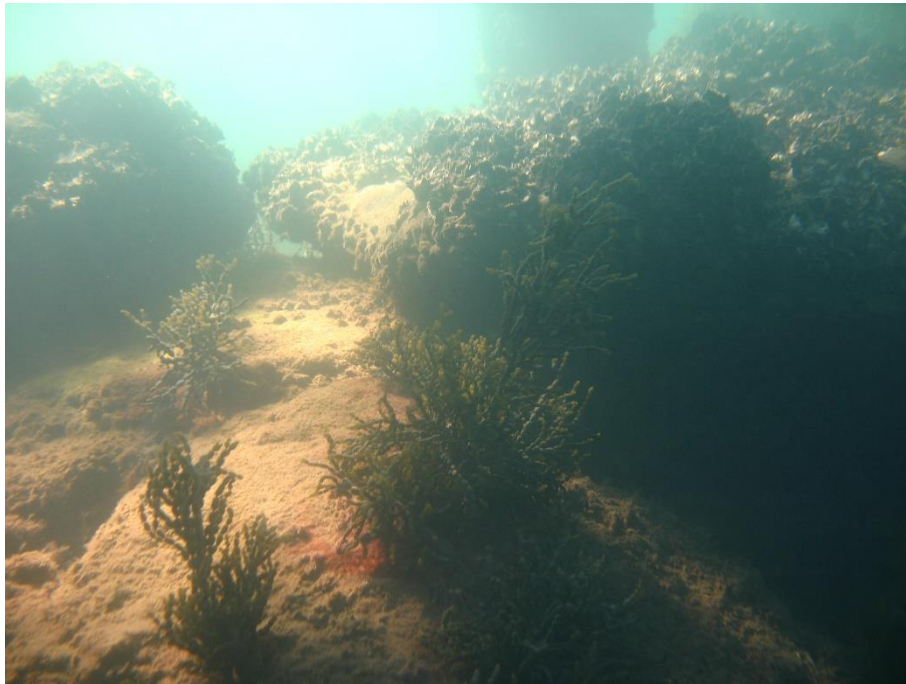
Large boulders were present under the existing jetty and up to 10 m seaward of the seawall (Figs. 8 - 9). The boulders under the jetty and the piles supporting the jetty were colonised by sessile fauna including sponges, ascidians and bryozoans (Figs. 8 - 9).

**Figure 8.** Subtidal boulders under the jetty colonised by sessile fauna and marine vegetation.

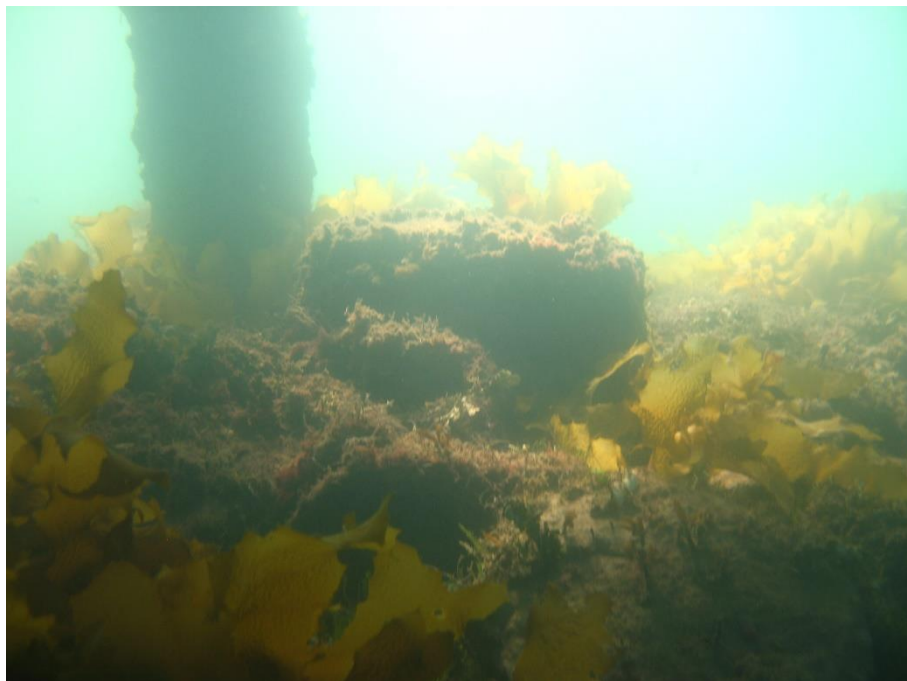
**Figure 9.** Subtidal boulders under the jetty colonised by sessile fauna and marine vegetation.

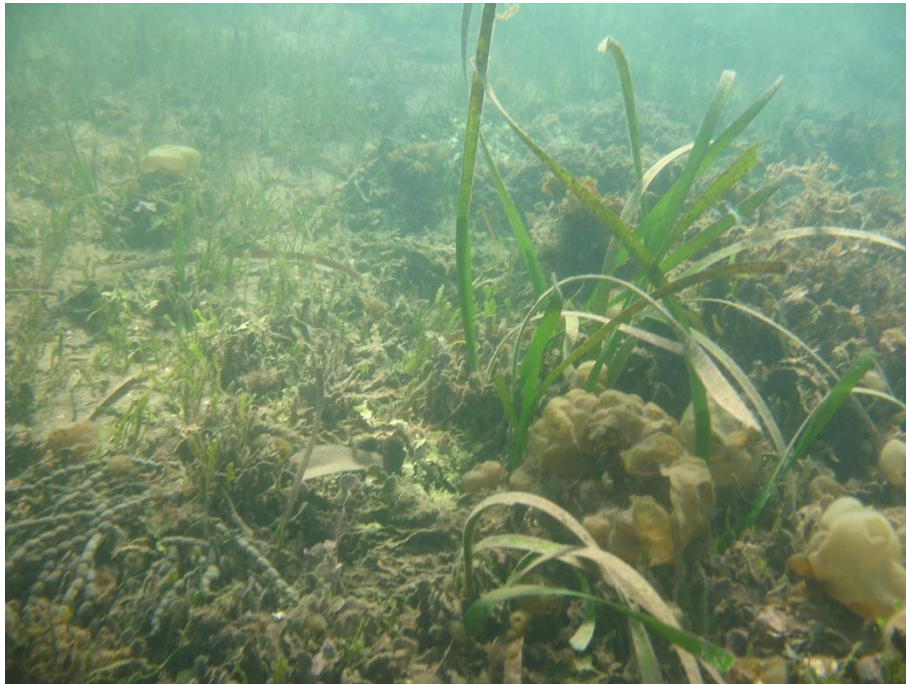
Macroalgae were found on the hard substratum (base of the seawall, boulders, flat sandstone rocky substratum and piles). The main species were *Hormosira banksia*, *Gracilaria* sp. in the shallows (Fig. 6), *Sargassum* sp., *Ecklonia radiata* (Fig. 9) and in deeper water the calcareous algae *Halimeda* sp. (up to 40% cover) (Figs. 10 and 113).

The invasive algae *Caulerpa taxifolia* was present from 8 to 10 m (1.0 – 1.2 m depth) seaward from the seawall with a percentage cover of up to 30% (Figs. 10, 14 and 16). *Caulerpa taxifolia* was also found colonising the piles and boulders under the jetty (Fig. 15).

**Figure 10.** Soft sediments with sparse boulders colonised by macroalgae (*Sargassum* sp., the calcareous *Halimeda* sp. and the noxious *Caulerpa taxifolia*) and seagrasses (*Posidonia australis* and *Zostera capricorni*).

The noxious algae *Caulerpa taxifolia* was found within the survey area. Great attention should be brought to minimise further dispersion of this invasive species during the works. Anchorage, post driving and dragging equipment on the bottom should be avoided in the areas where *Caulerpa taxifolia* is present. It will be important to inspect anchors, chains and other equipment that could have been in contact with *Caulerpa taxifolia* and, if found, to remove and dispose of any fragments

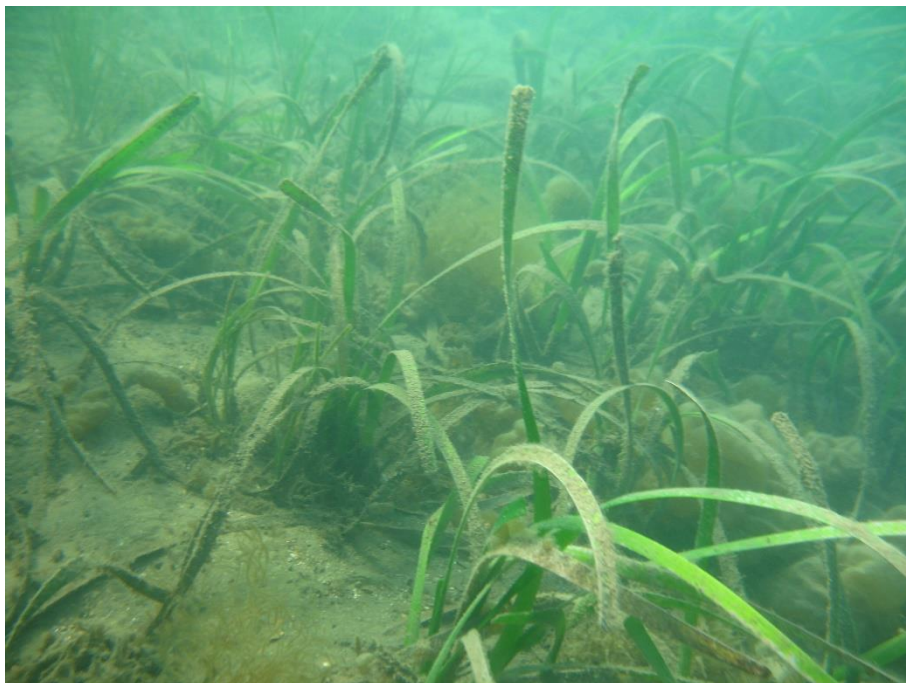
**Figure 11.** Fine sand and silt found in deeper water colonised by *Posidonia australis*, *Zostera australis* and sparse macroalgae.

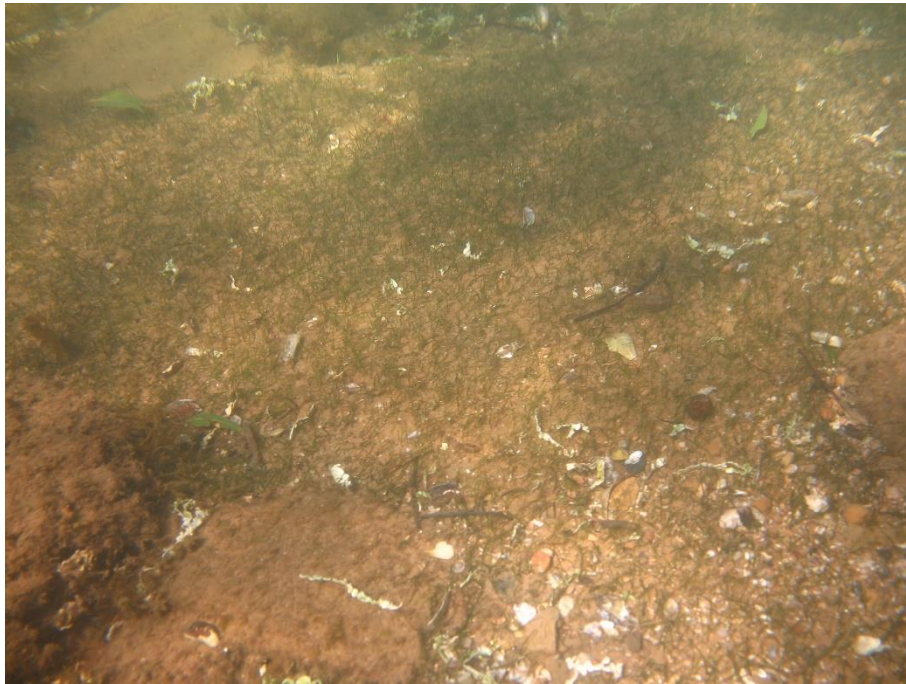
**Figure 12.** *Zostera capricorni* found in the shallow areas (short leaves).

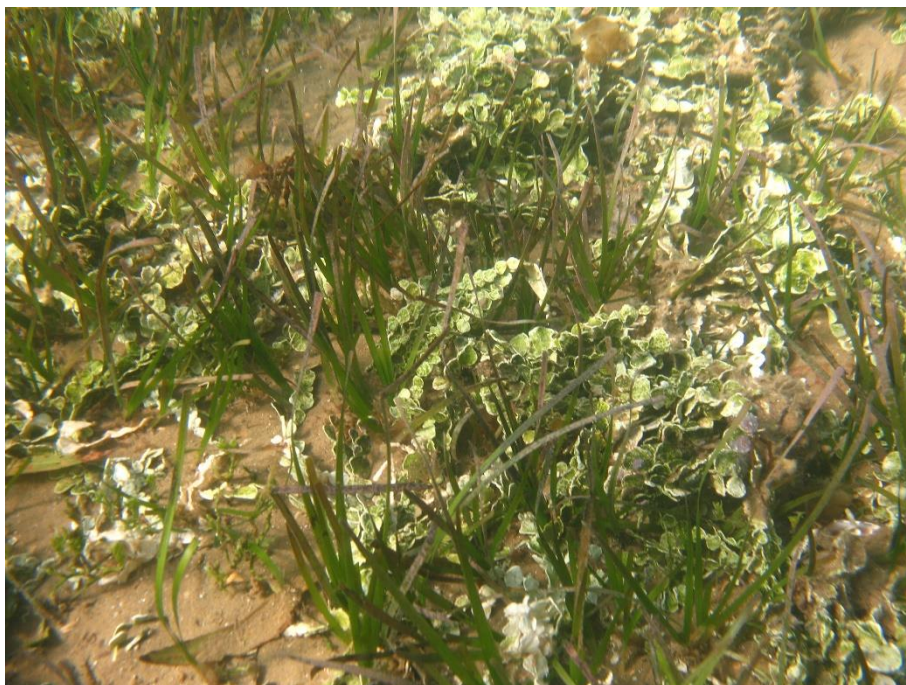
Three species of seagrasses were present within the extended survey area. *Zostera capricorni* was present from 2 - 4 m from the seawall in small patches, sparse (< 10% cover) with very short leaves (3 - 4 cm) (Fig. 13). In deeper water, 5m seaward of the seawall, *Zostera capricorni* increased in leaf length and percentage cover with the depth up to 30 % cover (Figs. 13 and 16). *Posidonia australis* was found approximately 14 - 16 m from the seawall at a depth of 1.4 m in isolated clumps (~5% cover). This *Posidonia* extended out to around 35 - 40 m at a depth of 4.0 m. At this depth a dense *Posidonia* bed with 60 - 80% cover was found, approximately 40m from the seawall (Figs. 10, 11 and 16). The seagrass *Halophila* sp. was also found within the survey area but was very sparse (Fig. 14).

**Figure 13.** *Zostera capricorni* found in deeper water on soft sediments in association with the calcareous algae *Halimeda* sp.

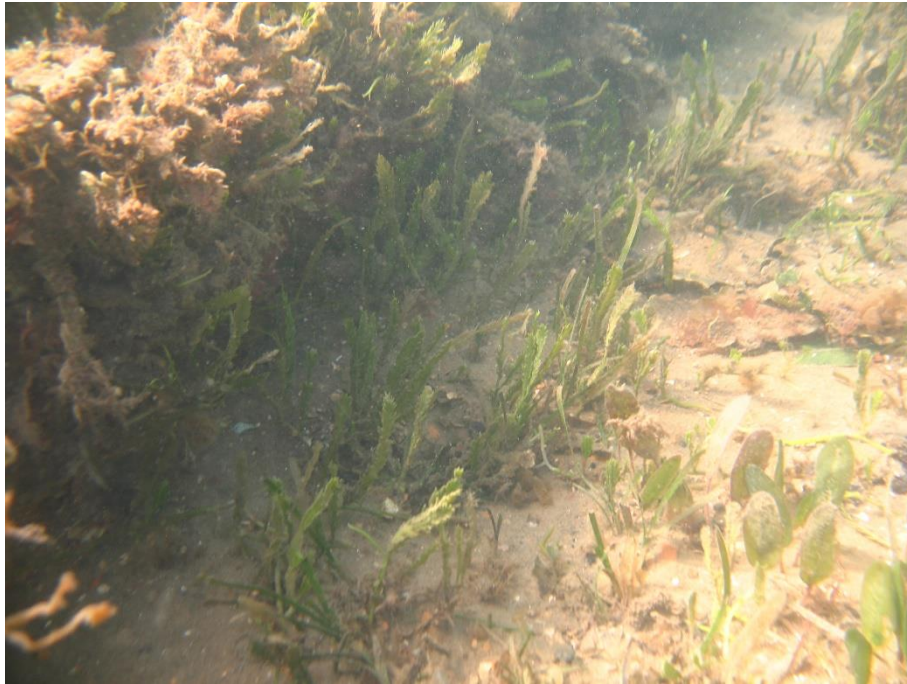
**Figure 14.** The invasive and noxious algae *Caulerpa taxifolia* and sparse seagrass *Halophila* sp. (bottom right corner).

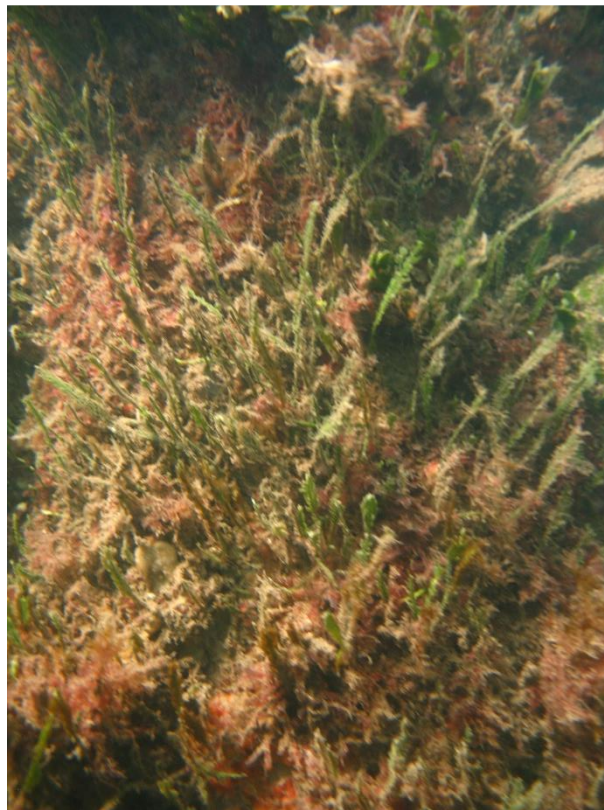
**Figure 15.** The invasive and noxious algae *Caulerpa taxifolia* and turfing algae colonising a pile supporting the jetty.

As a note, the rails of the existing slipway should remain in place as proposed. Removing them and especially the supporting piles would have a significant and direct impact on the seagrasses (*Zostera capricorni* and *Posidonia australis*) and a high risk of spreading fragments of *Caulerpa taxifolia*.

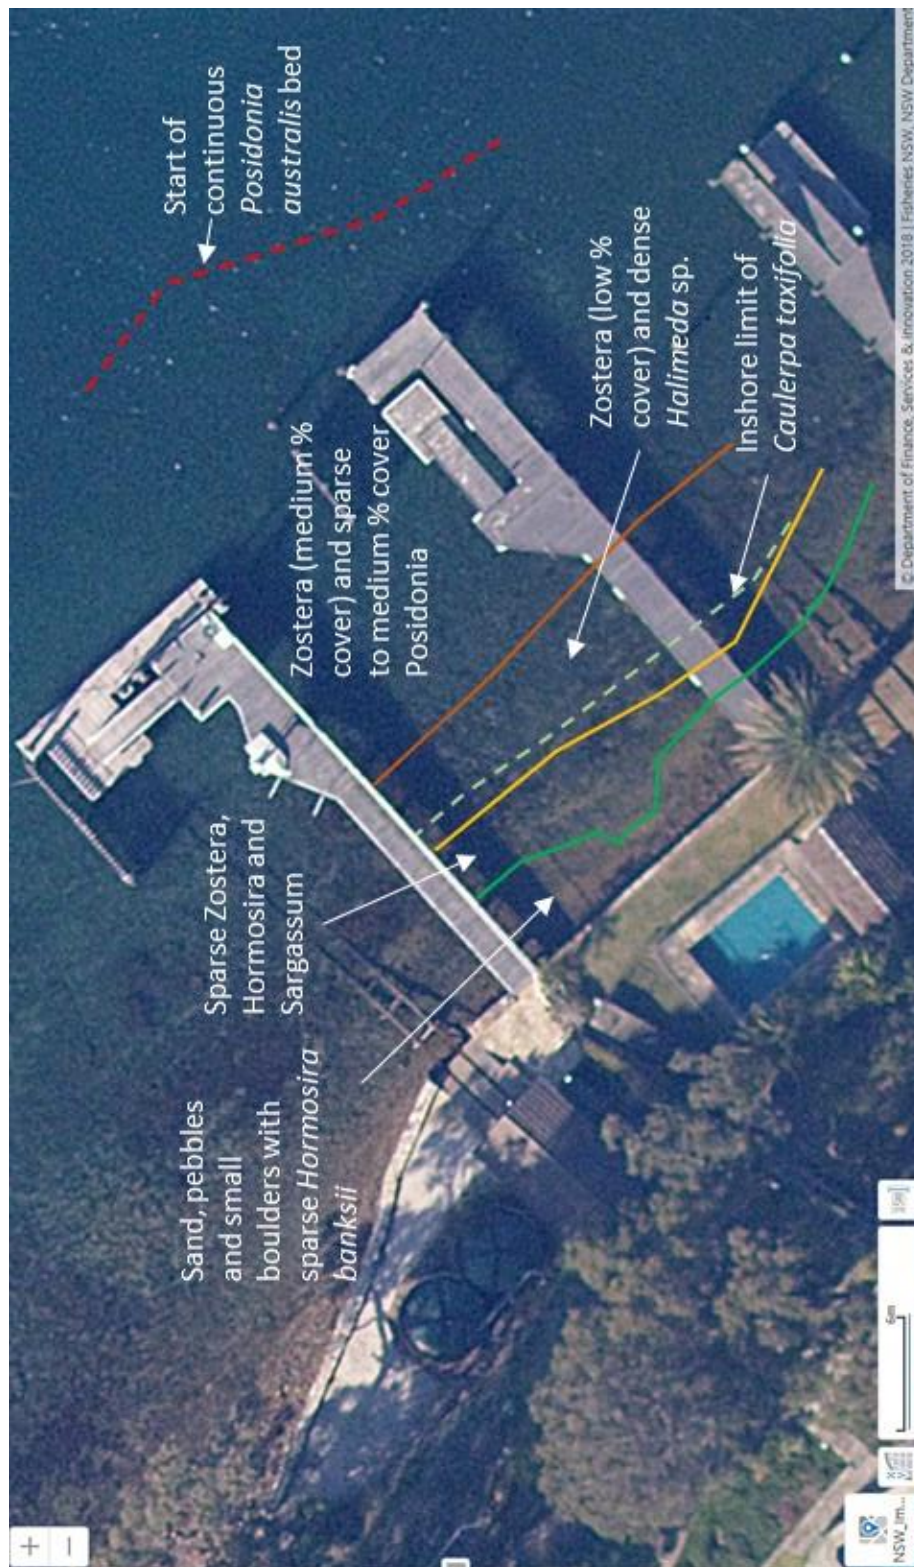
**Figure 16.** Distribution of the seagrasses and macroalgae present in the survey area.

Seagrasses (*Posidonia australis*, up to 60% cover and *Zostera capricorni* up to 30% cover) present in the study area and immediate vicinity, outside the footprint of the proposed works. During the construction work phase, potential direct and indirect impacts on seagrasses and on marine vegetation such as anchoring, heavy equipment laid/dragged and the deposition of material on the seafloor should be avoided in vegetated areas.
