# Arboricultural Impact Appraisal and Method Statement

2A William Street  
Avalon, NSW

Prepared for  
George & Lisa Tremopoulos  
c/o Jane Edwards Architecture

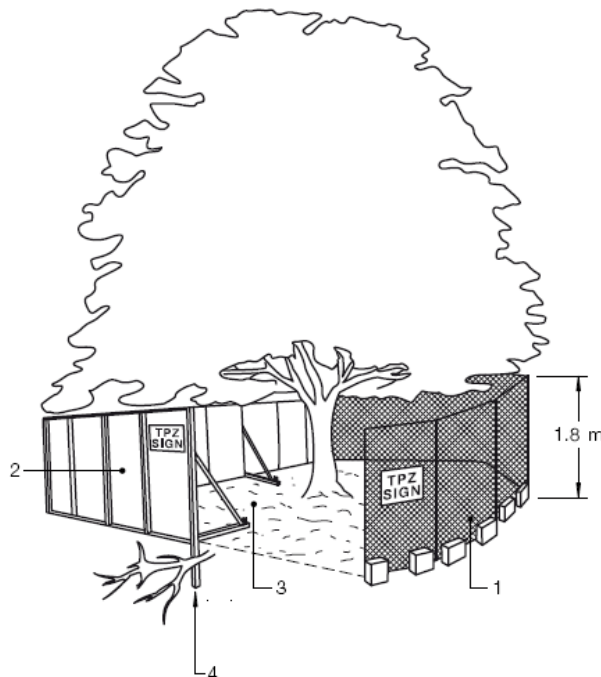
#### Legend

1. Chain wire mesh panels with shade cloth (if required) attached, held in place with concrete feet.
2. Alternative plywood or wooden paling fence panels. This fencing material also prevents building materials or soil entering the TPZ.
3. Mulch installation across surface of TPZ (at the discretion of the project arborist). No excavation, construction activity, grade changes, surface treatment or storage of materials of any kind is permitted within the TPZ.
4. Bracing is permissible within the TPZ. Installation of supports should avoid damaging roots.

4.2.1 **Protection fencing:** Tree protection fencing must comply with AS4970 (section 4.3) recommendations. An illustrative guide is included as Appendix 4. The approximate location of the barriers and the TPZs is illustrated on plan TMP01. The precise location of the fencing must be agreed with the project Arborist before any development activity starts.

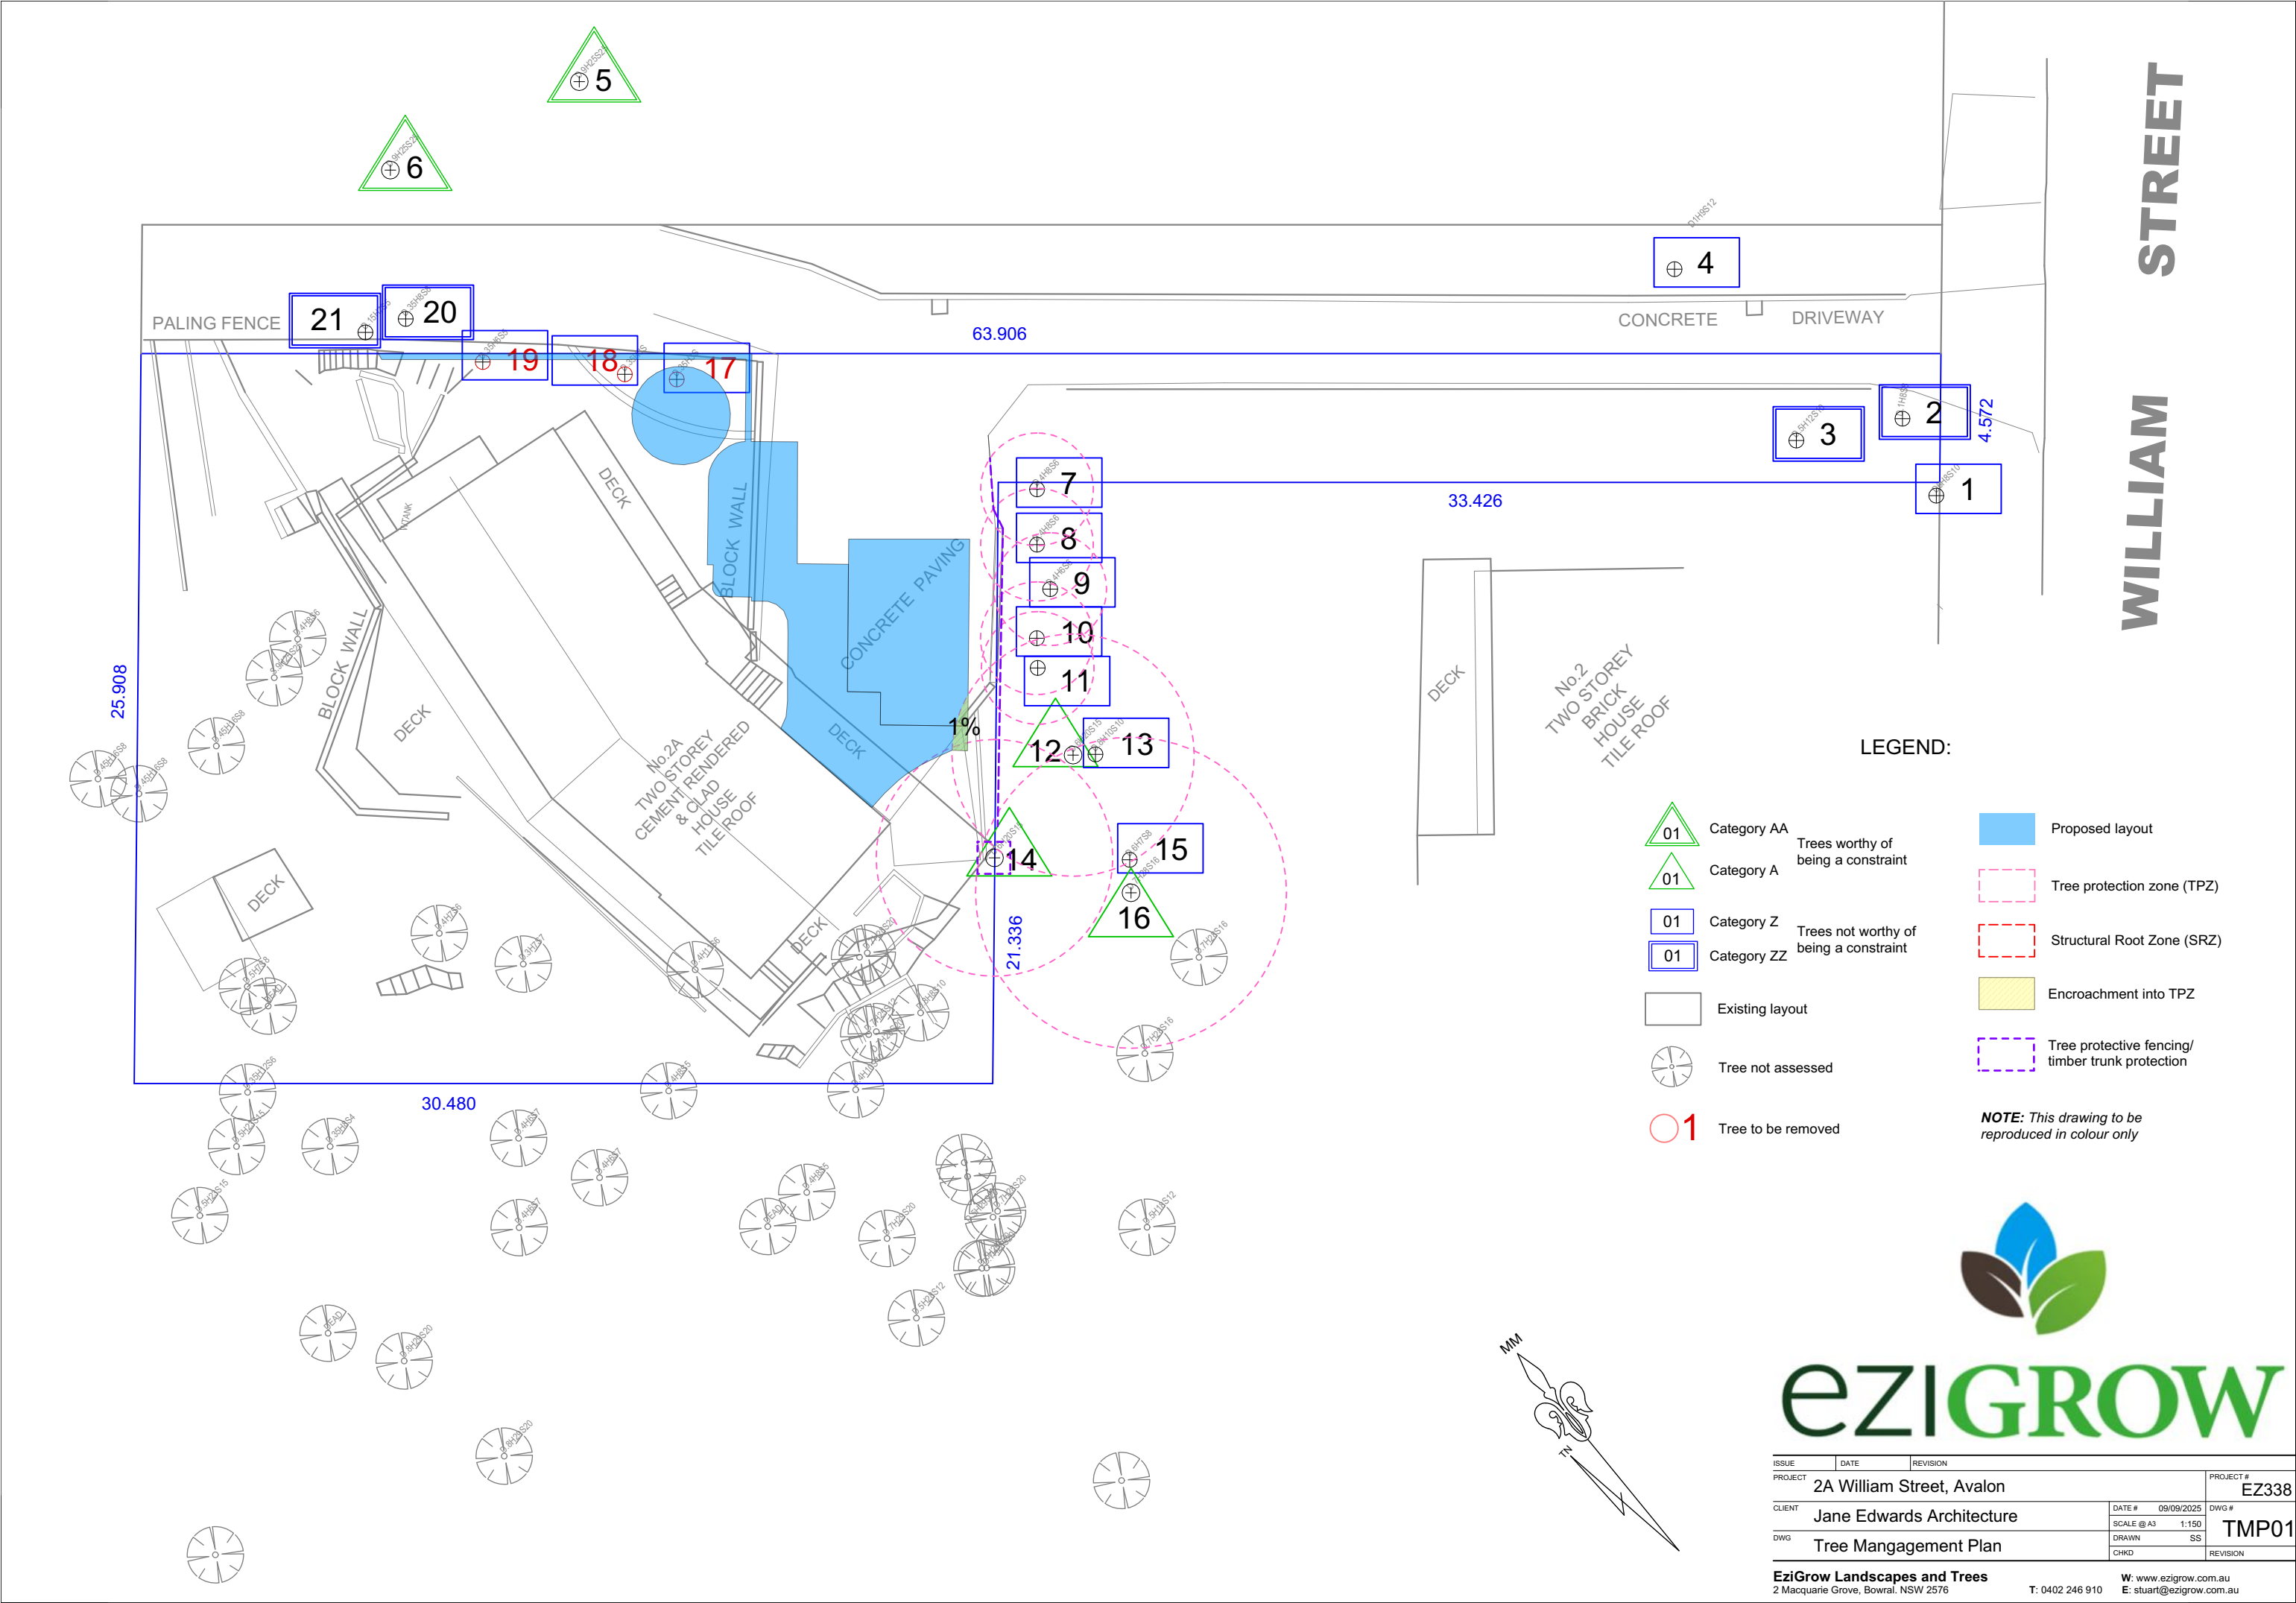
-refer attached Tree Management Plan, Dwg No. TMP01,  
by Ezigrow dated 09 September 2025

- 4.1.2 **Plan TMP01:** Plan TMP01 in Appendix 8 is illustrative and based entirely on provided information. This plan should only be used for dealing with the tree issues and all scaled measurements must be checked against the original submission documents. The precise location of all protective measures must be confirmed at the pre-commencement meeting before any demolition or construction activity starts. Its base is the existing land survey, which has the proposed layout superimposed so the two can be easily compared. It shows the existing trees numbered, with high categories (A) highlighted in green triangles and low categories (Z) highlighted in blue rectangles. It also shows the locations of the proposed protective measures.

- 2.2.4 **Identification and location of the trees:** I have illustrated the locations of the significant trees on the Tree Management Plan (Plan TMP01) included as Appendix 8. This plan is for illustrative purposes only and it should not be used for directly scaling measurements.

This guidance should always be read in conjunction with the Tree Management Plan (TMP01) illustrating the areas where specific precautions are necessary. Each area where precautions are required is explained on the plan as identified on the legend. All protective measures should be installed according to the prevailing site conditions and agreed as satisfactory by the Project Arborist before any demolition or construction work starts.
