## Arboricultural Impact Appraisal and Method Statement

41A Ponsonby Pde  
Seaforth, NSW

Prepared for  
Nathan Pickering

31 October 2021

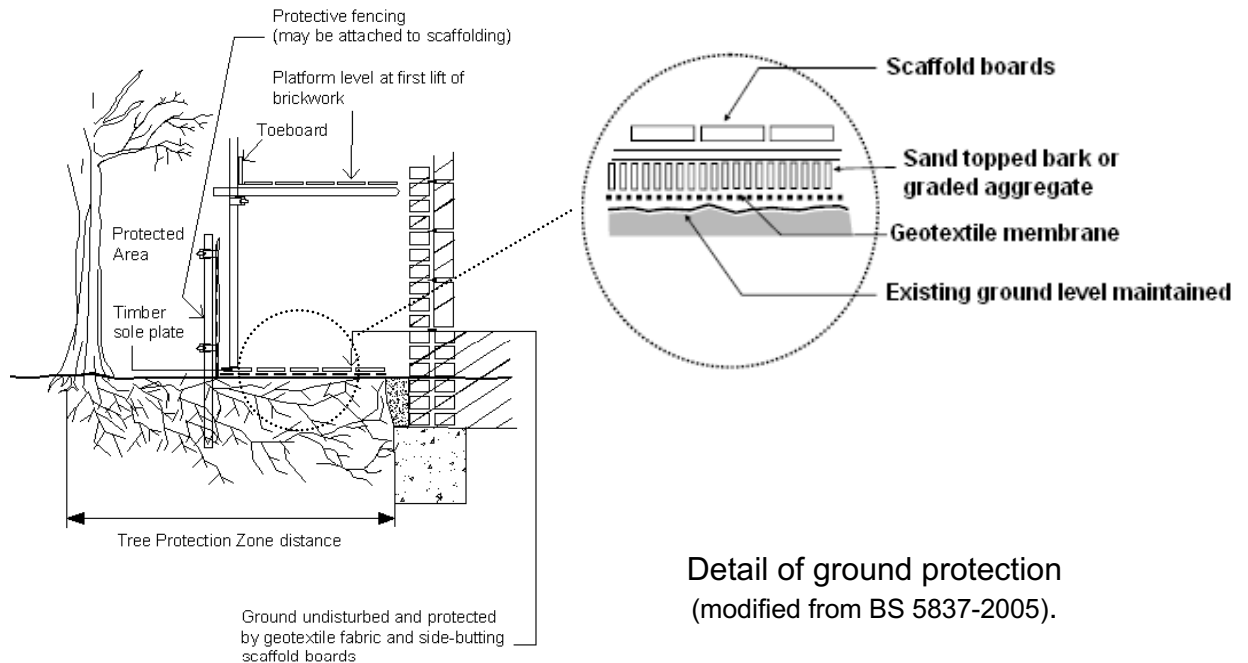
**Root zone protection:** Where necessary, access through the TPZ can be achieved by laying aggregate and timber boards (or similar) over the root zone to protect roots. The ground beneath the boarding should be left undisturbed and should be protected with a porous geo-textile fabric covered with sand or mulch.

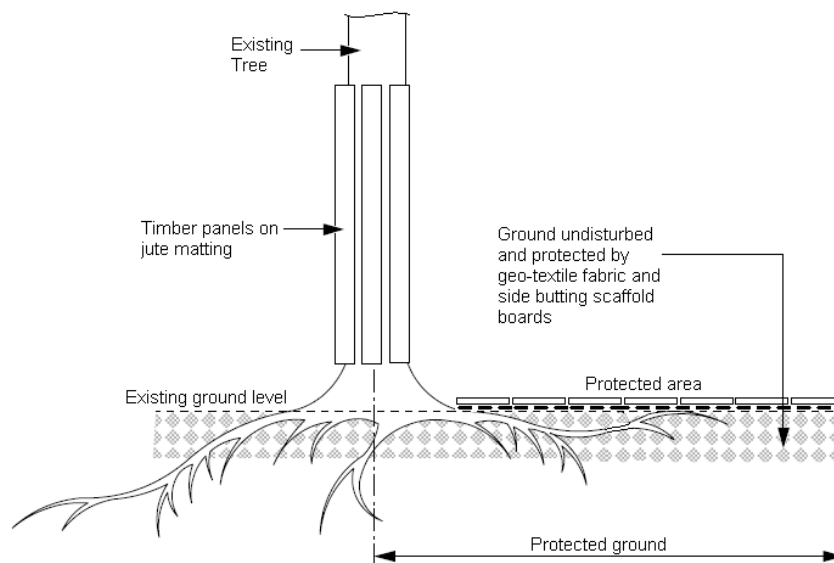
Detail of trunk protection.

**Trunk protection:** Where fencing cannot be installed, the vertical trunk of exposed trees shall be protected by the placement of 3.6m lengths of 50 x 100mm hardwood timbers, spaced vertically, at 150mm centres and secured by 2mm wire at 300mm wide spacing over suitable protective padding material e.g. Jute Matting. The trunk protection shall be maintained intact until the completion of all work on site.

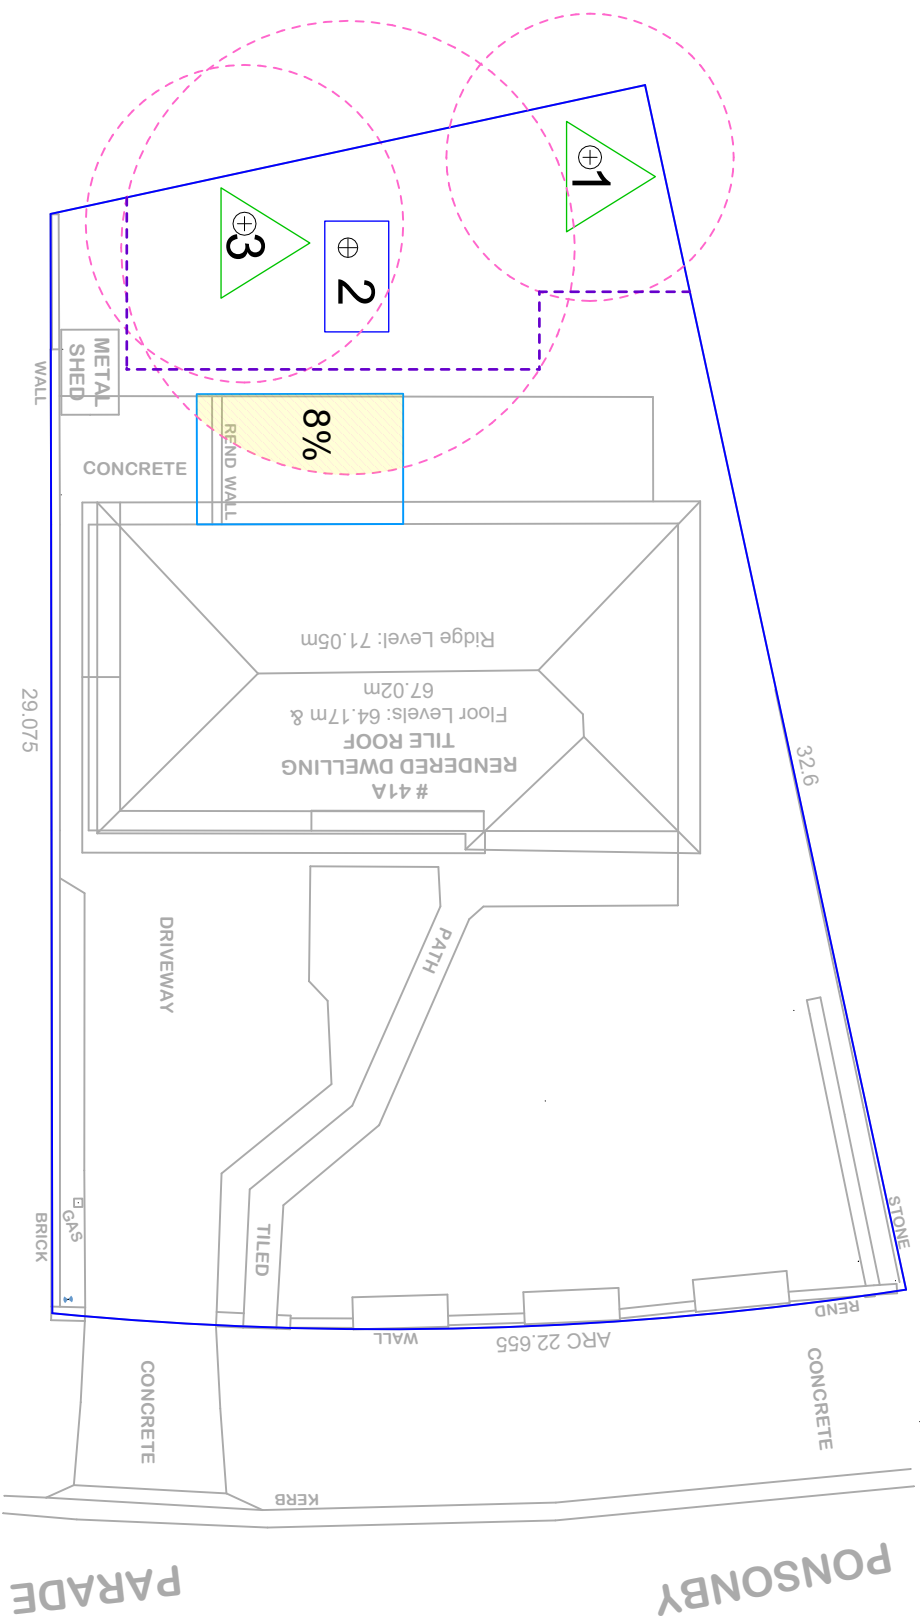
-refer attached Tree Management Plan, Dwg No. TMP01,  
by Ezigrow dated 31 October 2021.

- 2.2.4 **Identification and location of the trees:** I have illustrated the locations of the significant trees on the Tree Management Plan (Plan TMP01) included as Appendix 8. This plan is for illustrative purposes only and it should not be used for directly scaling measurements.

4.1.2 **Plan TMP01:** Plan TMP01 in Appendix 8 is illustrative and based entirely on provided information. This plan should only be used for dealing with the tree issues and all scaled measurements must be checked against the original submission documents. The precise location of all protective measures must be confirmed at the pre-commencement meeting before any demolition or construction activity starts. Its base is the existing land survey, which has the proposed layout superimposed so the two can be easily compared. It shows the existing trees numbered, with high categories (A) highlighted in green triangles and low categories (Z) highlighted in blue rectangles. It also shows the locations of the proposed protective measures.

4.2.1 **Protection fencing:** Tree protection fencing must comply with AS4970 (section 4.3) recommendations. An illustrative guide is included as Appendix 4. The approximate location of the barriers and the TPZs is illustrated on plan TMP01. The precise location of the fencing must be agreed with the project Arborist before any development activity starts.

4.3 **Precautions when working in TPZs:** Any work in TPZs must be done with care as set out in Appendix 6. On this site, special precautions must be taken near trees 1 and 3 as illustrated on plan TMP01 and summarised below:
