Address of site 1 BELLEVARD PARADE, MONA VALE NSW 2103

**GEOTECHNICAL SITE INVESTIGATION REPORT  
FOR  
PROPOSED ALTERATIONS & ADDITIONS  
AT  
1 BELLEVARDE PARADE, MONA VALE NSW 2103**

**Report Prepared for: LUKE DRIVER**

**Project No: SRE/1444/MV/25**

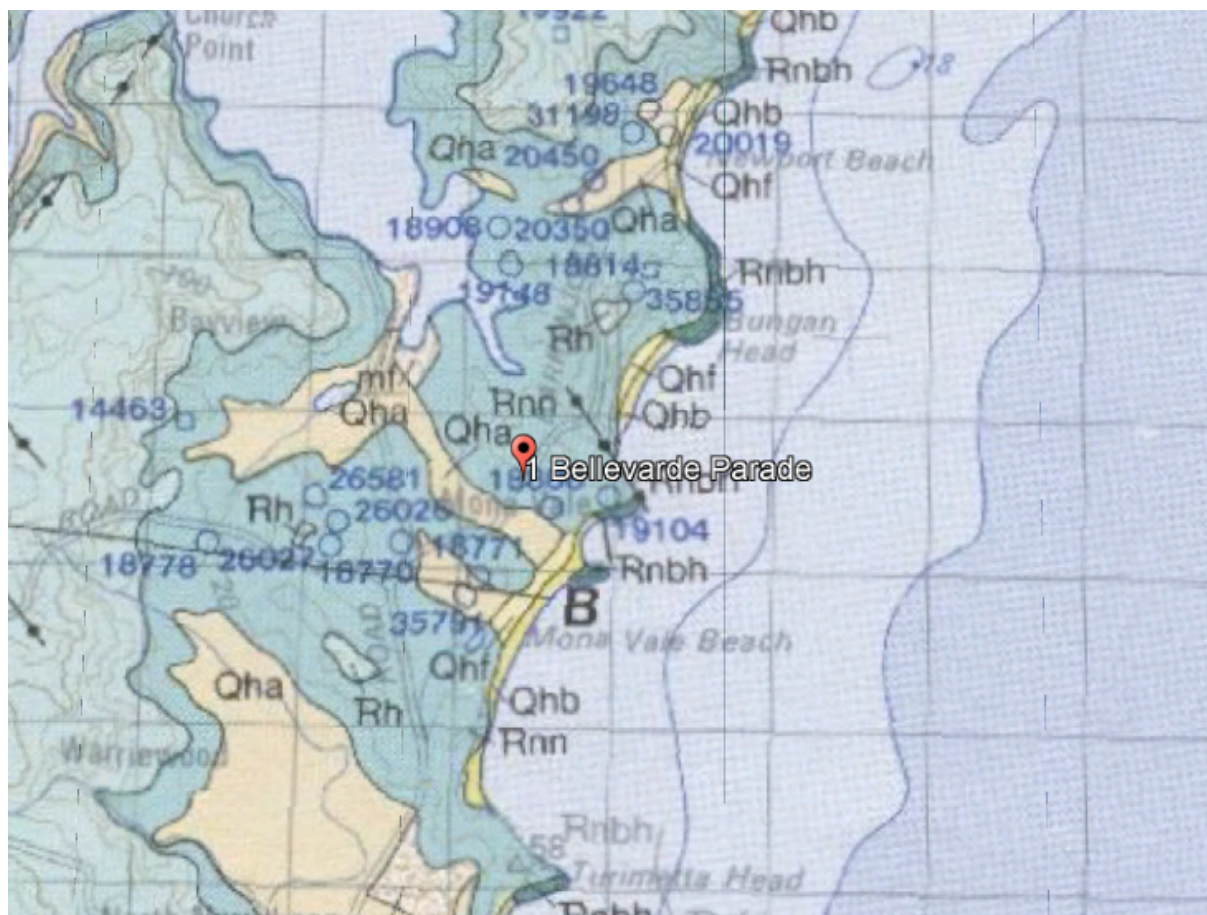
**Figure 1** – Portion of the Sydney 1:100,000 Geological Series Map 9130. Site area location is highlighted in a red/black sign.

A reproduction of the geological map is shown on following **Figure 1** and is based on a portion of the geological map of Sydney 1:100 000 Geological Series Sheet 9130 (EDITION 1) 1983 (interactive resource provided by the Geological Survey of NSW), which depicts the site geological condition.

From the analysis of Geology of Sydney 1:100 000 Geological Series Sheet 9130, it is indicated that the site is located within a region of Narrabeen Group “Rnn” Newport Formation and Garie Formation, which is comprised of interbedded laminate shale and quartz to lithic-quartz sandstone, minor red claystone North.

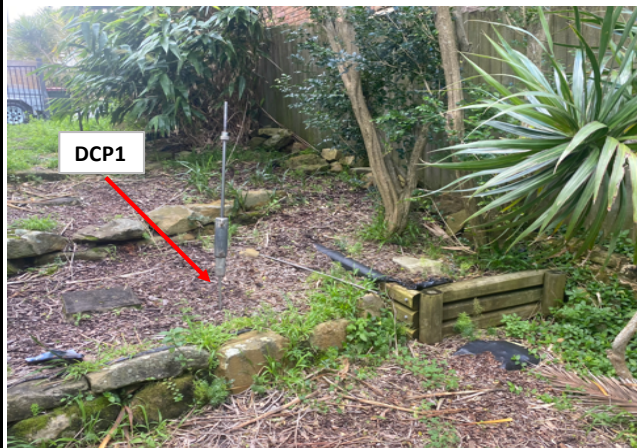
**Photo 1** - Northwest view of DCP1 test location.

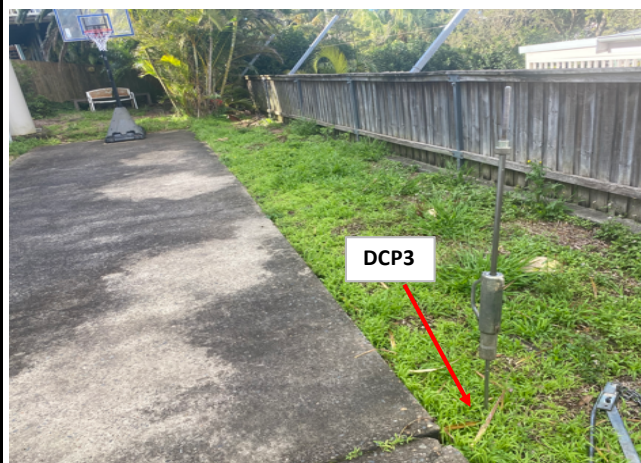
**Photo 3** - Northeast view of DCP3 test location.

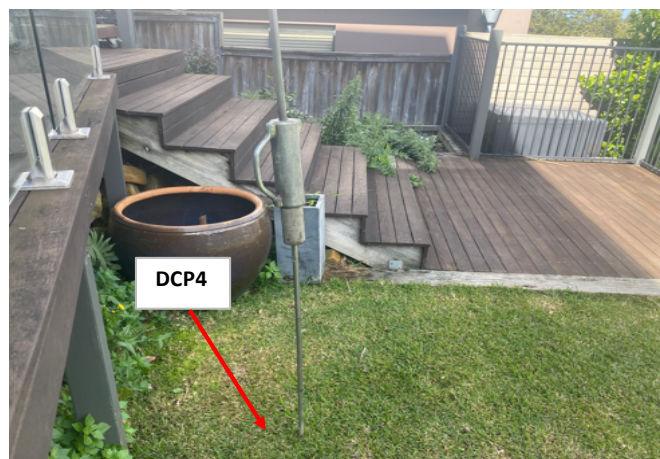
**Photo 4** - Southeast view of DCP4 test Location.

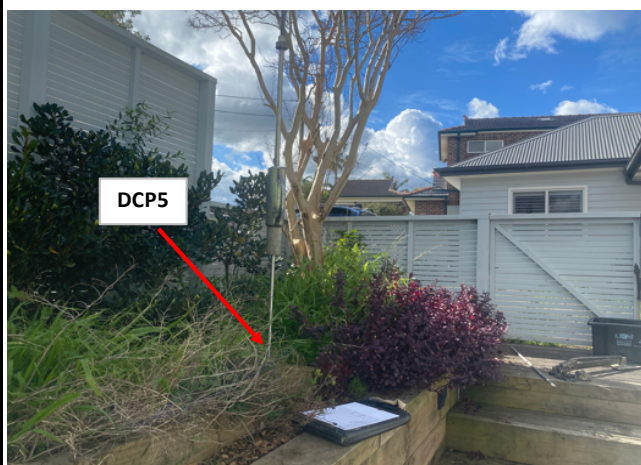
**Photo 5** - Northeast view of DCP5 test location.
