Arboricultural Impact Assessment

307 Sydney Road Balgowlah

Version 1

16th September 2025

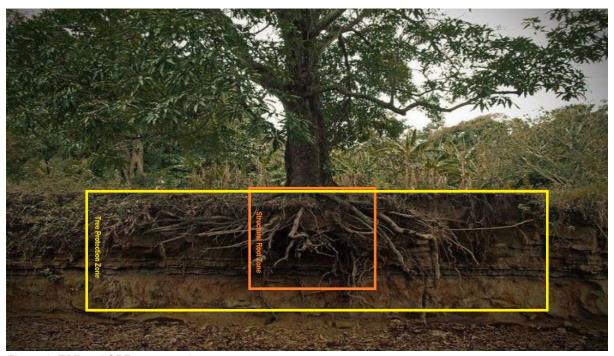
Figure 1: TPZ and SRZ cross section

The Structural Root Zone (SRZ) represents the minimum area required to maintain tree stability without consideration to the ongoing health of the tree. Severing roots within the SRZ that are >50mm is not recommended as it may lead to the decline or structural failure of the tree/s

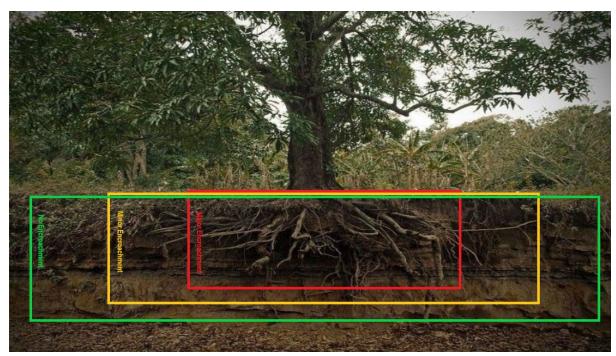
Figure 2: Encroachment zones

- No Encroachment: No likely foreseeable encroachment within the TPZ,
- **Minor Encroachment (<10%):** If the proposed encroachment within the TPZ is less than 10% and there is no encroachment into the SRZ then detailed root investigations should not be required. The area that has been encroached upon should be compensated for elsewhere and be contiguous with the TPZ,
- Major Encroachment (>10%): The project arborist must be able to demonstrate that the subject tree/s remain viable if the encroachment is greater than 10%. The area that has been encroached upon should be compensated for elsewhere and be contiguous with the TPZ,

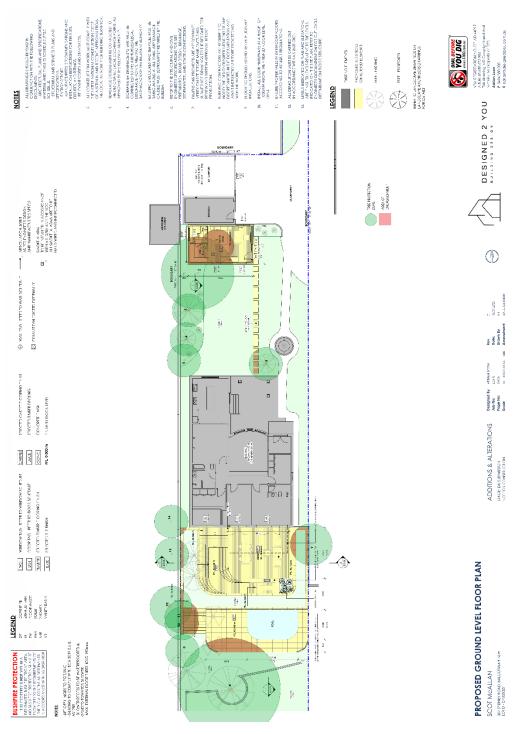
Below is an image of the tree locations showing the TPZ and encroachments.

Figure 3: Tree locations

Numbered tree locations can be found in Figure 3.

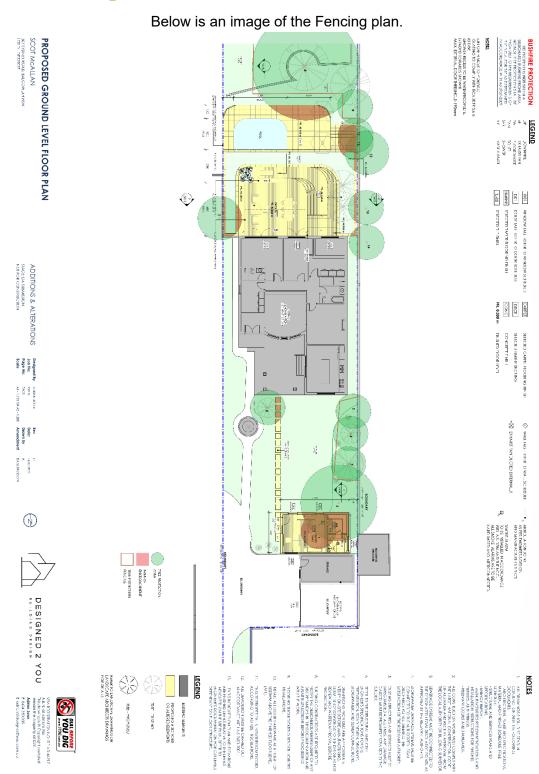
TPZ Fencing Plan

Figure 4: Fencing Plan - Fence in brown

Tree protection fencing must be established in the locations shown in *Figure 4*. Existing fencing, site hoarding or structures (such as a wall or building) may be used as tree protection fencing, providing the TPZ remains isolated from construction footprint.

- Enclosed to the full extent of the TPZ (or as specified in the Specifications and Tree Protection Plan).
- Temporary mesh panel fencing (minimum height 1.8m).
- Certified and inspected by the project arborist.
- Installed prior to the commencement of works.
- Prominently signposted with 300mm x 450mm boards stating, "NO ACCESS TREE PROTECTION ZONE".

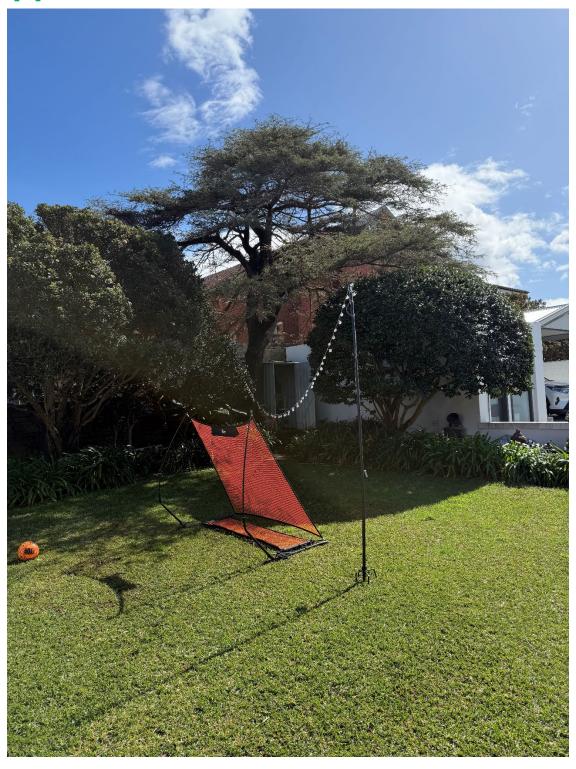
Figure 5: Trees 1, 2 and 3

0.0%	1.5	2.0	Consider for removal	Short 5-15Y	MoT	poor structure. Crown has been shaped.	Poor	Good	10	Mature	3	5	Camellia	sasanqua	Camellia	Т4
	0.0%	1.5	2.0	Consider for removal	Short 5-15Y	Low	poor structure. Crown has been shaped.	Poor	Good	10	Mature	3	5	Camellia	sasanqua	Camellia	ТЗ

22.2%	2.1	4.1	Consider for removal	Short 5-15Y	Medium	Tree in early stages of decline	Fair	Poor	34	Mature	7	9	deodor cedar	decora	Cedrus	T2
	100.0%	1.5	2.0	Consider for removal	Short 5-15Y	МОТ	poor structure. Crown has been shaped.	Poor	Good	10	Mature	8	5	Camellia	sasanqua	Camellia	Т1
Comments	Radius SRZ Radius Encroachment (M) (%)	SRZ Radius (M)	TPZ Radius (M)	Retention Priority	Useful Life Expactancy	Significance	Defects	Health condition	Health	DBH (CM)	Age Class	Canopy Spread (M)	Height (M)	Common Name	Species	Genus	Survey Number
							Results										
				8algowlah	Sydney Road Balgowlah	t - 307 Syd	Arboricultural Impact Assessment - 307	ultural In	borice	Ar						ect Name:	Proj

- Trees 1, 2, 10 and 11 (**4 trees**) have an unacceptable encroachment to the TPZ and or SRZ and will not be able to be retained if the proposal is to proceed.

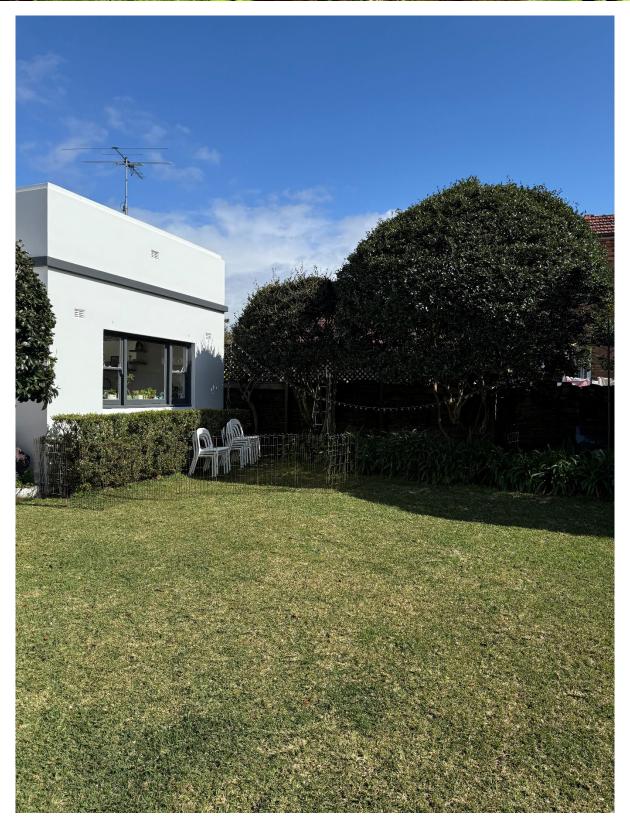
Figure 6: Trees 4 and 5

11.0%	1.5	2.0	Consider for removal	Short 5-15Y	Low	poor structure. Crown has been shaped.	Poor	Good	10	Mature	3	5	Camellia	sasanqua	Camellia	Т6
	0.0%	1.5	2.0	Consider for removal	Short 5-15Y	MoT	poor structure. Crown has been shaped.	Poor	Good	10	Mature	3	5	Camellia	sasanqua	Camellia	Т5

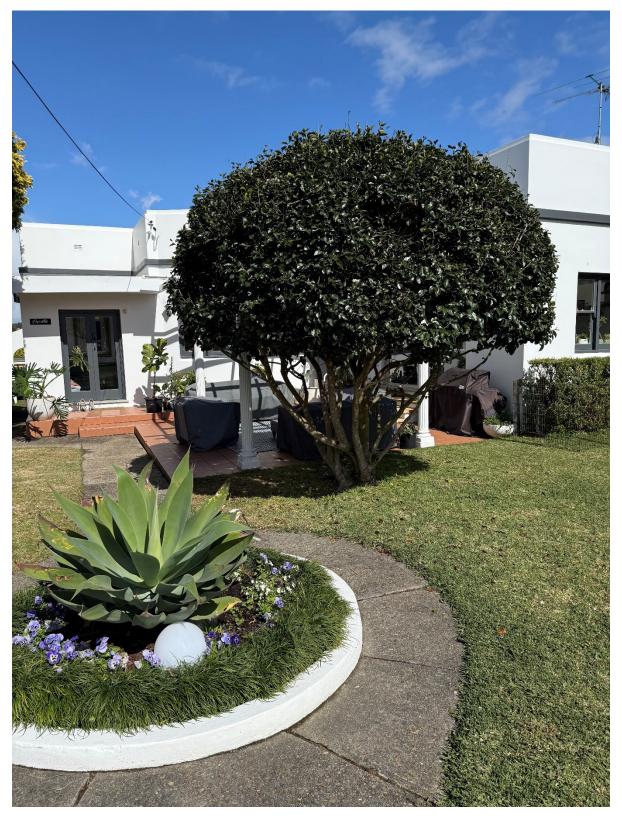
Figure 7: Tree 6

- Tree 6 will have a major below ground encroachment of around 11.0% due to the placement of the steppingstones for the footpath. This encroachment is expected to be minimal as the pavers require minimal excavation.

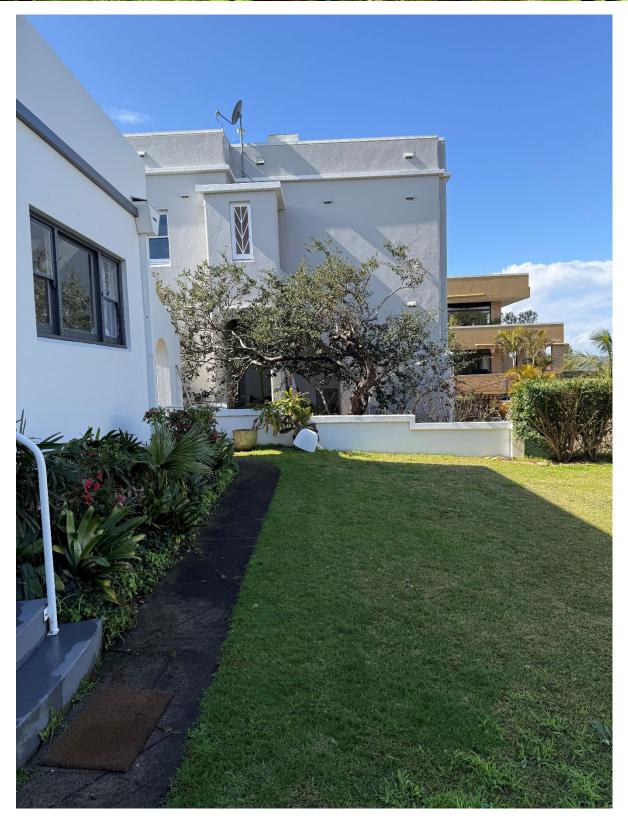
Figure 8: tree 7

0.0%	1.5	2.0	Consider for removal	Short 5-15Y	Low	Pruned top form a hedge	Poor	Good	15	Mature	8	6	Cypress	spp.	Cupressus	Т9
	7.6%	2.6	6.6	Consider for retention	Medium 15- 40Y	Medium		Good	Good	55	Mature	8	12	Date Palm	canariensis	Phoenix	Т8
Neighbouring tree	9.7%	1.8	2.6	Consider for removal	Short 5-15Y	Medium		Poor	Poor	22	Scenesc ent	10	6	Olive	europaea	Olea	17

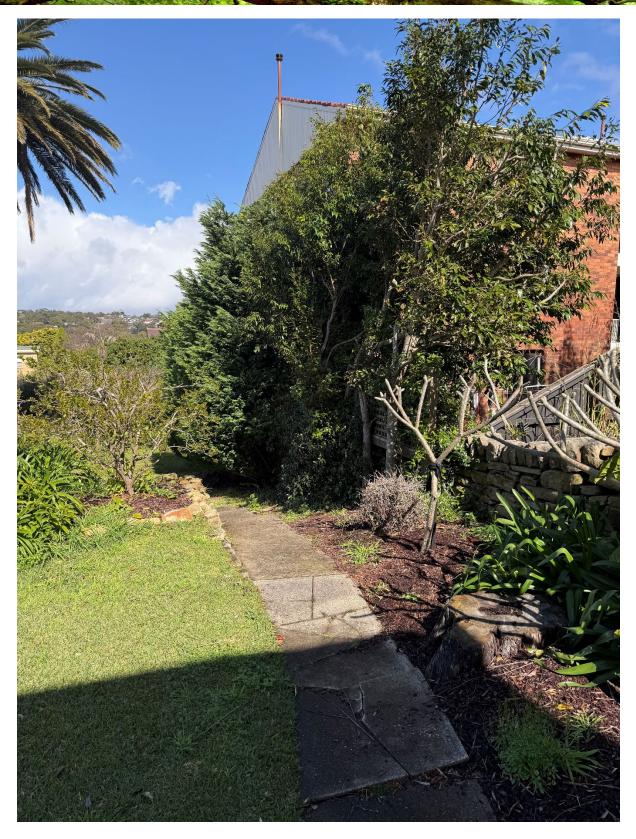
Figure 10: Trees 9-11

- Trees 1, 10 and 11 (3 trees) are located within the proposed building footprint.
 These trees will not be able to be retained if the proposed development is to proceed.

100.0%	1.5	2.0	Consider for removal	Remove 0- 5Y	Low	lopped	Poor	Good	12	Mature	3	6	Lilly Pilly	spp.	Syzygium	T11
	100.0%	1.5	2.0	Consider for removal	Remove 0- 5Y	Low	lopped	Poor	Good	12	Mature	3	6	Lilly Pilly	spp.	Syzygium	Т10

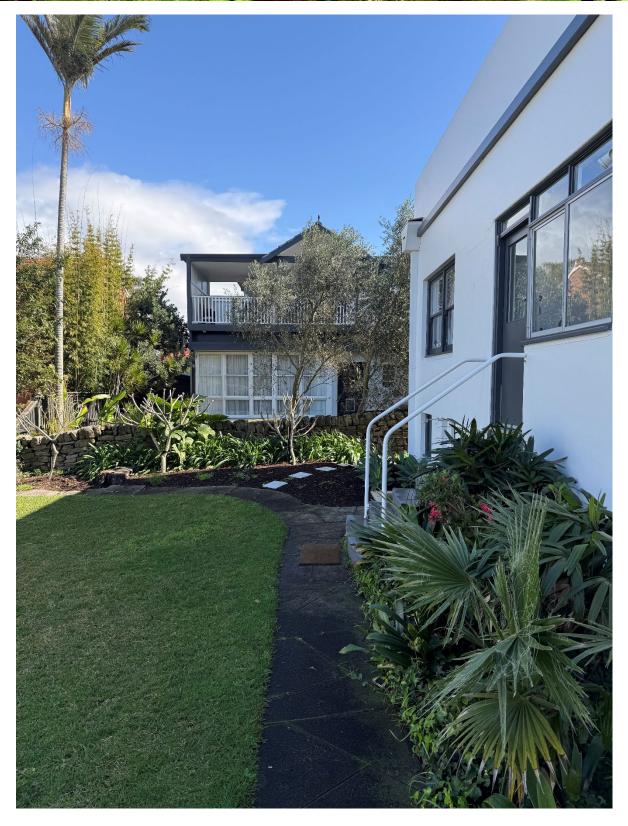
Figure 11: Trees 12-14

- Trees 12 and 13 (**2 trees**) will have a major below ground encroachment of around 12.2% and 17.7% respectively due to the proposed pool stairs and garden edging. This encroachment is not expected to have a significant impact as the garden edging will require only minor excavation. These trees will be able to be retained if the proposed development is to proceed.

Neighbouring tree	4.5%	1.5	2.0	Consider for removal	Short 5-15Y	Low		Fair	Good	∞	Semi Mature	2	5	Olive	europaea	Olea	T14
Neighbouring tree	17.7%	1.5	2.0	Consider for removal	Short 5-15Y	Low		Fair	Good	∞	Semi Mature	2	5	Olive	europaea	Olea	Т13
Neighbouring tree	12.2%	1.7	2.4	Consider for retention	Medium 15- 40Y	Medium		Good	Good	20	Mature	5	13	Bangalow Palm	cunninghamii	Archontophoenix cunninghamii	Т12
