13th April 2023

Mr Abel Bornstein 15 Quirk Street DEE WHY NSW 2099 D-1378

Re: Geotechnical Report - Alterations and Additions at 15 Quirk Street, DEE WHY

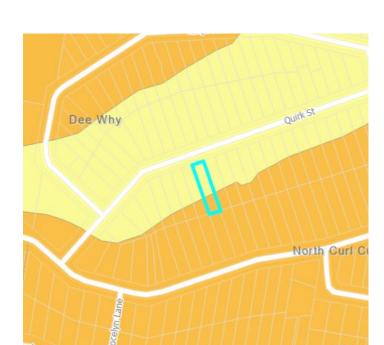
Figure 1: Land slip risk map for 15 Quirk Street, DEE WHY NSW 2099 (site location marked in Blue), in Area "A" & "B".

I, Edward A Bennett, practicing civil, structural, geotechnical & environmental engineer, hereby confirm that our company has inspected the above site for the proposed residential development consisting of Alterations & Additions and confirm that by review of Councils Policy, a full geotechnical report is unnecessary for properties in Area "A" & "B" of the Warringah LEP 2011 Land Slip Risk Map, refer below.
