# Long-Term Environmental Management Plan

Warriewood Community Centre, 4 Jacksons Road, Warriewood

2540-EMP-01-200125.v2d

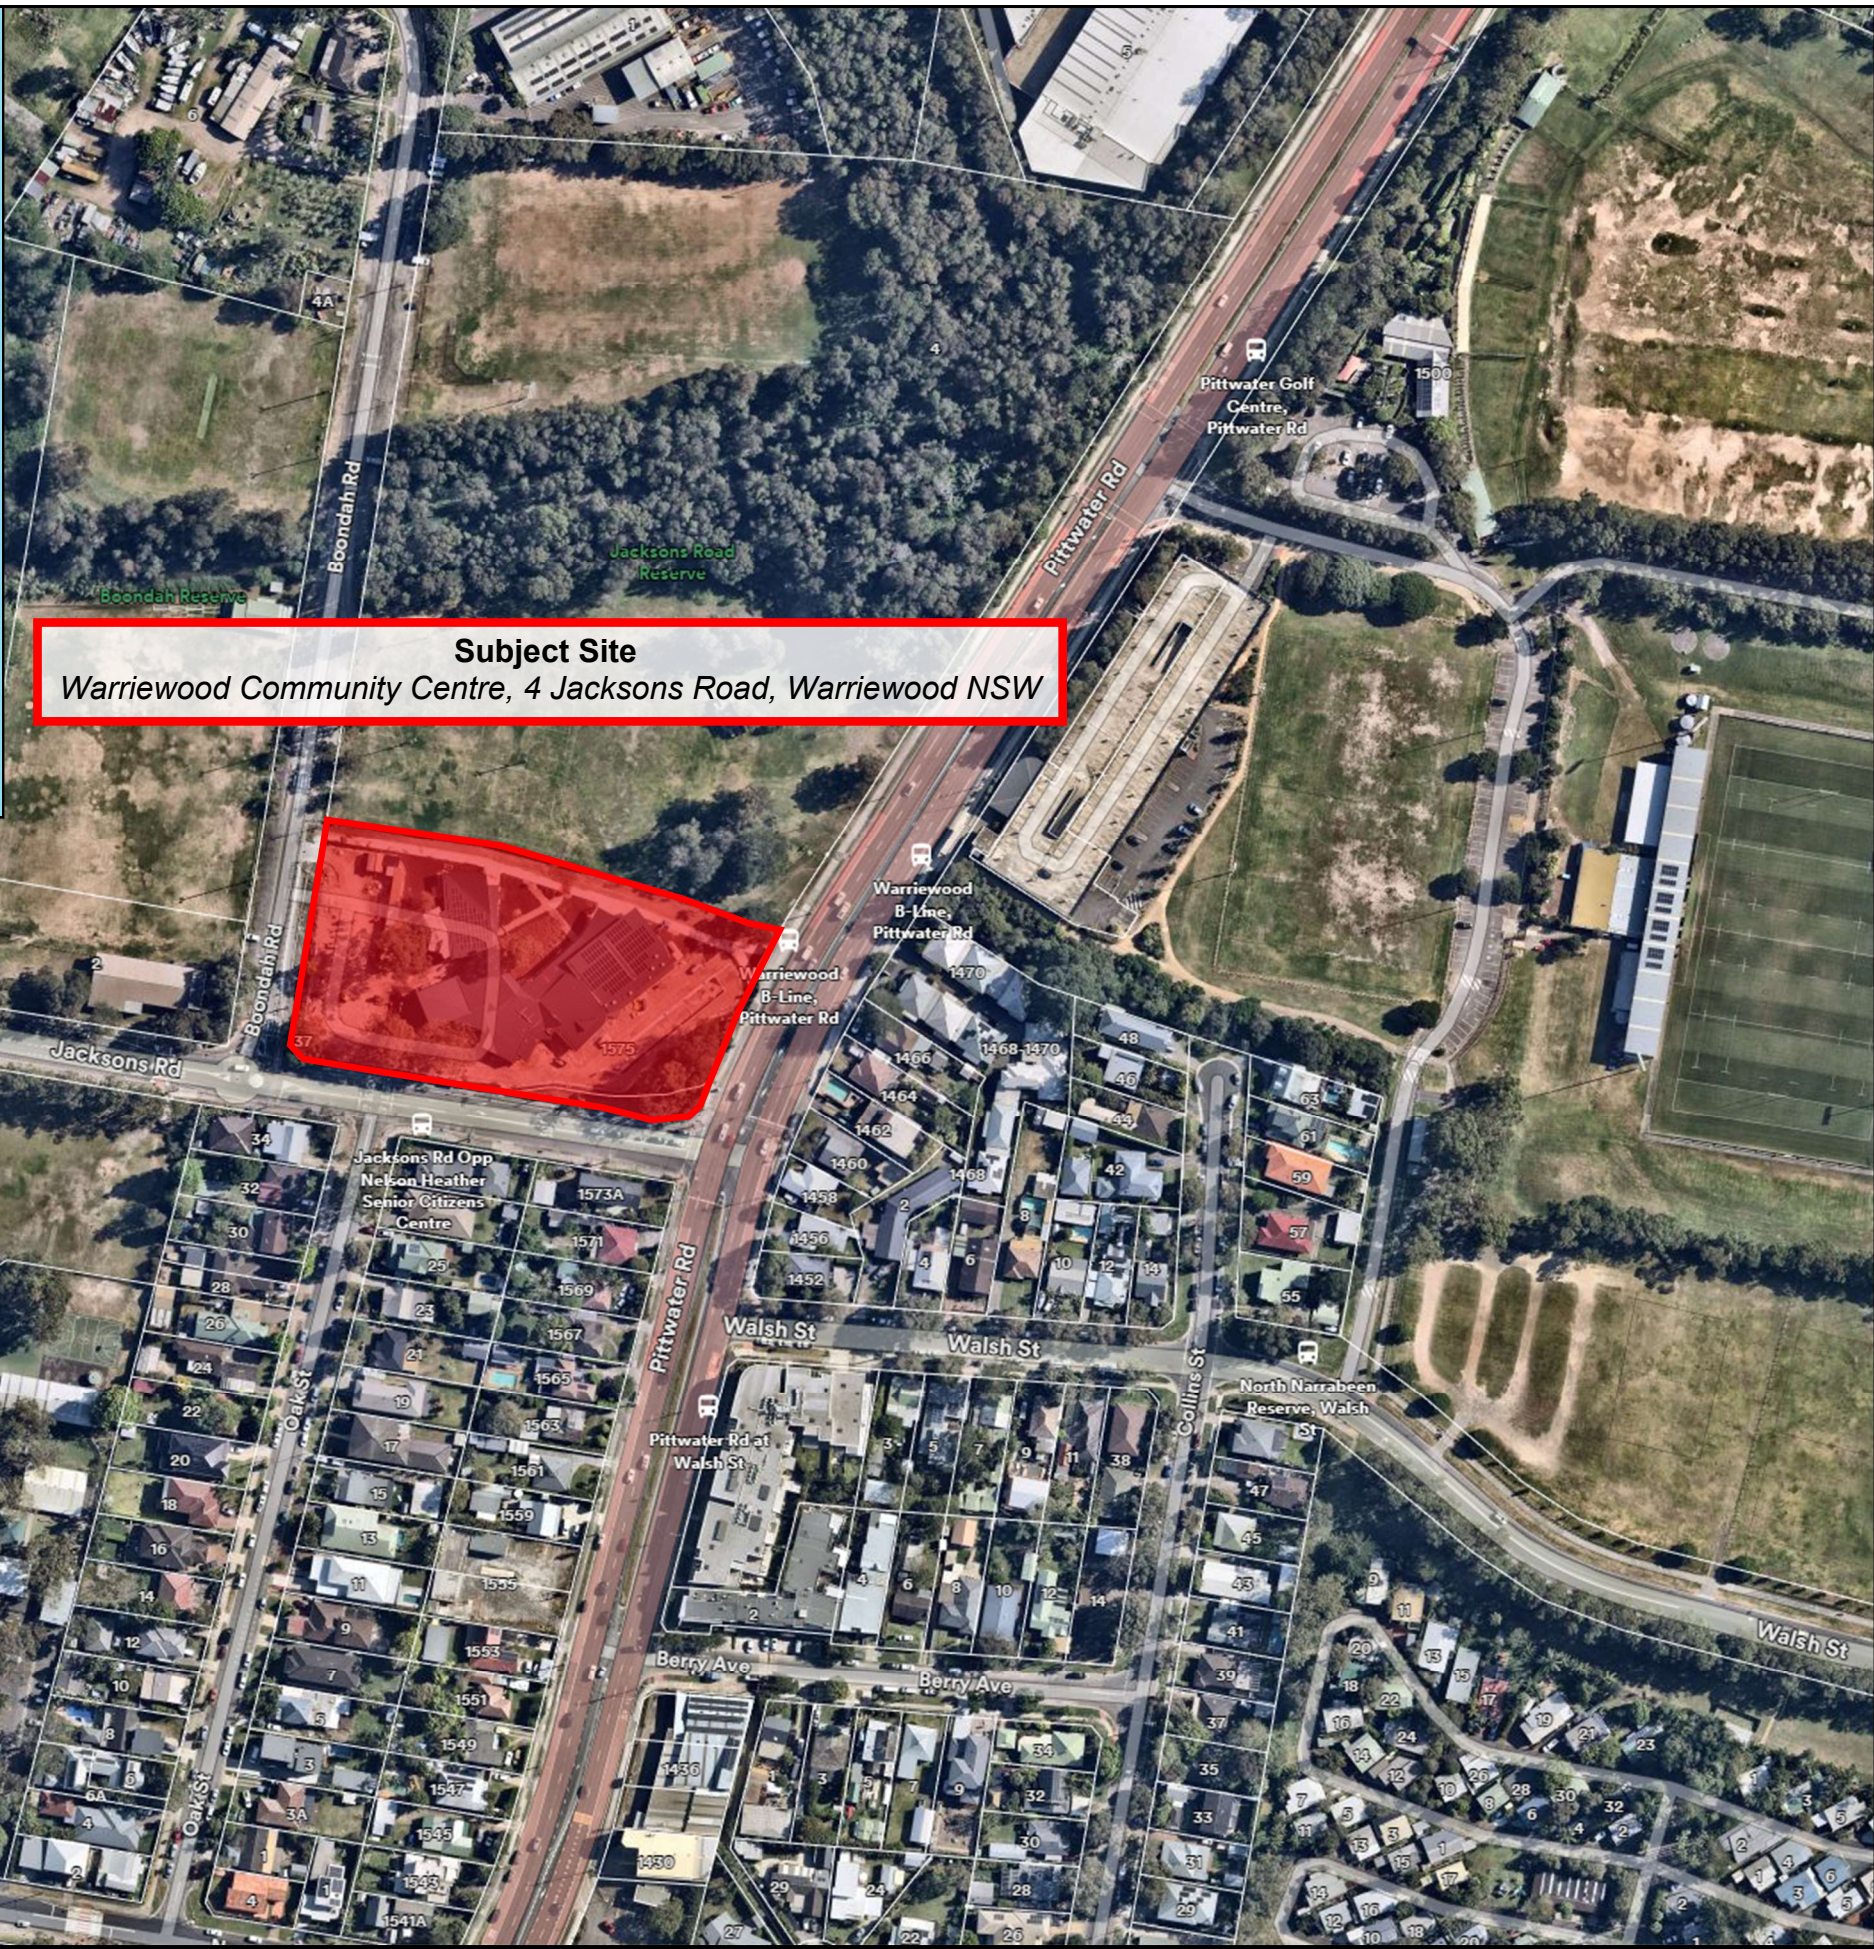
**Subject Site**  
Warriewood Community Centre, 4 Jacksons Road, Warriewood NSW

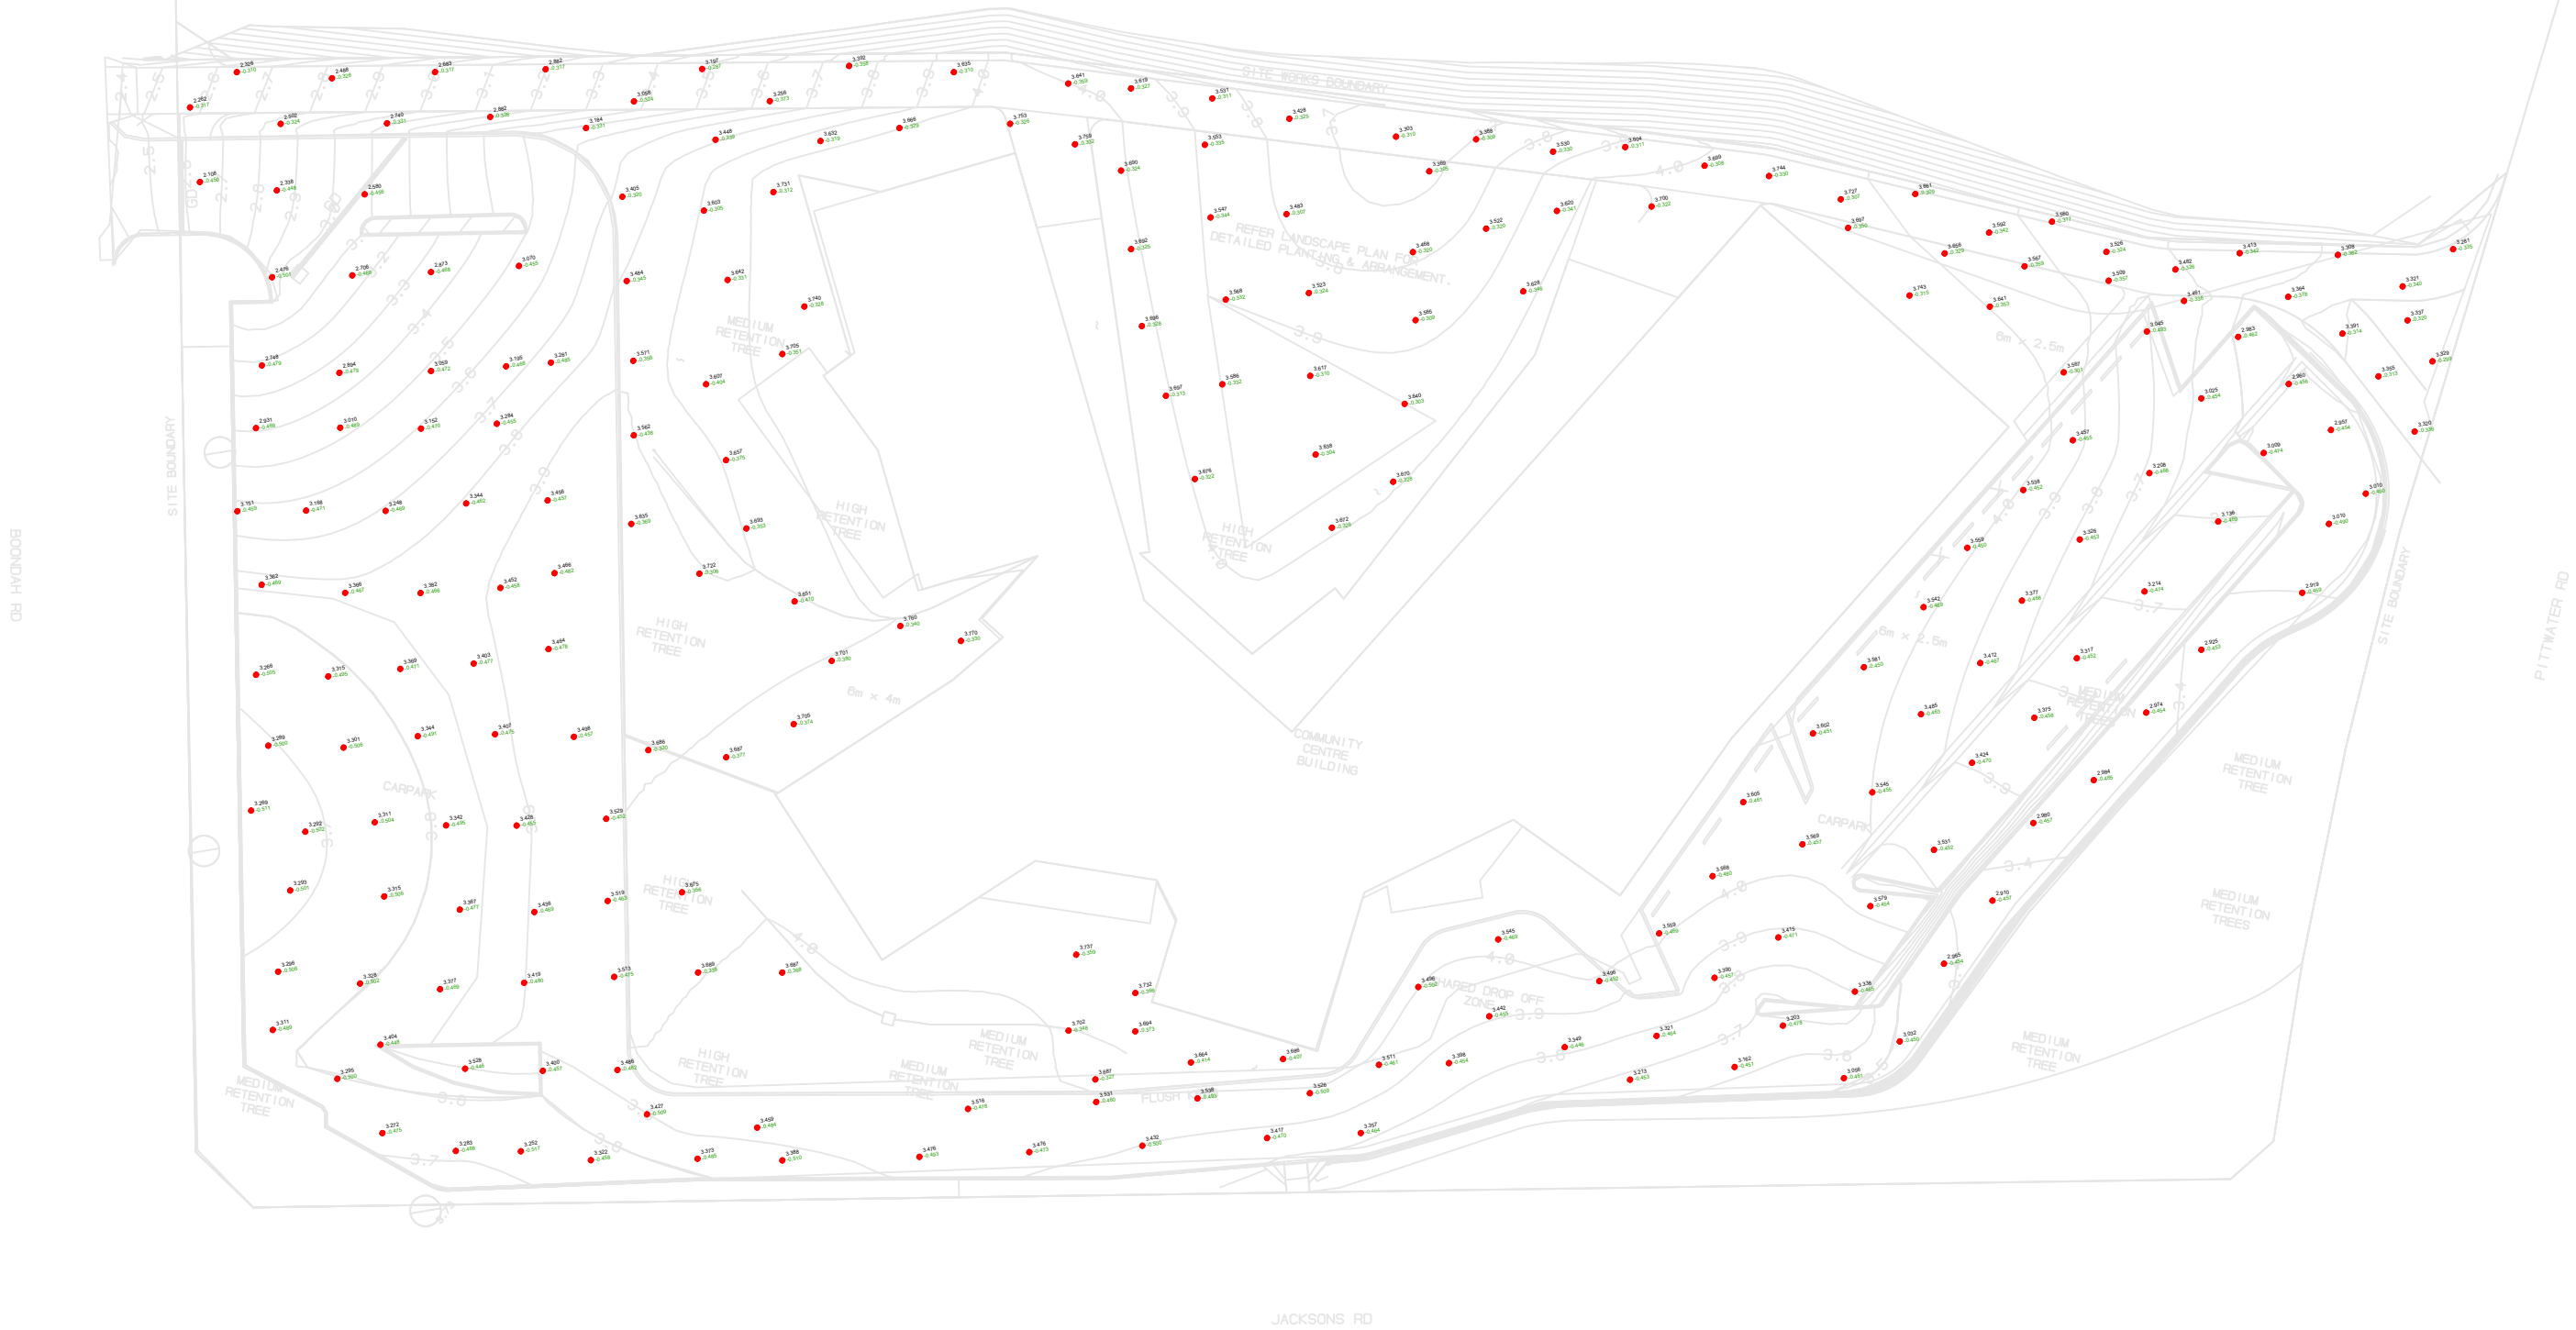
NOTES: MARKER LAYER DATA SUPPLIED BY TCE - SITE ROVER SURVEY  
GREEN NUMBER SHOWS DEPTH OF MARKER LAYER FROM DESIGN FSL  
BLACK NUMBER SHOWS RL OF MARKER LAYER

The geotextile marker layer exists between 0.302 – 0.506 RL across the site. A survey was not conducted for the marker layer located beneath the building footprints; however the marker layer is present immediately below the blinding concrete surfaces, and any disturbance of the concrete slab should be considered to impact the marker layer below.
