# **A Waterways Impact Statement**

**Lot 810 (No 74) in DP 752038 Willandra Road  
NARRAWEENA NSW 2099**

*Woodlots and Wetlands Pty Ltd  
220 Purchase Road  
Cherrybrook  
NSW 2126*

This Waterways Impact Statement concerns Lot 810 in DP 752038 (No 74) Willandra Road NARRAWEENA NSW 2099 (application DA2014/1164 (as modified)). A boarding house is proposed for lot 810. There are minor creases and depressions in lot 810 however these are not continuous and become indiscernible. They do not have defined beds or banks. They are therefore not considered to be 'waterways'.

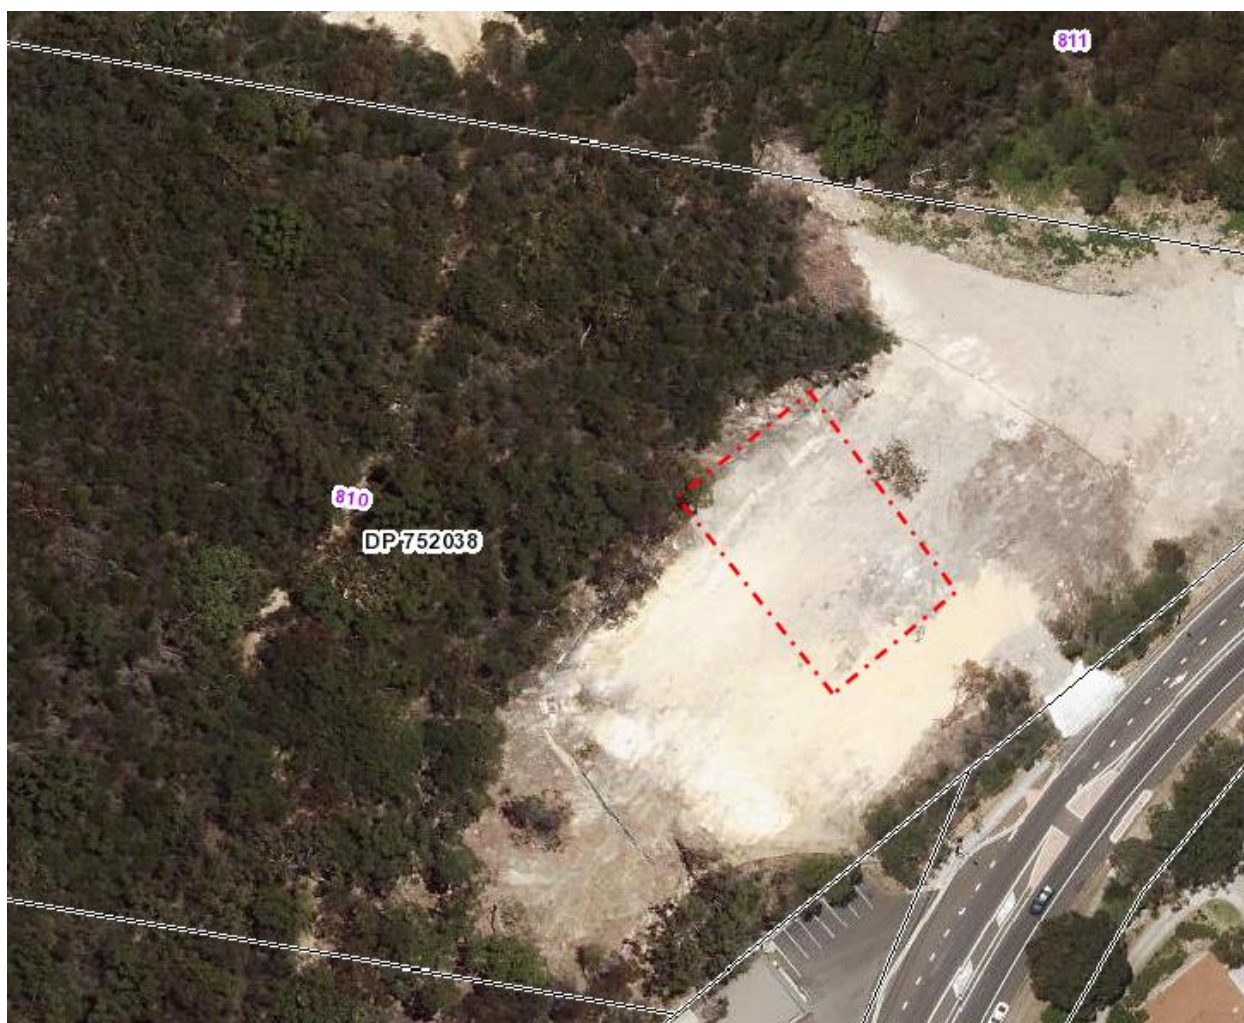
**Figure 2.4. Indicative footprint of the proposed dwelling.**

Figure 2.4 shows that the footprint of the development area is over 8 m away from the commencement point of the waterway. This is more than five times the 10m riparian zone width for a first order stream (Office of Water Guidelines for Riparian Corridors on Waterfront Land (2012a).

Figure 2.4 shows that connection between the bushland and any runoff occurs in the northern half of the adjacent site, lot 811. This is over 100m from the development footprint on lot 810.

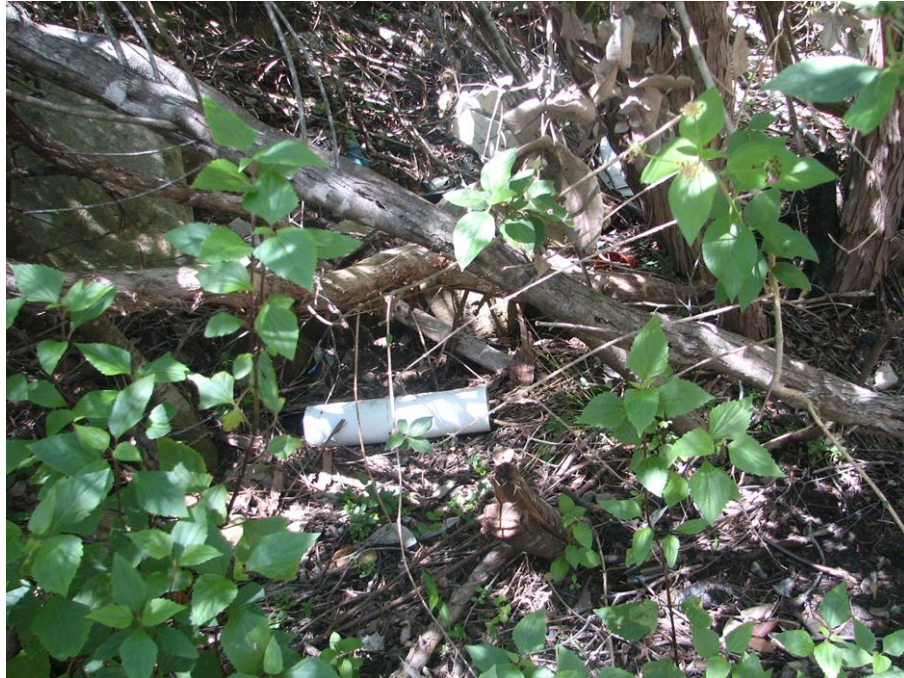
**Figure 2.6.** Prior to clearing the site had large quantities of building rubbish dumped on it. This has now been removed.

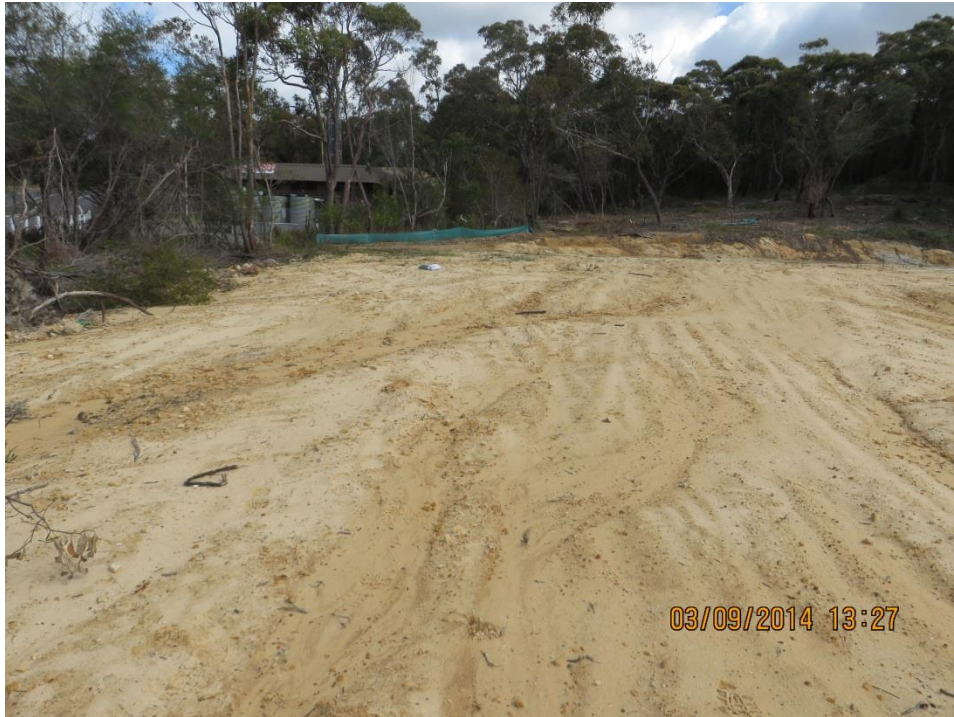
**Figure 2.8. The development area has been cleared and graded to an even easterly aspect slope. The RFS building can be seen in the background.**

Figures 2.7 to 2.9 shows that the southern portion of the lot has been cleared. The clearing has exposed sandy soils. These should be kept covered with vegetative litter and plants to reduce erosion risk.

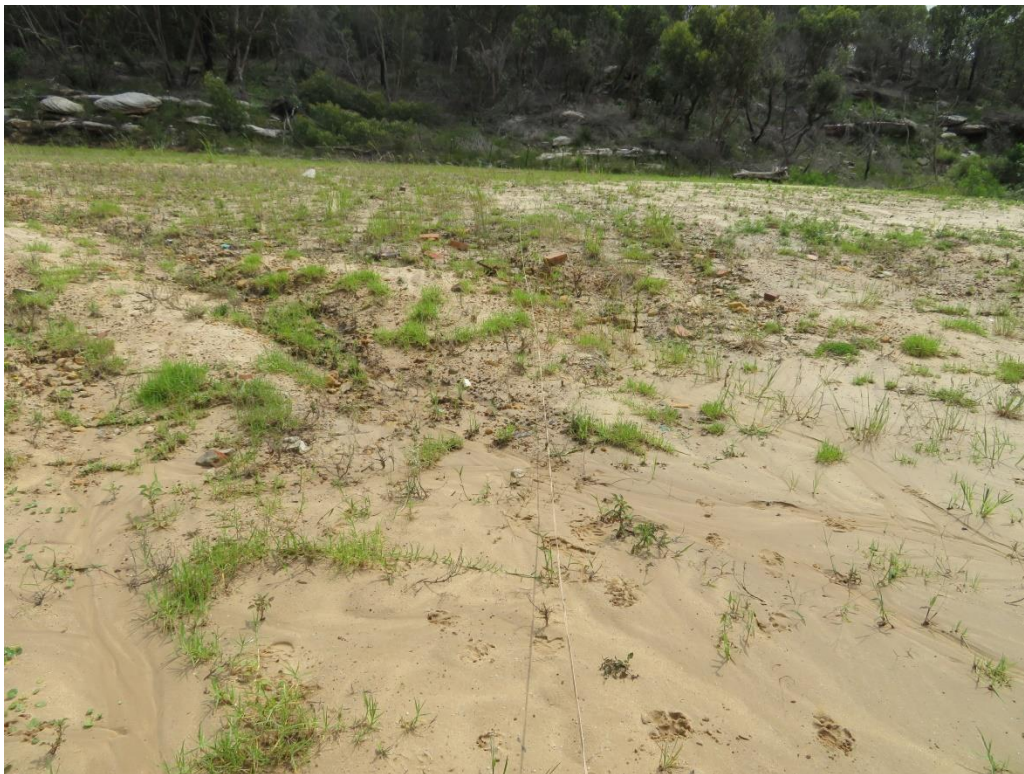
**Figure 2.9. Overview of site looking approximately north west from the SE entry point off Willandra Road. Photo date 20.3.2017.**

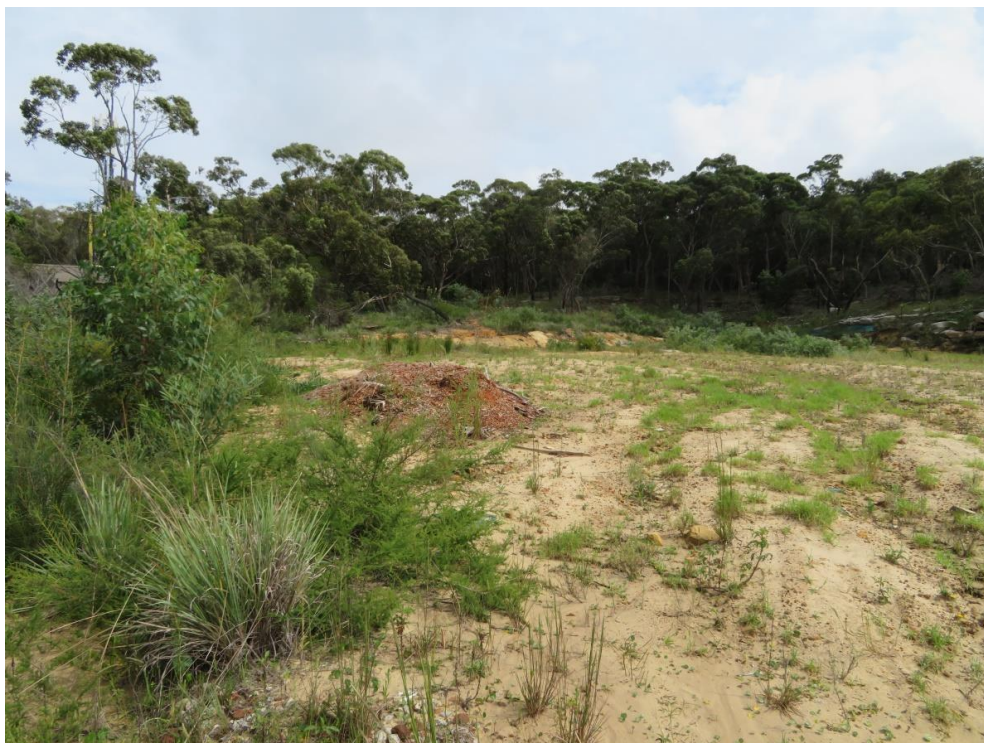
**Figure 2.10. Overview of site looking south west and upslope from the SE entry point off Willandra Road. The RFS building is in the upper LHS of the photo. Photo date 20.3.2017.**

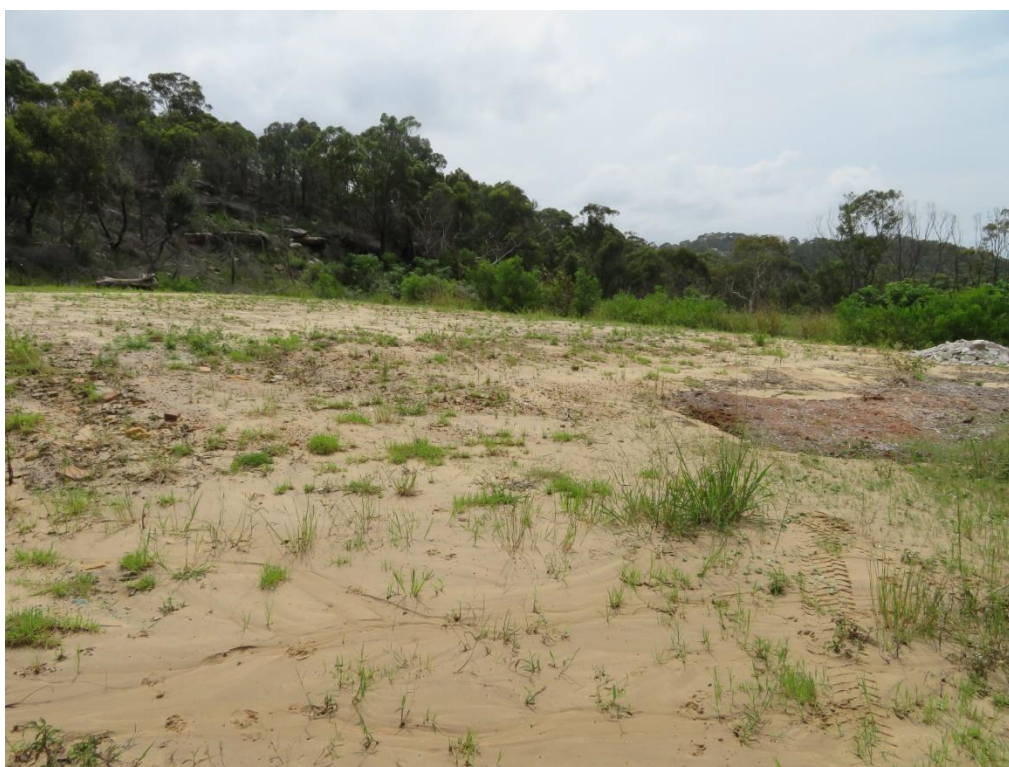
**Figure 2.11. Overview of site looking north from the entry point from the SE entry point off Willandra Road. Photo date 20.3.2017.**

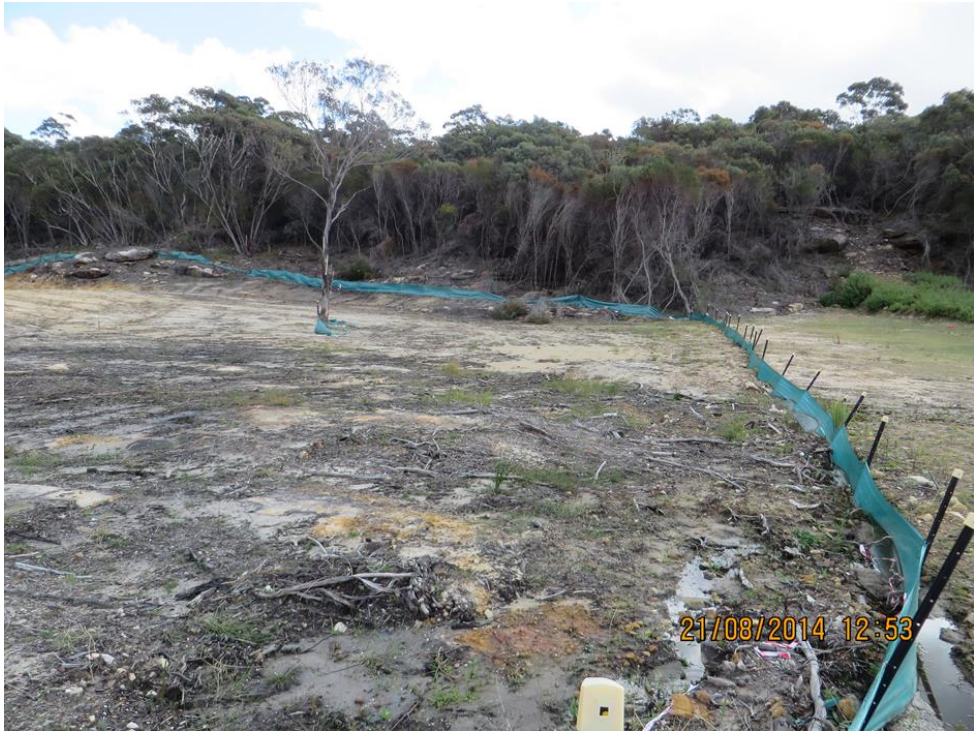
**Figure 2.12. The northern border area of the lot in August 2014.**

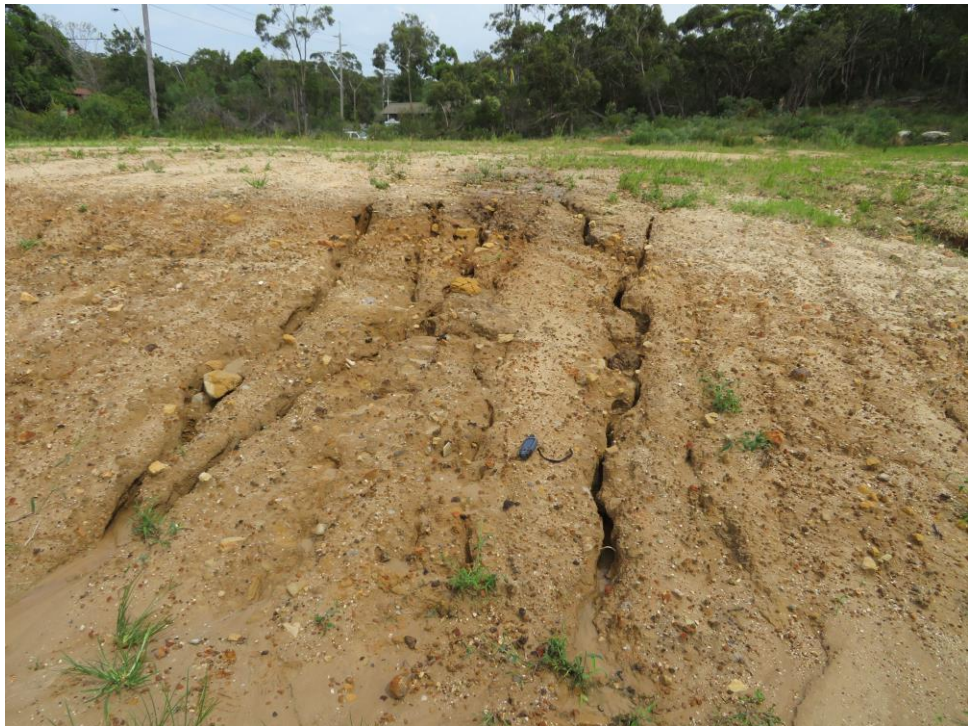
**Figure 2.13. There is a bare slope near the northern border of the development area. This has been eroded since exposure in 2014. It needs to be turfed to prevent further loss of soil.**

Apart from the construction footprint, the entire development area should be turfed.

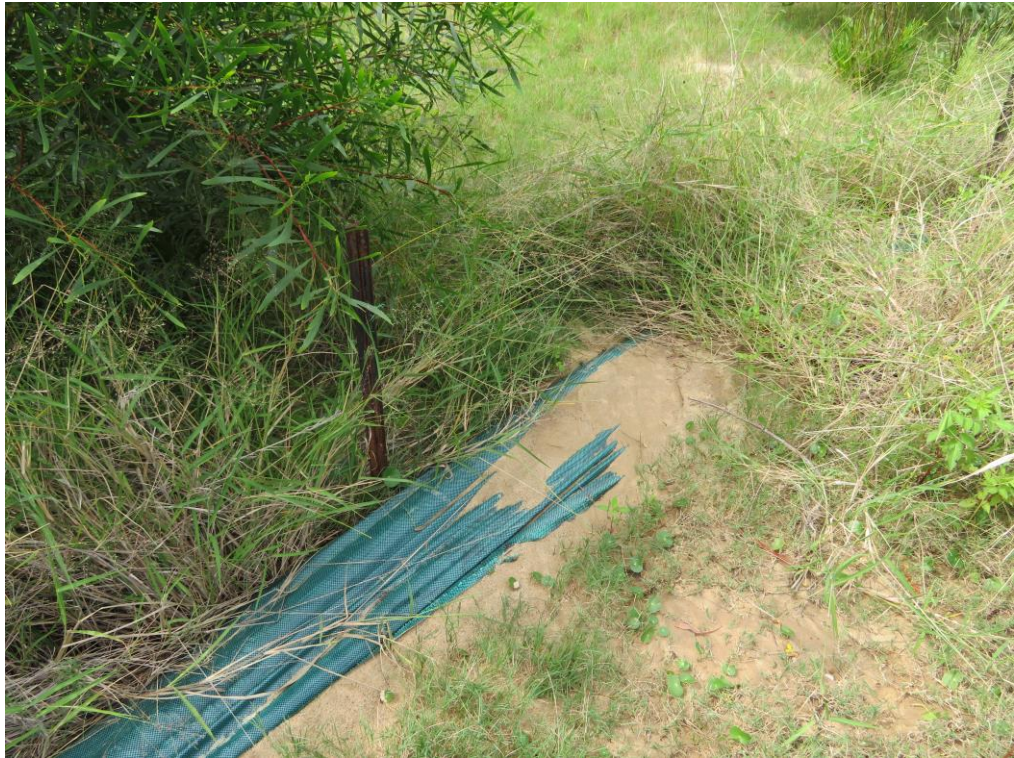
**Figure 2.14. The silt fence parallel to the northern border in March 2017. The native couch grass sward is providing an effective sediment trap. There is minimal 'escape' of sand off the lot and moving north.**

Any 'escaped' sediment is trapped within a few metres.

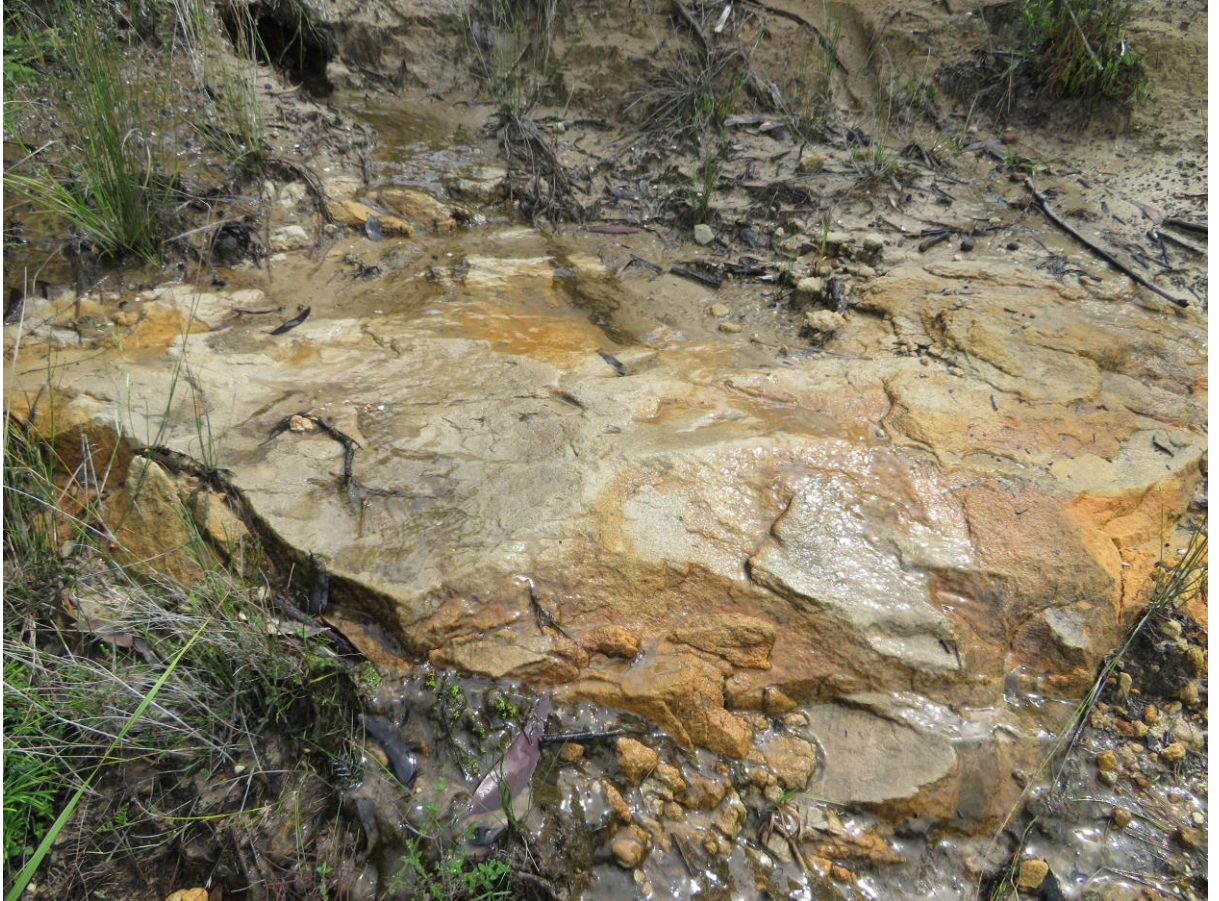
**Figure 3.1. Runoff water flowing over rocks and entering the cleared area (photo 20.3.2017).**

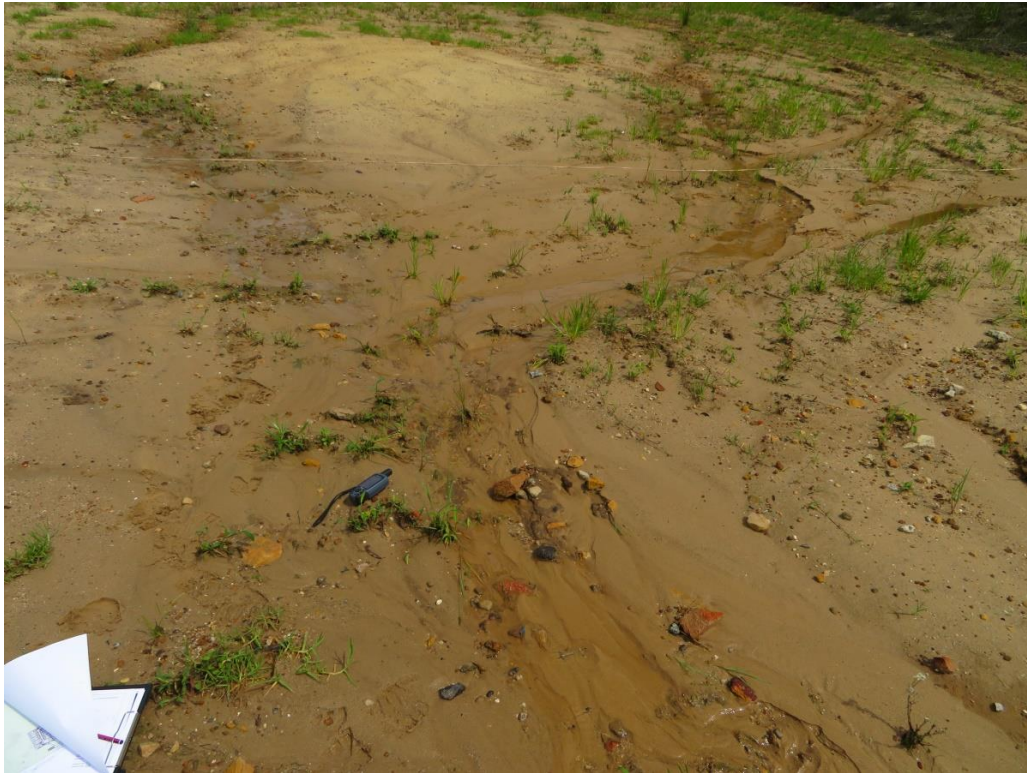
**Figure 3.2. Seepage from the adjacent sandstone hills flows onto the flatter portion of the site and forms braided flow paths. Photo date 20.3.2017.**

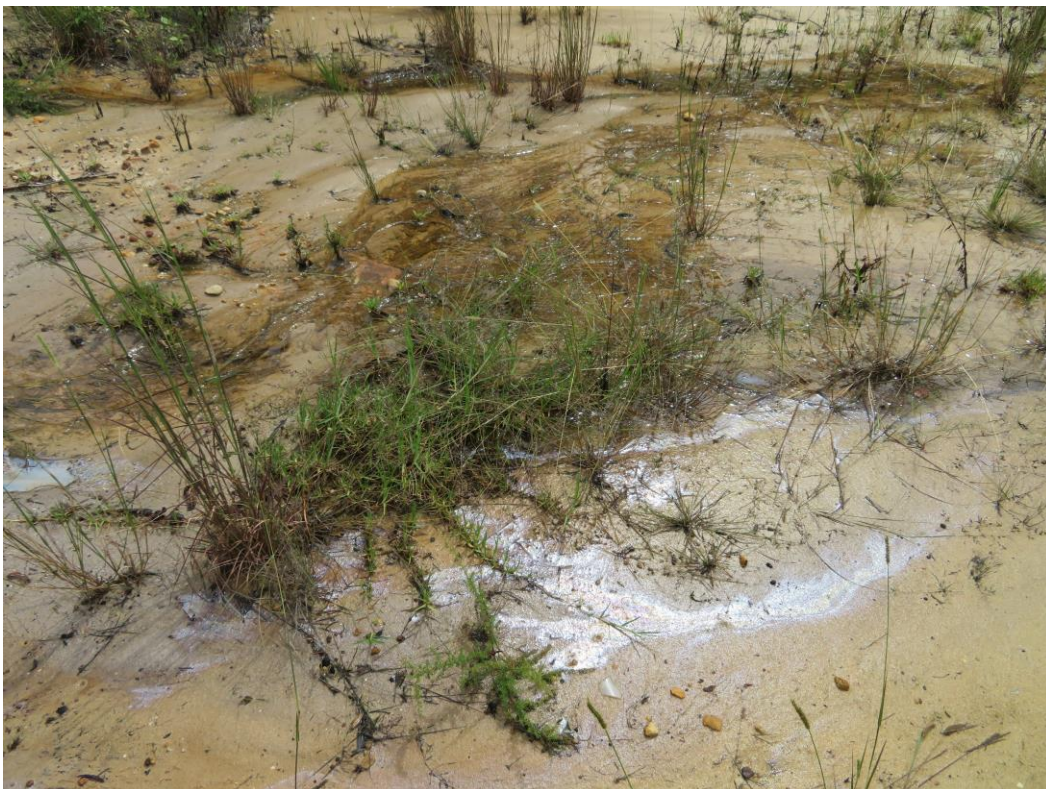
**Figure 3.3. Storm runoff flows within the development area consist of extremely shallow, shifting depressions which have a braided planform. Photo date 20.3.2017.**

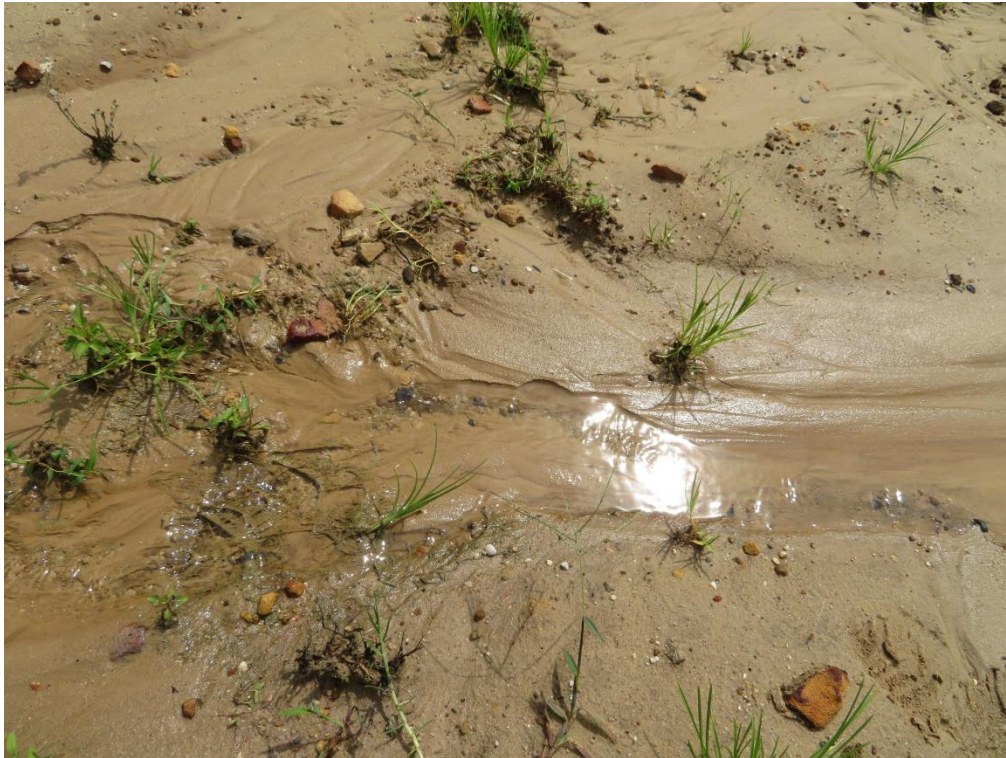
**Figure 3.4.** After prolonged rainfall in March 2017, the widest flow path was 150 to 200 mm wide and a maximum of 3mm deep. Photo date 20.3.2017.

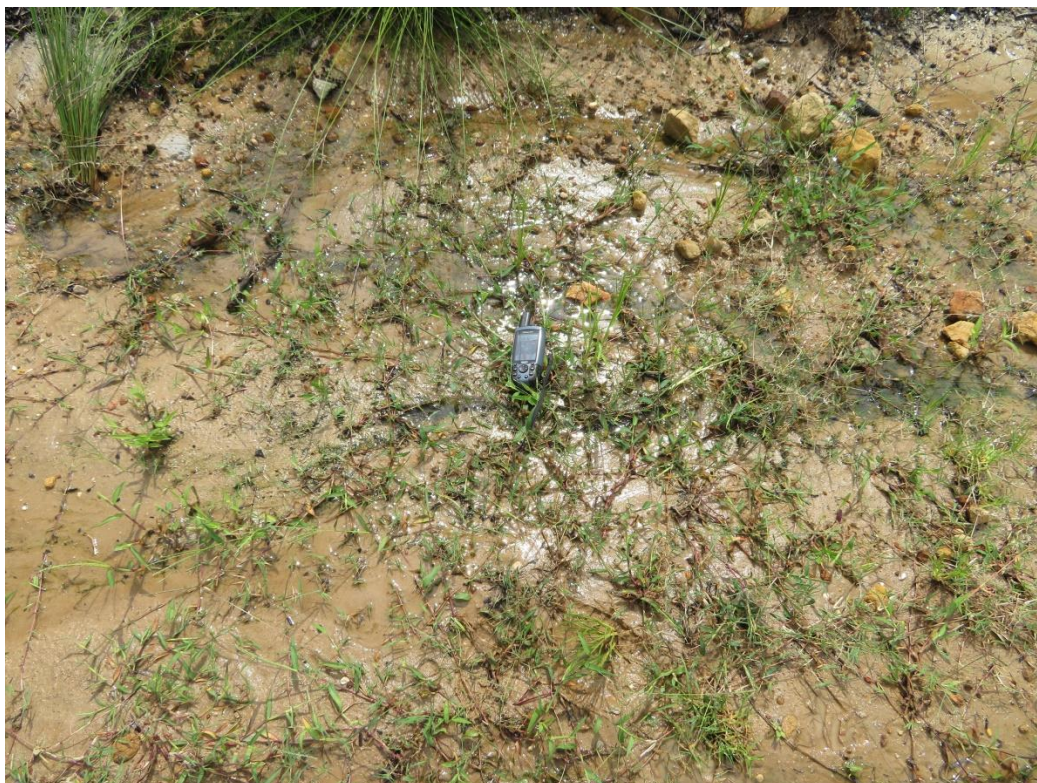
**Figure 3.5.** The stormwater runoff has created saturated sands in some areas during March 2017. Photo date 20.3.2017.

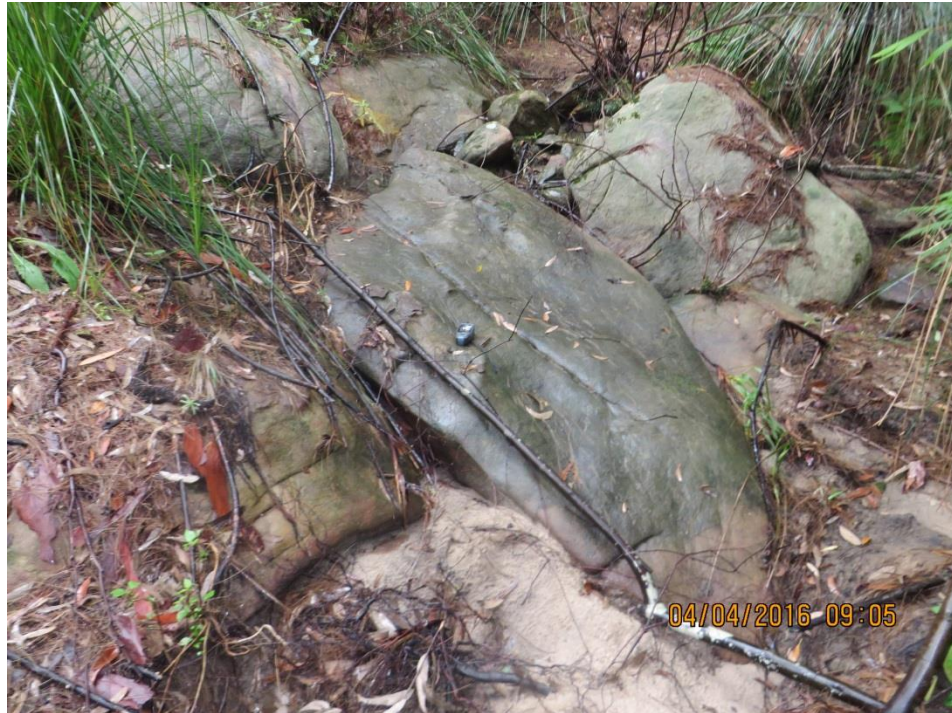
**Figure 3. Site 1.(339341 6264972) flow on, to below and among rocks. The large rock with the GPs on it has water flowing over it. There has been some sand mobilisation during intense rain events.**

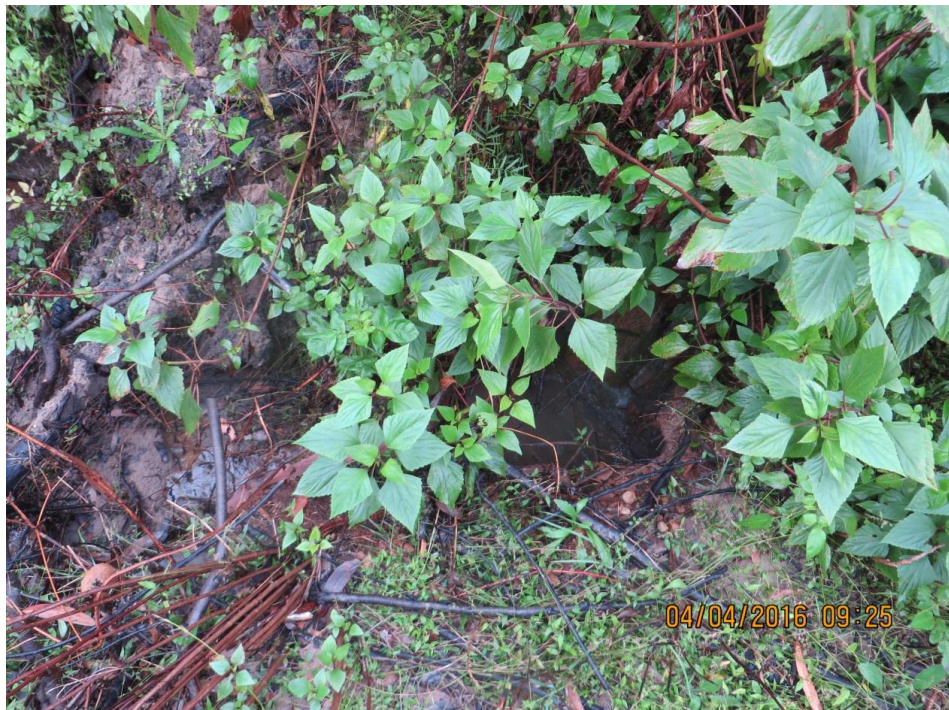
**Figure 5. Site 4. The confluence of 2 minor drainage lines. Some sub-surface flow is evident (339315 6264907).**

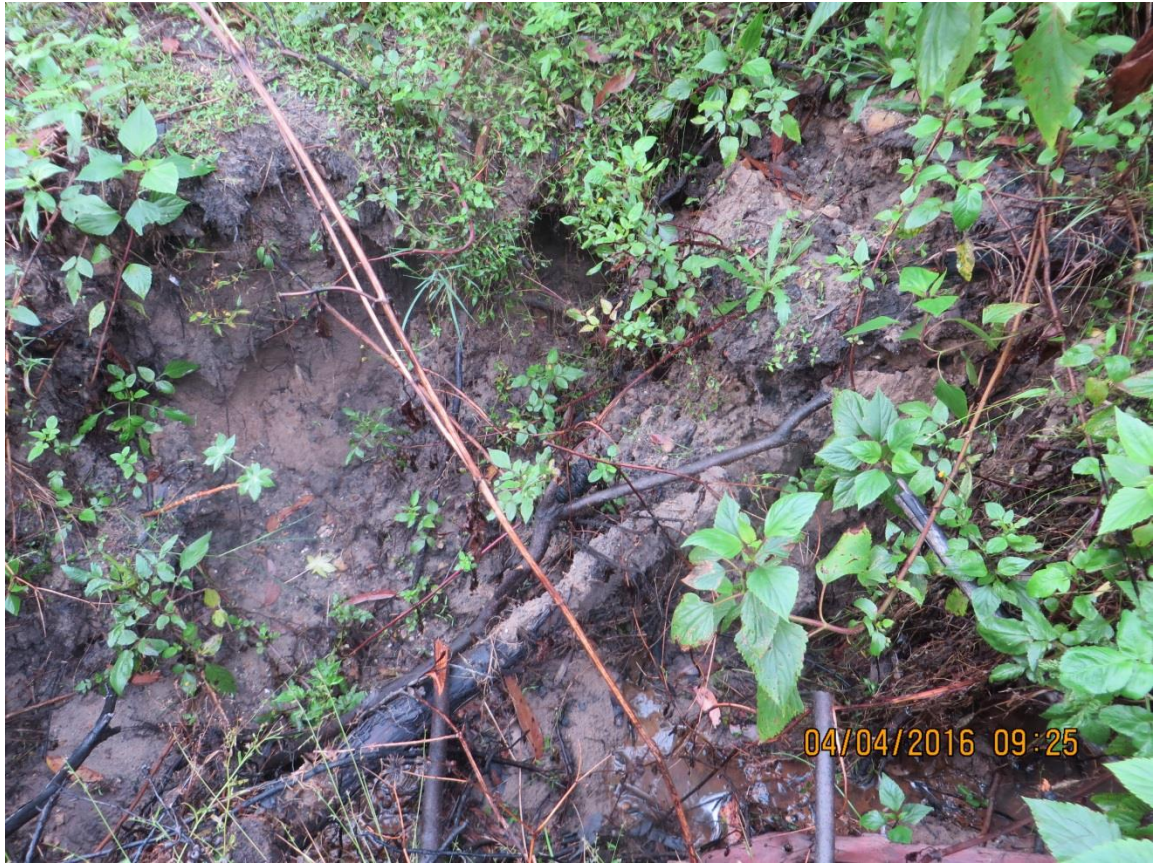
**Figure 6. Site 4. The heavy rainfall has cause local instability of the banks (339315 6264907).**

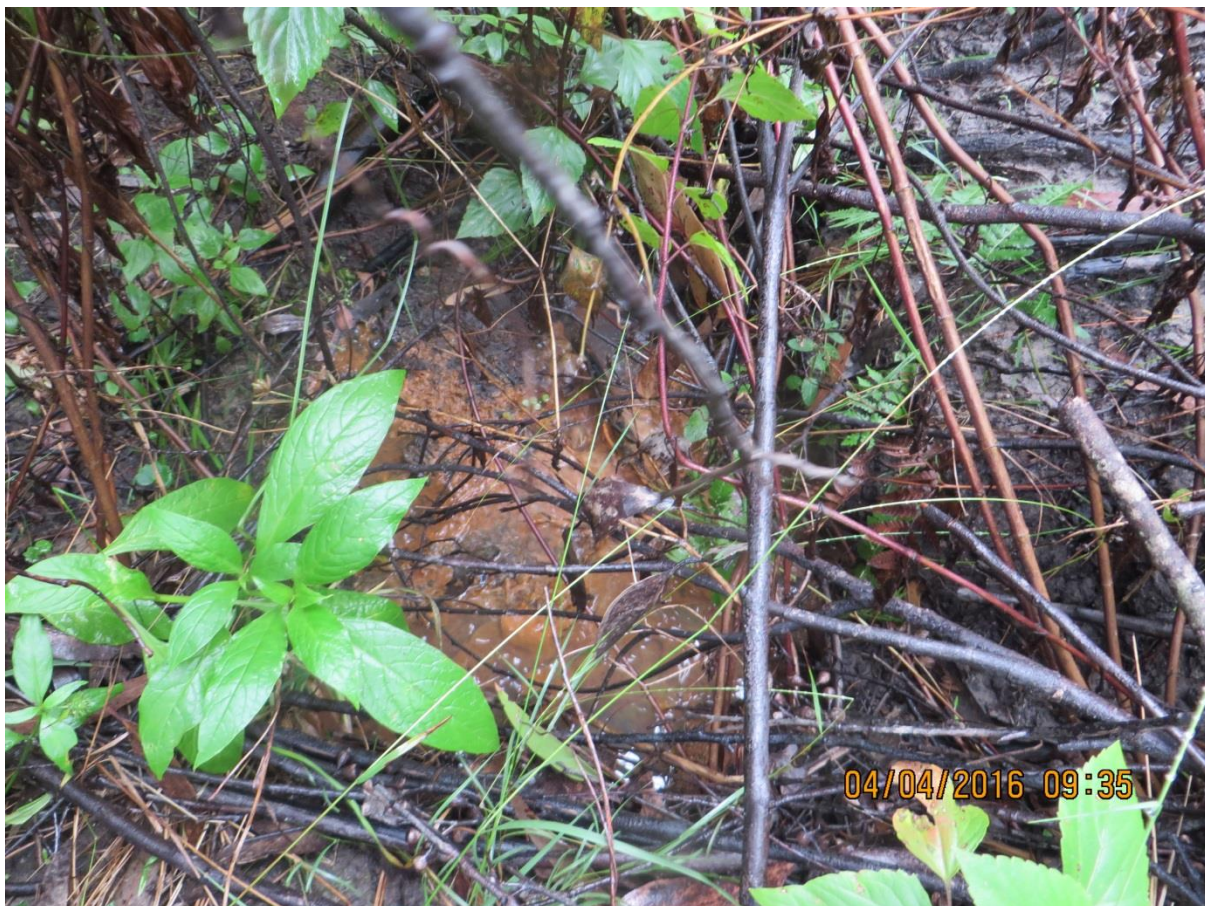
**Figure 7. Site 5 (339311 6264897). There were no watercourse bed or banks at this point. There are some small potholes with water in them. The iron staining suggests seepage from the nearby slope. There was no surface flow. The watercourse appears to commence slightly downslope of the point, near site 4.**
