ARBORICULTURAL IMPACT ASSESSMENT

Lot 12 / DP829988

38 The Drive

Prepared on: 26/05/2022

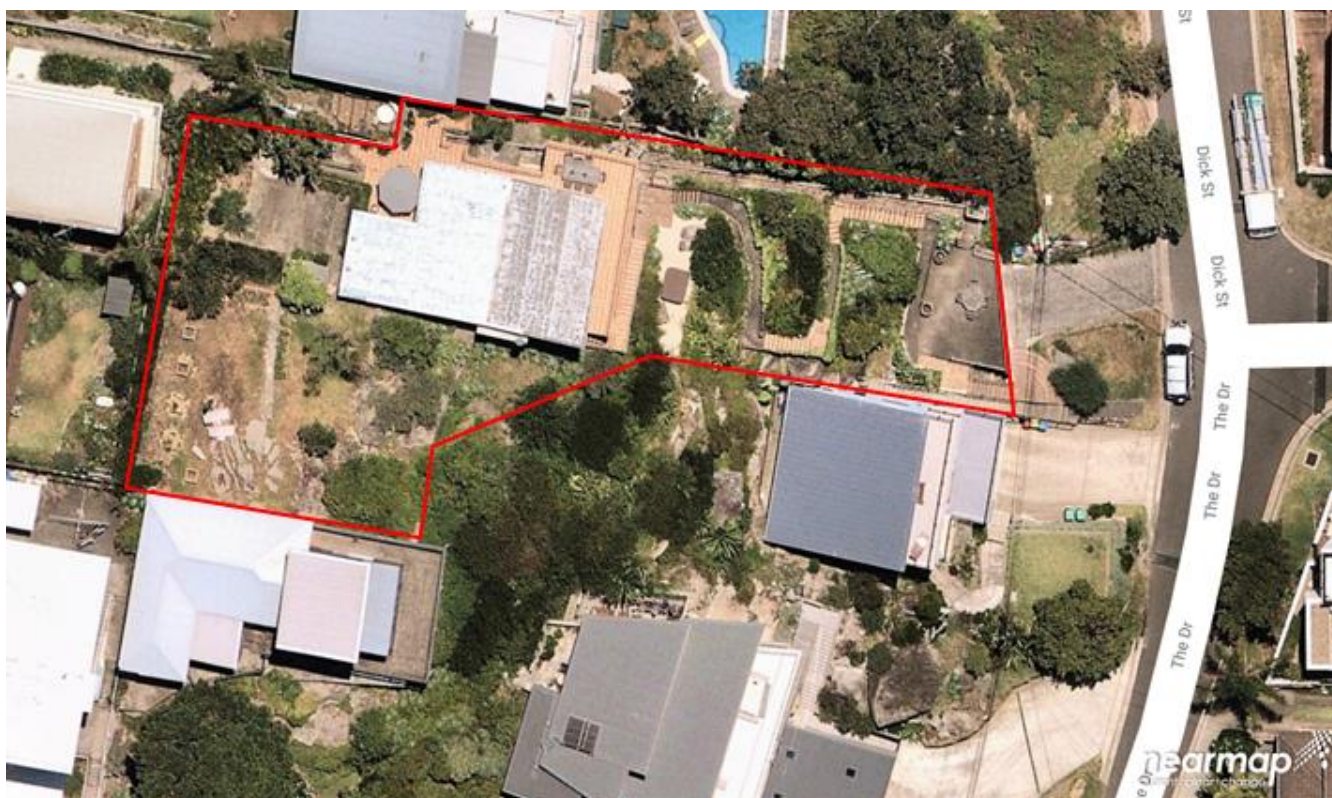
Figure 1: The subject site, site boundary shown in red. (Nearmap, 2021)

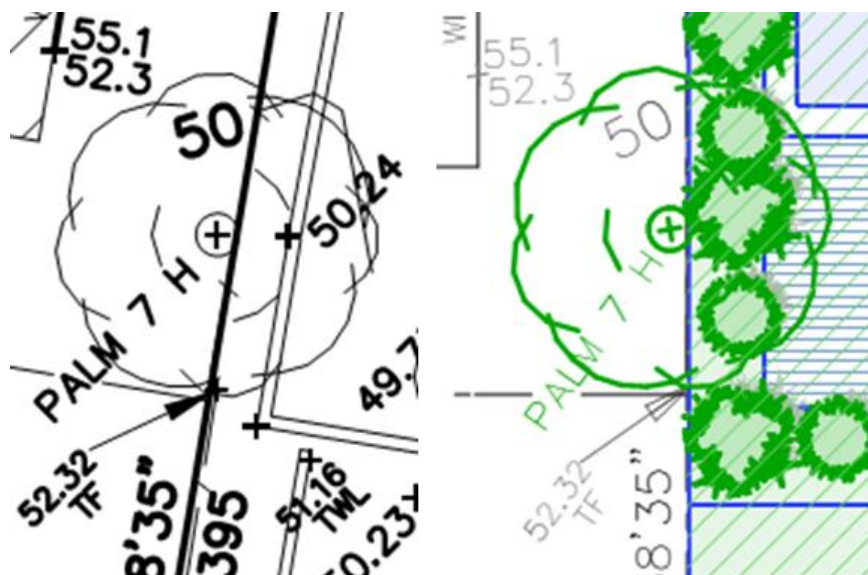
- 6.5 Tree 5 will have a major encroachment of approximately 45% to the TPZ from the proposed pool, surrounding decking and garden. Excavation for the proposed pool is within <10% of the TPZ. An existing retained garden bed shown on an excerpt of the site survey below (Figure 3) is expected to have restricted and contained root growth from T5. A garden bed is detailed in the same location for the proposed development (Figure 3). No detrimental impacts are expected. Arboricultural supervision will be required for works within the TPZ.

Figure 3: Tree 5, Existing and proposed.

- 8.3 The project arborist (AQF5) must be present to monitor and certify inground works within the TPZ of T5 to ensure the root ball of the neighbouring Cocos Palm is not structurally compromised.

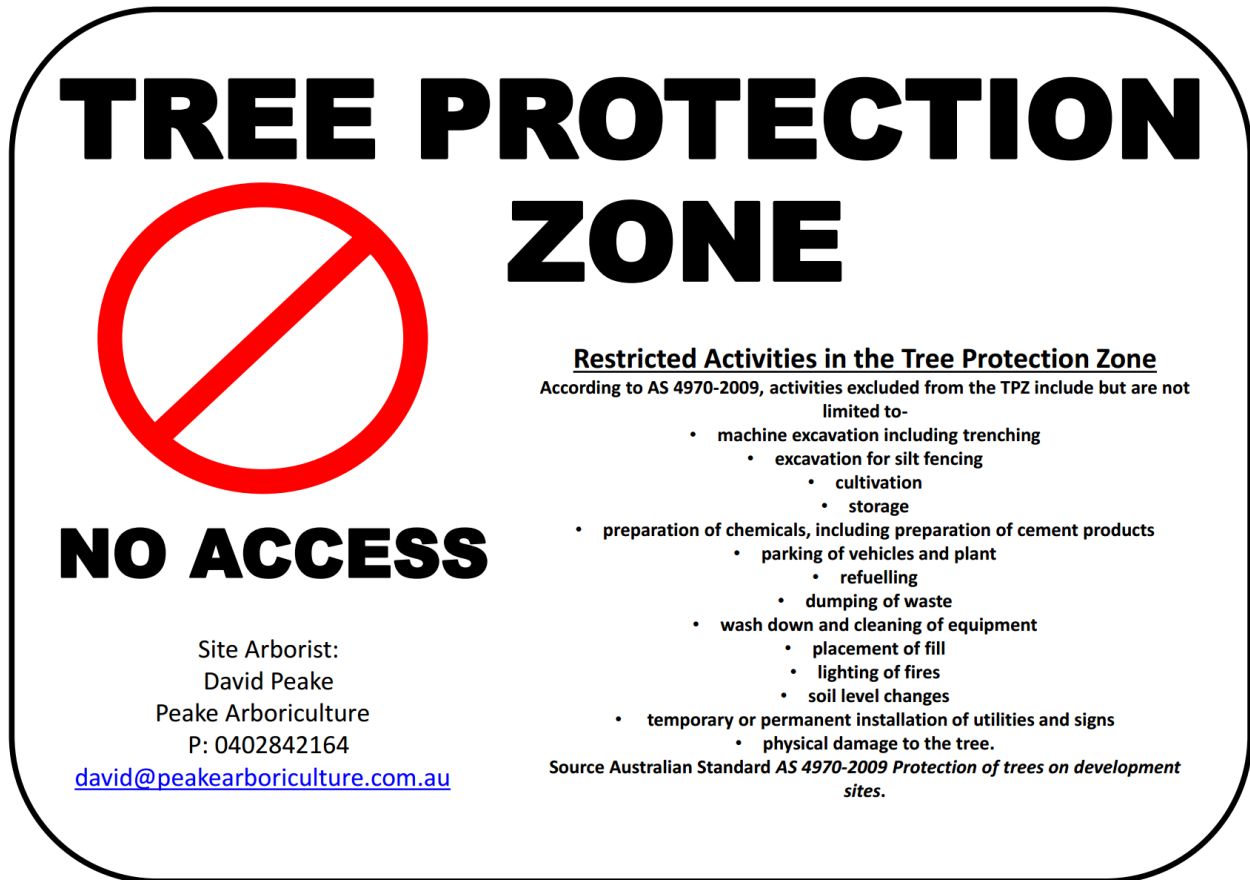
A tree protection zone sign must be affixed to all Fenced Tree Protection Zones. (Example Below)

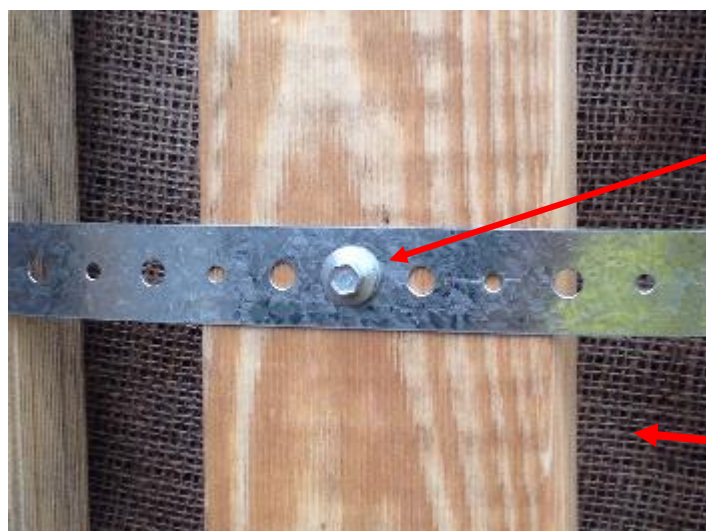
Wherever stems and branches are to be protected. Timber boards are to be used with padding underneath that will protect damage to the trees bark. All stem and branch protection timbers are to be strapped to the subject tree. Examples of stem protection are shown below.

Boards held in Place
by steel strapping.

Hessian is used as
padding to prevent
damage to the trees
bark.

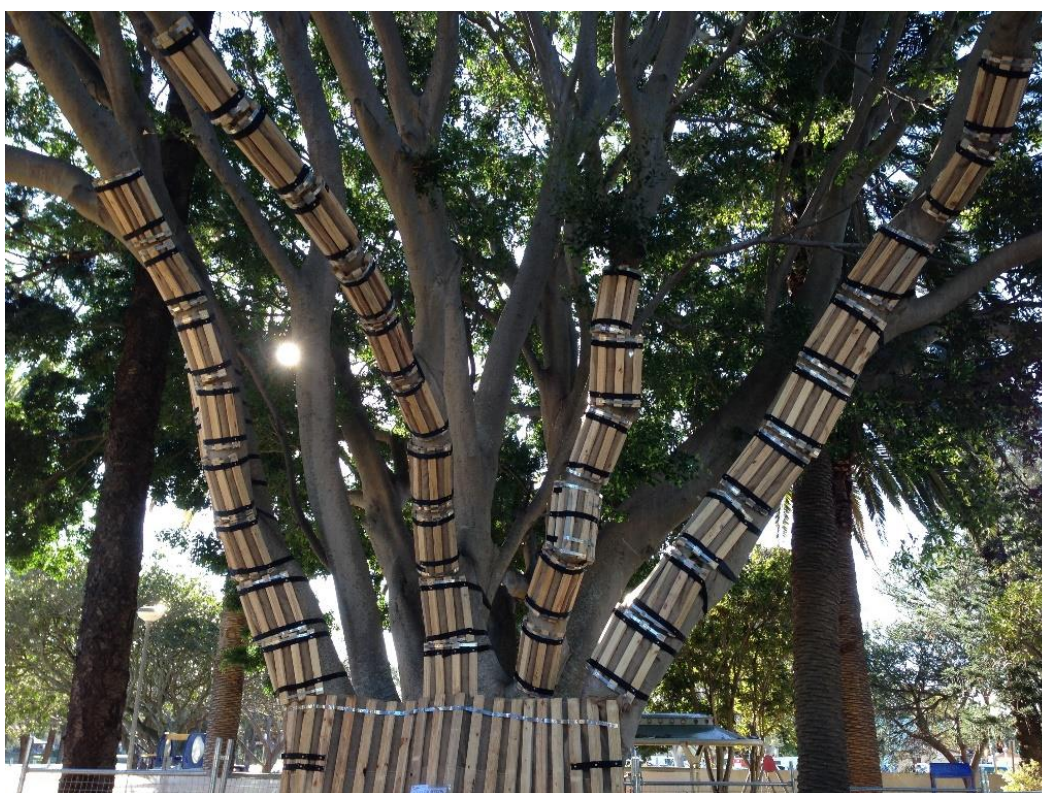
*An Example of completed Stem
Protection*

- 8.2 Prior to the commencement of any site works, stem protection is to be installed upon the trunks of trees 1 & 2. An example of completed stem protection is available in section 9.6 of this report. This is to mitigate possible impacts from site activities (loading and unloading of materials and movement around site etc.)
