GEOTECHNICAL SITE INVESTIGATION REPORT

PROPOSED NEW DWELLING

918 BARRENJOEY ROAD, PALM BEACH, NSW 2108

Project No: SRE/844/PB/21

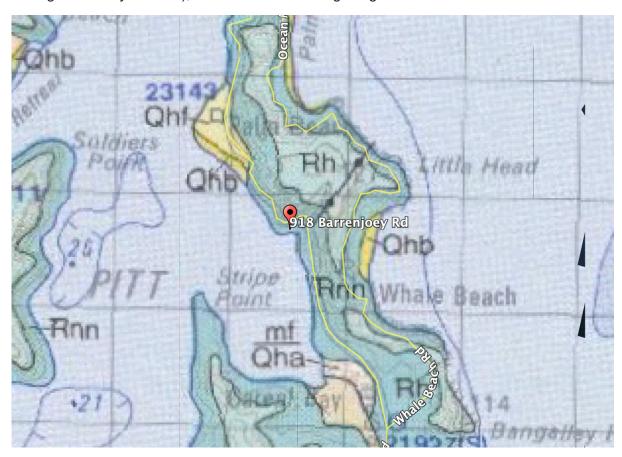
Figure 1 – Portion of the Sydney 1:100,000 Geological Series map 9130. Site area location is highlighted in a red/black sign.

From the analysis of Geology of the Sydney 1:100 000 sheet 9130, it is indicated that the site is located within the geology units of Reference "Rnn", age of Triassic, described as "interbedded laminite, shale, and quartz to lithic-quartz sandstone. The site belongs to of Newport Formation and Garie Formation of Narrabeen Group.

A reproduction of the geological map is shown in *Figure 1* and is based on a portion of the Sydney 1:100 000 Geological Series map 9130 (interactive resource provided by the Geological Survey of NSW), which shows the site geological condition.

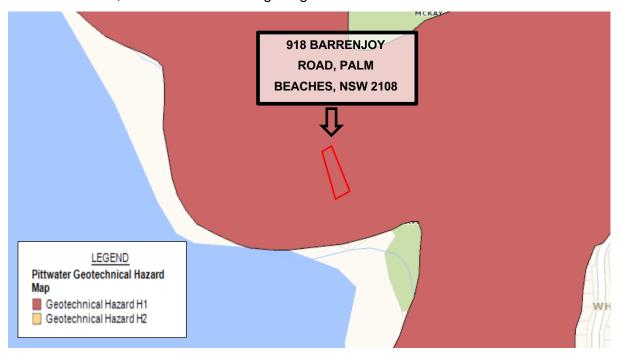
Figure 1 – Portion of the Pittwater Geotechnical Hazard map. Site area is highlighted in Red.

The site is located within a "Geotechnical Hazards Area H1", accordingly with the Pittwater Geotechnical Hazard Map from Pittwater LEP Local Environment Plan 2014.

A reproduction of the Pittwater Geotechnical Hazard Map is shown in *Figure 2* and is based on a portion of the Geotechnical Hazard Mapping LGA 2007 – GHD Longmaz from the Old Pittwater Council, which shows the site geological condition as follow:

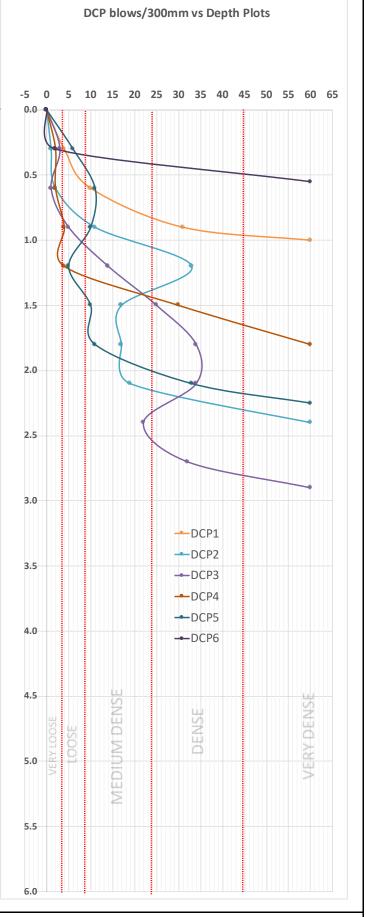
Equipment: 9kg Dynamic Cone Penetrometer									
	tem Depth (m)			N	lp (blows/3	300mm)			
ltem			n (m)	DCP1	DCP2	DCP3	DCP4	DCP5	DCP6
1	0.0	-	0.3	4	1	3	2	6	2
2	0.3	-	0.6	10	2	1	2	11	8 Bouncing @ 0.55m
3	0.6	-	0.9	31	11	5	4	10	
4	0.9	-	1.2	30 Bouncing @ 1.0m	33	14	4	5	
5	1.2	-	1.5		17	25	30	10	
6	1.5	-	1.8		17	34	60 Refusal @ 1.8m	11	
7	1.8	-	2.1		19	34		33	
8	2.1	-	2.4		36 Bouncing @ 2.4m	22		60 Refusal @ 2.25m	
9	2.4	-	2.7			32			
10	2.7	-	3.0			60 Refusal @ 2.9m			
11	3.0	-	3.3						
12	3.3	-	3.6						
13	3.6	-	3.9						
14	3.9	-	4.2						
15	4.2	-	4.5						
16	4.5	-	4.8						
17	4.8	-	5.1						
18	5.1	-	5.4						
19	5.4	-	5.7						
20	5.7	-	6.0						
						000

Note: * Reach practical refusal 60 blows per 300mm

> "Bouncing" indicates reached top of rock/boulders/obstacles/concrete/steel or in some cases can be due to presence of a hard obstacle such as steel, rubble, flouters, boulders, cobbles or hard materials

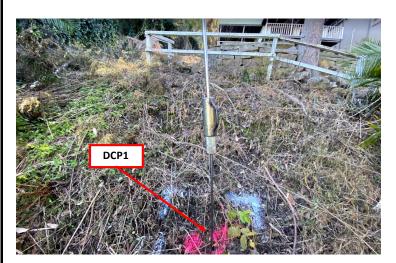
Photo 1 - Northwest view to DCP1 test location.

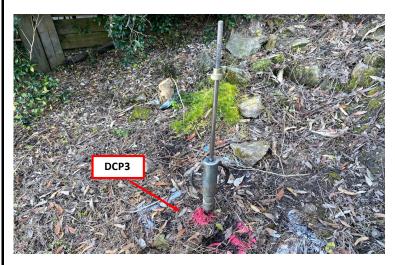
Photo 3 - West view to DCP3 test location.

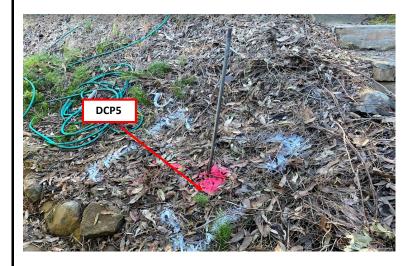
Photo 5 - Northwest view to DCP5 test location.
