## **Arboricultural Impact Assessment**

Proposed Cabin Construction at  
11 Catalina Crescent, Avalon Beach

**Date:** February 2024

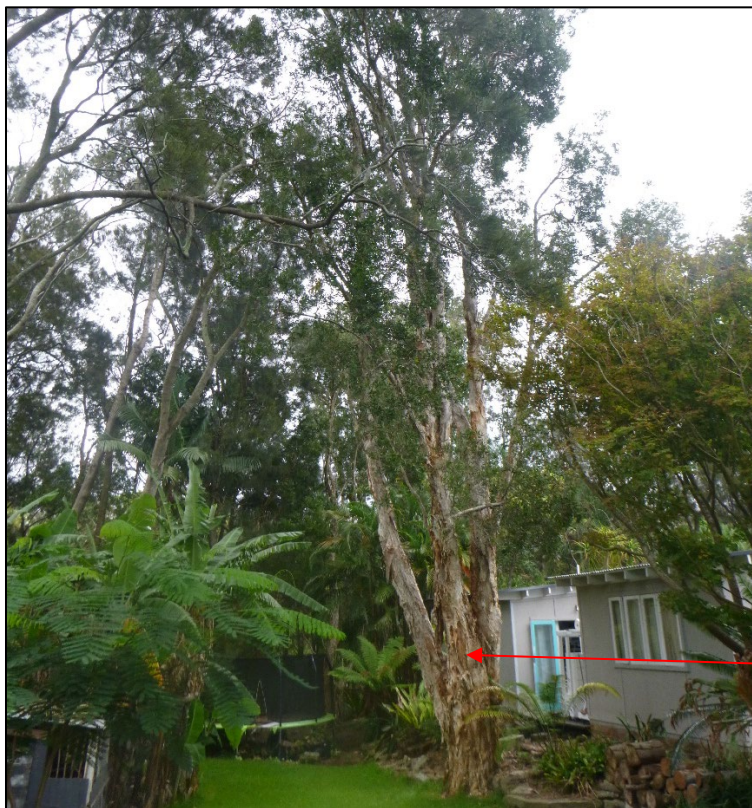
The subject tree is a mature Broad-leaved Paperbark, *Melaleuca quinquenervia* located close to the existing cabins. This tree is a locally native species and prominent landscape feature. A detailed description of the subject tree is included at Page 5.

Photo A: Subject tree

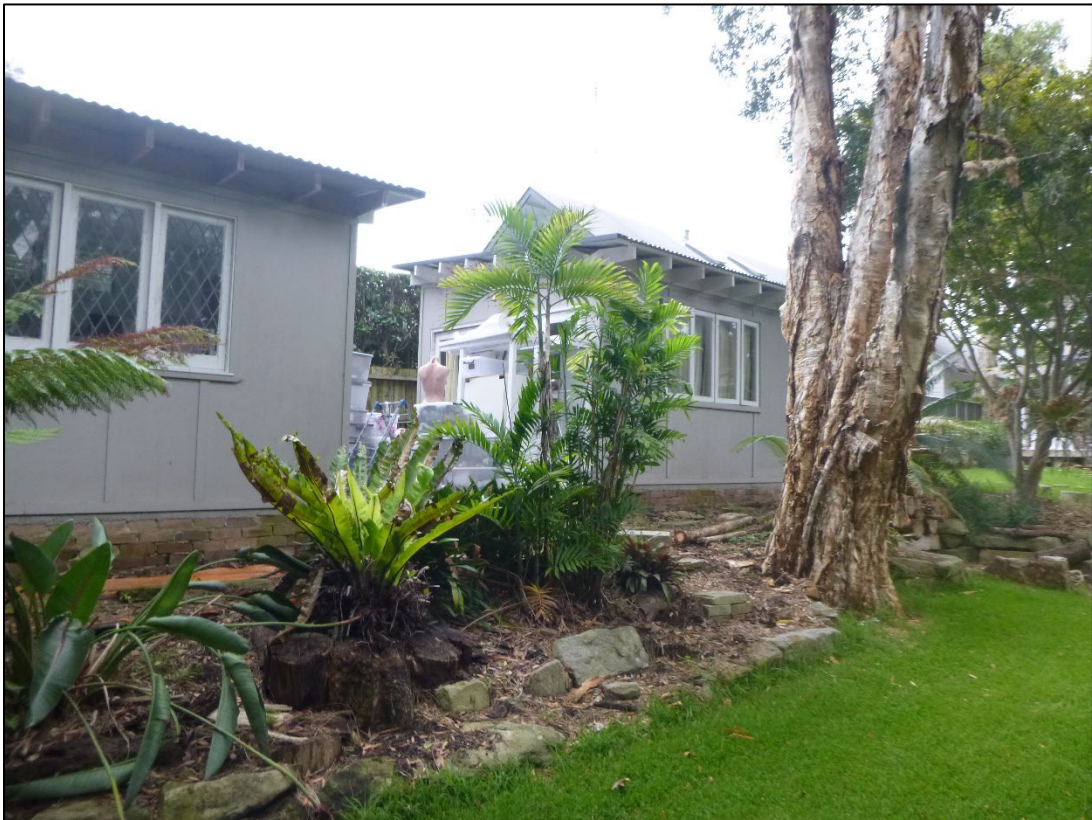
| Subject Tree –Broad-leaved Paperbark, <i>Melaleuca quinquenervia</i> | |
|---|---|
| Comments | The existing cabin footings do not appear to have affected the health, vitality or structural condition. |

**Photo B:** Trunk of the subject tree relative to the existing cabins.  
BLUEGUM - Tree Care and Consultancy

The existing cabin footings shall be retained in ground with no disturbance. Any tree roots that are located beneath the existing sections of cabin shall remain undisturbed.

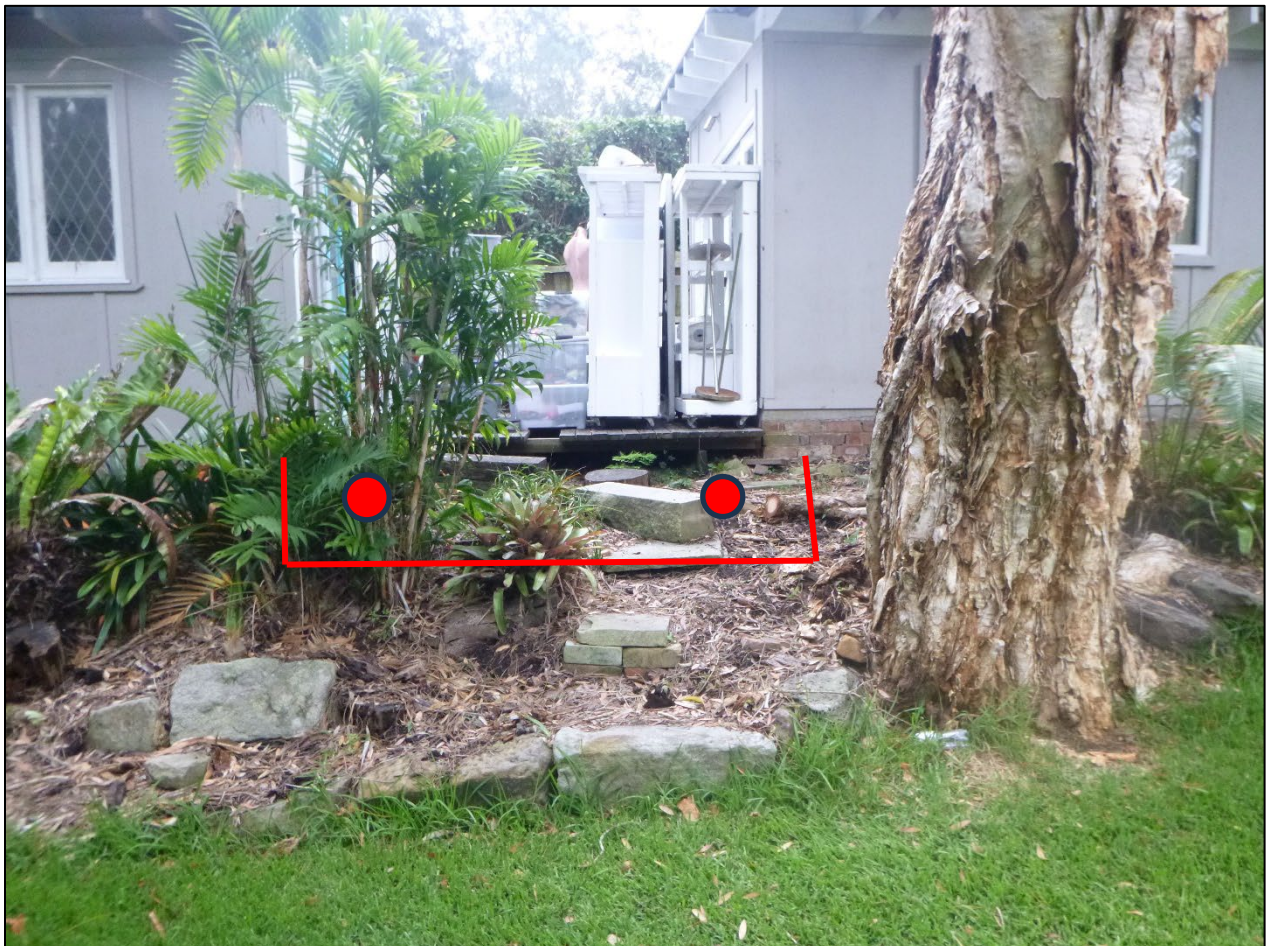
**Photo C:** Area where test digging is required to determine pier footing locations.

**Test Digging to Locate Pier Positions:** Prior to setting out the bathroom floor framework, test digging must be undertaken to locate a suitable space for piers between structural roots greater than 50mm diameter. This must be undertaken using hand tools with care taken not to injure tree roots. This process should be undertaken under guidance from the Project Arborist. A photographic record must be kept of this for certification purposes.
