Subject: Construction Certificate J100142

Development Consent Permit 105/08

20 Montpelier Place Manly

CONSTRUCTION CERTIFICATE No J100142

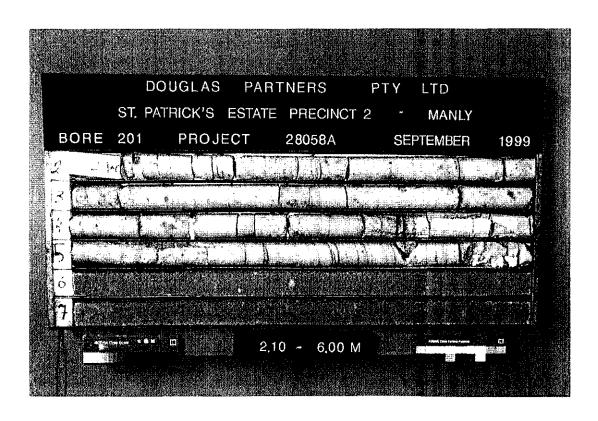
CLIENT: HUGHES TRUEMAN REINHOLD

PROJECT: PRECINCT 2: ST PATRICK'S ESTATE

0.8	SAND - light brown sand CLAYEY SAND - very stiff, brown grey clayey sand - I.3m - light brown					-					1 1			S			3,5,13 N=18					
-3	SANDSTONE - low and extremely low strength, slightly weathered, fractured to slightly fractured, off white, coarse grained gravelly sandstone with extremely low and very low and medium strength bands				1 1 1 1 1 1 1 1 1 1 1 1 1 1 1 1 1 1 1 1		1	; ; ; ; ; ; ; ; ; ; ; ; ; ; ; ; ; ; ;						C	100	88	PL (A)≃C.2MPa PL (A)≈C.5MPa					
Į.	- 4.76m;J 80" -85" smooth planar - 5.19m;J 80" -85" smooth planar - 5.68m;J 40" -45" rough planar		1 1 1 1 1 1 1 1 1 1 1 1 1 1 1 1 1 1 1 1					1 1						С	100	74	PL (A)≃0.5MPa PL (A)=0.3MPa					
-8 6.0°	TEST BORE DISCONTINUED AT 6.0 METRES	h-Assidue-A					i		1													
-9			11 11 11 11 11 11 11 11 11 11 11 11 11								:						CASING: SL TO 2 Im

WATER OBSERVATIONS: FREE GROUNDWATER OBSERVED AT 1.7m WHILST AUGERING REMARKS:

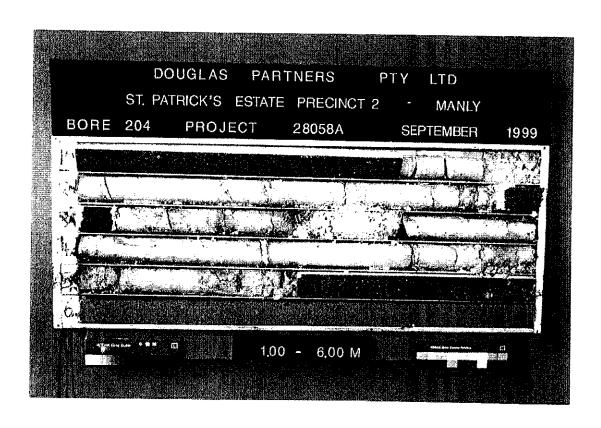
CLIENT: HUGHES TRUEMAN REINHOLD

PROJECT: PRECINCT 2: ST PATRICK'S ESTATE

reactured, light yellow to off white, coarse grained sandstone PL (A)=0.IMPa 2.9 3.05 3.05 SANDSTONE — low to medium and low strength, slightly and highly weathered, slightly fractured, off white, coarse grained gravelly sendstone PL (A)=0.06MPa PL (A)=0.3MPa C 86 41 PL (A)=0.3MPa	- - - r	TON DATELY HOAD, MANLY	-,			ΠTI	V	- H(JLE	. S()			AZIMUTH:
SAND - grey sand SAND - grey sand SANDSTONE - extremely low strength sandstone 1.0 - 1.0m - 700mm Core loss C 22 0 PL (A)=0.IMPa slightly weathered, fractured to slightly fractured, that yellow to off white, coarse grained sandstone 2.5 - 2.9m - 150mm Core loss 3.65 SANDSTONE - low to medium and low strength, slightly and highly weathered, slightly fractured, off white, coarse grained sandstone C 94 66 PL (A)=0.06MPa strength, slightly and highly weathered, slightly fractured, off white, coarse grained sandstone PL (A)=0.3MPa strength, slightly and highly weathered, slightly fractured, off white, coarse grained sandstone SANDSTONE - low to medium and low strength, slightly and highly weathered, slightly fractured, off white, coarse grained sandstone PL (A)=0.3MPa strength, slightly and highly weathered, slightly fractured, off white, coarse grained sandstone PL (A)=0.3MPa strength, slightly and highly weathered, slightly fractured, off white, coarse grained sandstone		1	5 Log		T	Non- Cañes 1	7t	SI	trengt	h_			San	npling & In Situ Testing

SANDSTONE - extremely low strength sandstone 10 - I.Om - 700mm Core loss 17 SANDSTONE - very low to low strength, slightly weathered, fractured to slightly fractured. Ignt yellow to off white, coarse grained sandstone 2.9 - 2.9m - I50mm Core loss 2.9 - 2.9m - I50mm Core loss C 94 66 PL (A)=0.1MPa 2.9 - 2.9m - I50mm Core loss C 94 66 PL (A)=0.06MPa 3.65 SANDSTONE - low to medium and low strength, slightly and highly weathered, slightly fractured, off white, coarse grained gravelly sandstone PL (A)=0.3MPa 5.45 - 5.45m - 550mm Core loss	(m)	Strata	Graphy	Safe Safe Safe Safe Safe Safe Safe Safe	Here Very Lock	Med. Bense	Very Dense	Very Low	1 1 1	Kery Hagh	Sample	Core Rec. %	8	! ε
SANDSTONE - very low to low strength, slightly weathered, fractured to slightly fractured, light yellow to off white, coarse grained sandstone 2.9 3.05 SANDSTONE - low to medium and low strength, slightly and highly weathered, slightly fractured, off white, coarse grained gravelly sandstone C 94 66 PL (A)=0.1MPa C 94 66 PL (A)=0.06MPa PL (A)=0.3MPa Signify and highly weathered, slightly and highly weathered, slightly fractured, off white, coarse grained gravelly sandstone C 66 41 PL (A)=0.3MPa		SANDSTONE - extremely low strength sandstone			1 1 1 1 1 1 1 1 1 1 1 1 1 1 1 1 1 1 1 1

2.9 - 2.9m - 150mm Core loss C 94 86 PL (A)=0.1MPa 3.65 SANDSTONE - low to medium and low strength, slightly and highly weathered, slightly fractured, off white, coarse grained gravelly sandstone PL (A)=0.3MPa C 86 41 PL (A)=0.3MPa 5.45 - 5.45m - 550mm Core loss		SANDSTONE – very low to low strength, slightly weathered, fractured to slightly fractured, light yellow to off white, coarse			; ;		-	Ī			С	22	0	PL (A)=0.IMPa

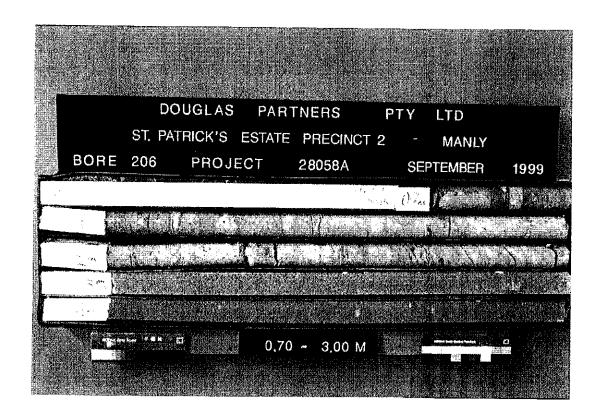
CLIENT: HUGHES TRUEMAN REINHOLD

PROJECT: PRECINCT 2: ST PATRICK'S ESTATE

0.4	SAND - brown sand						I I		1	1 1		1 1				
0.7	SANDSTONE - low to medium and medium strength, moderately weathered, slightly			 		1	1 1	İ	-		,	1 1				PL (A)=0.3MPa
1	SANDSTONE - low to medium and medium strength, moderately weathered, slightly fractured to unbroken, off white yellow, coarse grained gravelly sandstone						1 1	í !	i E			1 1				PL (A)=0.5MPa
				1 1			1 1	1	1	1 1	1 1	1 I 1 I 1 I	1

WATER OBSERVATIONS: NO FREE GROUNDWATER OBSERVED WHILST AUGERING **REMARKS:**

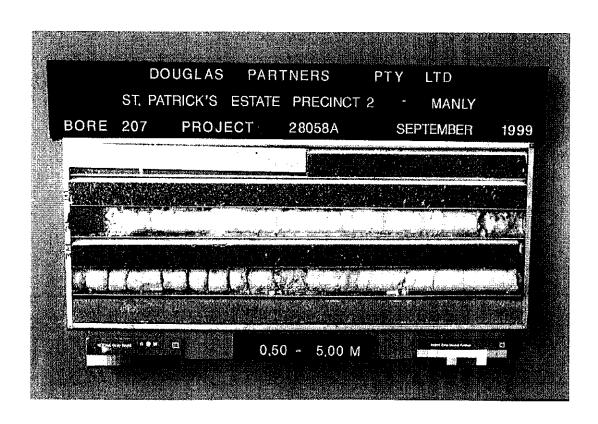
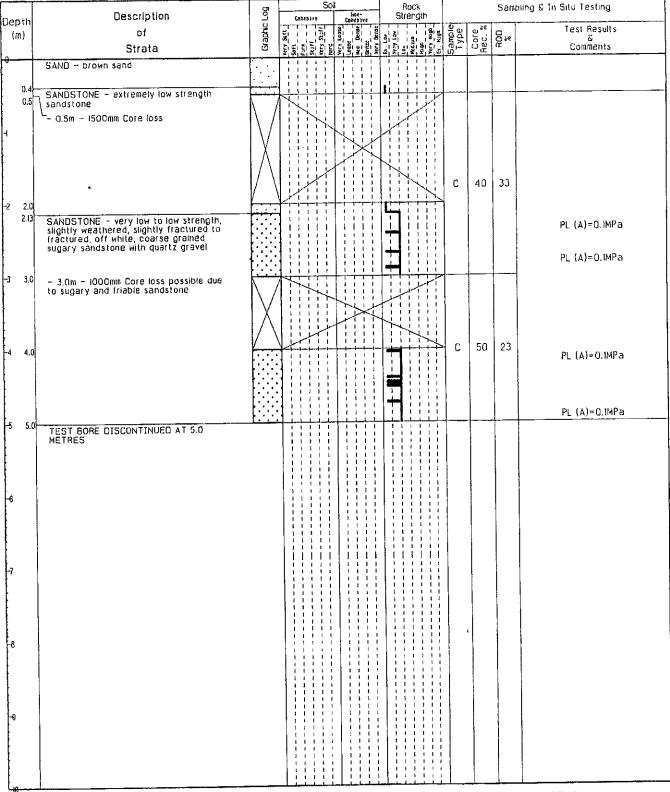
BORE No: 207
DATE: 29/9/99
SHEET 1 OF 1

CLIENT: HUGHES TRUEMAN REINHOLD

PROJECT: PRECINCT 2: ST PATRICK'S ESTATE

WATER OBSERVATIONS: NO FREE GROUNDWATER OBSERVED WHILST AUGERING REMARKS:

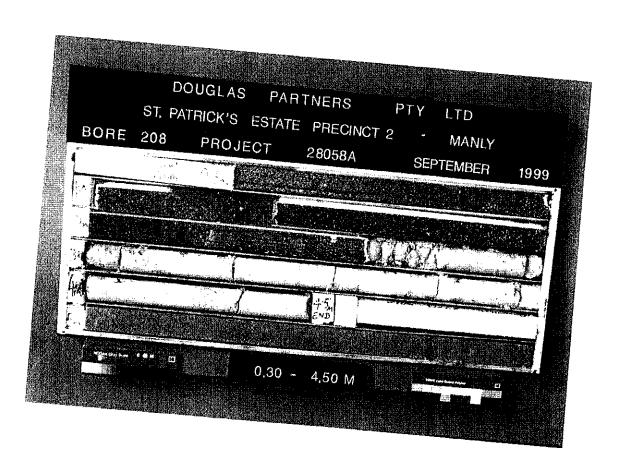
CLIENT: HUGHES TRUEMAN REINHOLD

PROJECT: PRECINCT 2: ST PATRICK'S ESTATE

2.55	CORE LOSS 2250mm - possibly due to extremely low strength, sugary and friable sandstone		- 					X						С	17	Φ	
2.75	SANDSTONE - very low strength, slightly weathered, fractured, off white, coarse	/ / / / /			i		1 1	: I		크	7	1 1	1				PL (A)=0.2MPa
1	grained, sugary sandstone SANDSTONE – low then low to medium strength, slightly weathered, slightly fractured, off white, coarse grained gravelly sandstone				1 1 1 1 1 1 1 1 1 1 1 1 1 1 1 1 1 1 1 1								1 1 1 1 1 1 1 1 1 1 1 1 1 1 1 1 1 1 1 1	С	100	99	PL (A)=0.2MPa PL (A)=0.3MPa

WATER OBSERVATIONS: NO FREE GROUNDWATER OBSERVED WHILST AUGERING REMARKS: R = ROTARY

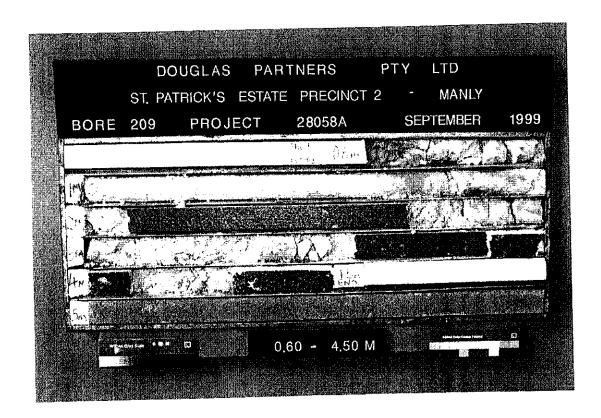
CLIENT: HUGHES TRUEMAN REINHOLD

PROJECT: PRECINCT 2: ST PATRICK'S ESTATE

0.3	Description of Strata SAND - dark brown sand SANDSTONE - extremely low strength, light yellow to off white, medium to coarse grained sandstone SANDSTONE - extremely low to very low strength, slightly weathered, slightly fractured, light yellow to off white grey, coarse grained sugary and friable sandstone with quartz grayel	Graphic Log	Soft -	1 2 2 2 2 2 2 2 2 2 2 2 2 2 2 2 2 2 2 2		!!	Sive	Very Bense	5);; [8]	1 1	Ex. High	Sample Type	Core Rec. %		oling & In Situ Testing Test Results & Comments

WATER OBSERVATIONS: NO FREE GROUNDWATER OBSERVED WHILST AUGERING

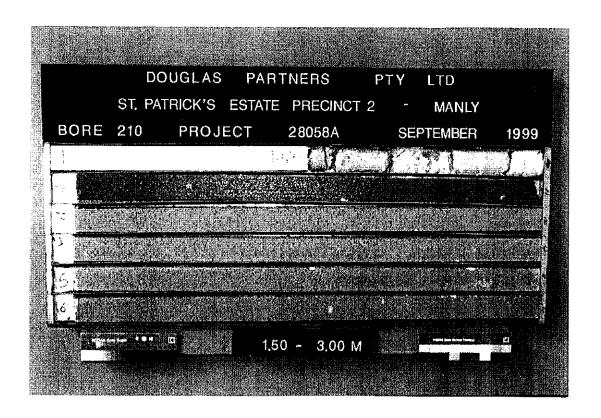
CLIENT: HUGHES TRUEMAN REINHOLD

PROJECT: PRECINCT 2: ST PATRICK'S ESTATE

WATER OBSERVATIONS: NO FREE GROUNDWATER OBSERVED WHILST AUGERING **REMARKS:**
