REPORT TO
SYESUN PTY LTD

ON
REMEDIATION ACTION PLAN

FOR
PROPOSED GARDEN CENTRE REDEVELOPMENT

AT
277 MONA VALE ROAD, TERREY HILLS, NSW

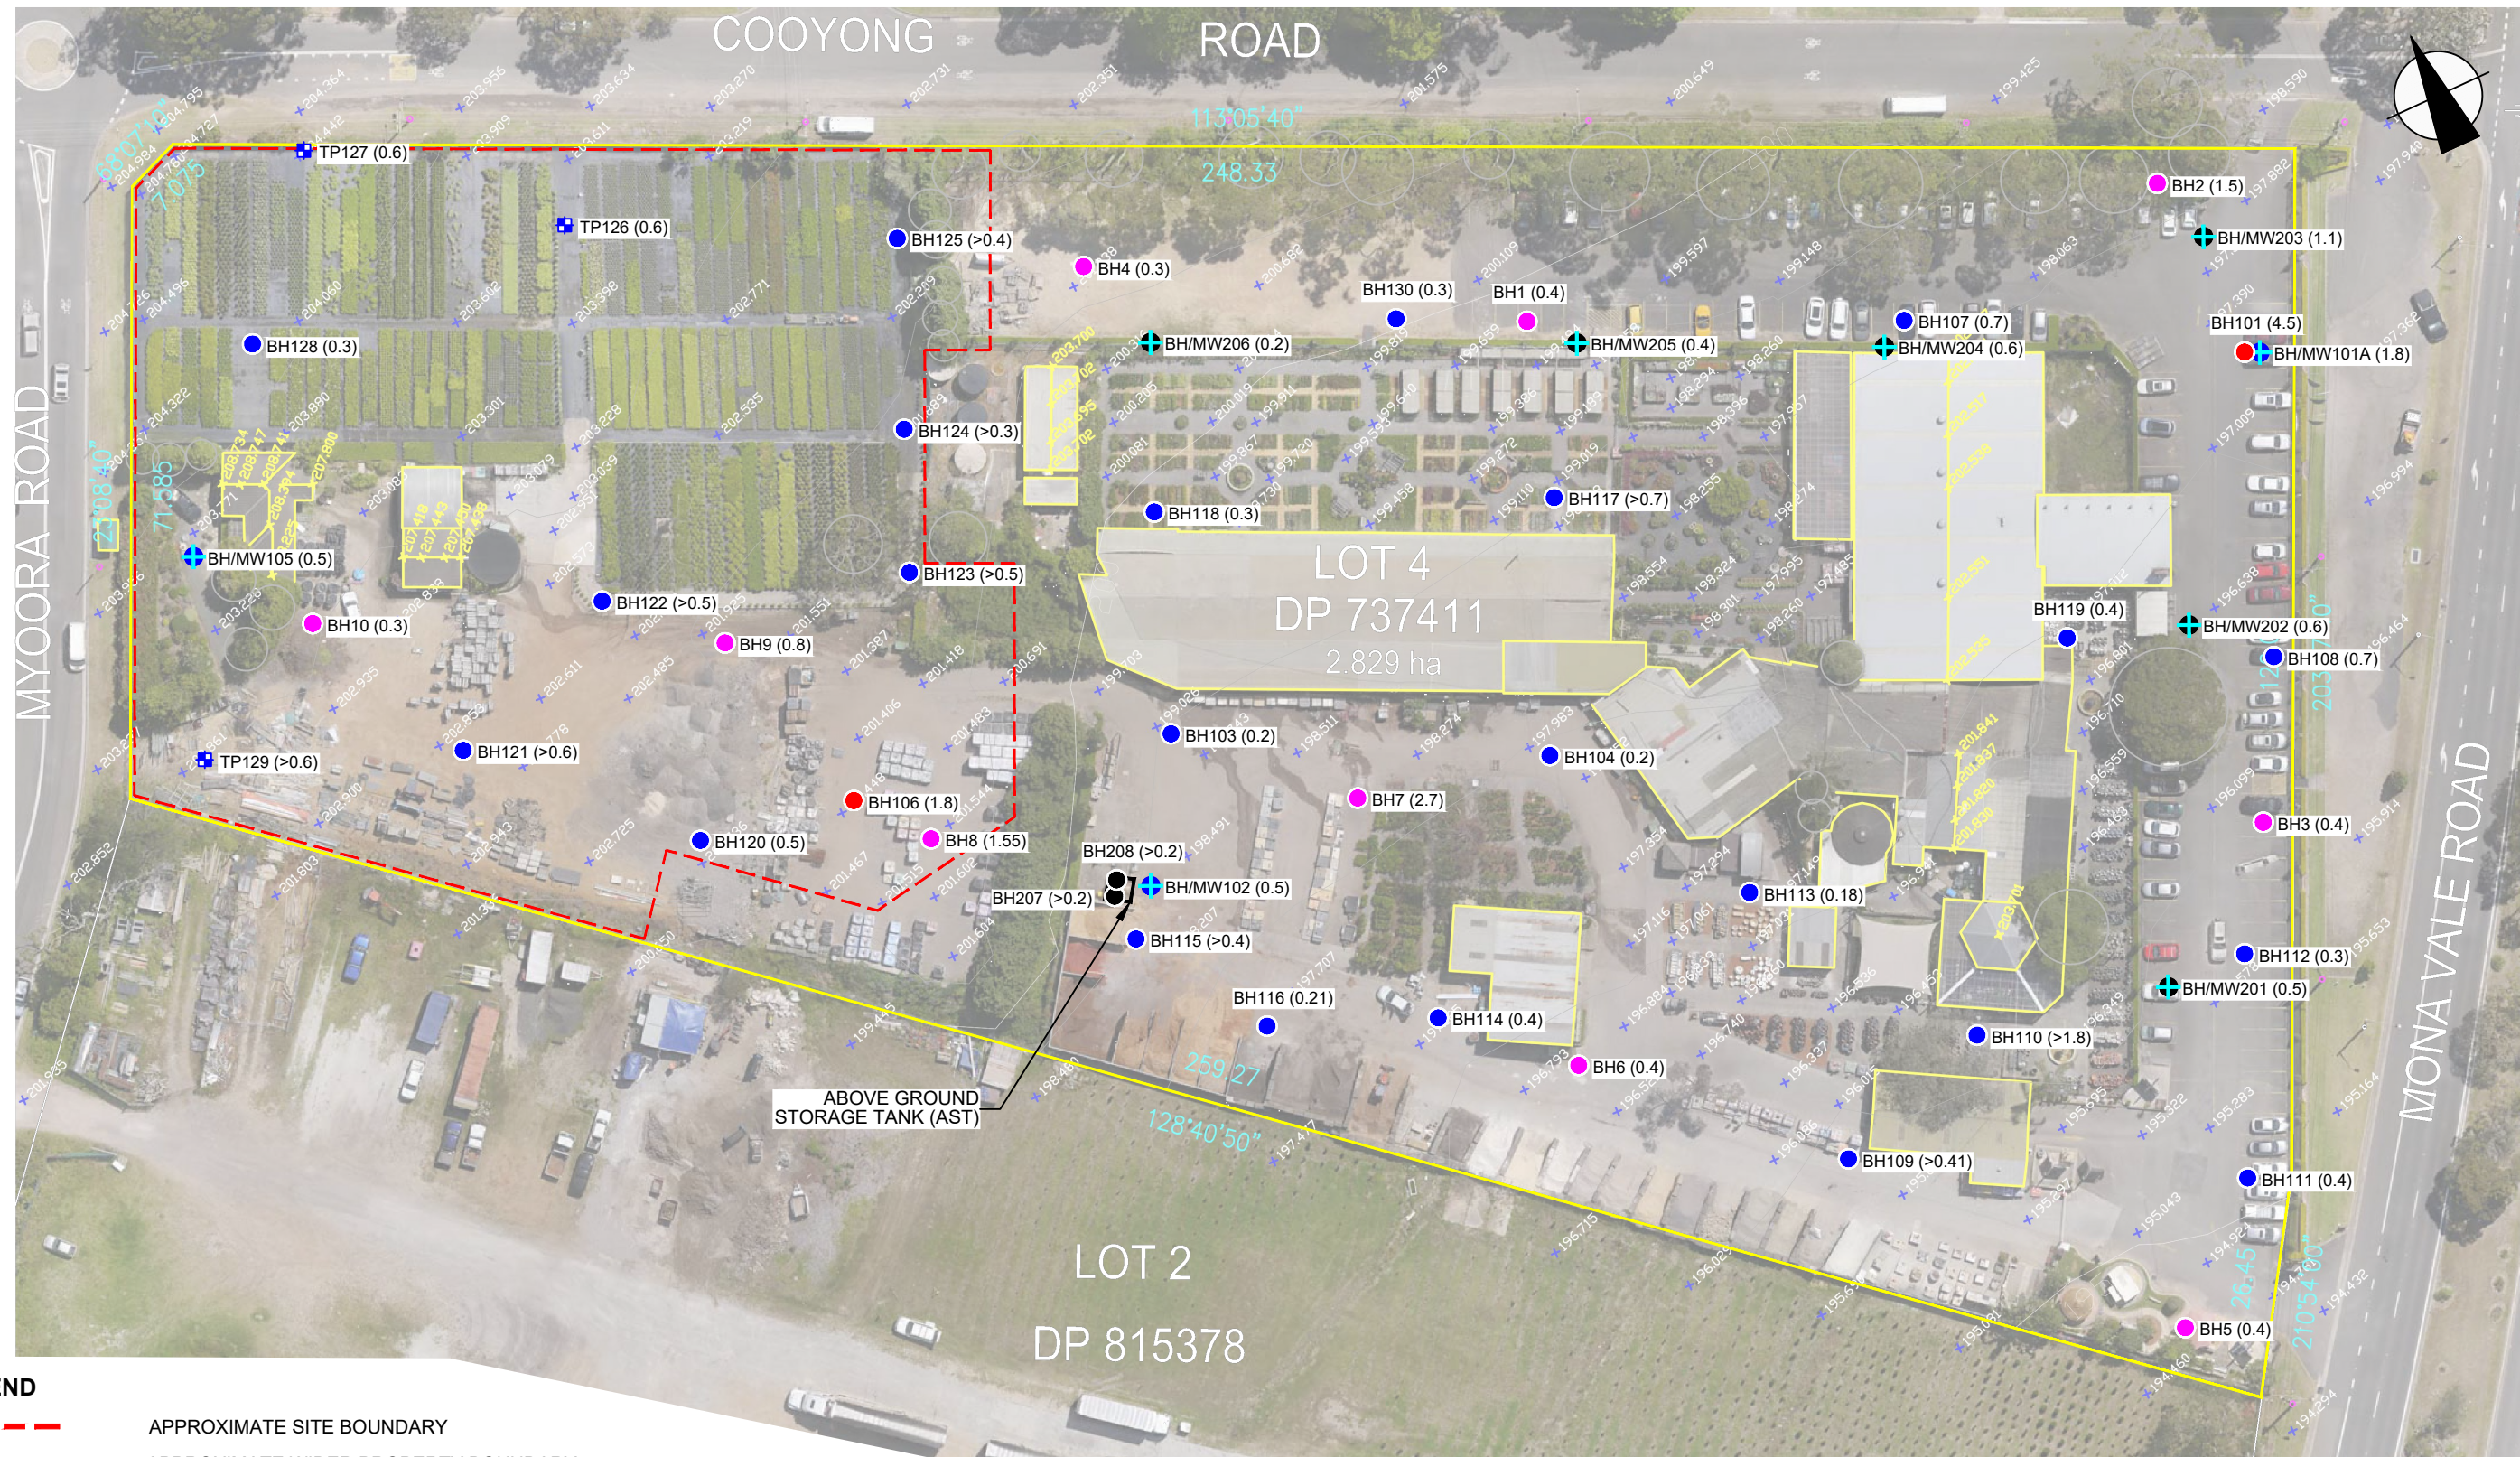
- APPROXIMATE SITE BOUNDARY
- APPROXIMATE WIDER PROPERTY BOUNDARY
- BH(Fill Depth) BOREHOLE LOCATION, NUMBER AND DEPTH OF FILL (m) (JKE, 2021)
- BH(Fill Depth) BOREHOLE LOCATION, NUMBER AND DEPTH OF FILL (m) (JKE, 2022)
- BH/MW(Fill Depth) BOREHOLE AND GROUNDWATER MONITORING WELL LOCATION, NUMBER AND DEPTH OF FILL (m) (JKE, 2022)
- TP(Fill Depth) TEST PIT LOCATION, NUMBER AND DEPTH OF FILL (m) (JKE, 2022)
- BH(Fill Depth) BOREHOLE AND HAZARDOUS GROUND GAS WELL LOCATION, NUMBER AND DEPTH OF FILL (m) (JKE, 2022)
- BH208 BOREHOLE LOCATION, NUMBER AND DEPTH OF FILL (m)
- BH/MW201 BOREHOLE AND HAZARDOUS GROUND GAS WELL LOCATION, NUMBER AND DEPTH OF FILL (m)

Fill was encountered at the surface or beneath the pavement in all boreholes, except BH113 and BH116, and extended to depths of approximately 0.2m to 4.5m. The fill typically comprised silty gravelly sand/gravelly silty sand, silty sand and silty clayey sand/silty sandy clay with inclusions of igneous and ironstone gravel, ash, slag and building rubble (brick, concrete, asphaltic concrete [AC], glass and tile fragments). During the PSI, fill was also found to contain organic material.

We note that shallow fill (typically less than 1m deep) was encountered during drilling for installation of the HGG monitoring wells and the no organic material was encountered in the fill. This confirms that the deep fill in the BH101 area is very localised and not representative of the general site conditions in the north-eastern area of the wider property. Furthermore, this area is a significant distance from the site applicable to the revised proposed development scheme and is therefore not of concern.

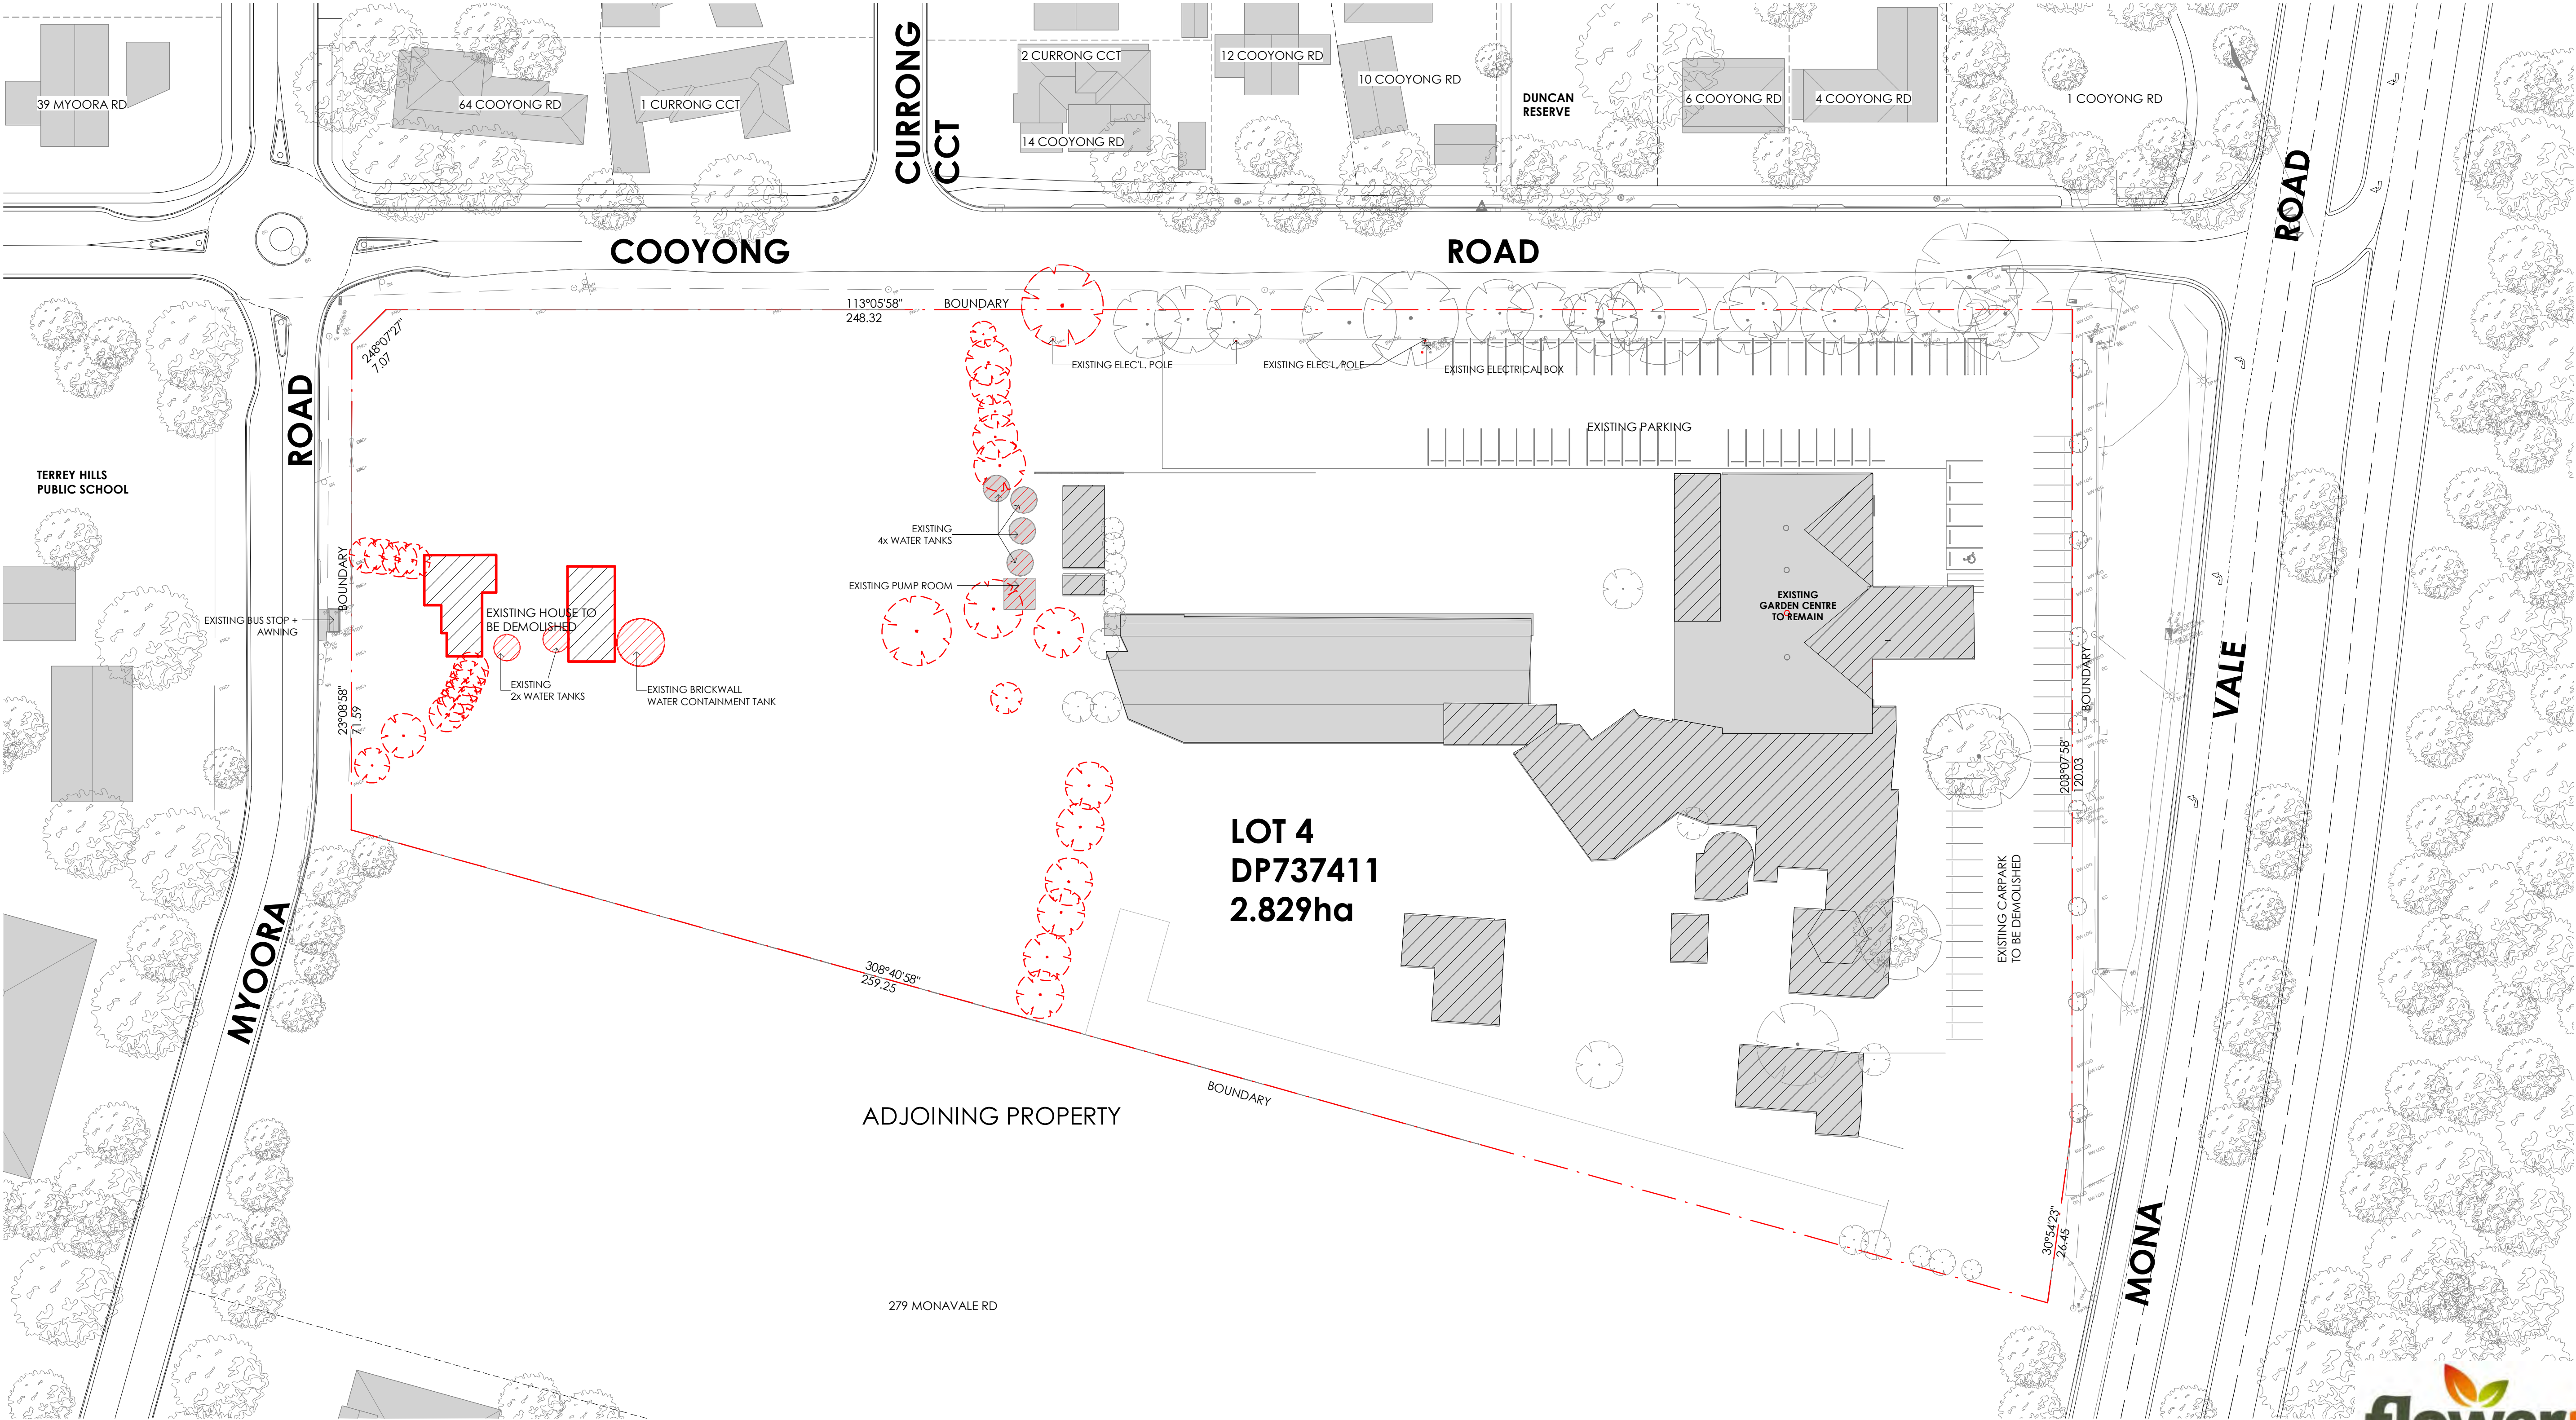
DEMOLITION PLAN

- TO BE DEMOLISHED
- EXISTING TREES TO BE RETAINED
- TREES TO BE REMOVED

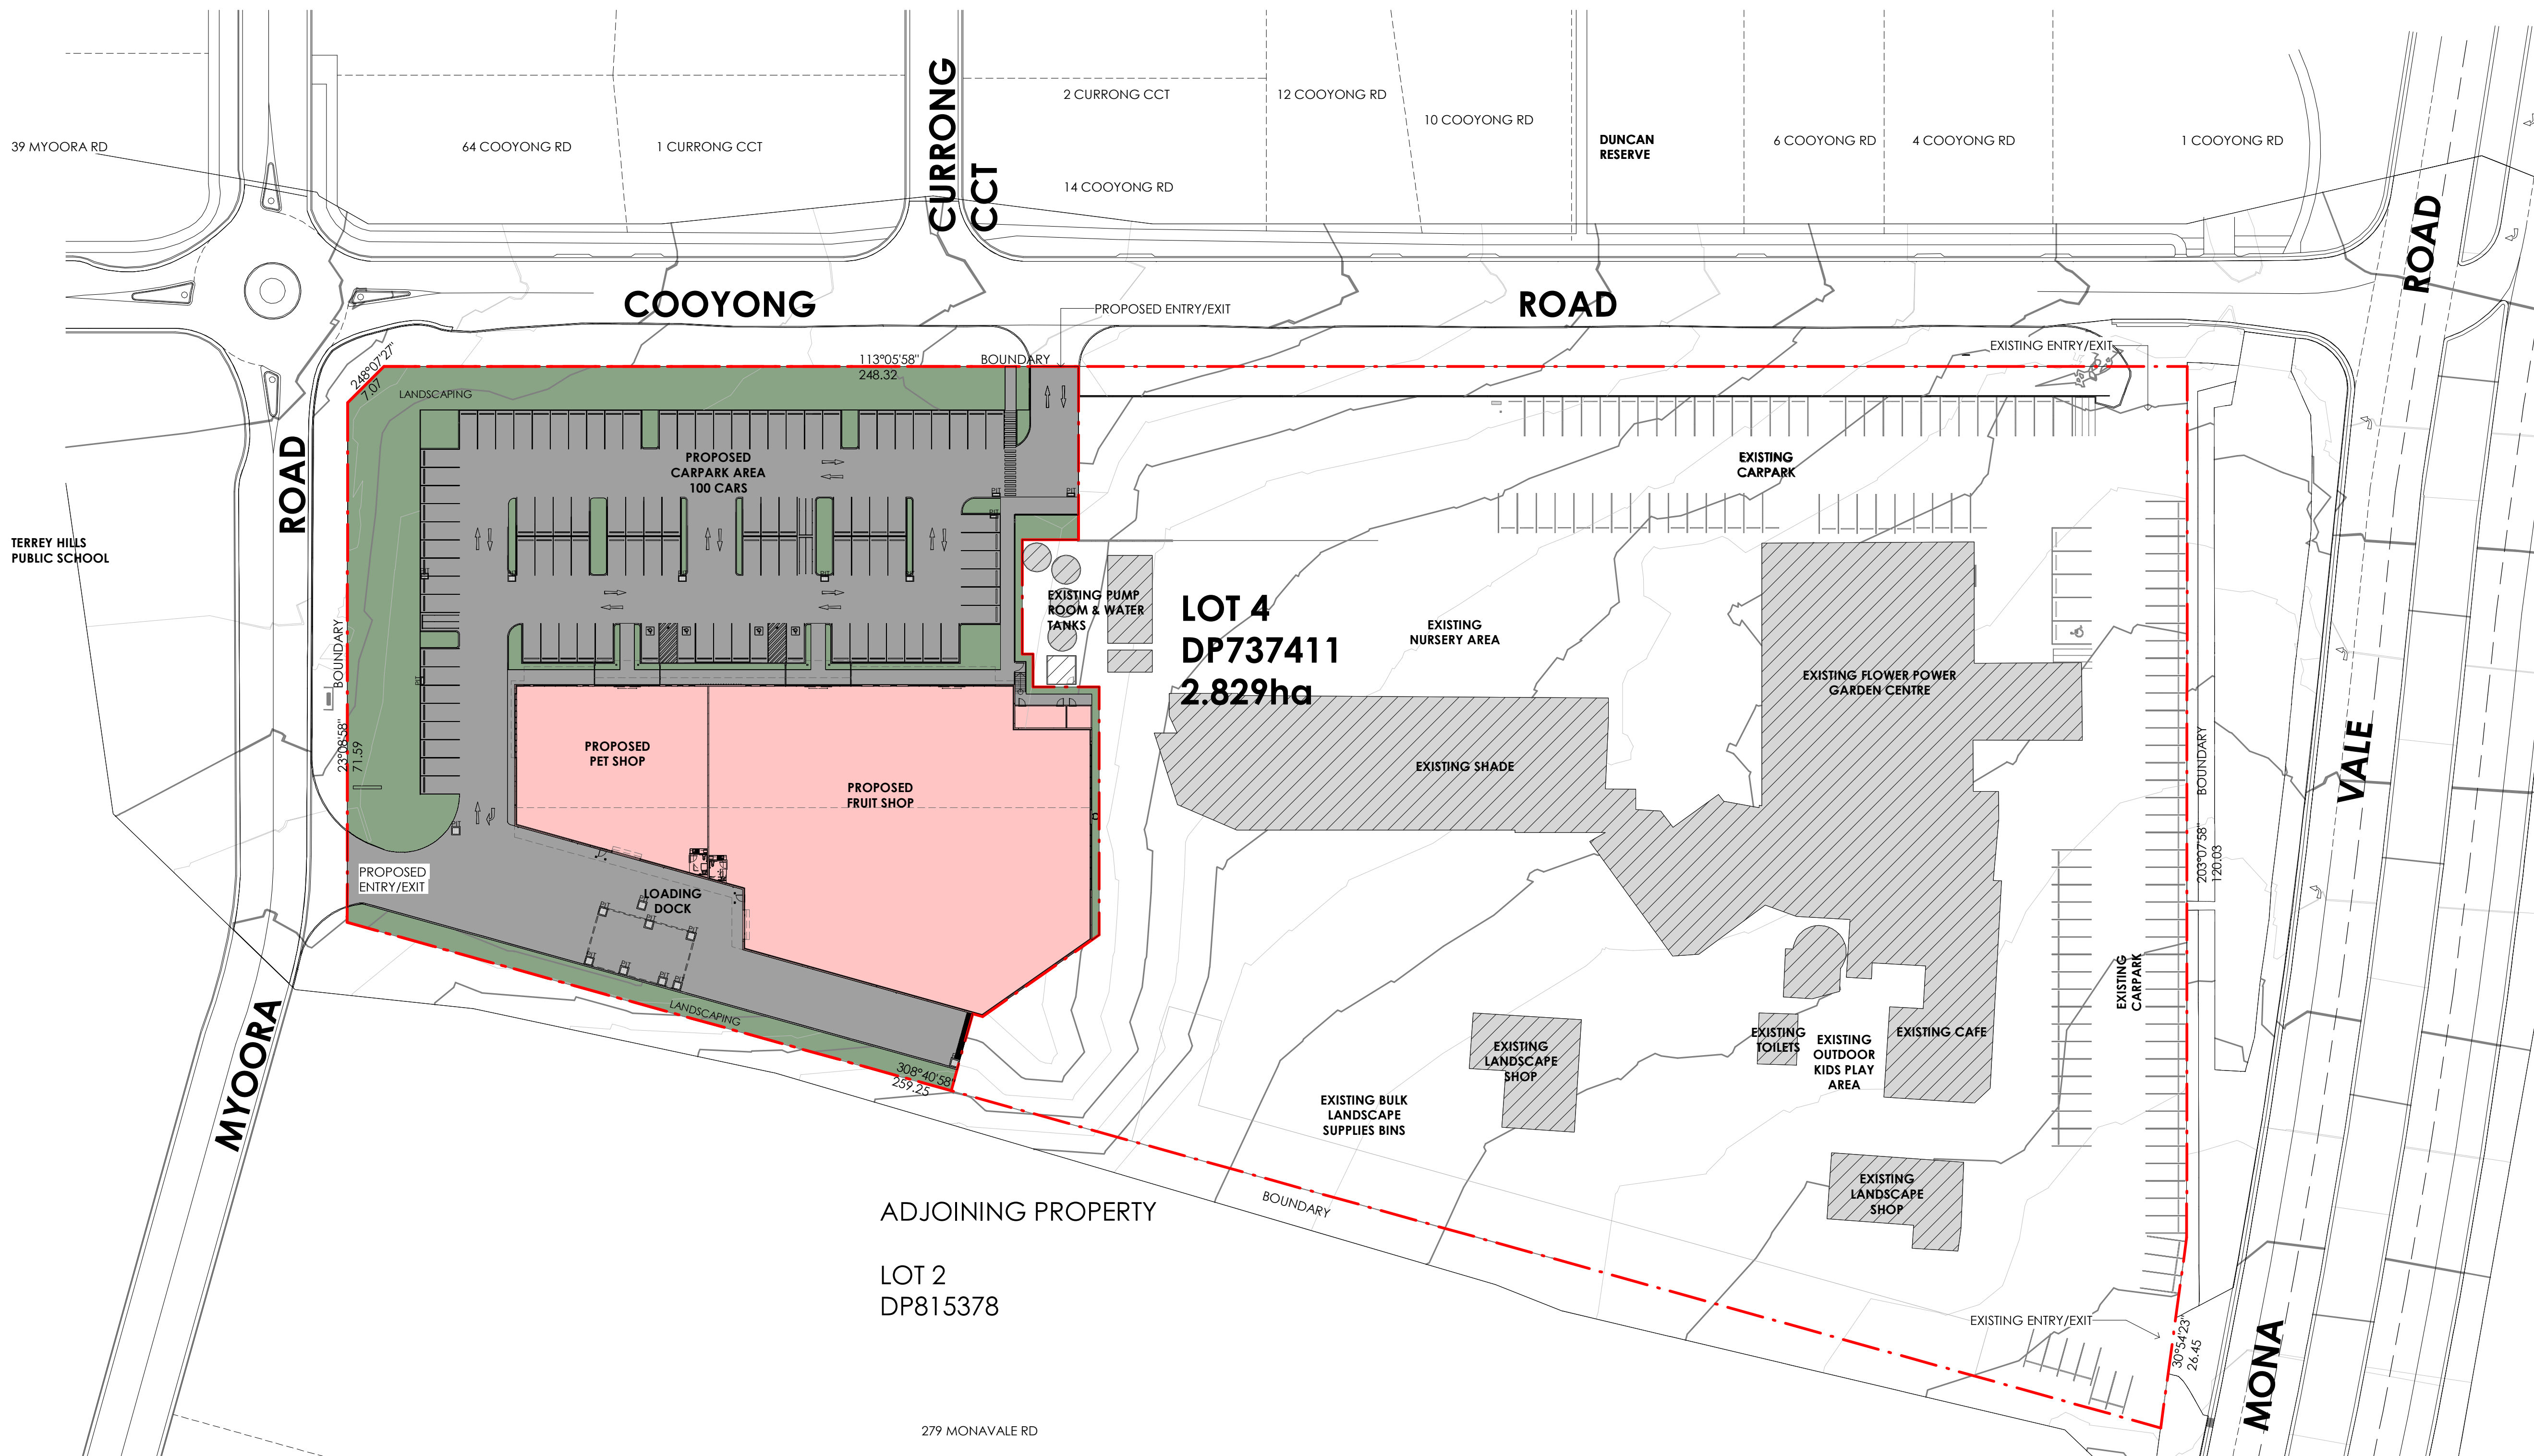
SITE COVERAGE AREA PLAN

SITE AREA	28,289 m ²
CONSTRUCTION ZONE	8,793 m ²
SITE COVERAGE AREA	2,690 m ²

DA AS SUBMITTED 8,490 m ² (30.0 %)
PERMEABLE AREA	1,798 m ² (20.4%)
	DA AS SUBMITTED 13,691 m ² (48.3 %)
IMPERMEABLE AREA	4,304 m ² (48.9 %)
	DA AS SUBMITTED 6,108 m ² (21.6 %)
BUILDING FOOTPRINT AREA	2,690 m ² (30.5 %)

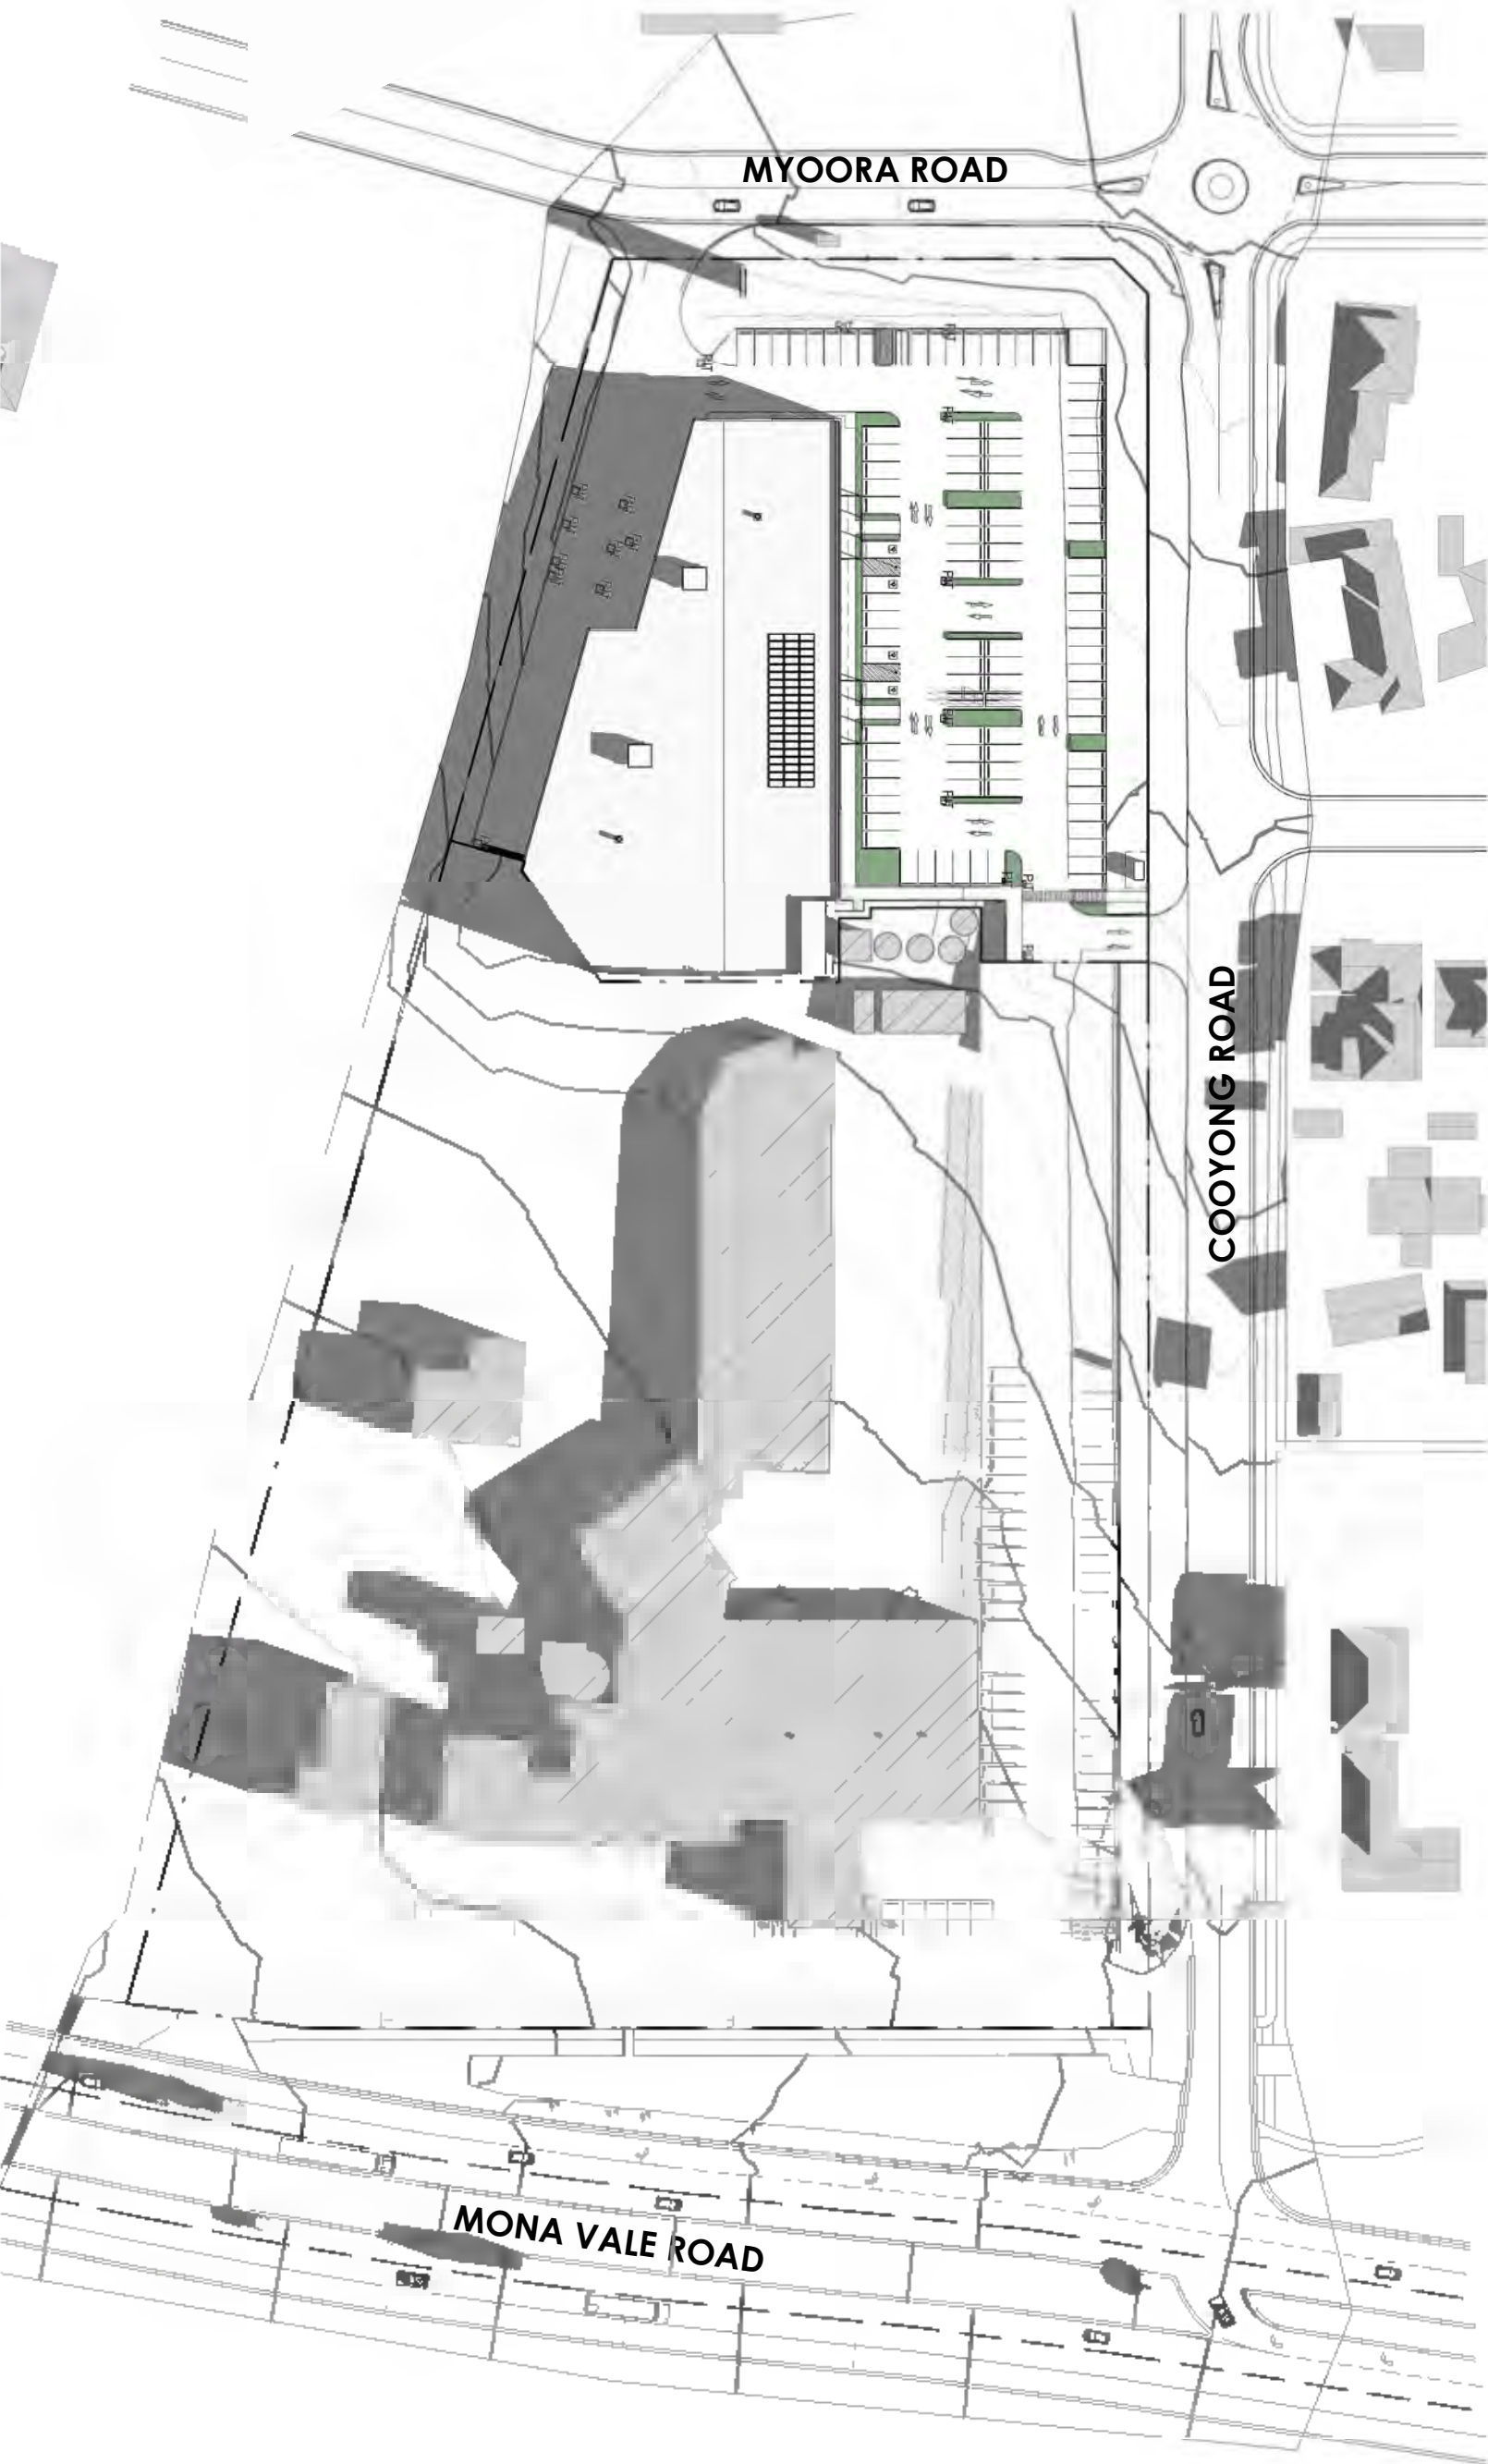
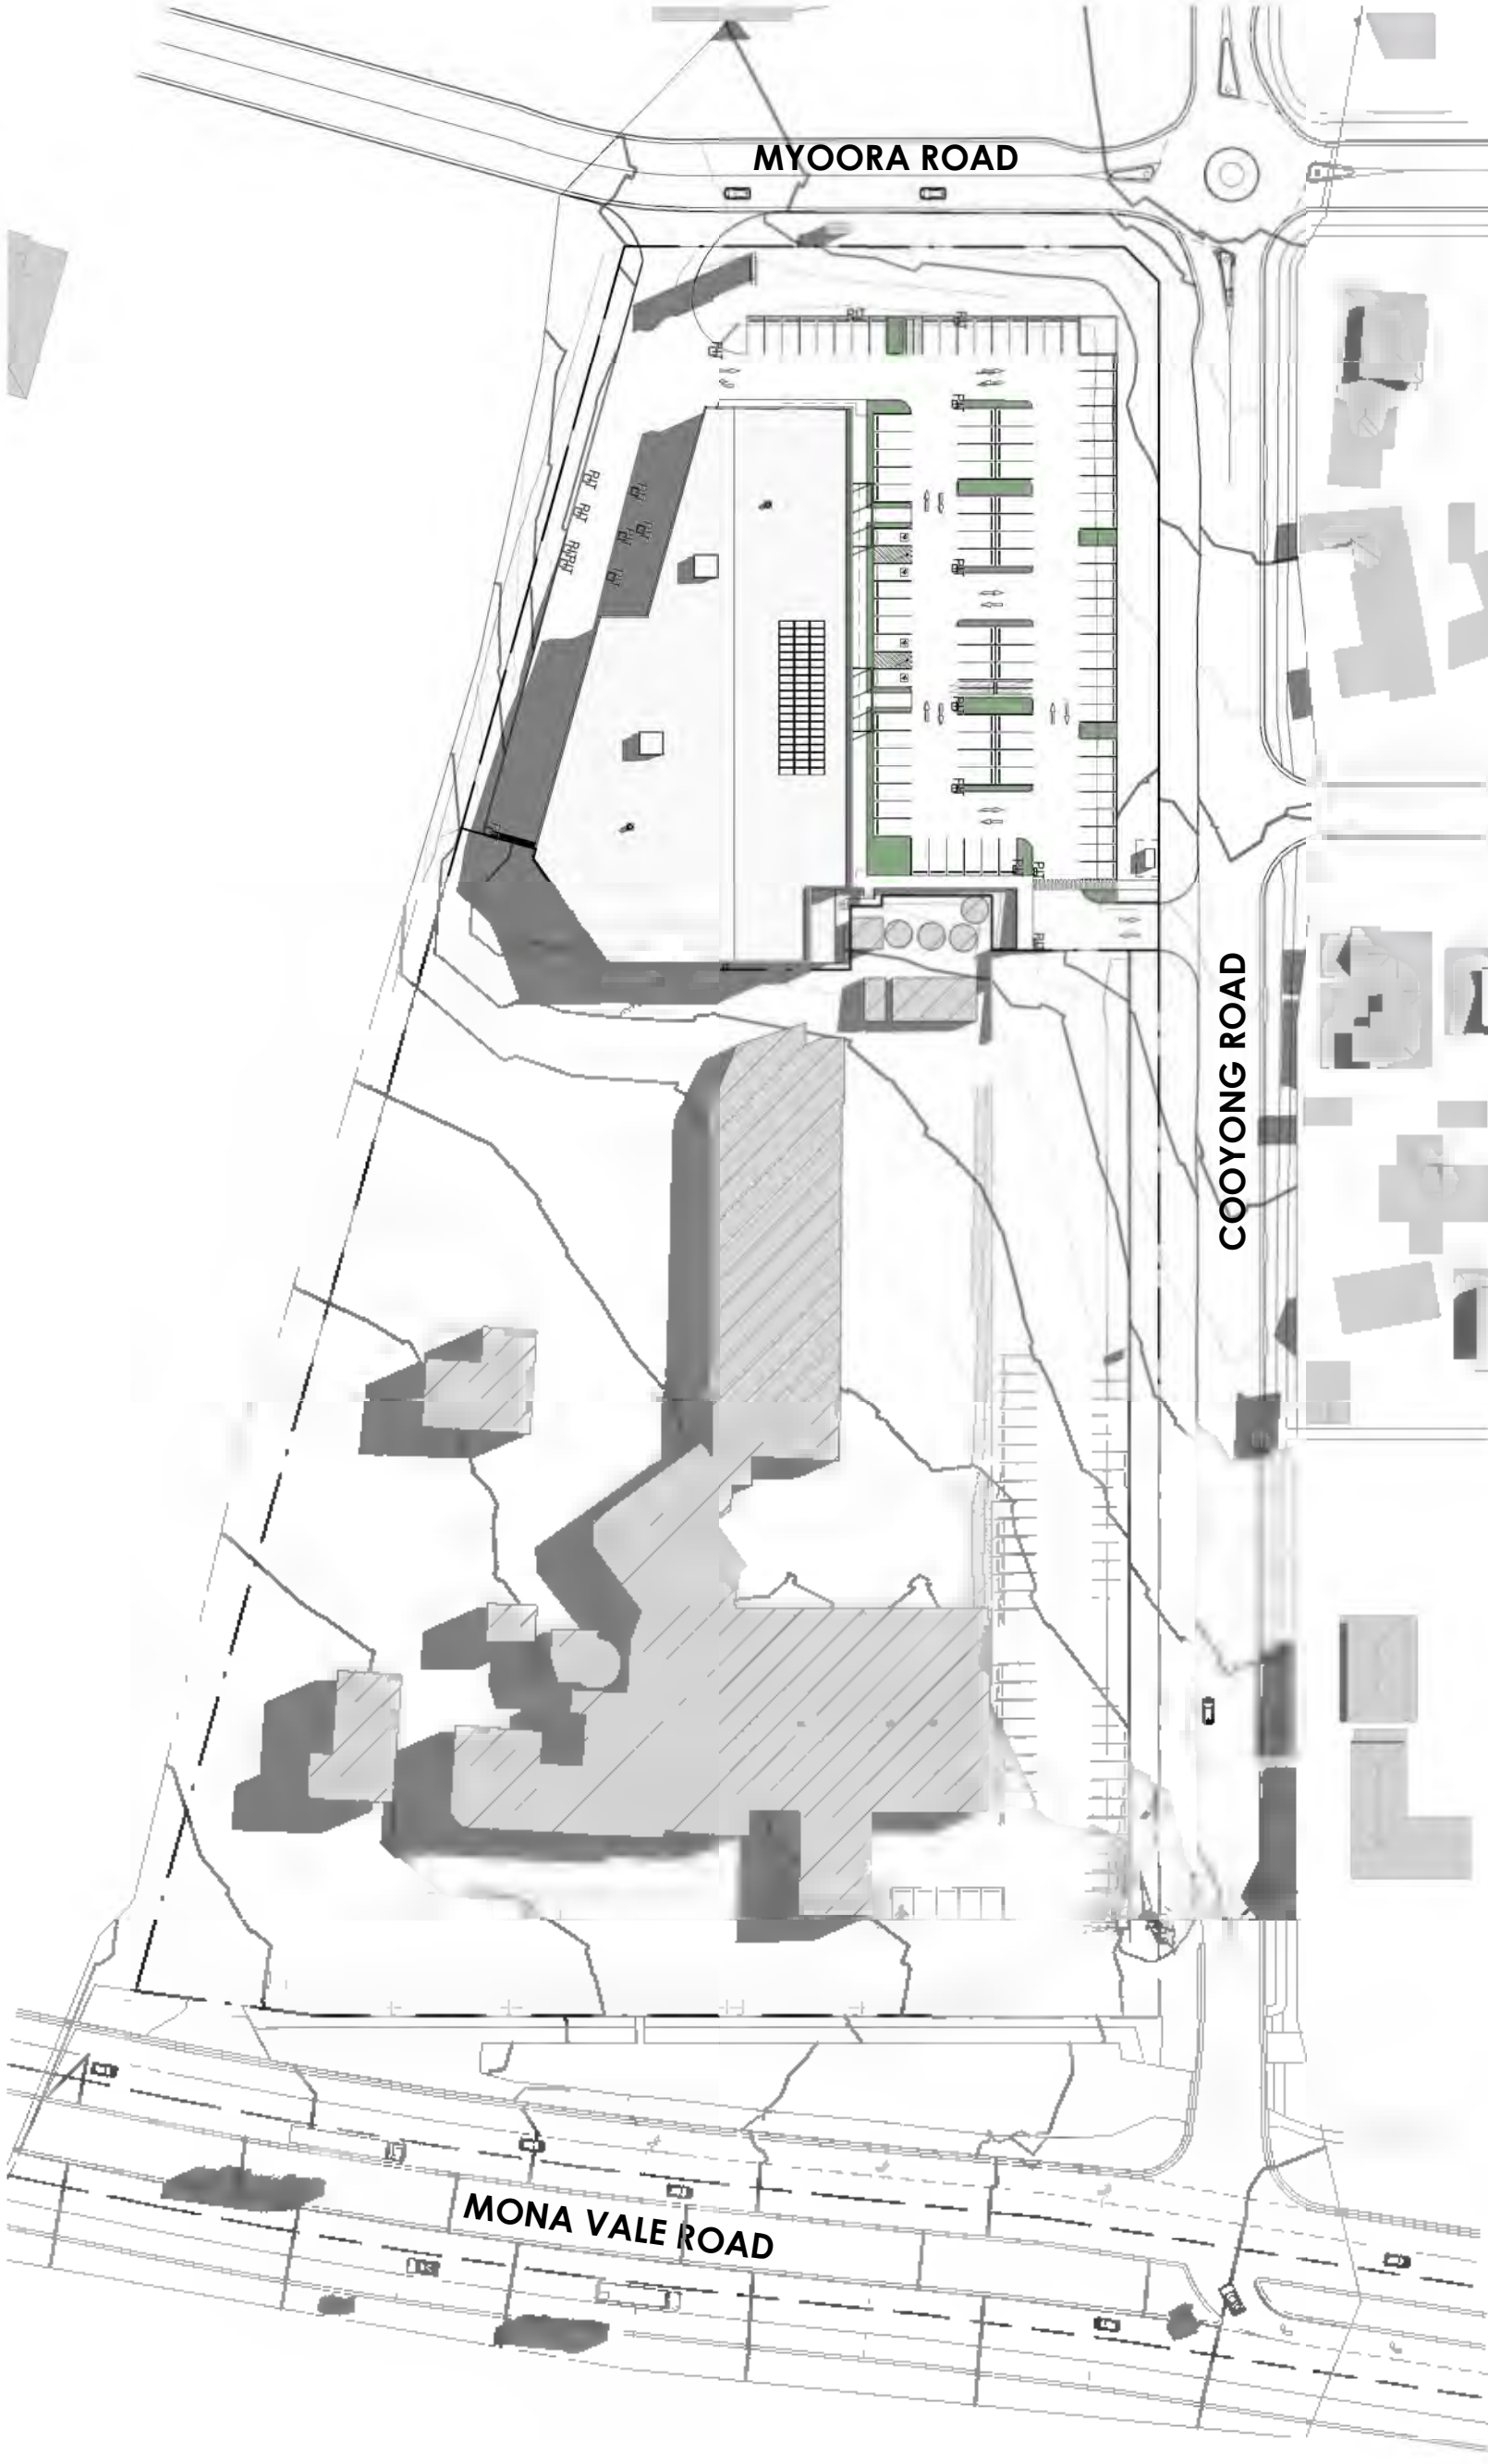
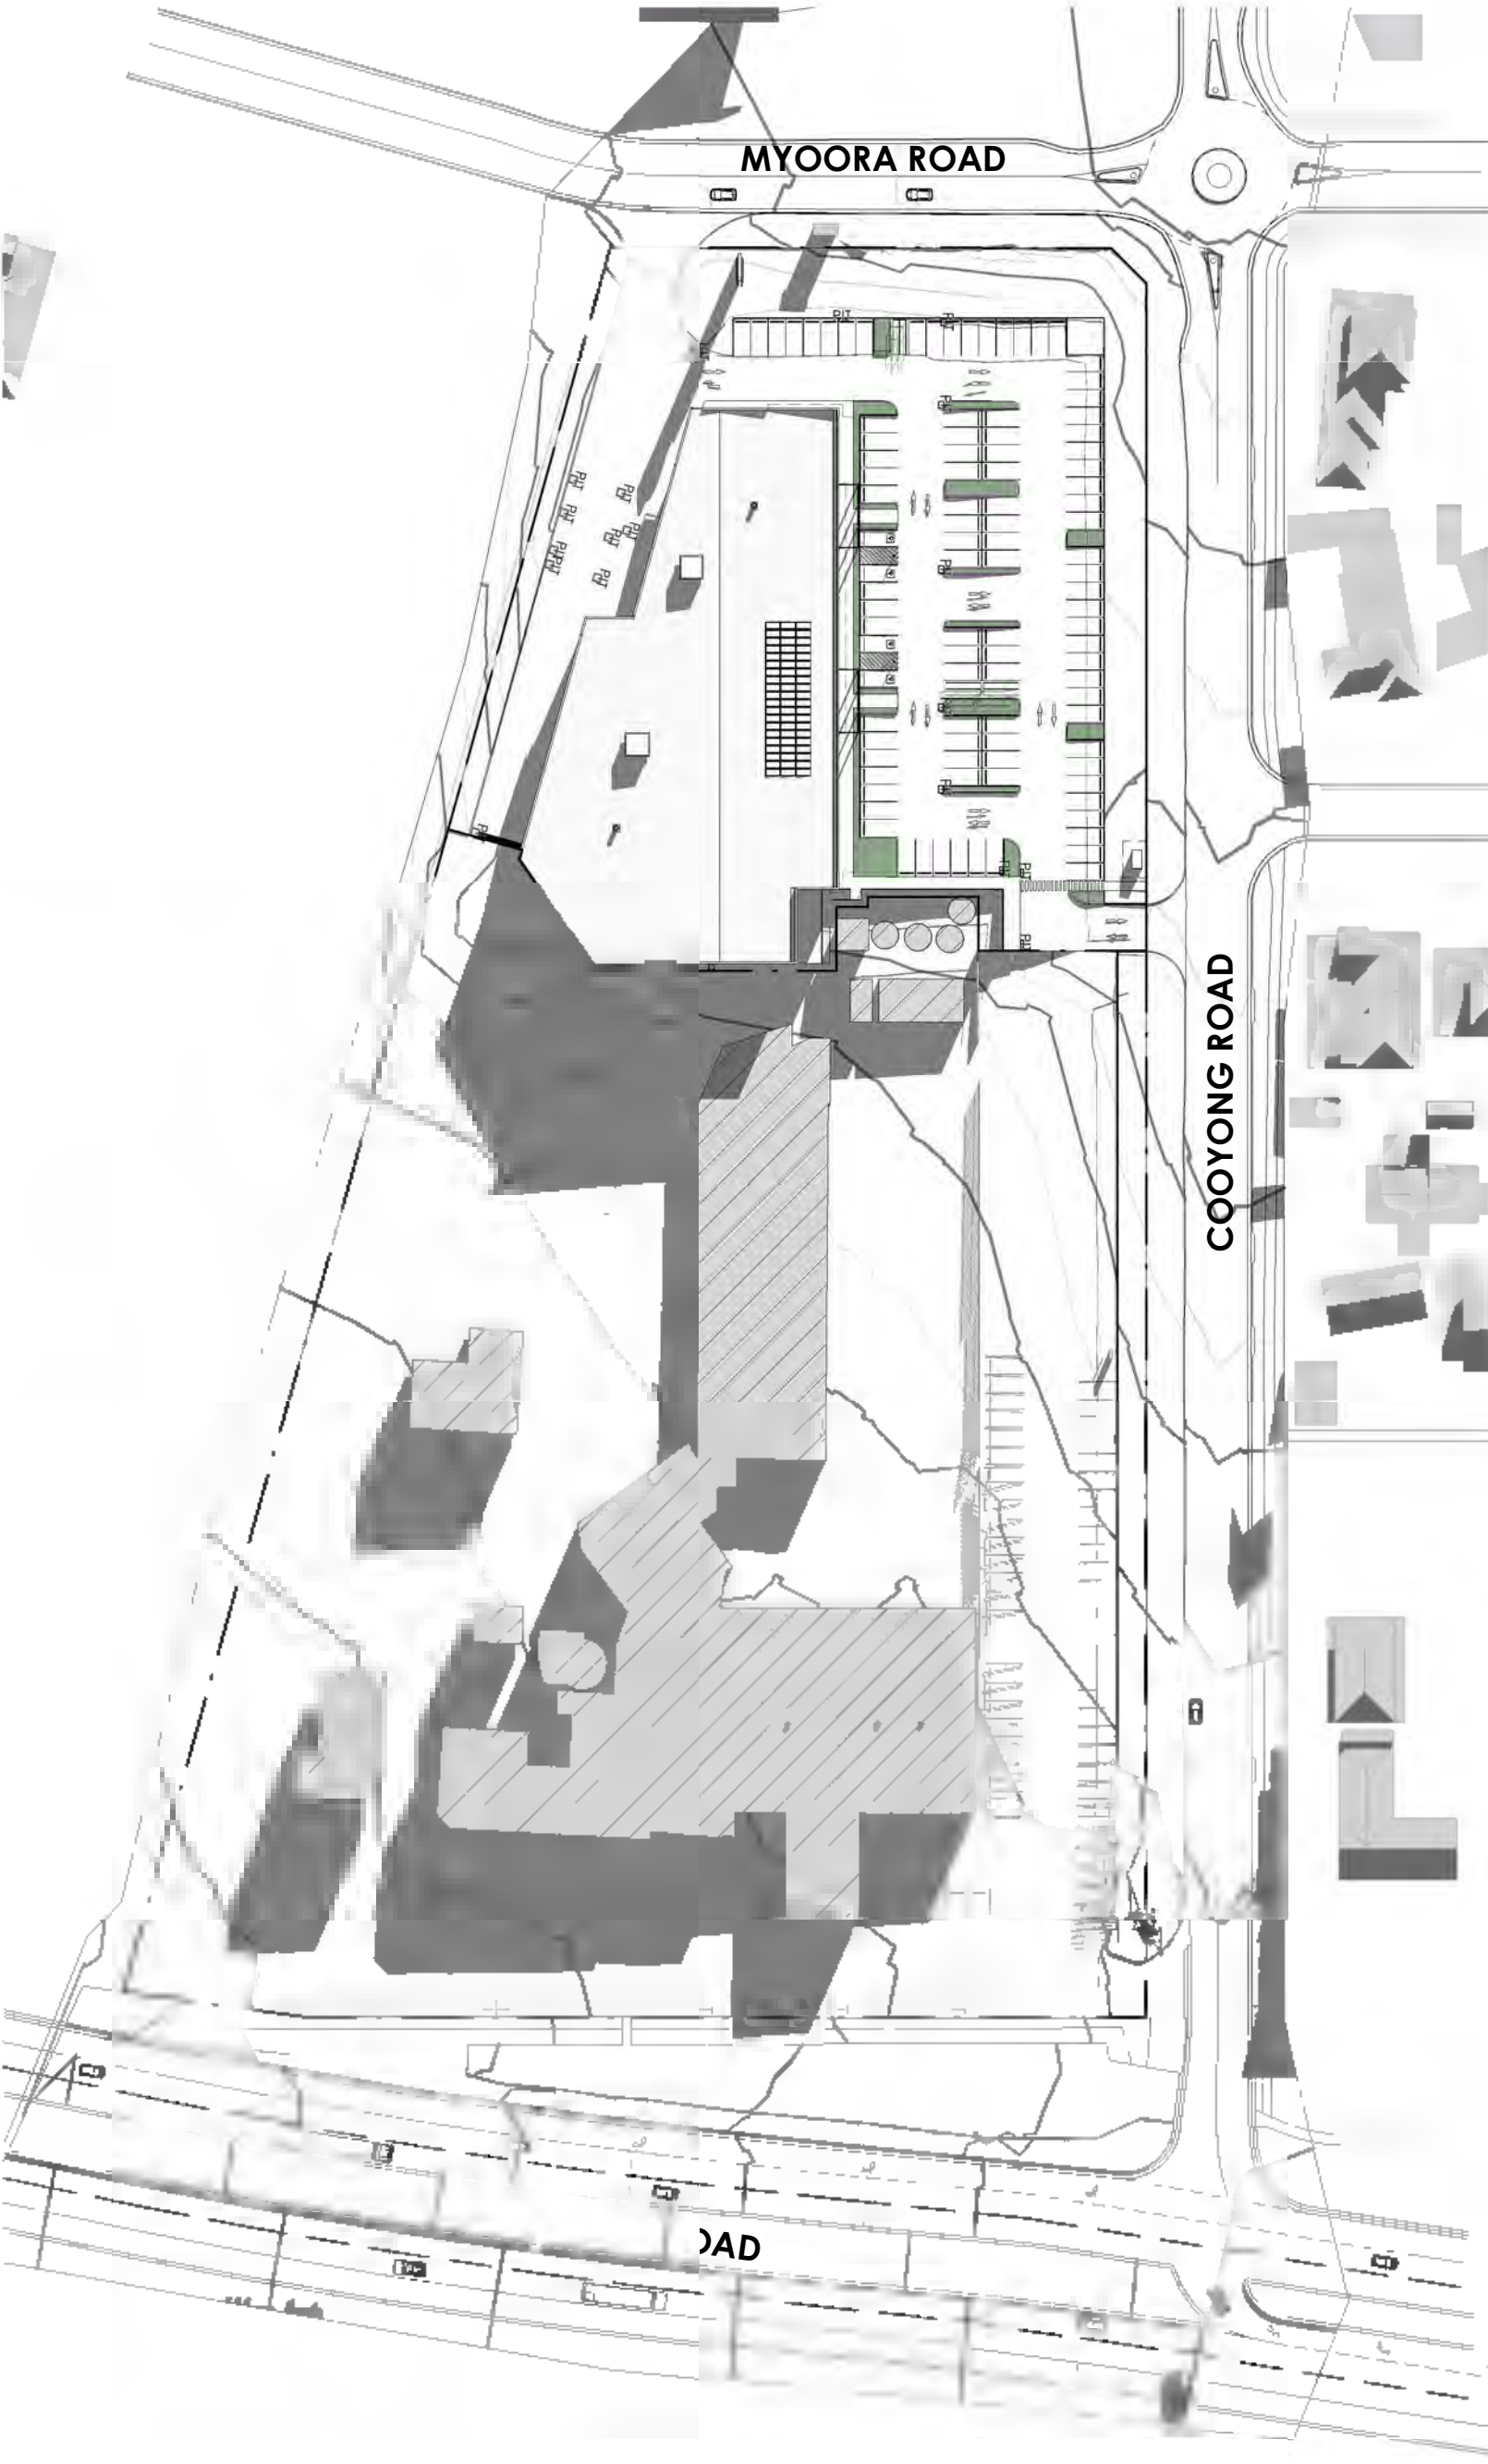
SHADOW DIAGRAMS

1 JUNE 22nd - 9am
Scale: 1 : 1000

2 JUNE 22nd - 12pm
Scale: 1 : 1000

3 JUNE 22nd - 3pm
Scale: 1 : 1000
