## View Loss Analysis

### 14 Bellevue Parade, North Curl Curl

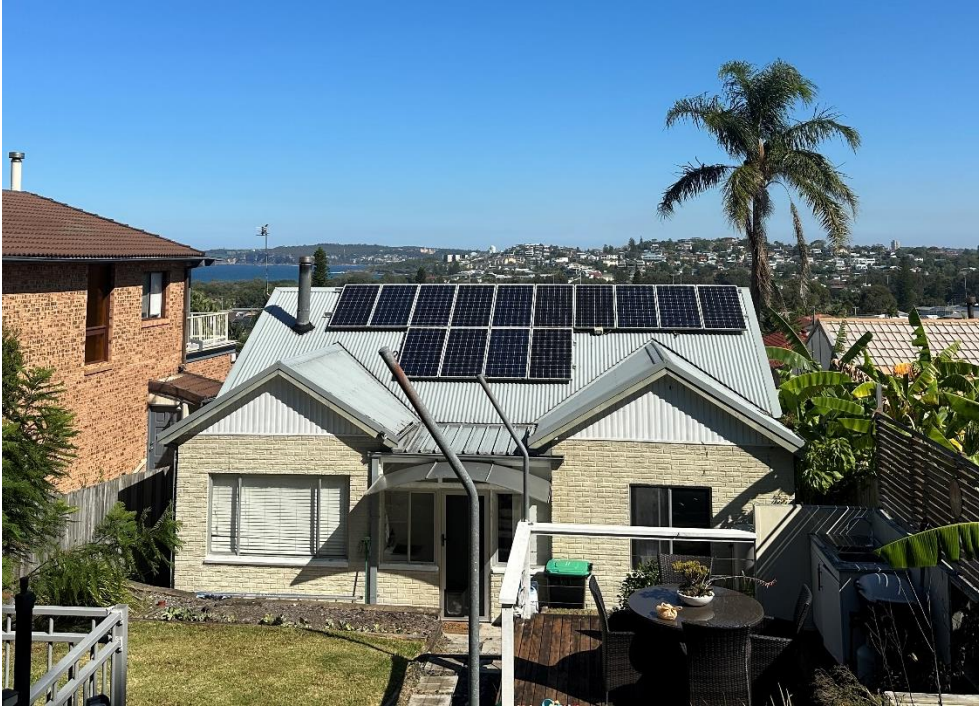
Figure 2: Water and district views, looking south from the rear yard of the subject site.

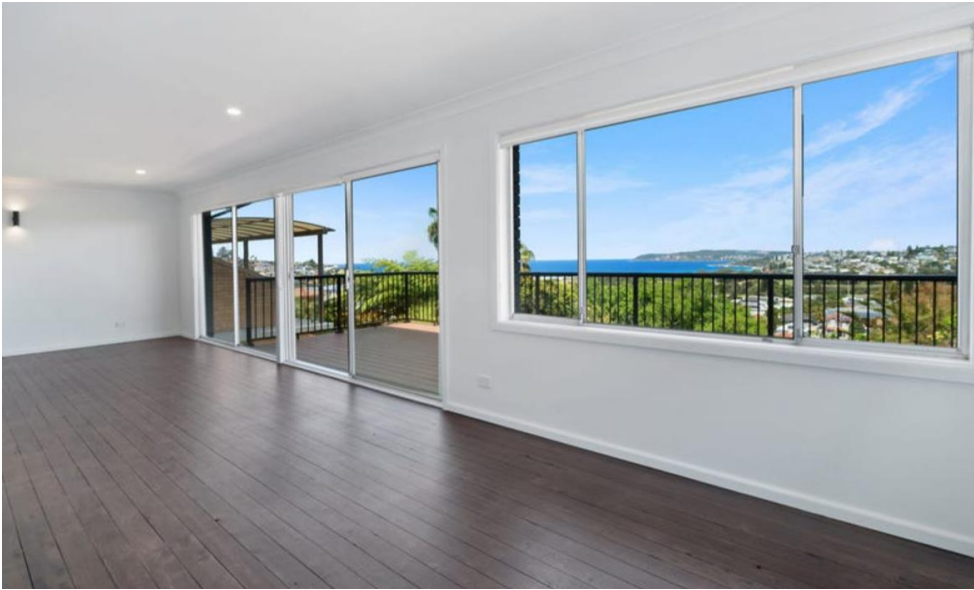
Views from 99 Headland Road are obtained from the rear first floor living room and balcony, looking south and south-east across the subject site, as illustrated below.

**Figure 3: Water views from the living room at 99 Headland Road, looking south-east.**

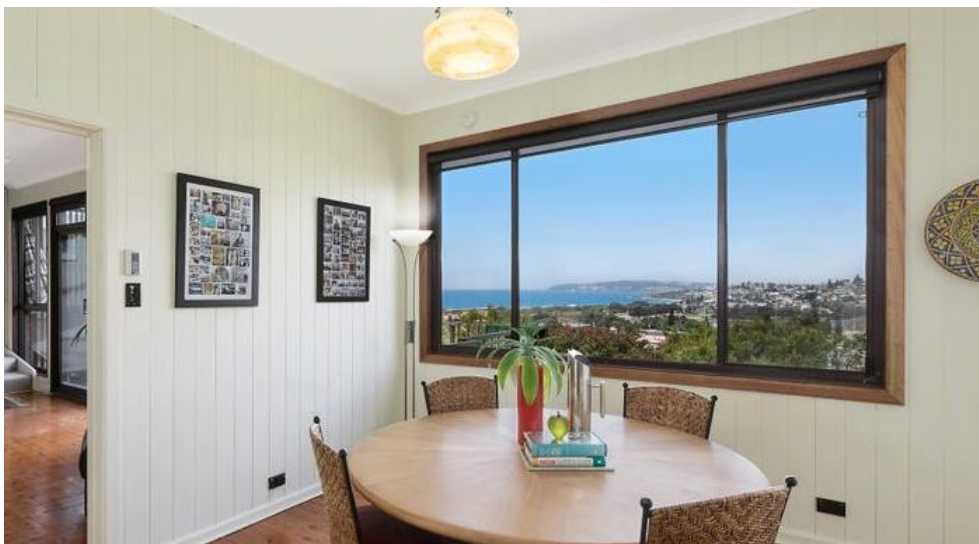
Views from 101 Headland Road are obtained from the ground floor dining, family and living rooms, ground floor deck and the rear yard, looking south-east, as illustrated below. It is noted the subject site is not visible from 101 Headland Road.

**Figure 5: Water views from the dining / living room at 101 Headland Road, looking south-east.**

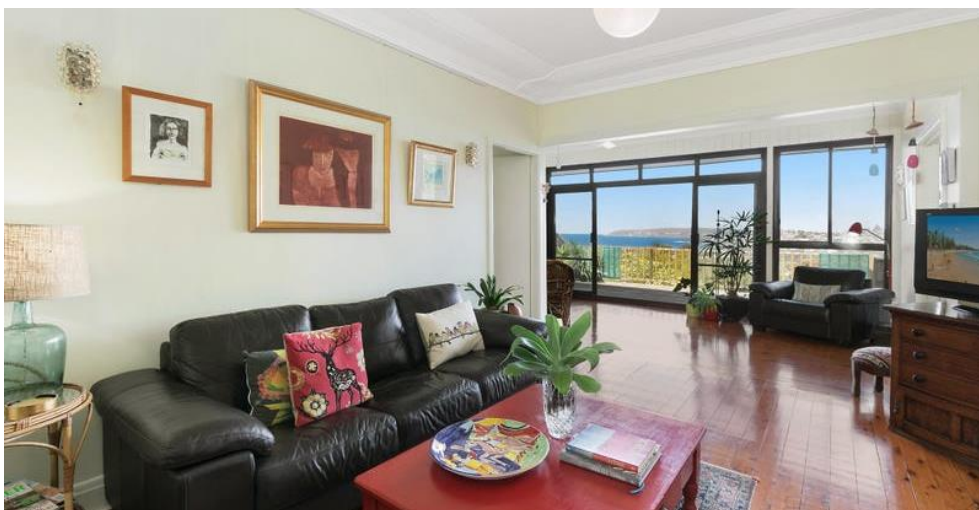
**Figure 6: Water views from the living room at 101 Headland Road, looking south-east.**

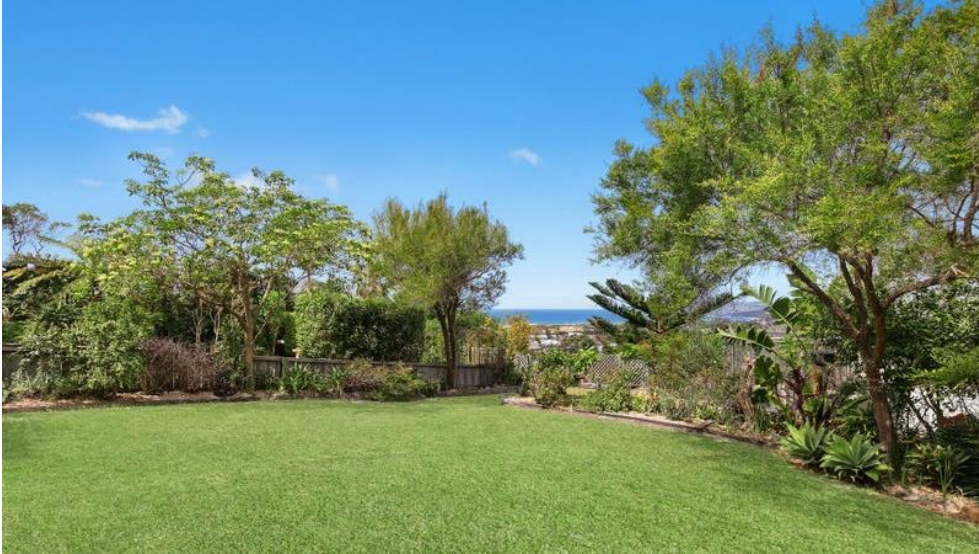
**Figure 7: Water views from the rear yard at 101 Headland Road, looking south-east.**

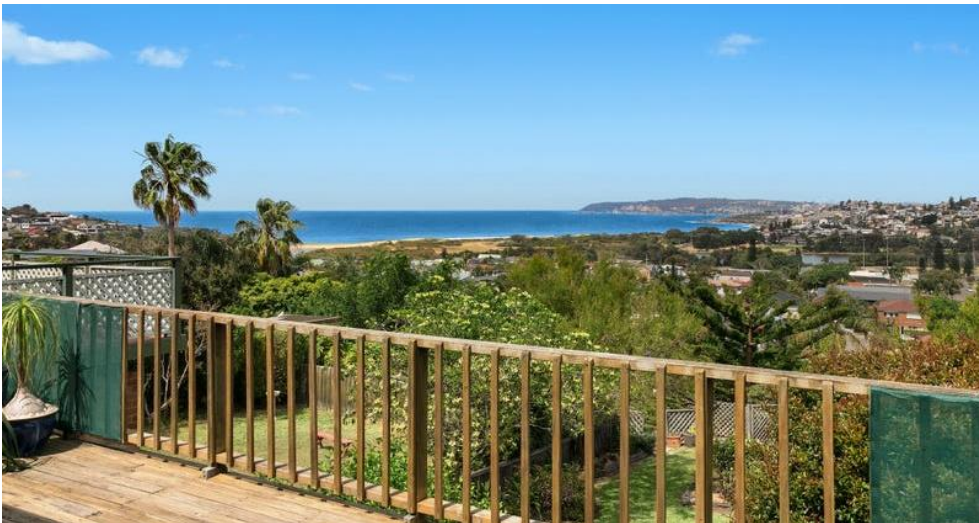
**Figure 8: Water views from the rear deck at 101 Headland Road, looking south-east.**
