Report on  
Geotechnical Investigation

Proposed Residential Development  
29, 31 & 35 Reddall Street  
Manly

Prepared for  
Reddall Street Pty Ltd

Project 207028.00  
February 2023

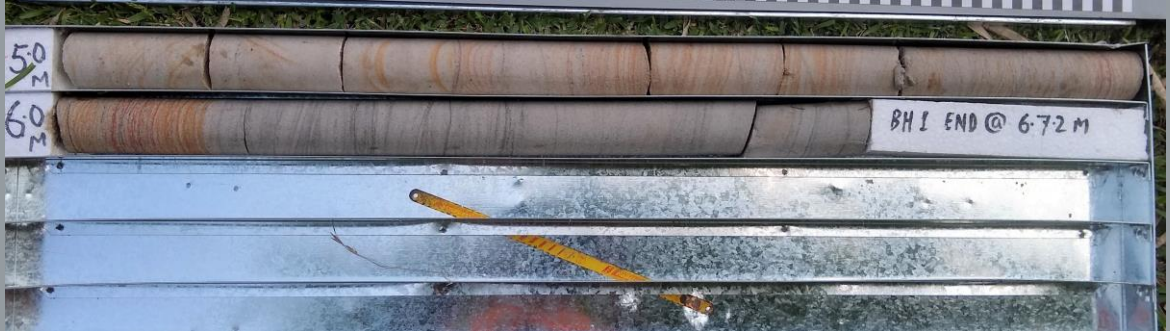
Project No: 207028.00  
BH ID: BH 1  
Depth: 5.00 - 6.72 m  
Core Box No.: 2/2

5.00-6.72m

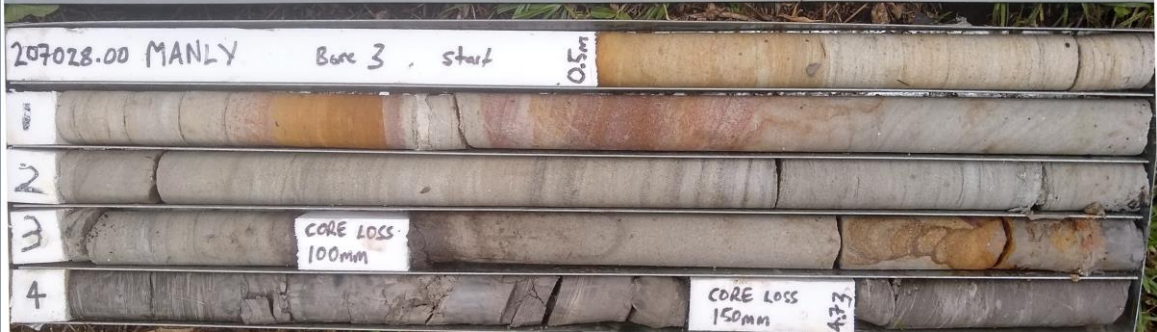
Project No: 207028.00  
BH ID: BH3  
Depth: 0.50 - 5.00 m  
Core Box No.: 1/2

0.5-5.00m

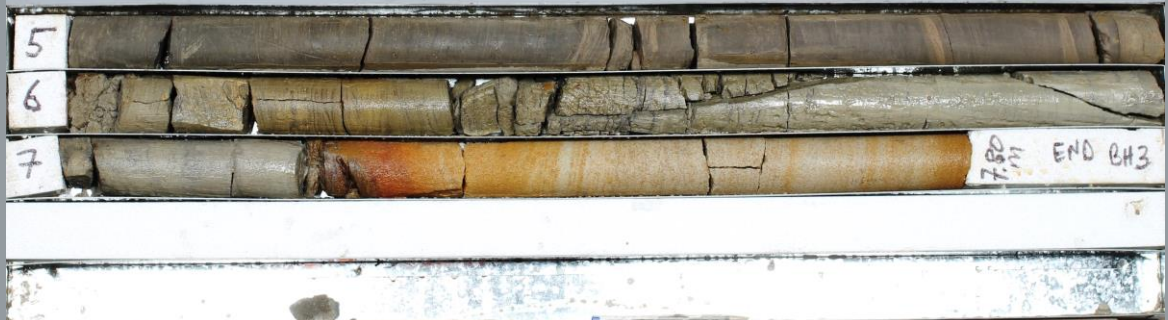
Project No: 207028.00  
BH ID: BH3  
Depth: 5.00 - 7.80 m  
Core Box No.: 2/2

5.00-7.80m

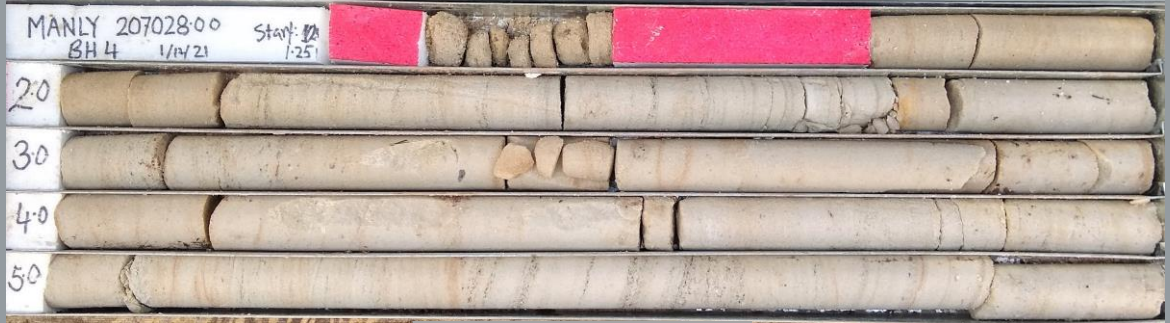
Project No: 207028.00  
BH ID: BH 4  
Depth: 1.25 - 6.00 m  
Core Box No.: 1/1

1.25-6.00m

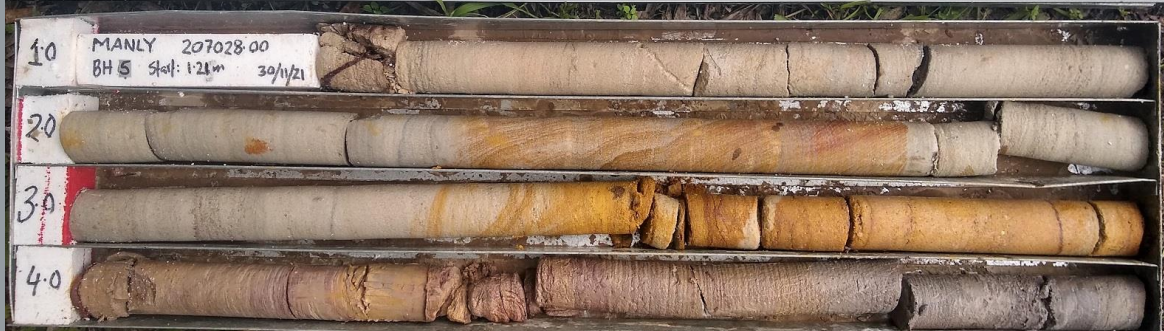
Core Box No.: 1/2

1.25-5.00m

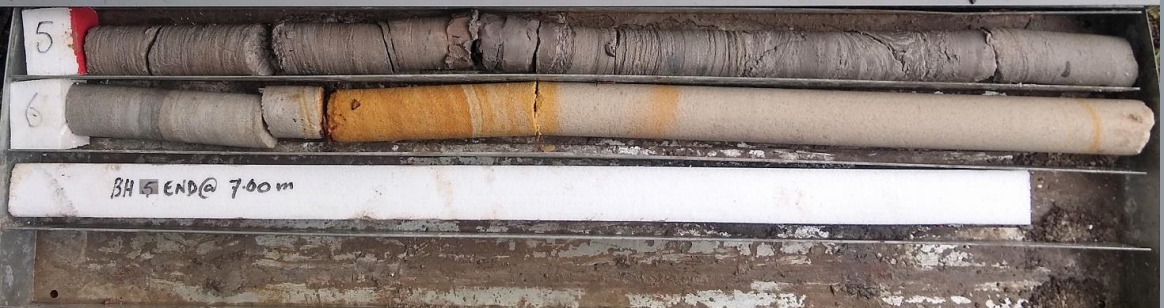
Core Box No.: 2/2

5.00-7.00m

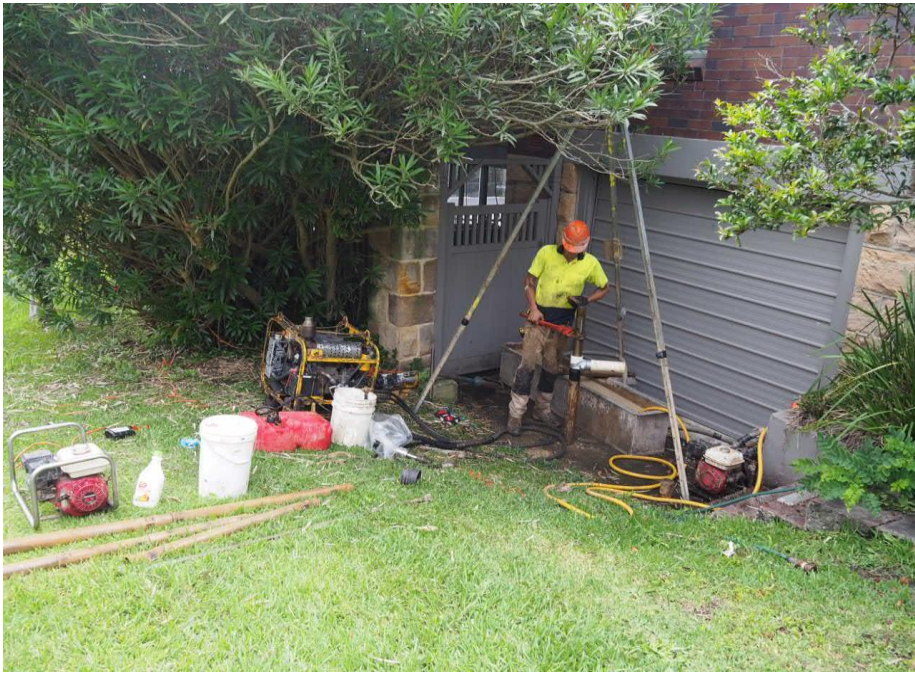
Photo 1: Drilling Bore 1 on 29 Reddall Street

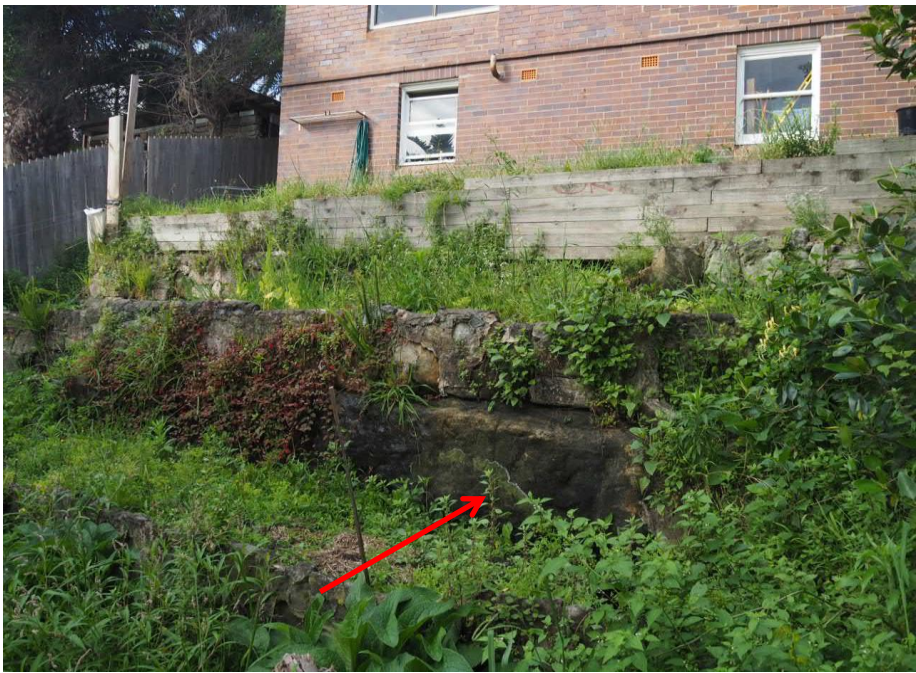
Photo 2: Sandstone bedrock outcrop on 31 Reddall Street

Sandstone bedrock exposures were noted on and beside the site and are indicated on Drawing 1. Areas of seepage were noted across Reddall Street, most probably due to shallow groundwater flow across the surface of the bedrock (refer to Photo 6).

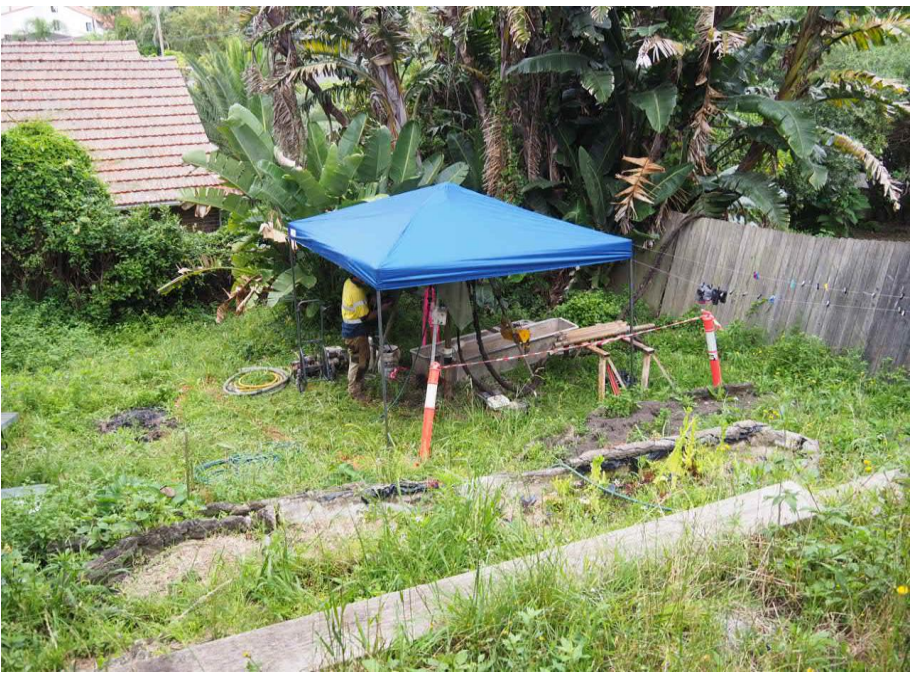
Photo 3 - Drilling Bore 3 on 31 Reddall Street

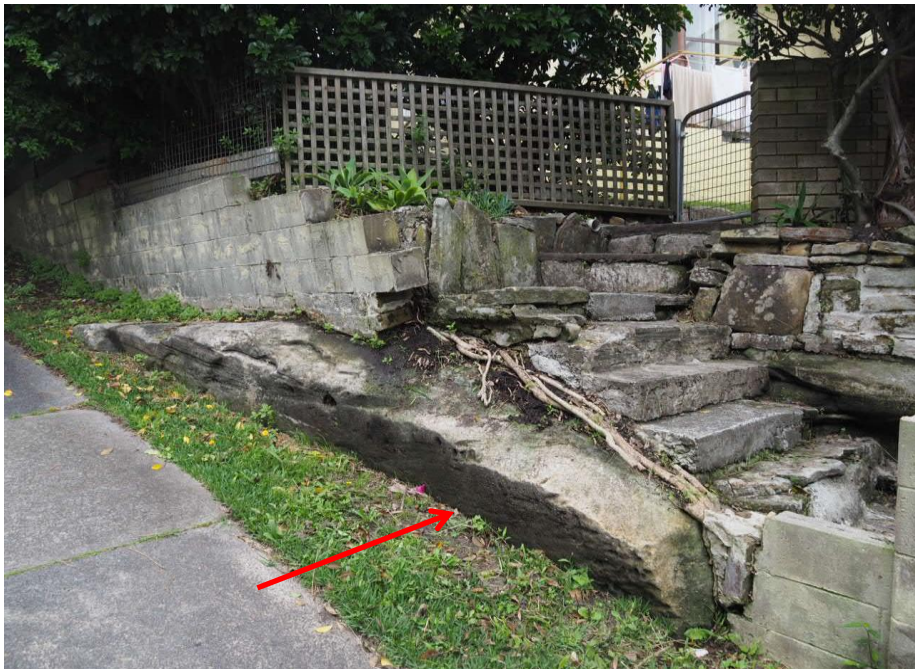
Photo 4: Sandstone bedrock and leaning boundary wall beside College Street

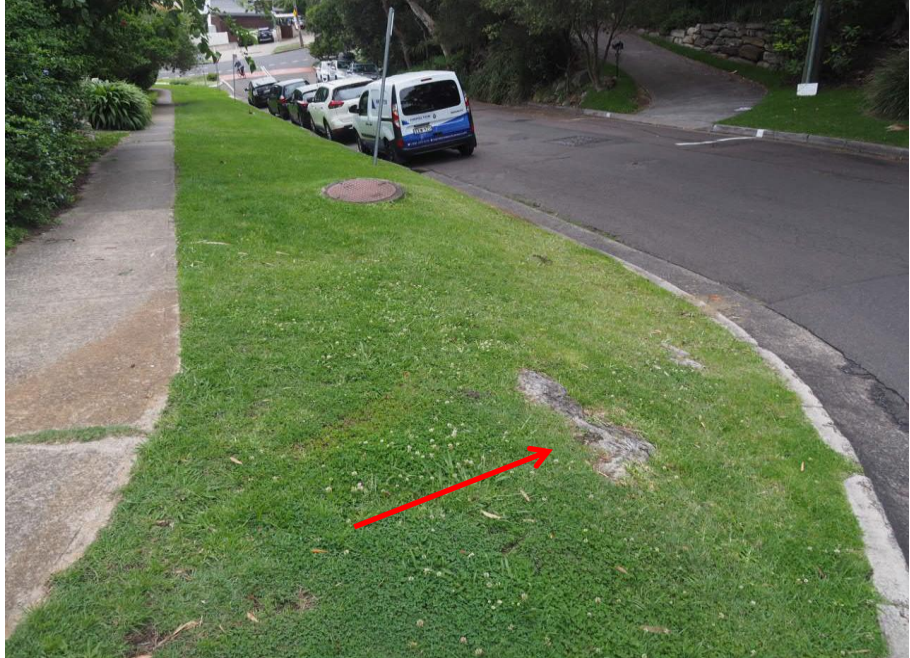
Photo 5: Sandstone bedrock outcrop at corner of Reddall & College Streets

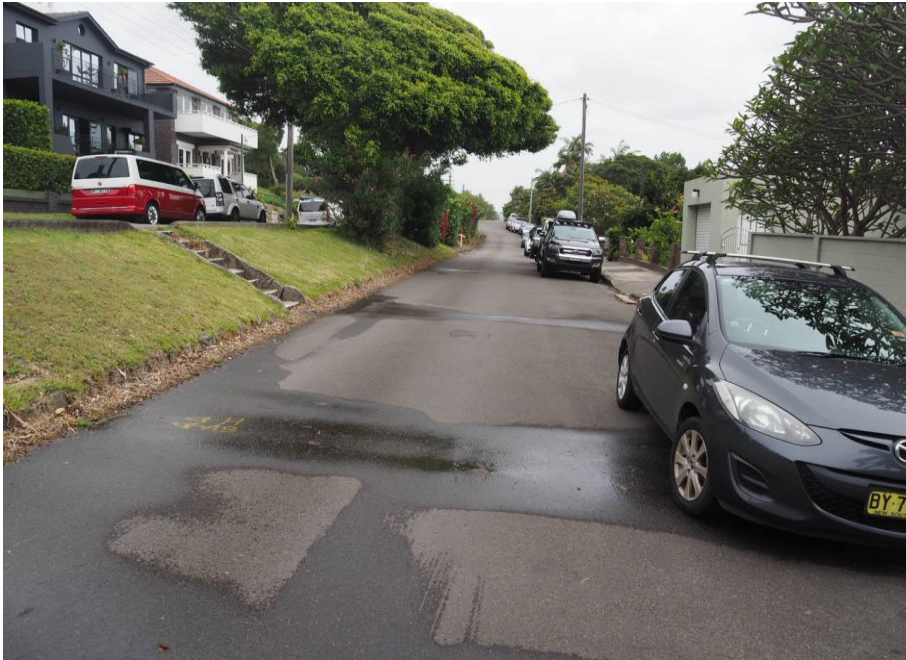
Photo 6: Seepage across Reddall Street following extended rainfall
