Report Title: Geotechnical Report 885 Barrenjoey Road, Palm Beach  
Report Date: 23/10/25

## **GEOTECHNICAL INVESTIGATION:**

New Carport at **885 Barrenjoey Road, Palm Beach**

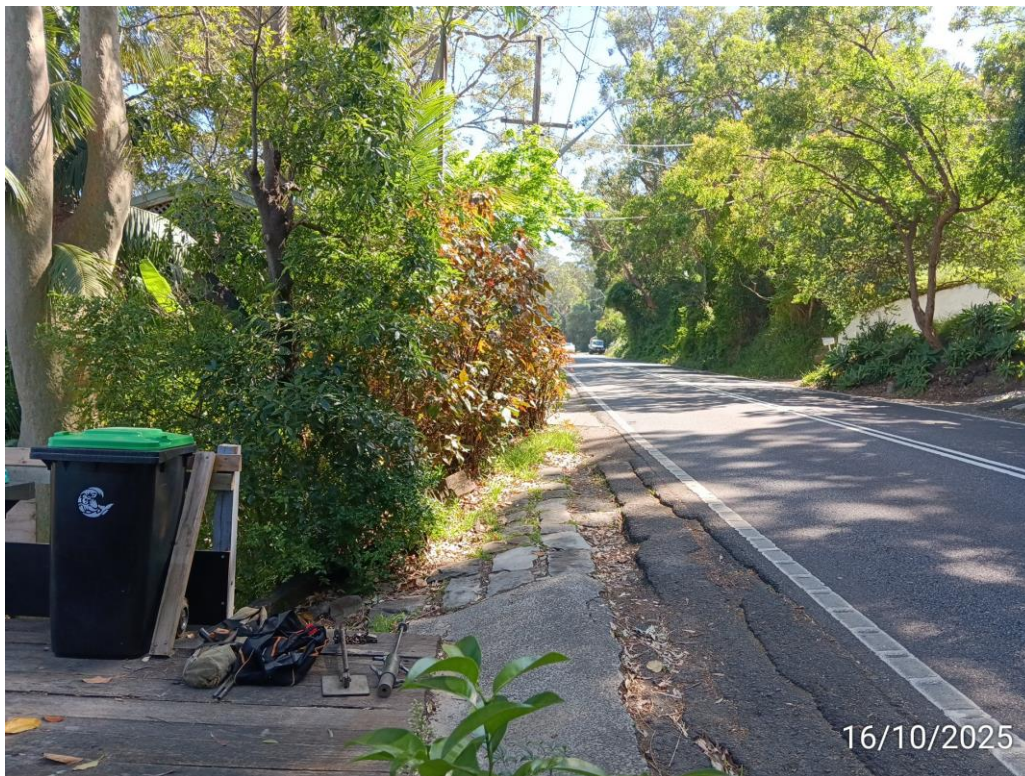
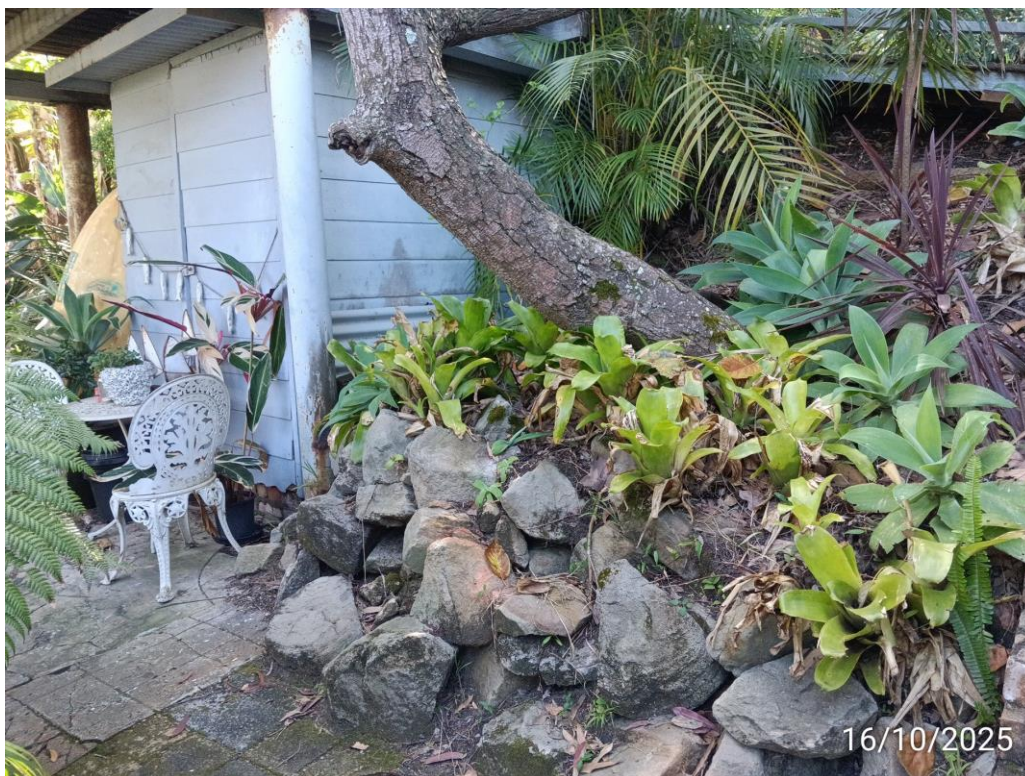
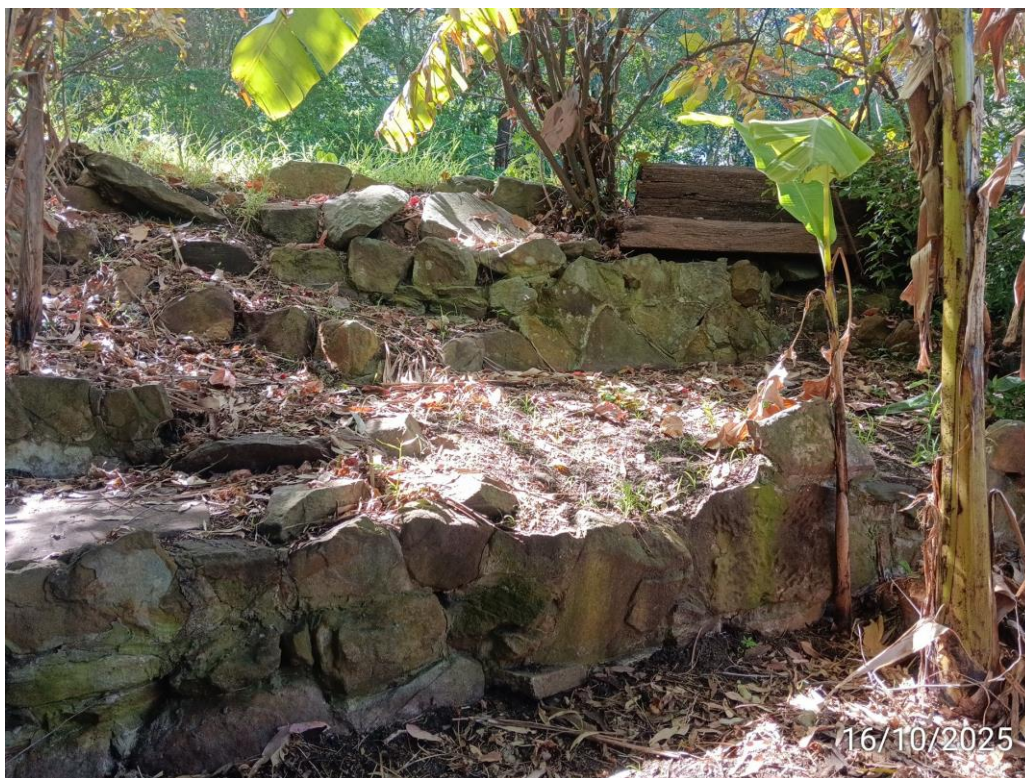
- 2.3** Fill provides a level platform for the road, road reserve and a garden area on the uphill side of the property (Photos 1 to 3). The fill is battered at stable angles or lined by rough stacked rocks and low sandstone flagging. A suspended timber carport with shed below is located at the uphill side of the property (Photo 4). The posts that support the carport stand vertical. The carport and shed will be replaced as part of the proposed works. The part two storey house is supported on brick walls, brick piers and

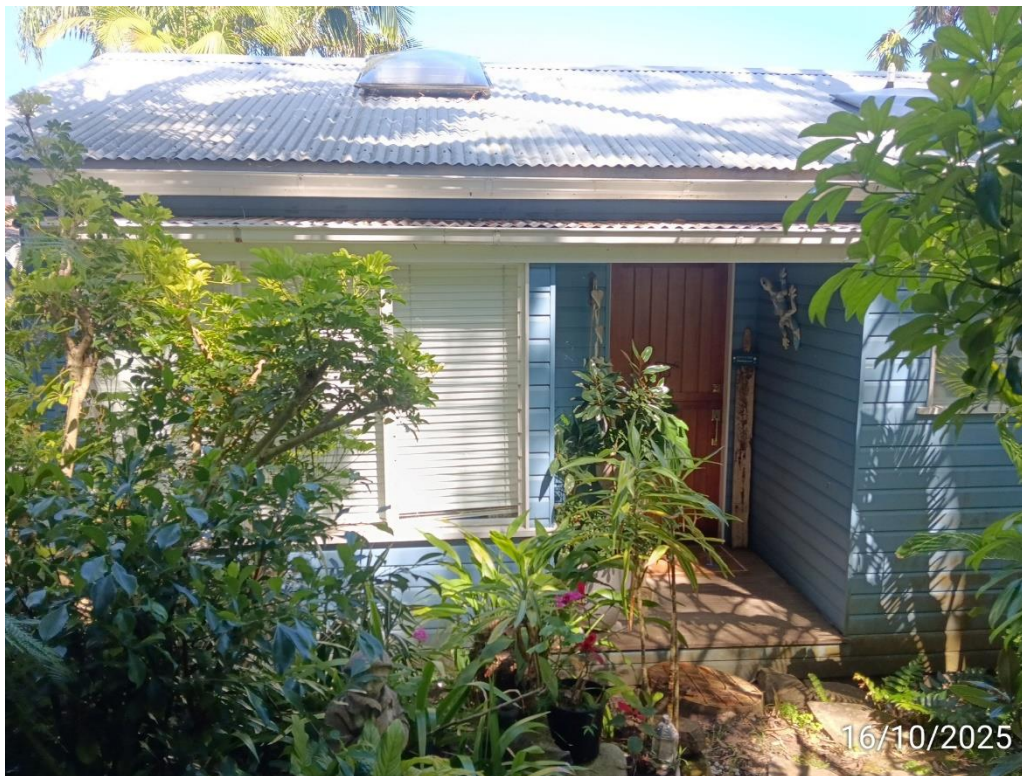
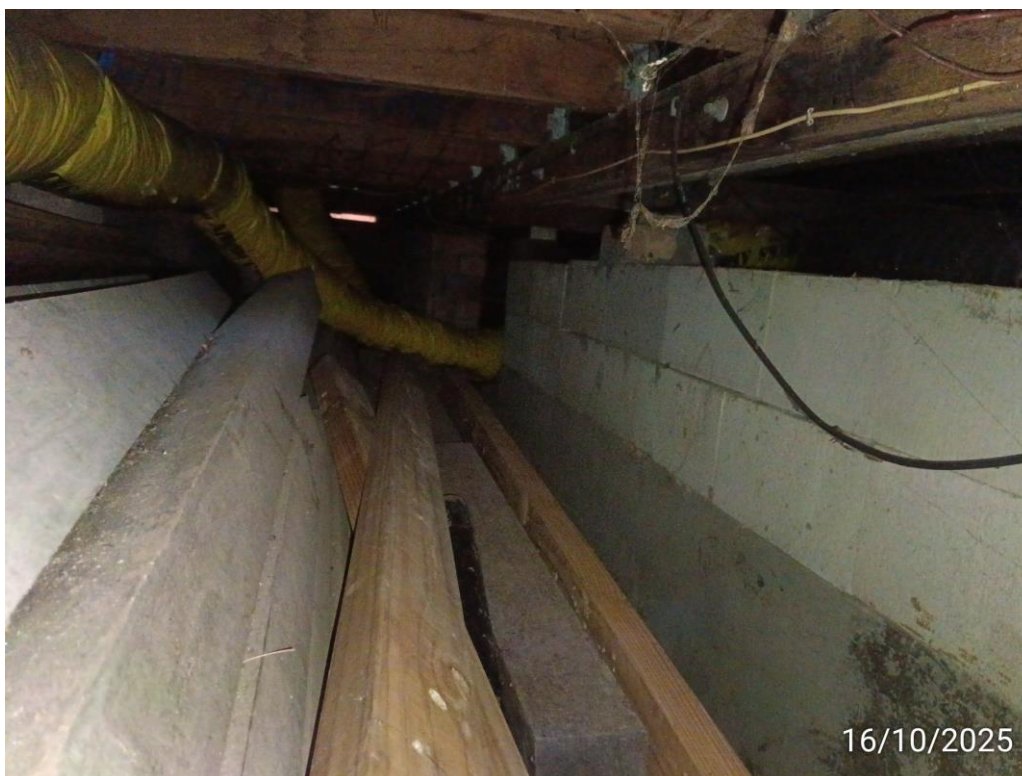
concrete block walls (Photos 5 & 6). The external supporting walls show no significant signs of movement. The majority of the foundation space was inaccessible. Fill provides level platforms for deck, paved, lawn and garden areas at the downhill side of the property. Mortared sandstone retaining walls up to ~2.0m high support the fill (Photos 7 to 9). The visible portions of the walls at the downhill side of the property appear to be stable. Part of the upper retaining wall (Photo 7) was obscured by vegetation and could not be assessed. Detached sandstone joint blocks are located at the waterfront (Photo 10). No signs of slope instability were observed on the property that could have occurred since the property was developed. The adjoining neighbouring properties were observed to be in good order as seen from the street and subject property.

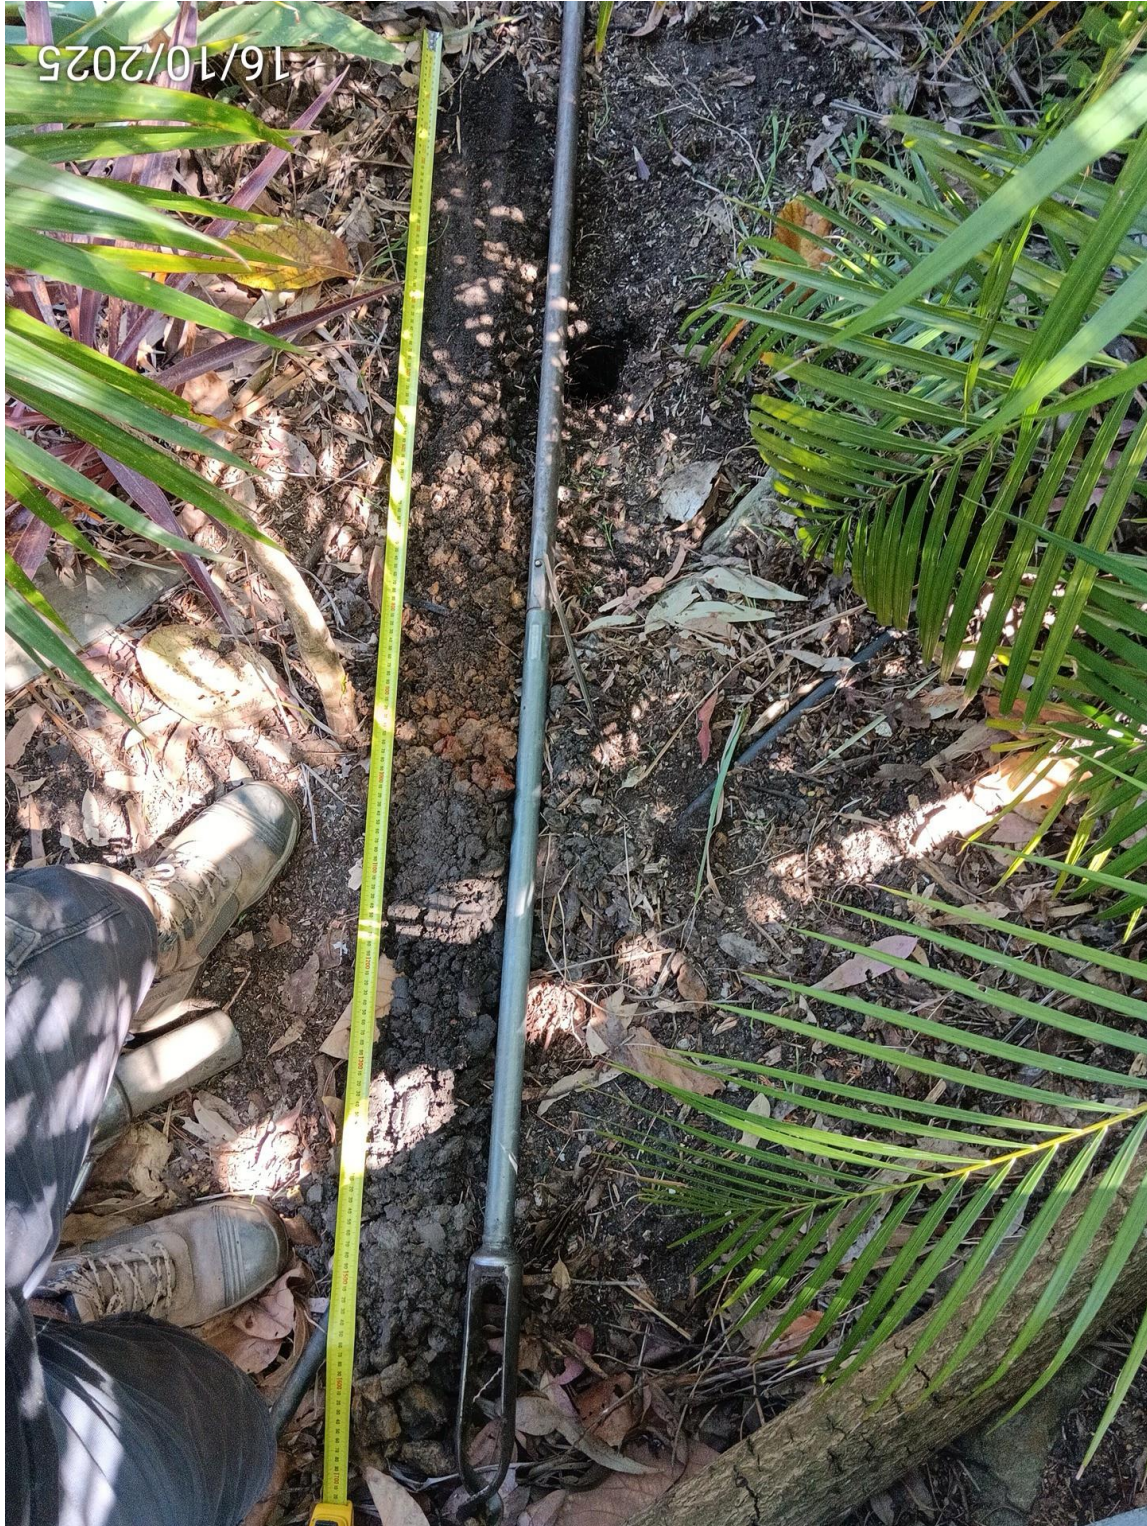
*Photo 11: AH1 – Downhole is from top to bottom.*

## AUGER HOLE 1 (~RL13.6) – AH1 (Photo 11)

| Depth (m) | Material Encountered |
| 0.0 to 1.3 | <b>FILL</b> , sandy soil and clay, with some rock fragments, dark brown, light brown, orange, moist, fine to coarse grained. |
| 1.3 to 1.5 | <b>SILTY SAND</b> , grey, damp, fine to medium grained. |
| 1.5 to 1.7 | <b>CLAY</b> , light brown, orange and grey, mottled, firm to stiff, moist. |

End of hole @ 1.7m in firm to stiff clay. No water table encountered.
