Marine Habitat Survey

Address | 139 – 141 Riverview Road, Avalon Beach

Job Number 24-048-05 C

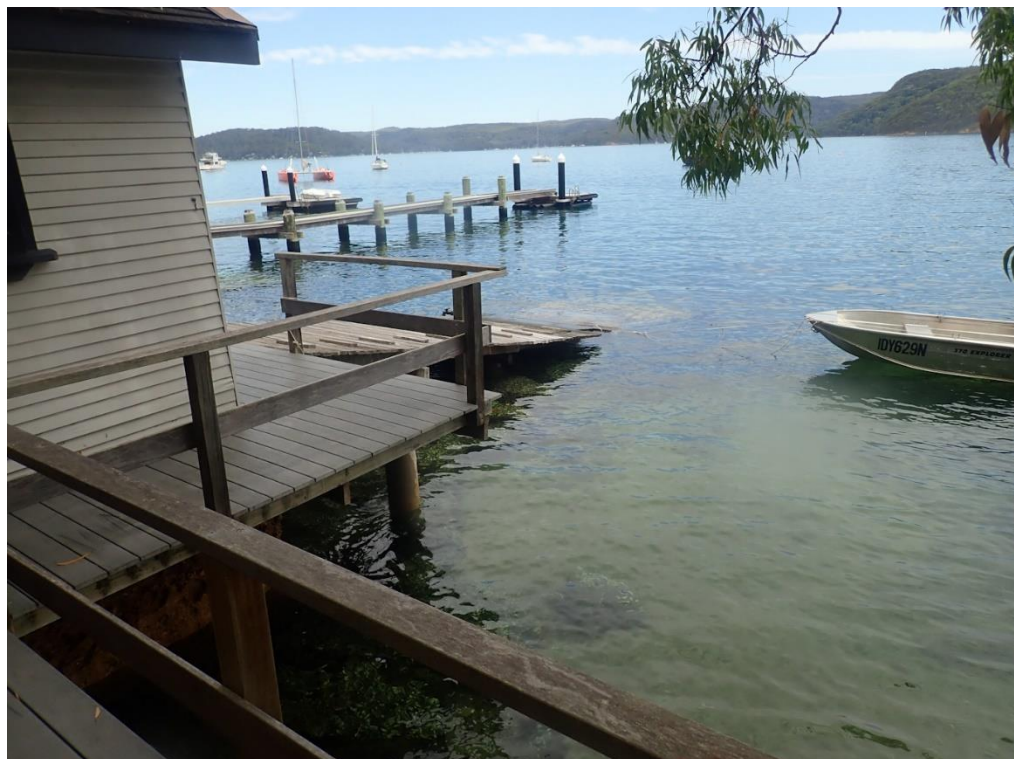
Photo 2. The northern side of the boatshed, timber deck and timber skid ramp.

The existing structures present at The Property at the time of the on-site survey (Photos 1 - 4) included:

- a boatshed on the southern side of The Property, surrounded on the northern and western sides by a timber deck (the deck finished approximately 5 m beyond the MHWM);
- a timber skid ramp (6.75 x 2.8 m) located out the front of the boatshed south to the boatshed's southern building line and placed on top of an area of stacked rocks;
- a concrete ramp (5.5 x 2.9 m) that is an extension of the timber skid ramp and was crumbling away at the seaward end.

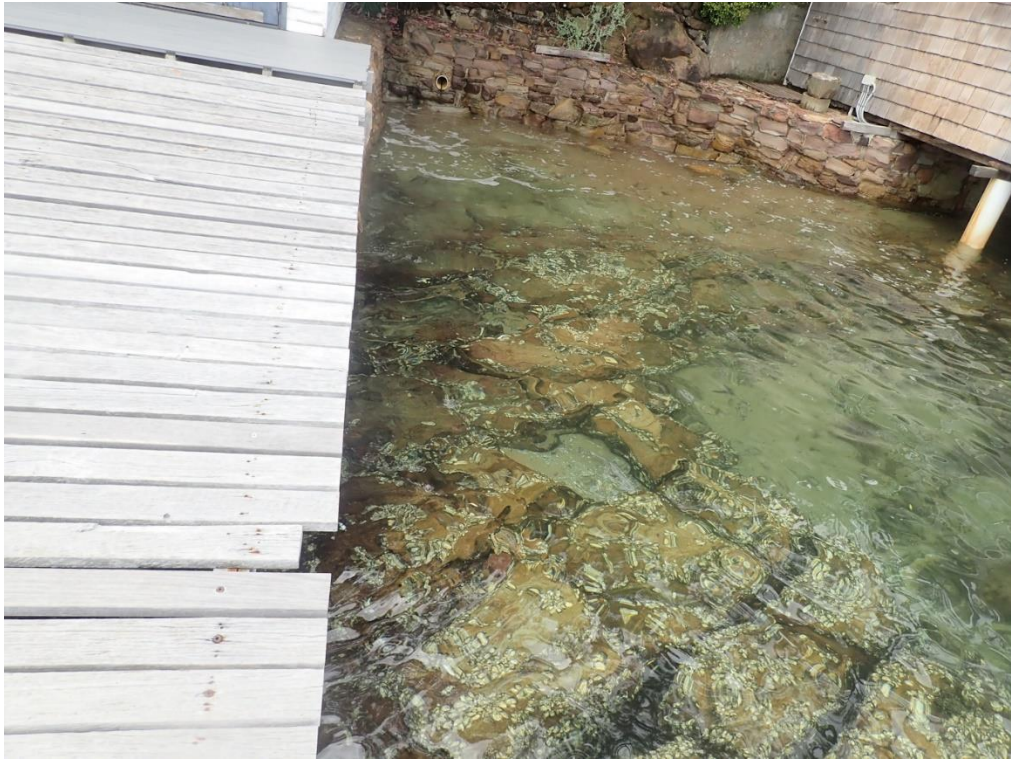
Photo 3. The intertidal habitats of seawall, sand and boulders on the southern side of the skid and boatshed.

The intertidal zone at The Property consisted of artificial and natural habitats. A stacked stone seawall stretched across the width of The Property (Photo 3). The seawall was fronted by bedrock covered in a layer of intertidal sand. The sandy seabed was covered in numerous large boulders and rocks on the southern side of the boatshed and skid ramp (Photos 3 - 5) and an area of stacked boulders and large rocks under the timber skid. This rocky intertidal habitat extended out to the end of the existing timber skid ramp. The intertidal habitat to the north of the skid ramp and boatshed consisted predominantly of sand on bedrock.

The seawall was devoid of intertidal biota. The boulders and rocks under the skid ramp and on the southern side of The Property were colonised by a medium to high density cover of Sydney rock oysters (*Saccostrea glomerata*). The outermost 2 - 3 m of rocky substrata was colonised by clumps of brown Neptune's necklace (*Hormosira banksii*). The intertidal sand was unvegetated.

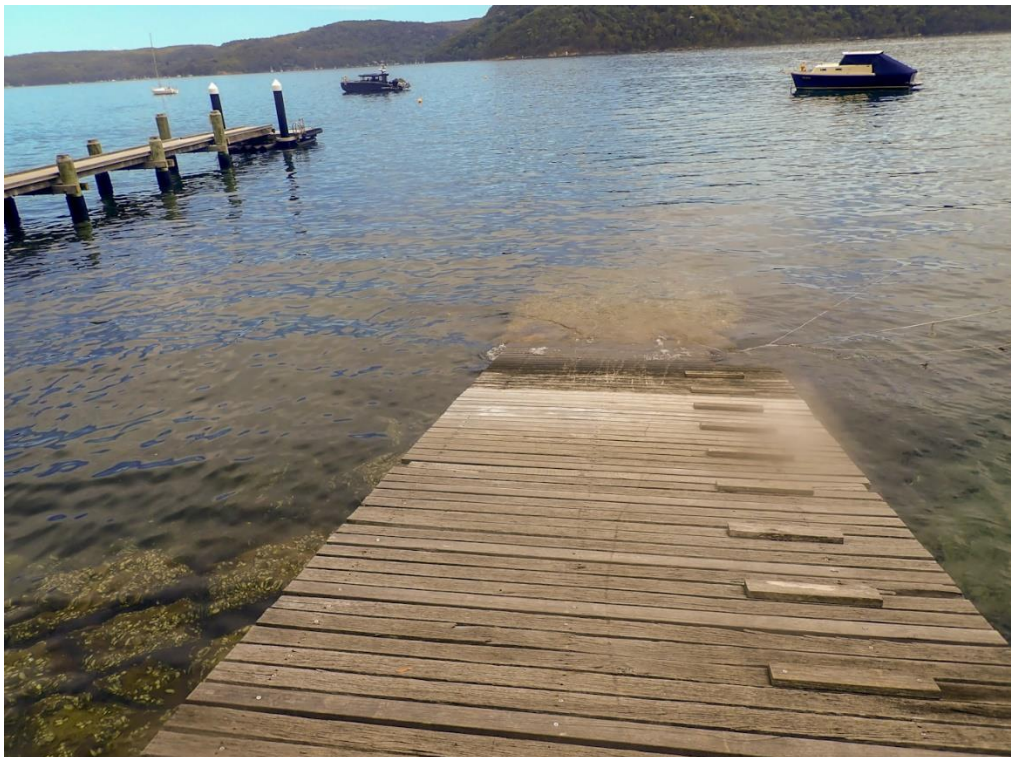
Photo 4. The timber skid ramp and submerged concrete ramp, with intertidal boulders on the left hand side of the skid ramp.

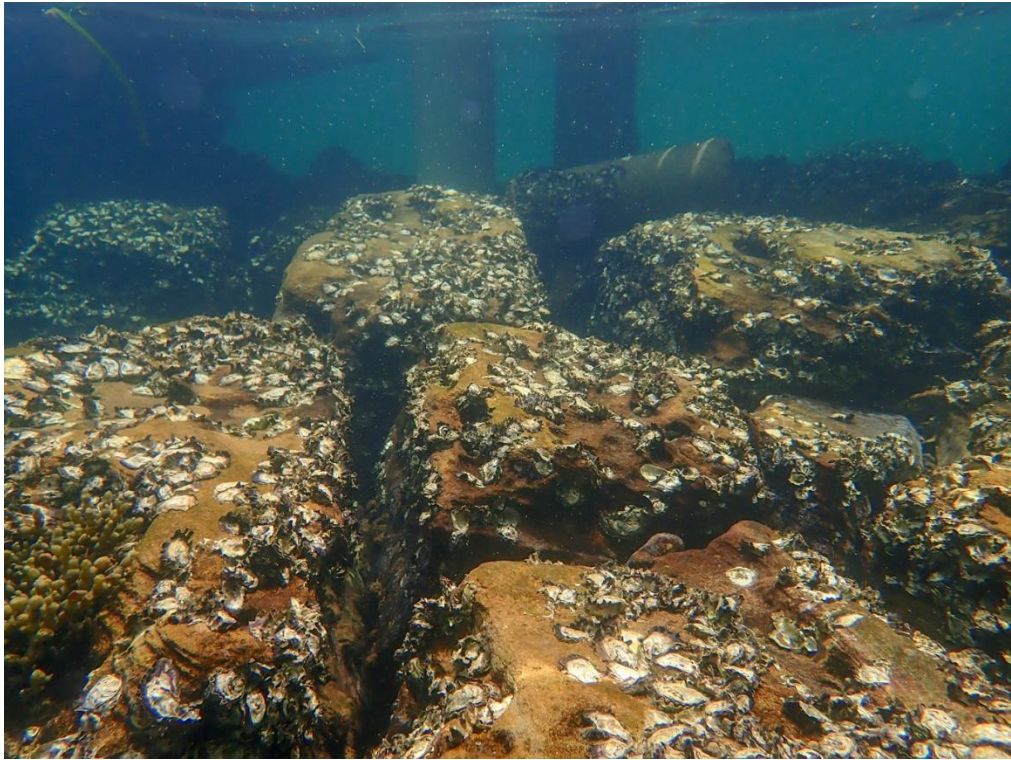
Photo 5. Submerged intertidal boulders on the southern side of the skid ramp, colonised by oysters and Neptune's necklace.

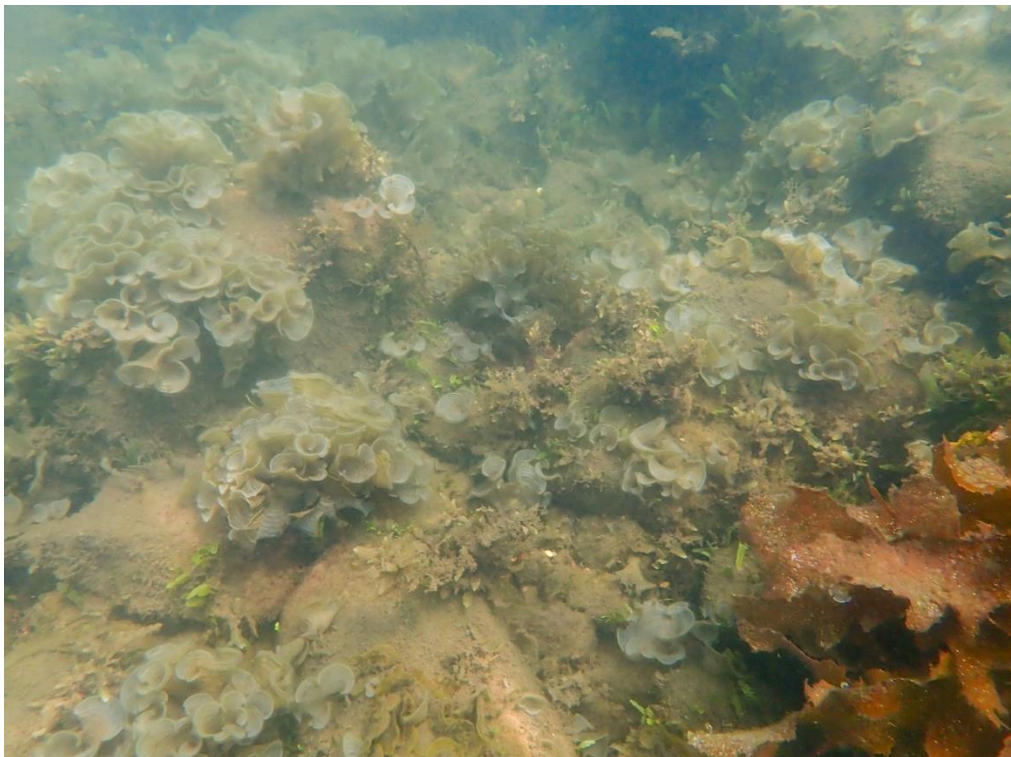
Photo 6. Shallow, subtidal rocky reef on the southern side of the concrete ramp, colonised by brown macroalgae.

The subtidal zone within the on-site survey area of The Property started off the end of the existing timber skid ramp and consisted of a gradually sloping seabed composed of sand covered with a high proportion of rocks and rubble (Photo 6). The rocks and rubble continued offshore for 11 m (Photo 7), before transitioning to a gradually sloping seabed of sand (Photos 8 - 10) which continued uniformly offshore beyond the survey area.

The rocky substrata that stretched offshore for 11 m beyond the end of the timber skid ramp (Photos 6 - 7) was colonised by a high density cover of brown macroalgae (bubbleweed *Sargassum* sp., kelp *Ecklonia radiata*, scrollweed *Padina* sp. and turfing filamentous), along with a low density cover of the green invasive weed *Caulerpa taxifolia*. The entire sandy subtidal seabed across The Property was colonised by seagrass (Photos 7 - 10). There was a narrow bed of medium density *Zostera* that started at the end of the rocky reef followed by a wider bed of mixed seagrass - medium density *Zostera* and *Halophila* along with low density scattered clumps of *Posidonia* (see section c. below for more seagrass density and distribution details). The mixed seagrass bed extended offshore to 31 m beyond the end of the timber skid ramp, at which point the sandy seabed became unvegetated.

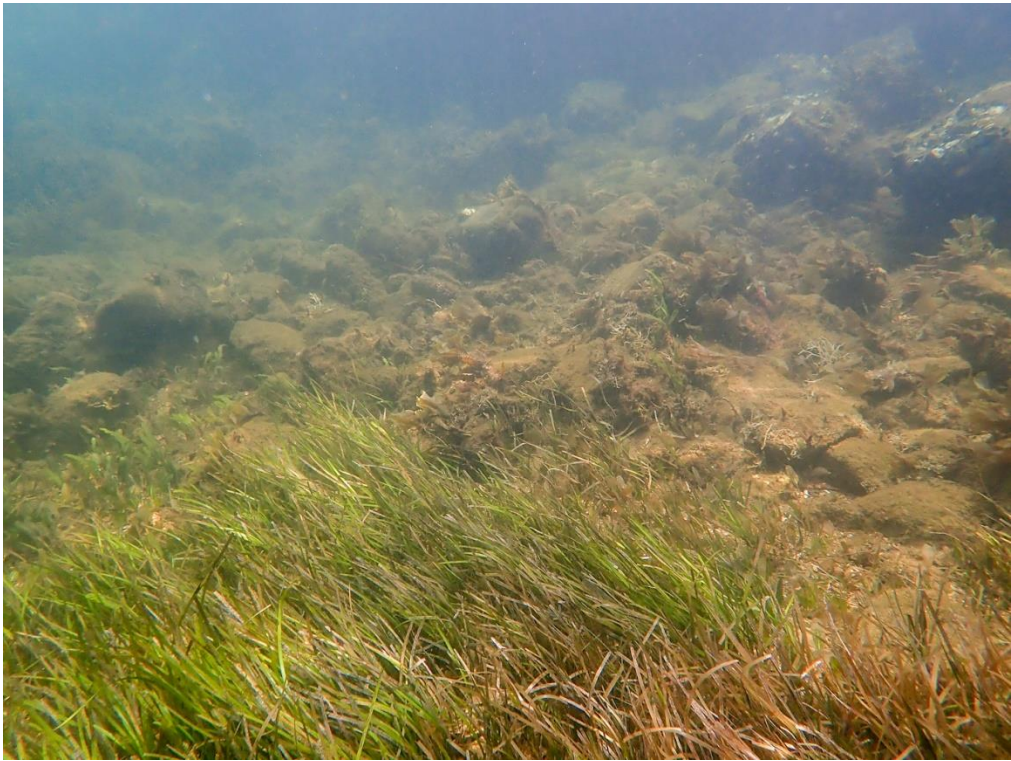
Photo 7. The inner margin of the narrow bed of medium density *Zostera* (ZosC2L) that started at the end of the rocky reef.

There was a narrow bed of medium density, long leaved *Zostera* (ZosC2L; Photos 7 - 8) that started at the end of the rocky reef and extended offshore for 5.4 m. The above *Zostera* bed transitioned to a 14 m wide bed of mixed seagrass (Photos 9 - 10). The mixed bed consisted of low to medium density, long leaved *Zostera* (ZosC1/2L); medium density *Halophila* (HalC2L); low density clumps of long leaved *Posidonia* (PosA1L) that were scattered across the seabed, with gaps of up to 2 - 3 m between each clump (Photos 9 - 10); and a low density cover of the green invasive weed *Caulerpa taxifolia*.

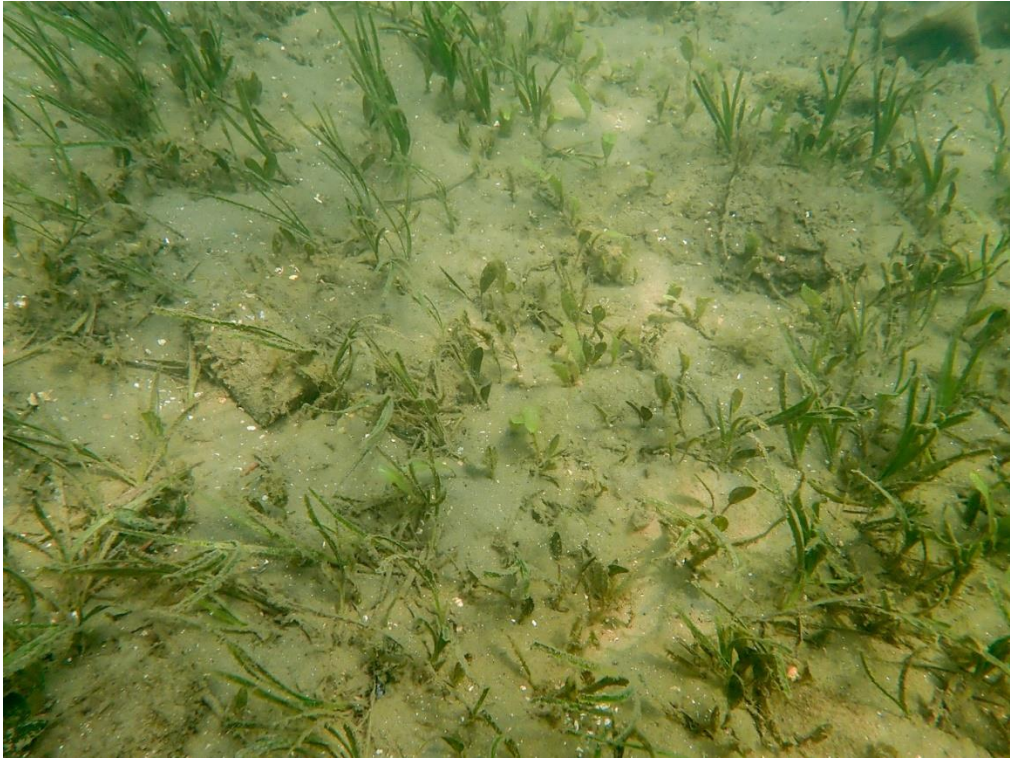
Photo 9. Mixed bed of medium density *Halophila* and low density *Zostera* (HalC2L/ZosC1L). There were scattered clumps of *Posidonia*, with 2 - 3 m gaps between each clump, within this bed - but the absence of *Posidonia* in this photo is evidence of its patchiness.

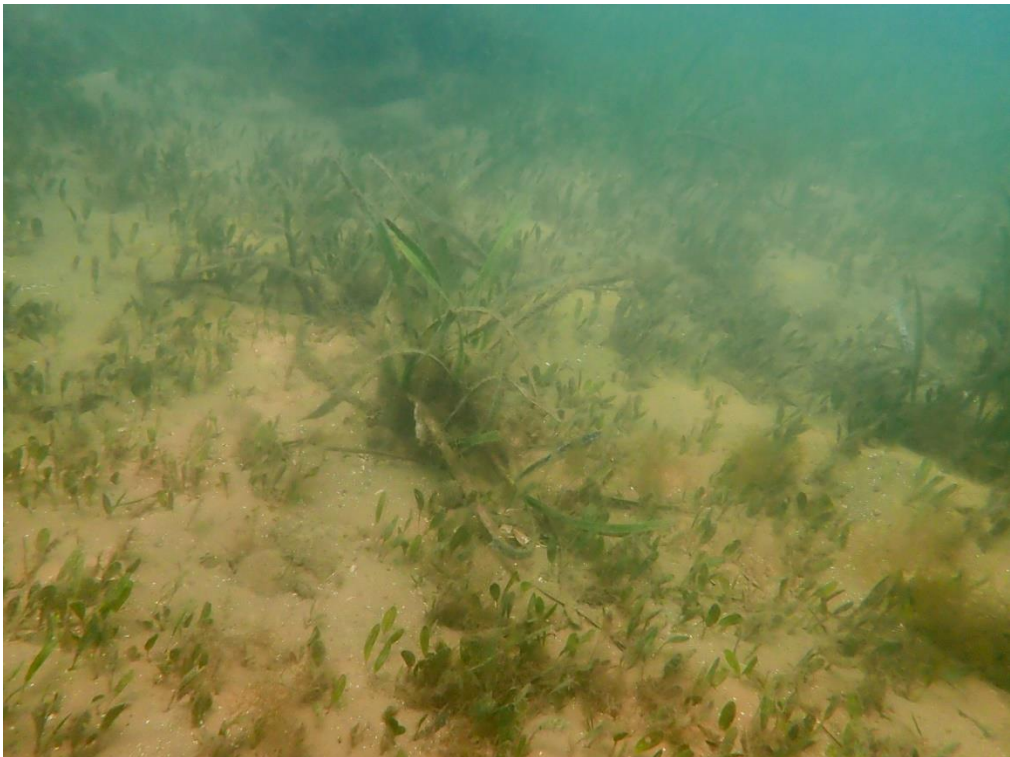
Photo 10. Mixed bed of medium density *Halophila*, low density *Zostera* and scattered clumps of low density *Posidonia* (HalC2L/ZosC1L/PosA1L).
