# Arboricultural Impact Assessment and Management Plan

150 Queenscliff Road, Queenscliff.

Prepared For: **Christina and Anthony Clarke.**

Dated: **October, 2022.**

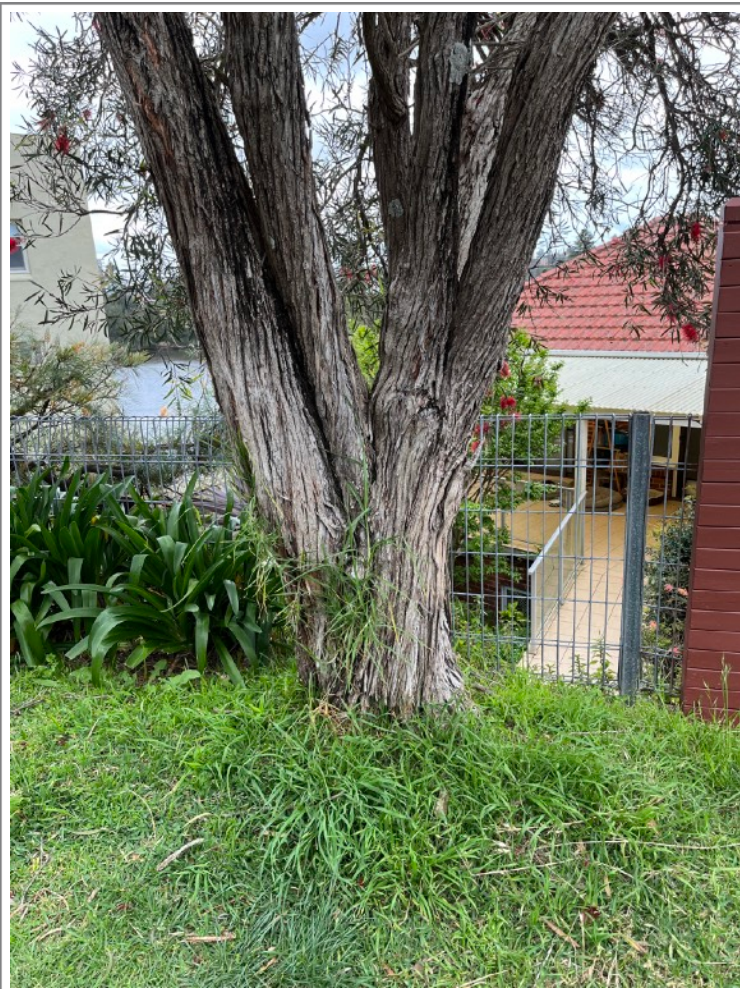
2.2.2 The documented tree is a semi mature example of the species that has been planted directly adjacent to the north of the site's northern boundaries. The tree has grown to approximately 6m in height and is supported on multiple leaders from within 1m of ground level. This canopy is supported on a series of leaders with a combined diameter of less than 50cm in diameter. This basal structure has multiple inclusions, while the tree retains a relatively sparse upper canopy.

3.3 As noted, the tree's basal structure has multiple inclusions. This is a structural fault that can lead to the failure of the sub dominant leader and undermines the value of the tree.

**Figure 1** Shows the poor basal development of the Bottlebrush and the inclusions detailed.

6.1 It will be recommended that the *Callistemon viminalis*, or Bottlebrush be removed.

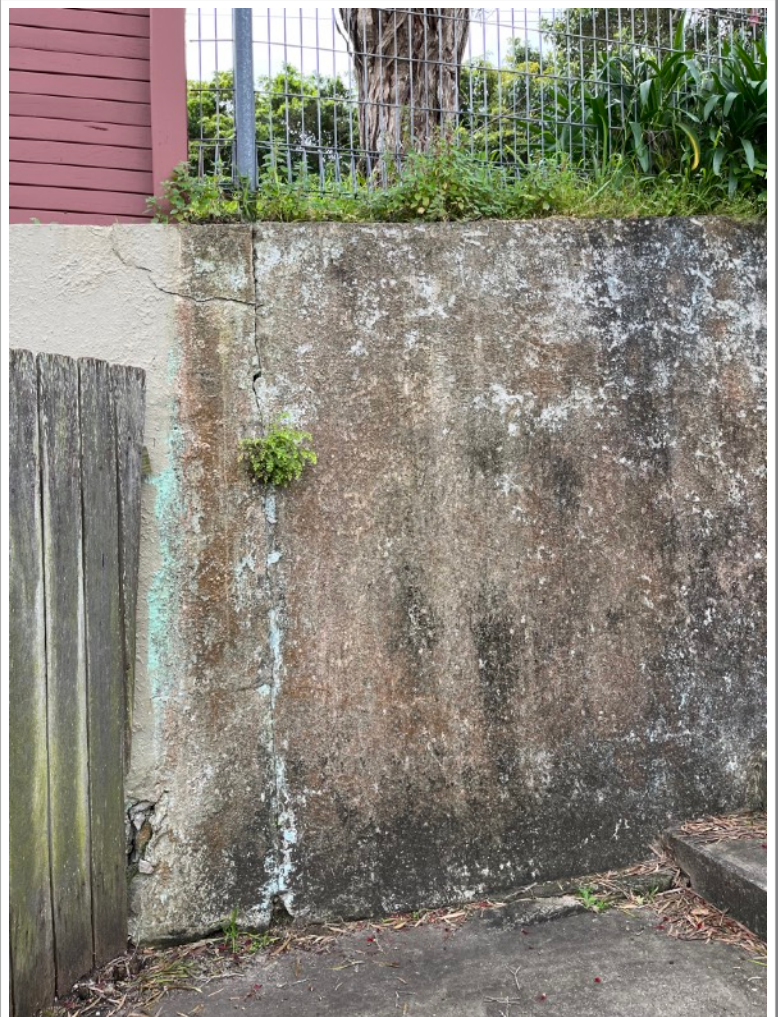
3.4 The tree has forced the boundary wall south resulting in a vertical crack from ground level. **See Figure 2.**

4.1 The *Callistemon viminalis*, or Bottlebrush remains a fraction of its full biological potential with mature examples of the species regularly growing to over 12m in height and can be expected to be supported on trunks of well over 60cm in diameter. The tree has affected the front boundary wall and will continue to in time.

**Figure 2** Shows the compromised northern boundary wall.

4.2 Works required to reconstruct this boundary wall are within the tree's SRZ as outlined within AS4970 for the Protection of Trees on Development Sites and will affect larger diameter tree roots. This will affect both the tree's ability to absorb soil moisture and nutrients as well as structural integrity.
