**REPORT TO  
COURTNEY SMITH**

**ON  
GEOTECHNICAL INVESTIGATION AND  
STABILITY ASSESMENT**

**FOR  
PROPOSED ALTERATIONS AND ADDITIONS**

**AT  
11A MONASH CRESCENT, CLONTARF, NSW**

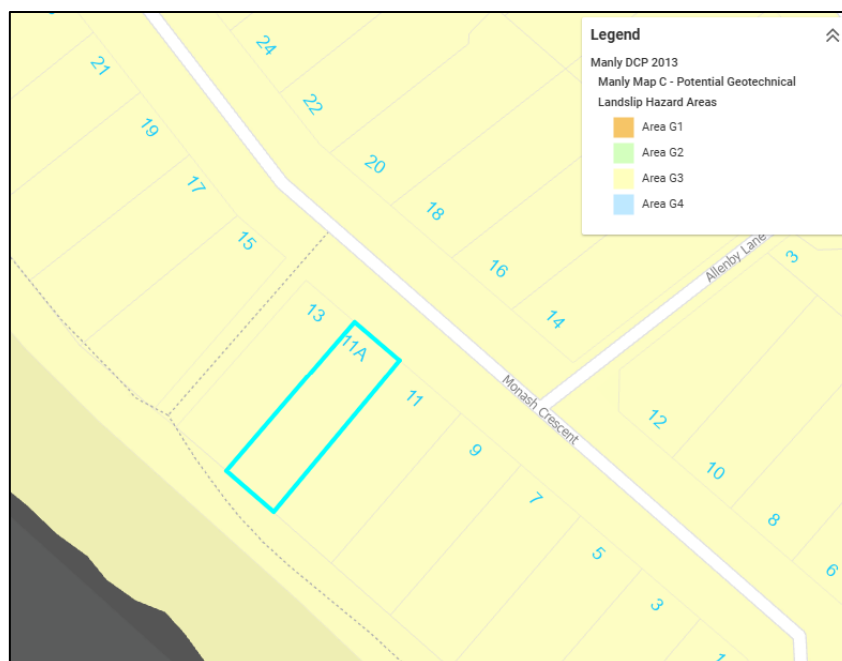
Based on the Northern Beaches online mapping tool, the site falls within a landslip hazard area 'G3', as shown in Plate 2 below. While a slope stability assessment would typically not be required for this site, as greater than 1m of fill is likely to be present behind the seawall and excavation will extend to depths of greater than 2m, an assessment is required. As such, we have undertaken a slope stability assessment.

Plate 2 – Northern Beaches Council Landslip Hazard Mapping
