# *Arboriculture Assessment & Management Statement*

## *for lodged Development Application DA2019/0373)*

**Site:** Lot 9 in DP 8184  
19 Wallumatta Road  
NEWPORT BEACH, NSW

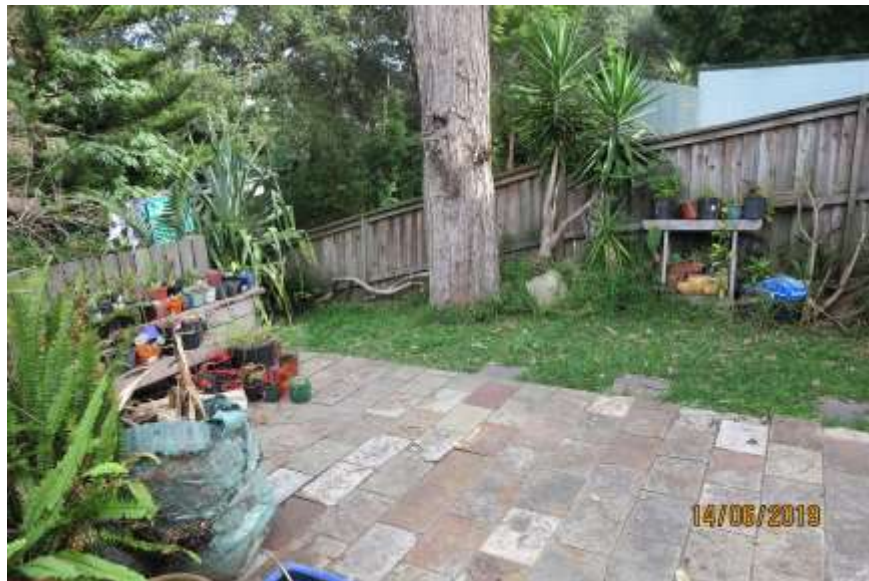
**Figure 8:** Above illustrates the location of Tree #1 relative to existing built infrastructure. Below, illustrates the location of Tree #2 relative to existing built infrastructure.

- *Retain, Protect & Manage*
- *Install “Temporary Metal Mesh Fencing” as close to the calculated TPZ radial distance of 8.20m as the site/proposed works naturally allows.*

- *Retain, Protect & Manage*
- *Install only a 'Tree Trunk Guard' as existing infrastructure to be retained separates soils from works being proposed.*
- *Any excavation required within 8.60m of the tree trunk centre must be completed manually to a depth of 1.00m (or to solid rock). Any 'live woody tree root less than 50mm in diameter may be severed cleanly without the input of the sites retained Practicing/Consulting Arborist, (both written & photographic evidence of works completed must be provided to the Principle Certifying Authority).*

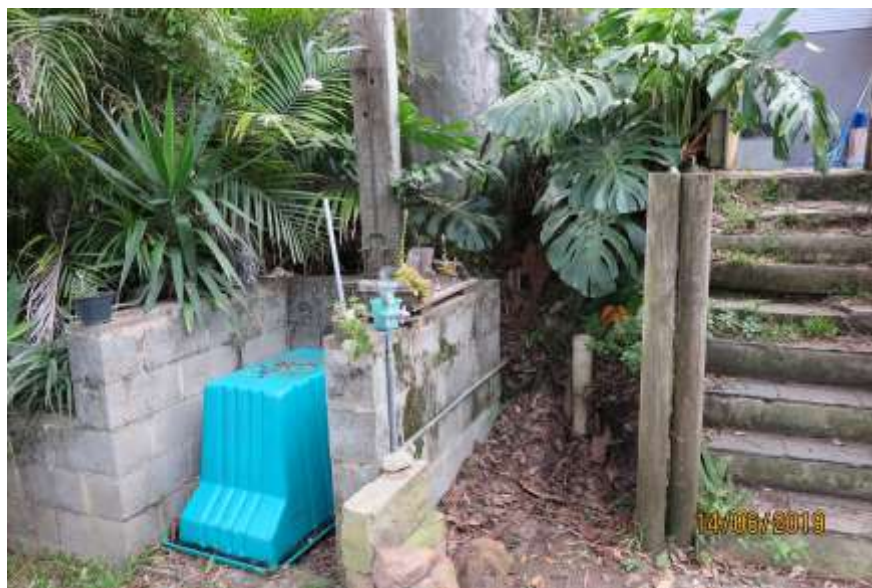
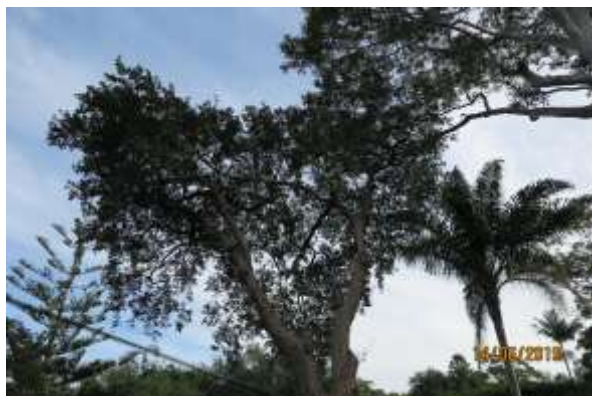
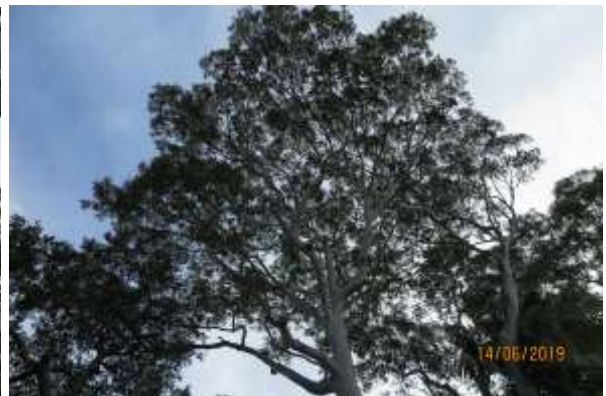
**Figure 9:** Illustrates Tree #1 (left) & Tree #2 (right) canopy condition.

The proposed Alterations & Additions do not require any pruning of either discussed tree canopy.
