| TITLE<br>PROPOSED POOL ELEVATION | | |

**DA0081/2017**

# Arboricultural Assessment Report

### Executive Summary – Achievable (Recommended) AS3959 Level of Compliance

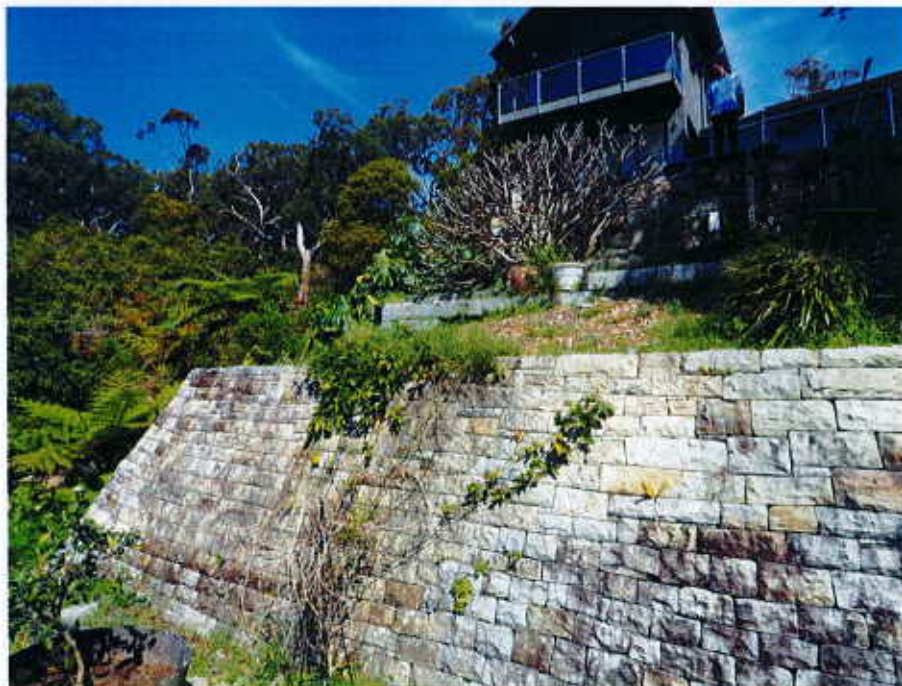
Rear Private Open Space & Dwelling Elevation (Looking Southwest)  
Note sandstone wall in foreground to be retained.
