**Project:** Proposed Residential Development  
**Site Location:** 11 Oak Street, North Narrabeen NSW 2101  
**Reference:** 13942-GR-1-1  
**Report Date:** 22 October 2021

**Geotechnical Investigation Report**

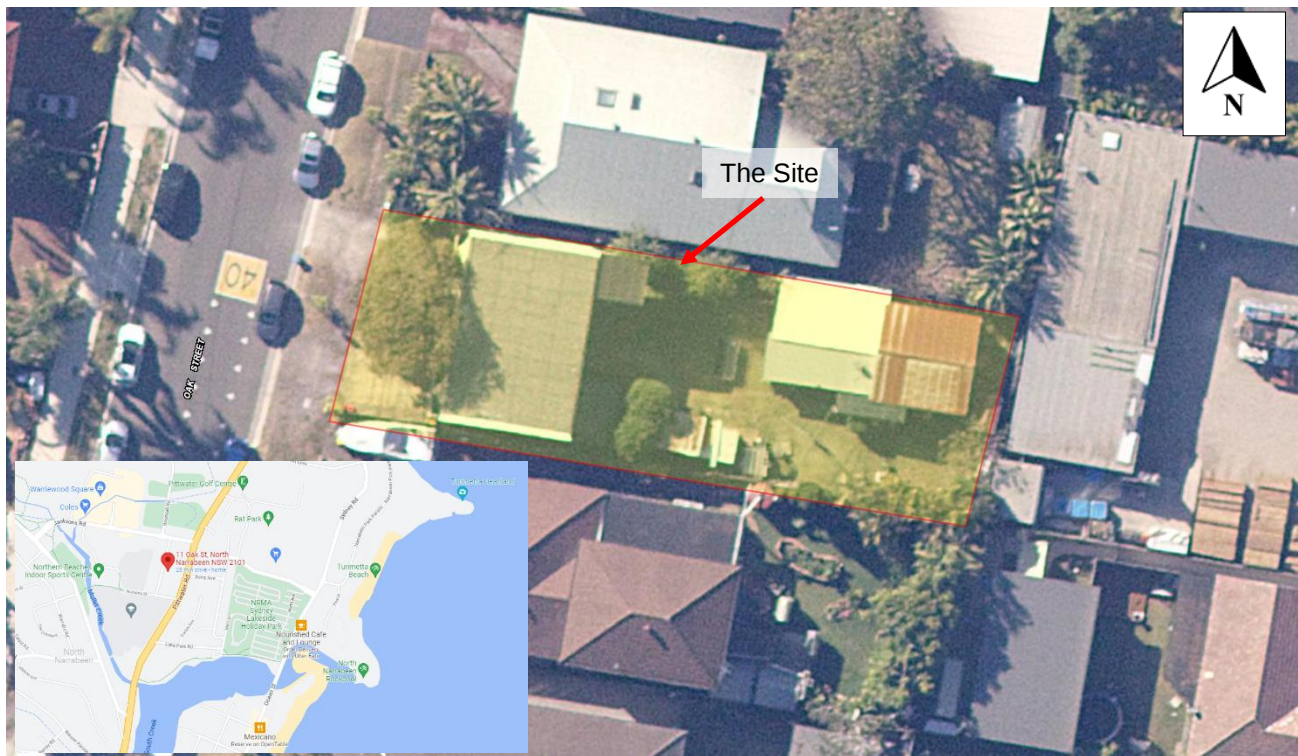
**Figure 1 - The Site Location**

The site is a residential dwelling within the suburb of North Narrabeen, part of the Northern Beaches Council, and comprises a rectangular block of land with an approximate total area of 693m<sup>2</sup>. The site is bounded by Oak Street to the west, and residential properties in all other directions as shown in Figure 1.

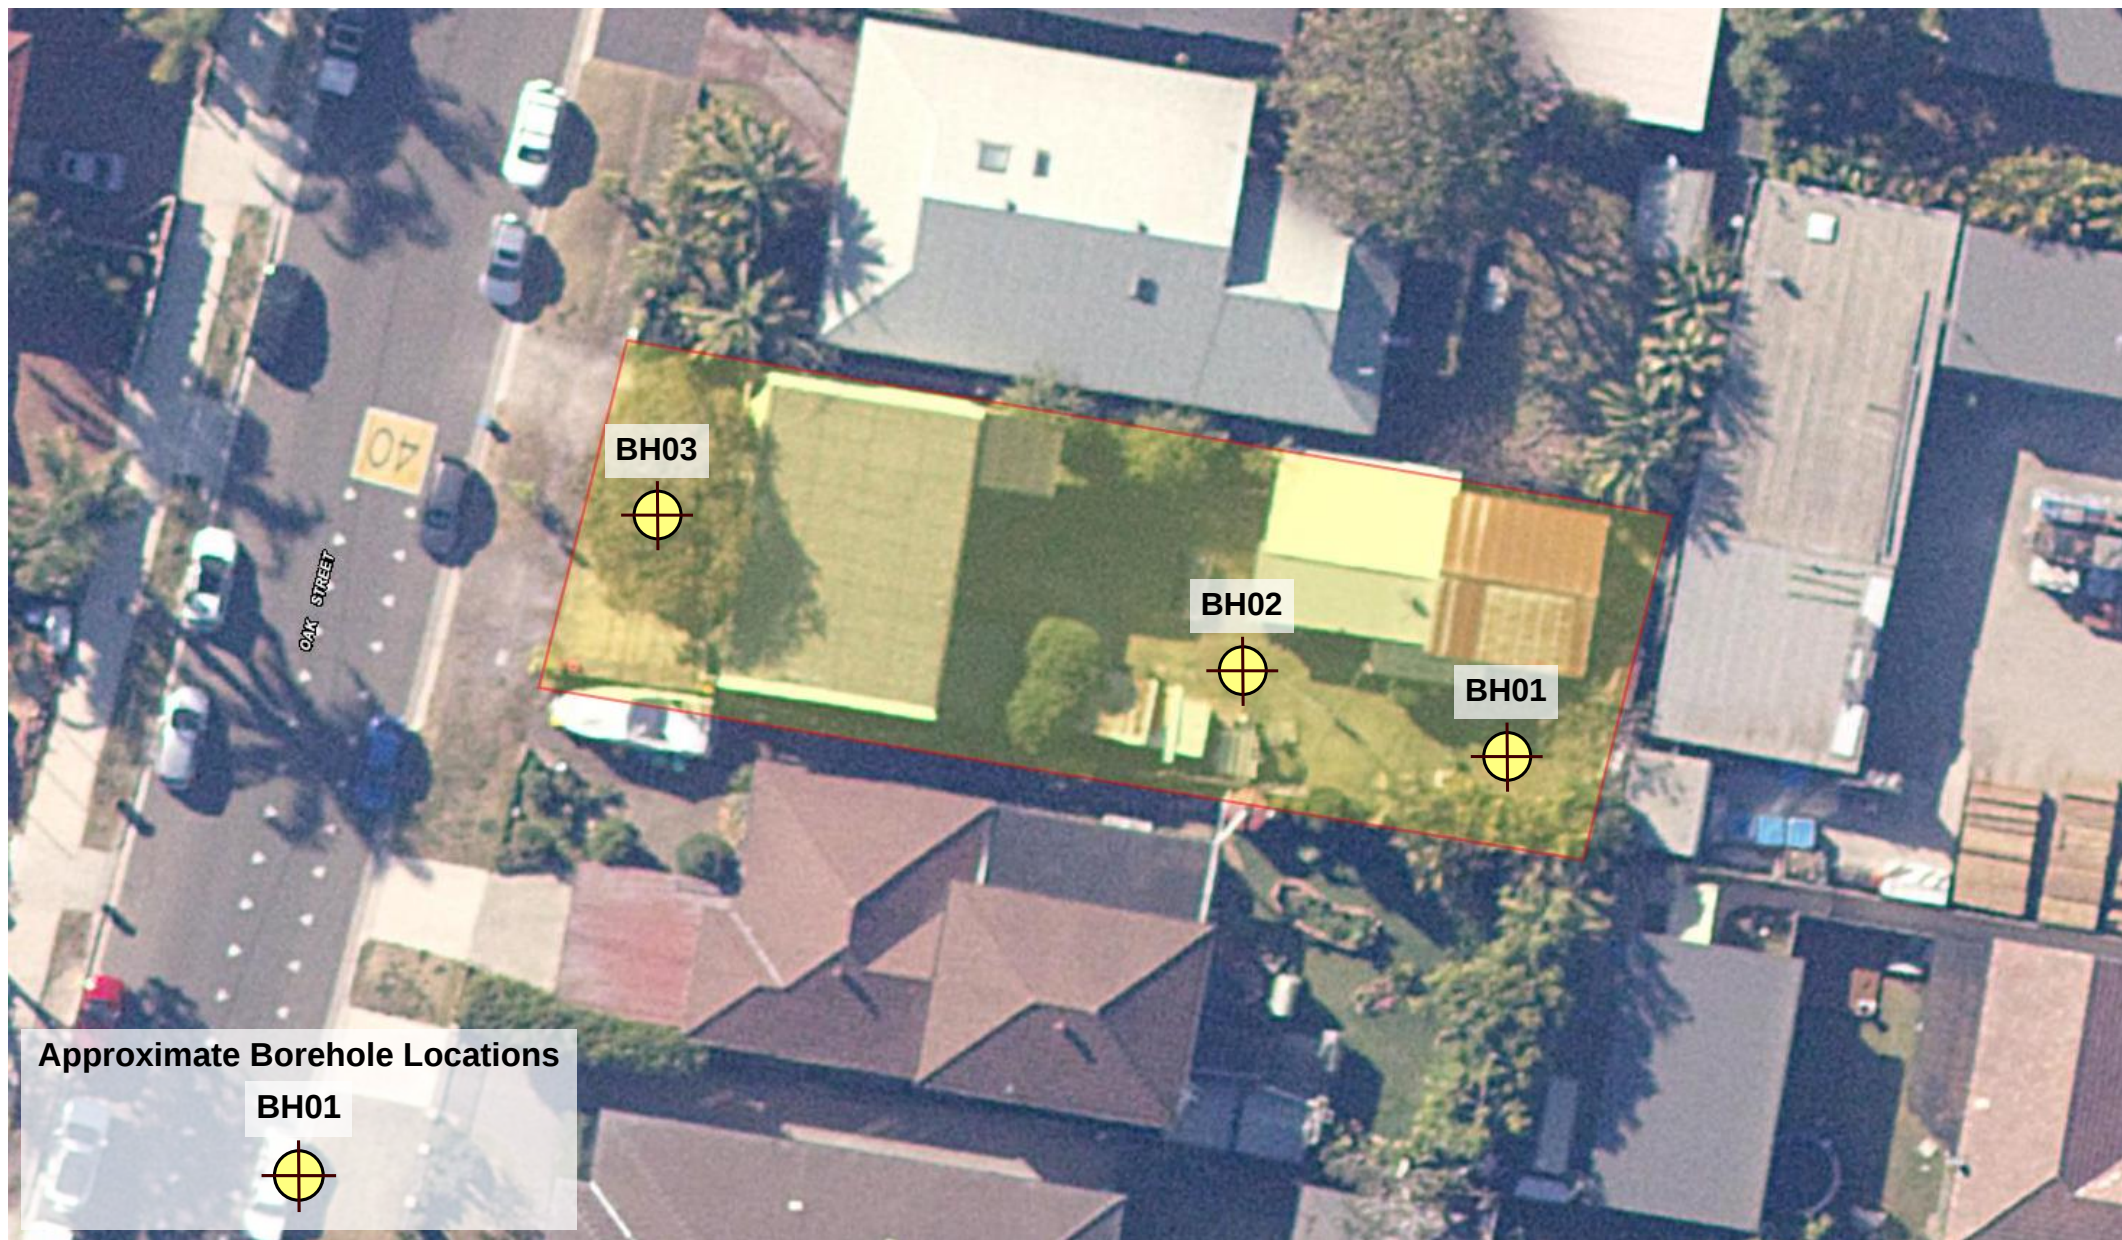
**Attachment B – Geotechnical Investigation Plan (Drawing 13942-GR-1-A)**

After the site walkover and inspection, the proposed borehole positions located on site were checked against Dial Before You Dig (DBYD) plans for services and utilities. Three boreholes were hand augered to a maximum refusal depth of 2.6m below ground level (BGL) on inferred dense sand within the footprint of the proposed structures.

Geotechnical Investigation Plan (Not to Scale)
