# **Marine Habitat Survey 129 Riverview Road, Avalon Beach**

Prepared For: Copley Marine Consulting Group  
Report Date: 22 November 2019

### Document Details

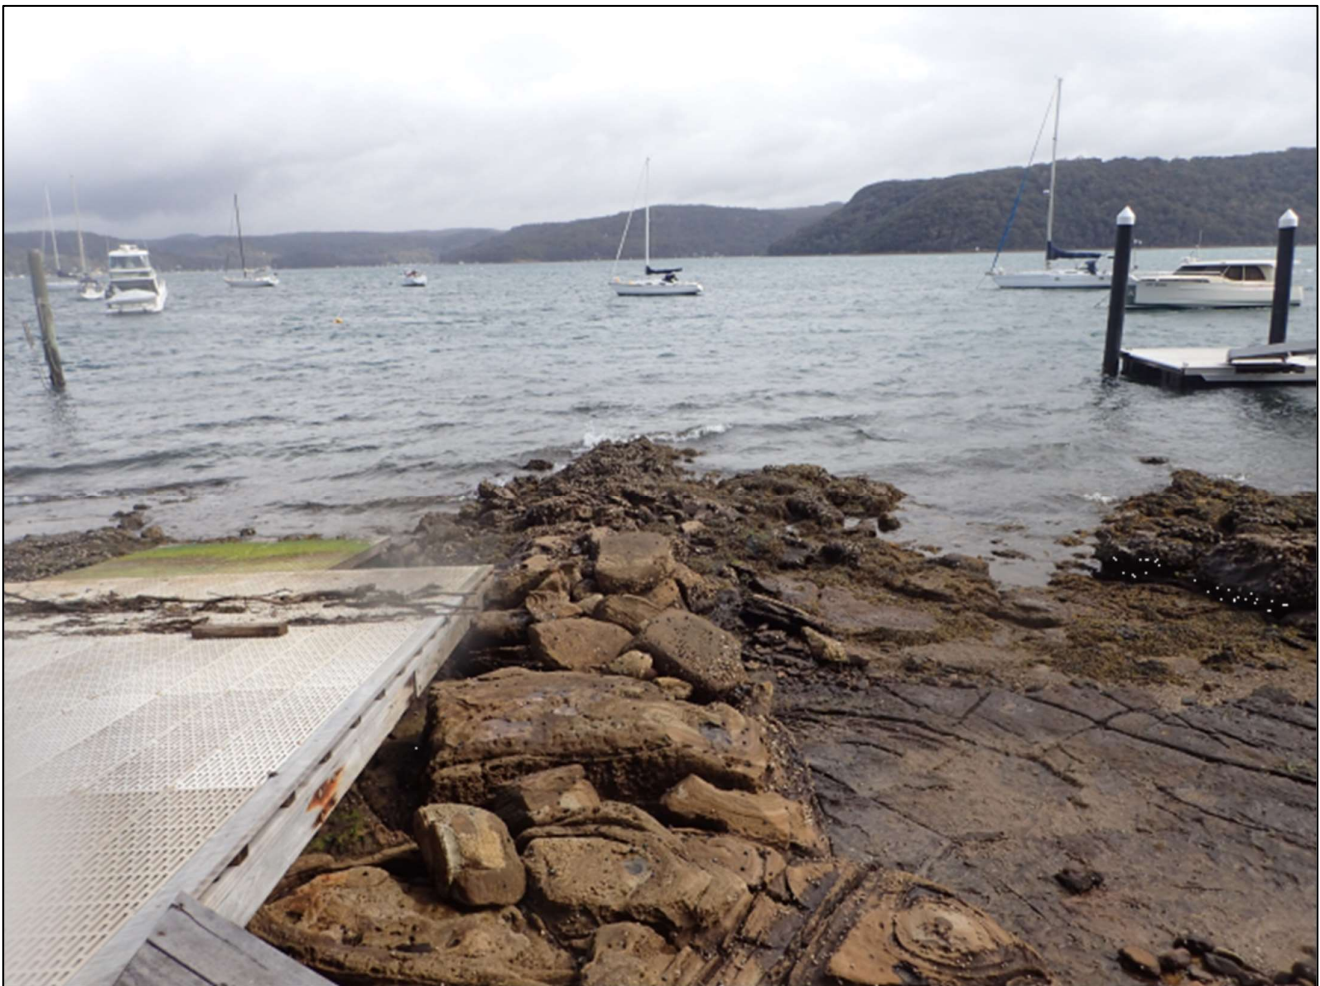
The structure is proposed adjacent (and on the northern side) of an existing boatshed ramp at the subject site (Figure 3 and 4).

Figure 3: Location proposed for the additional waterfront structures adjacent to the existing boatshed ramp.

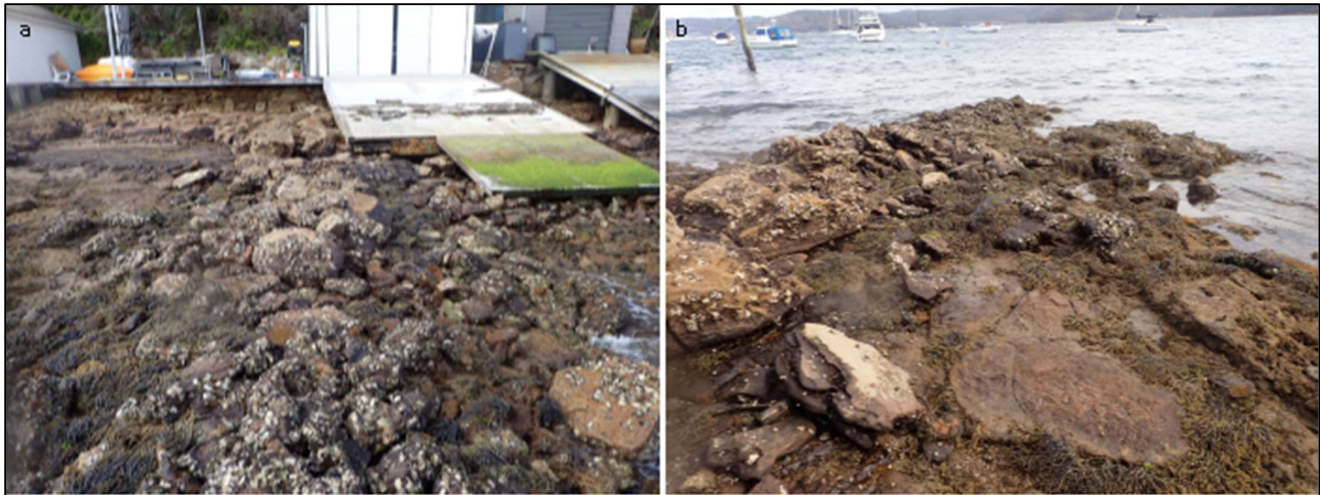
The Intertidal zone consisted of a mixture of rock shelf, rubble and ballast rock. This rocky intertidal area extended between 10 and 15 m from the shoreline and formed an irregular groyne adjacent to the existing ramp and along the alignment of the proposed jetty (Figure 6). Habitat was dominated by Sydney rock oysters (*Saccostrea glomerata*), periwinkles (*Bembicium nanum*, *Austrocochlea porcata* and *Nodilittorina unifasciata*), oyster limpets (*Patelloida mimula*), mulberry whelks (*Morula marginalba*), black nerites (*Nerita atramentosa*).

In lower areas a dense cover of the common brown macroalga *Hormosira banksii* smothered areas of rock and rubble. Some small patches of the common green alga *Ulva* sp. were also present in the intertidal area. No other intertidal vegetation was observed.

Figure 6: Typical rocky intertidal habitat forming an irregular rock groyne, looking (a) from the water's edge, (b) and the shore.

- Disturbance of intertidal habitat during installation of the jetty piers and shading from the jetty. Intertidal habitat within the proposal footprint is confined to a rocky shoreline with species that commonly occur within the locality and are considered less sensitive to shading impacts.

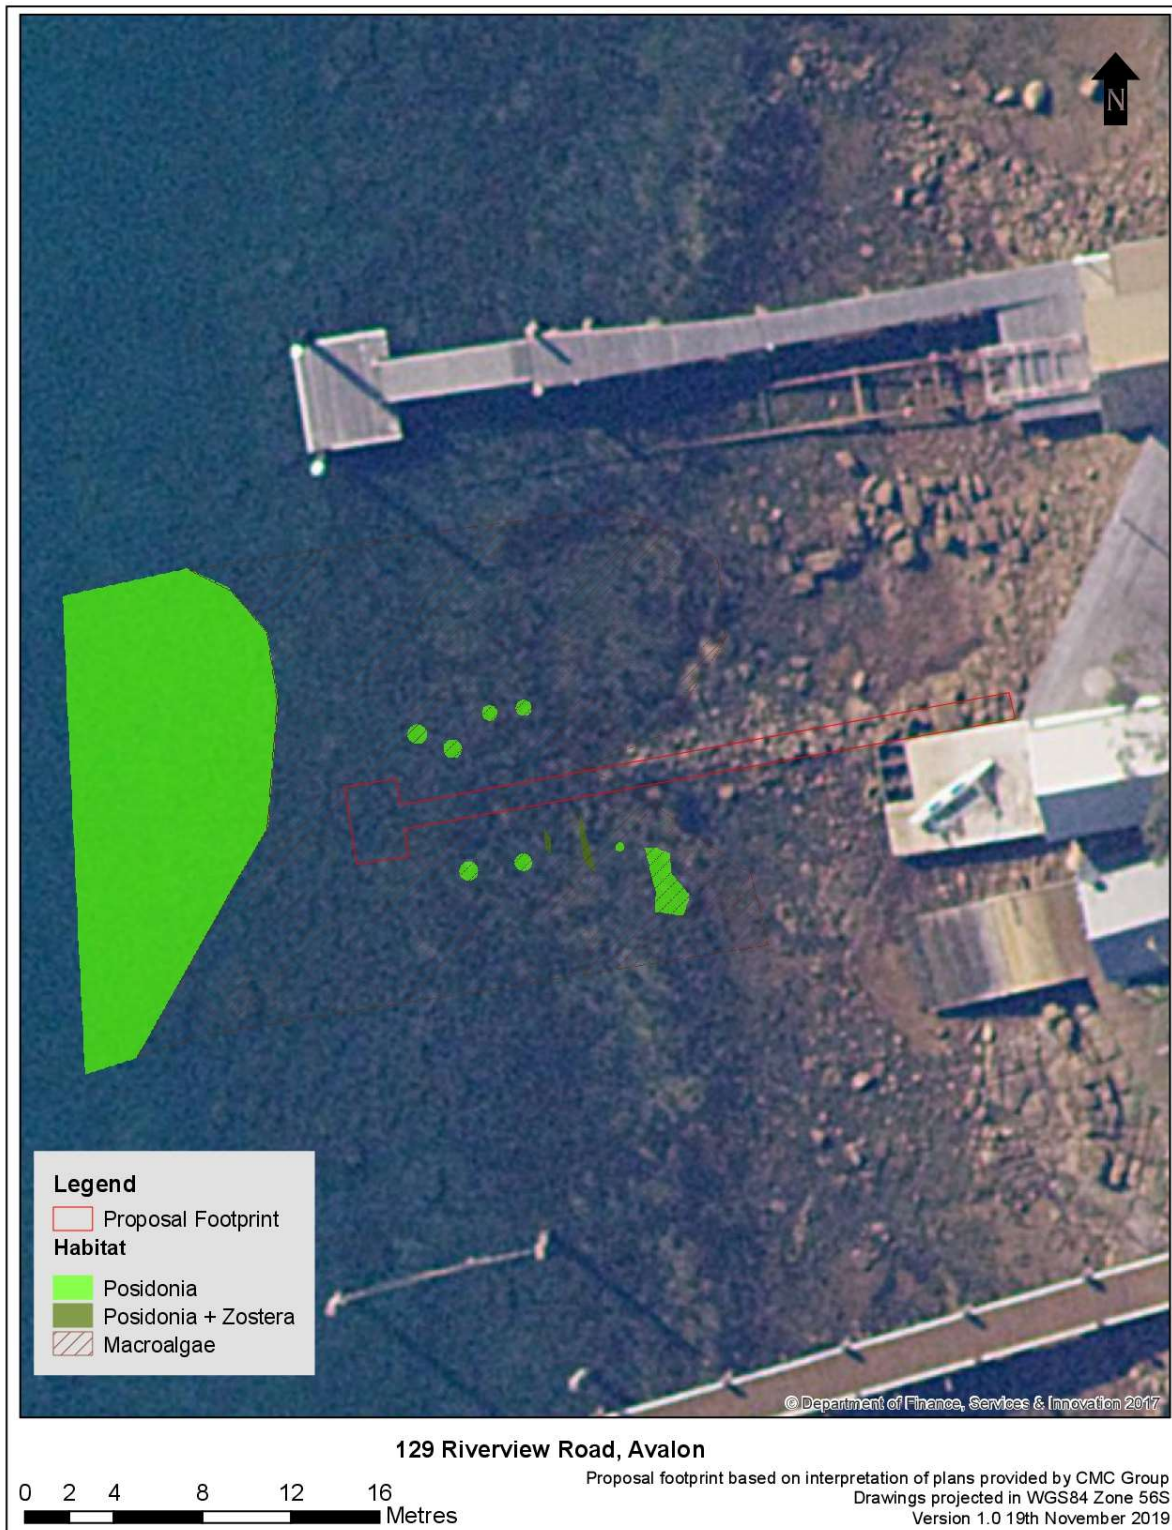
Figure 8: Map of benthic habitat showing seagrass in the study area

The Endangered Population in Pittwater of *Posidonia australis* seagrass occurs in this area. The majority of *P. australis* is confined to a larger bed approximately 3 to 5 m seaward of the proposal (Figure 8), where it is growing in medium density (Figure 9). Some small and very low-density patches of *P. australis* restricted to areas where sediment had accumulated between the rocks were also found in closer proximity to the structure, which were as close as 1 to 2 m to the proposal footprint in places (Figure 8). The majority of these small isolated patches typically consisted of 2 or 3 individual *P. australis* plants (Figure 9).

The proposed development is unlikely to have any impacts on any threatened marine species. The Endangered Seagrass Population in Pittwater of *Posidonia australis* does occur in the study area but is not within the proposal footprint and the majority is 3 m or greater beyond the proposal footprint. There is also minimal potential from this proposal to impact on any other threatened species of fish, sharks and marine mammals, which are typically only likely to be transient visitors to the site at times. However, the Endangered white's seahorse (*Hippocampus whitei*) is known to utilise artificial habitat and may utilise habitat provided by the pylons associated with this structure in the future.
