# Stage 2 Detailed Site Investigation

1 Bibbenluke Avenue, Duffys Forest, NSW

5046200086 – R02

Prepared for Mr Brian Anschau  
7/10/2020

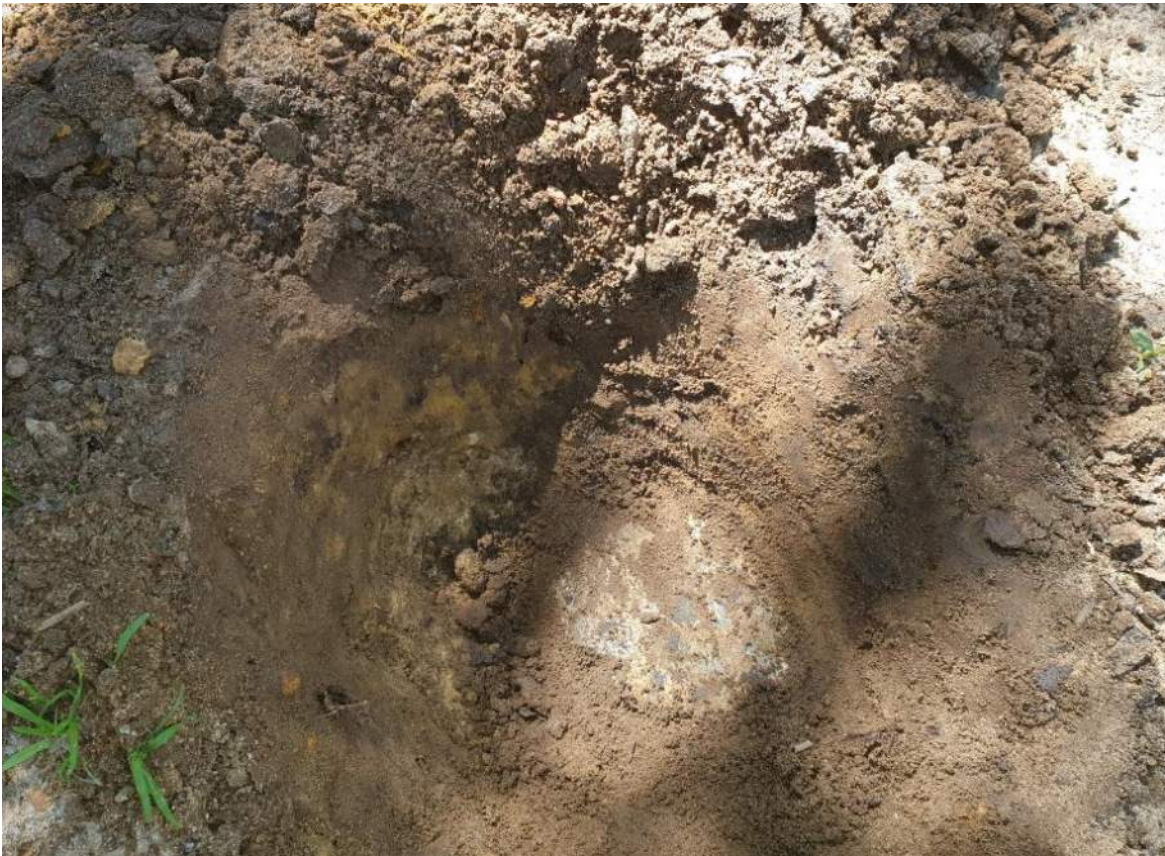
**Image 7.1.1.1 View of test pit at sampling point TP02**

The observations indicated the presence of a shallow fill layer (<0.05m) in a number of test pit, underlain by natural clayey sand. Fill material in test pits TP01 and TP06 contained frags of tiles and terracotta.

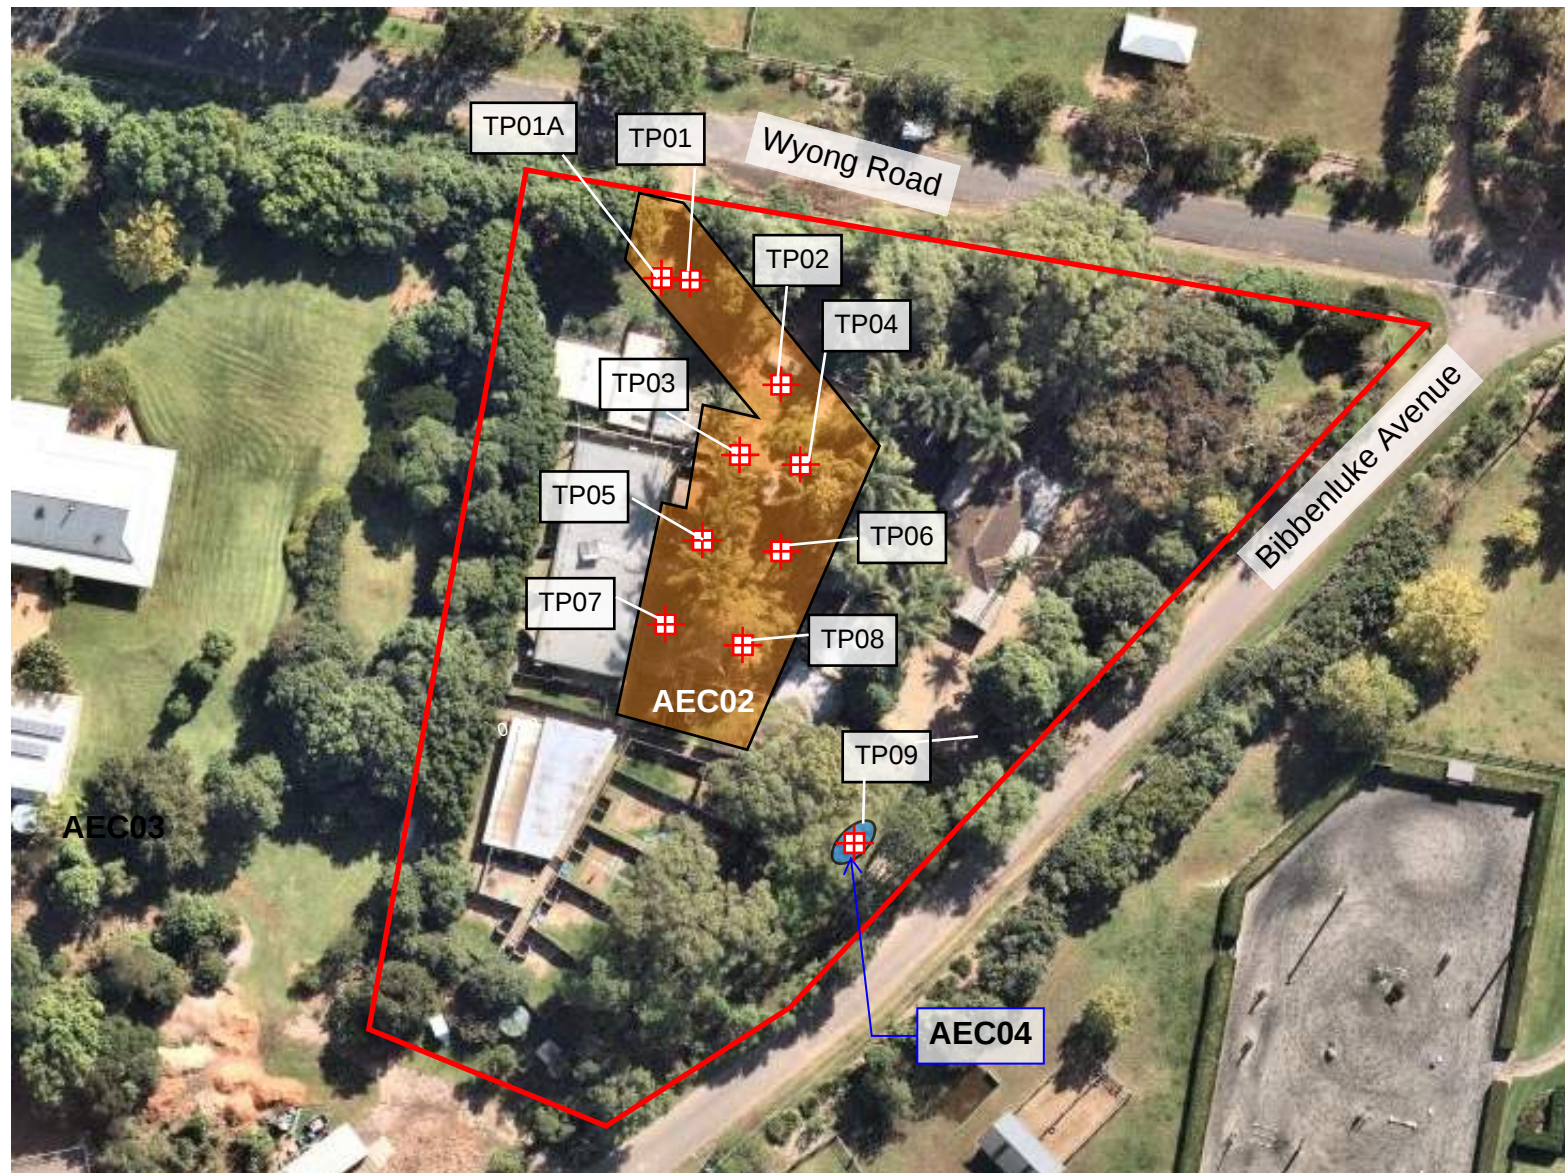
Site Layout

- AEC02 - Demolished Former Building Footprints
- AEC04 - Shallow Fill Area
- Approximate site boundary
- Sample Locations
