# Arboricultural Impact Assessment

**Proposed New Carport at  
885 Barrenjoey Road, Palm Beach**

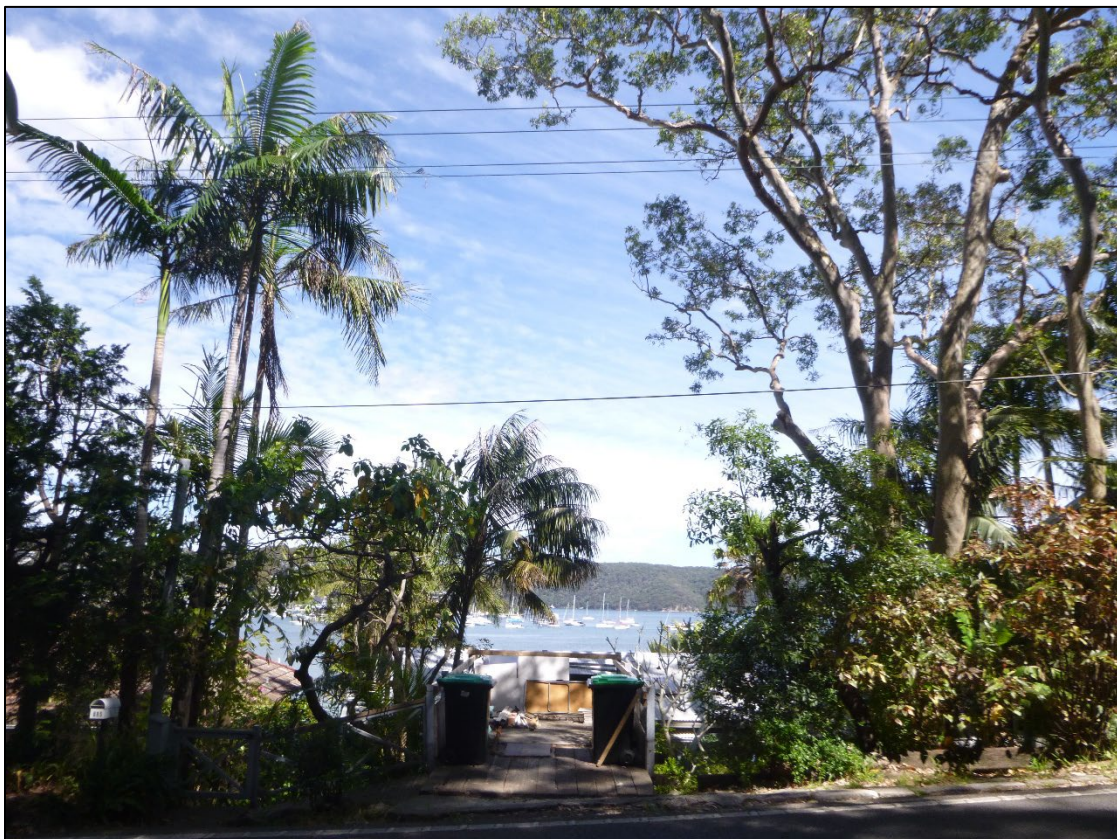
**Photo A:** Subject trees viewed from the site frontage.
