**GEOTECHNICAL RISK MANAGEMENT POLICY FOR PITTWATER**  
**FORM NO. 1 – To be submitted with Development Application**

MR 30529  
6<sup>th</sup> April, 2016  
Page 1

## **RISK ANALYSIS & MANAGEMENT FOR PROPOSED ALTERATIONS, ADDITIONS AND POOL AT 907 BARRENJOEY ROAD PALM BEACH**

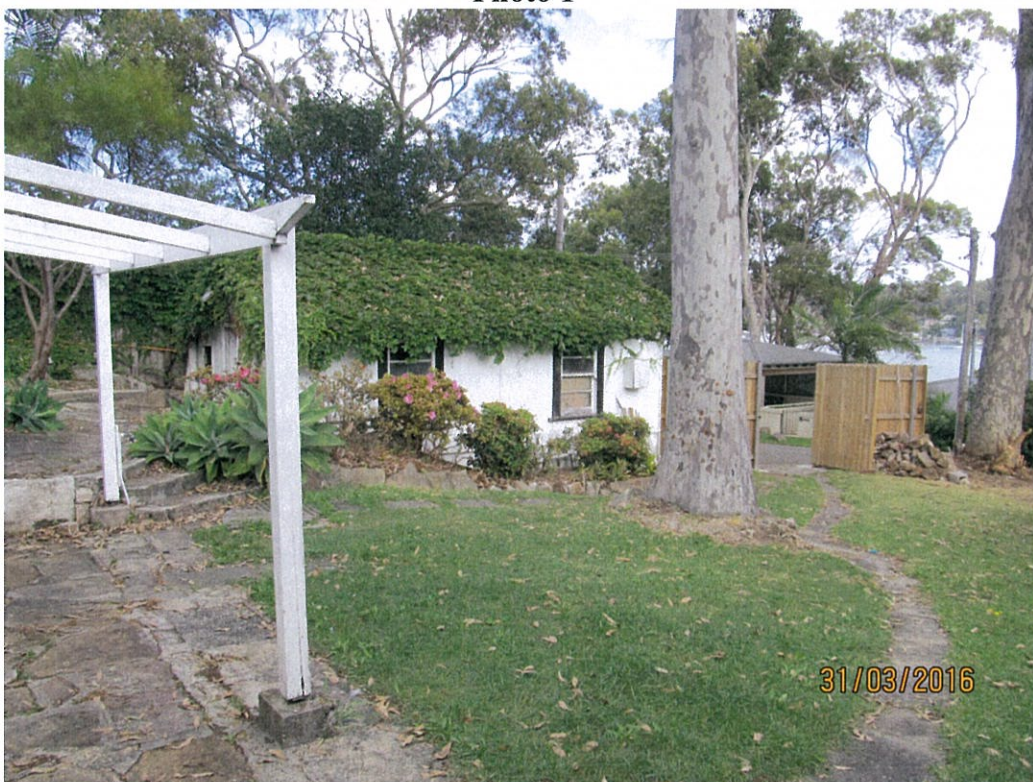
Photo 1

**3.3** Primary vehicular access to the block is via the Thyra Road frontage. From the road frontage a short concrete vehicle crossing and driveway rise to a detached single garage situated toward the south-western corner of the block (Photo 1). The cut batter for the road was supported by a stable sandstone flagging wall. At the time of our inspection the wall was being removed and preparations for a retaining wall and fence were underway (Photo 1). A gently sloping lawn covered yard extends from the rear of the residence to the western boundary (Photo 2). The cut for the garage is supported by a stable formed concrete wall. While considered stable in its current condition, the wall shows evidence of significant cracking and failure at its south-eastern corner (Photos 3 & 4). We would recommend the wall be demolished as part of the proposed works. A paved and sandstone patio extends from the western side of the existing residence (Photo 5). Access around the house is possible along concrete pathways that extend along the northern and southern sides of the residence (Photos 6 & 7). A terraced garden area extends from the eastern side of the residence to a recently constructed timber fence (Photos 8 & 9). The paved and grassed terraces and garden beds are supported by stable concrete block walls. A clad shed is situated along the northern boundary (Photo 9). The eastern section of the block has been landscaped with the upper level terrace at road level supported by a low concrete block wall (Photos 10 & 11). Vehicular access to the block is also possible via a gate at the Barrenjoey Road frontage (Photo 12).

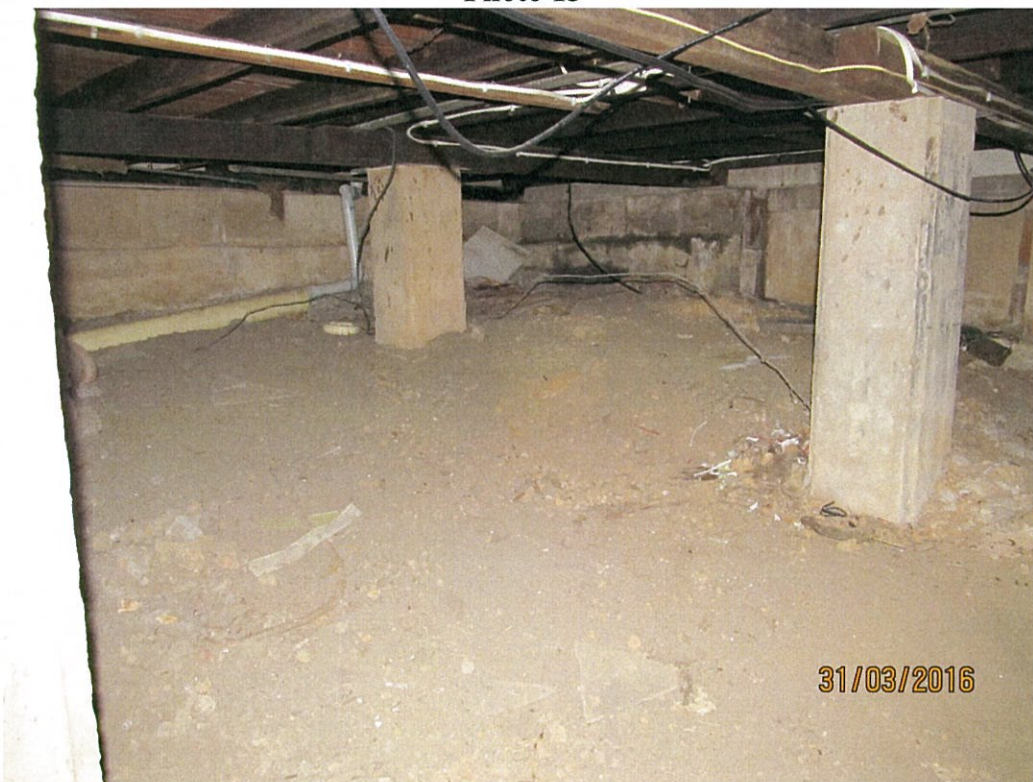
Photo 13

**3.4** The part-two storey brick and clad residence is in average condition for its age. It is supported on brick walls and piers that displayed no evidence of cracking or significant movement that could be identified at the time of our inspection (Photos 13 & 14).
