# **34 Coasters Retreat**

## **Arboricultural Assessment and Report**

**January 2016**

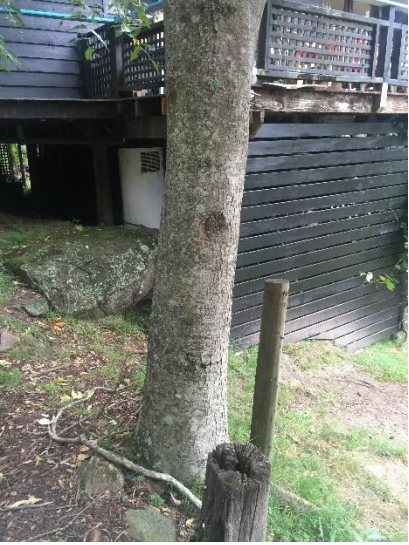
| <p>Tree 1 trunk</p> | <p>Tree 1 part canopy showing proximity to existing neighbouring property</p> |

- Tree #1: With careful excavation (i.e. manual excavation) for flexibly located footings/support piers (these must be outside the Structural Root Zone radial distance of 2.70m) this tree's “Useful Life Expectancy” is very unlikely to be compromised by the development proposal.

No temporary “Tree Protection Zone” fencing is specified as the proposed works are largely within its calculated TPZ radial distance of 7.20m.

As the proposal is a suspended structure the building footprint will itself act as an exclusion zone.

No inground services are to installed within the TPZ radial distance.

Excavated footing/pier sites within the TPZ radial distance are to be photographed as evidence the excavation has not damaged any significant diameter woody tree root.

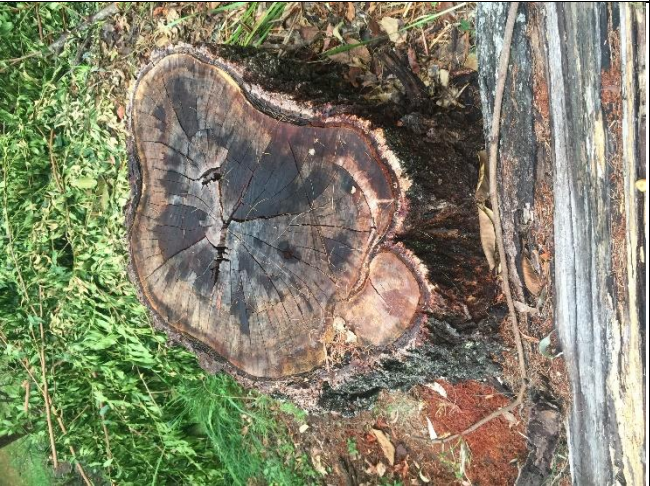
- Tree #2: This tree is confirmed to have been removed by unknown persons prior to our data collection process.

| <p>Trees at entrance – no development proposed here.</p> | <p>Tree 2 – cut tree</p> |

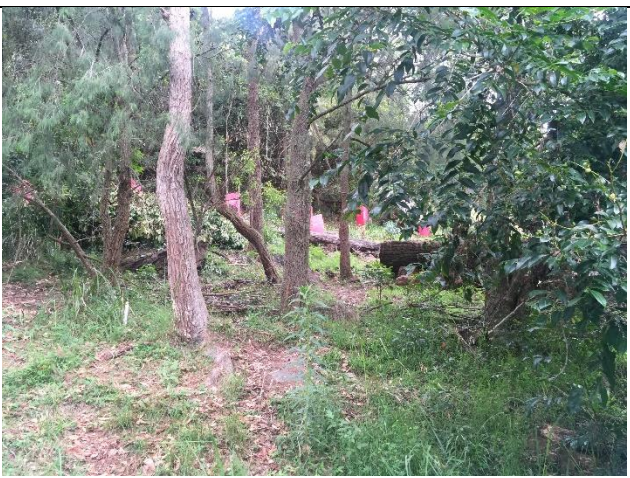
| <p>Tree 3 group of <i>Allocasuarina torulosa</i></p> | <p>Canopy of Tree 10</p> |

- Trees #3: This is actually a group of 6 same species trees. With careful excavation (i.e. manual excavation) for flexibly located footings/support piers (these must be outside the Structural Root Zone radial distance of 2.00m) these tree's “Useful Life Expectancy” is very unlikely to be compromised by the development proposal.

Temporary “Tree Protection Zone” fencing is specified as the proposed works are largely outside the calculated TPZ radial distance of 3.60m.

Temporary “Tree Protection Zone” fencing is specified to incorporate the group of 3 trees known as Tree's #4.

No inground services are to installed within the TPZ radial distance.

Excavated footing/pier sites within their TPZ radial distance are to be photographed as evidence the excavation has not damaged any significant diameter woody tree root.
